KITSAP COUNTY COURTHOUSE FINAL REPORT

SUBJECT: Kitsap County Courthouse
Existing Site Conditions Assessment

SUBJECT: Kitsap County Courthouse
Design Recommendations

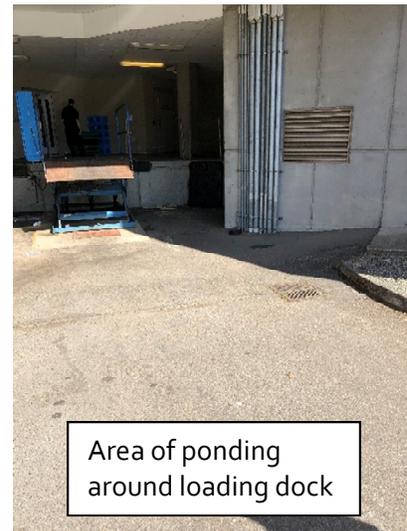
- Ponding within the existing loading dock area north and east of the existing jail.
- Numerous existing stormwater structures are not within localized low points and stormwater flow paths and functionally unable to collect stormwater. The overall grading within the area of concern drains to the loading dock area discussed above, and likely contributes to the ponding issues noted.

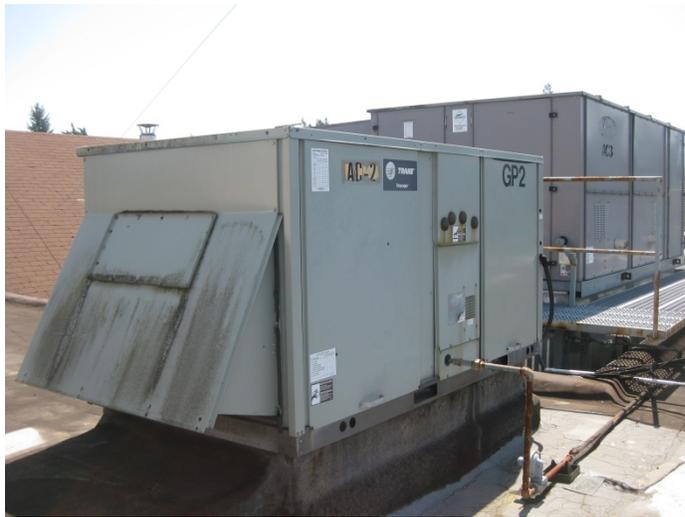
Figure 1 Typical Rooftop HVAC Equipment

The units typically match the ages of the various building additions/revisions; except that a number of units were replaced as part of a year 2000 energy services project. The newer equipment (still approximately 18 years old) includes the boilers (and pumps), multizone units, penthouse AHU's, two rooftop air conditioning units, some of the gas packs units, and some split system air conditioning units. The other existing equipment is past its useful life and should be scheduled for replacement.

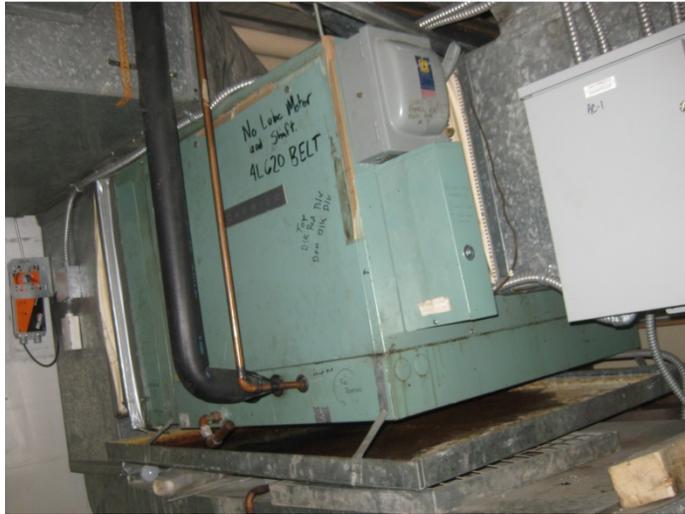
The penthouse air handlers serve a variable-air-volume (VAV) system in the east area of the building with aged VAV terminal units (Trane "Varitrac" units) that are well past their useful life. The penthouse air handler relief fan has failed (and is scheduled for replacement). The condenser/compressor units serving these penthouse air handlers are also past their useful life.

Figure 2 Basement Aged AC Unit

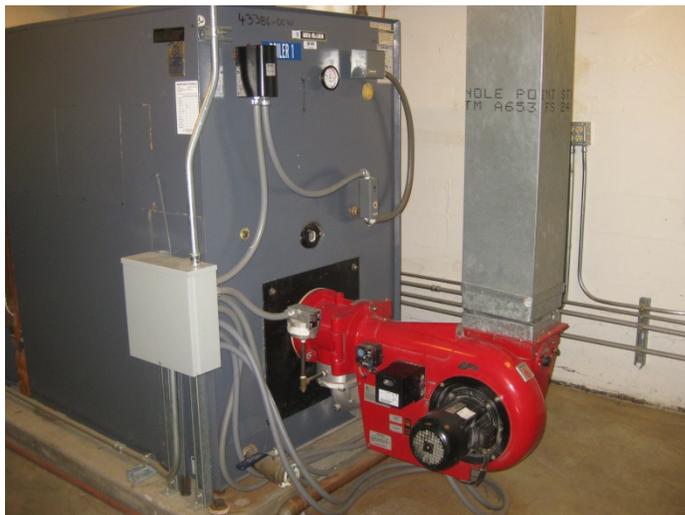
The hydronic system is a hot water heating type, using two central gas fired boilers, located in the basement. The units were installed in 2000, and are Weil McClain sectional cast iron type with 2700 MBH input capacity. The boilers have had newer burners installed, manufactured by Weishaupt. The boilers appear to be in good condition however one boiler was down for repairs. These are considered low efficiency boilers as compared to new condensing type. The piping system is black steel (or copper) and is in fair condition; there is an on-going chemical treatment for the system.

Figure 3 Gas Fired Boiler

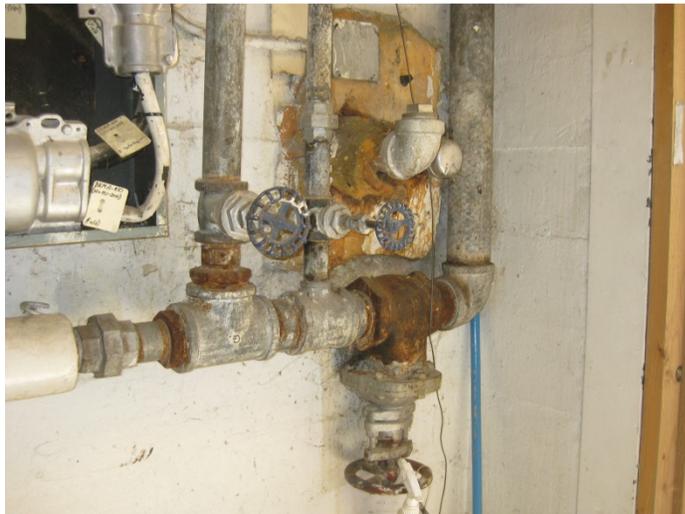
Waste and vent piping systems uses cast iron and galvanized steel piping, and appears to be in fair condition. The domestic water piping is of galvanized steel and copper, and is in poor condition. There have been leaks and the system valves no longer allow for isolation of parts of the building, requiring the entire building water supply to be shut down for maintenance.

Figure 4 Domestic Water Piping

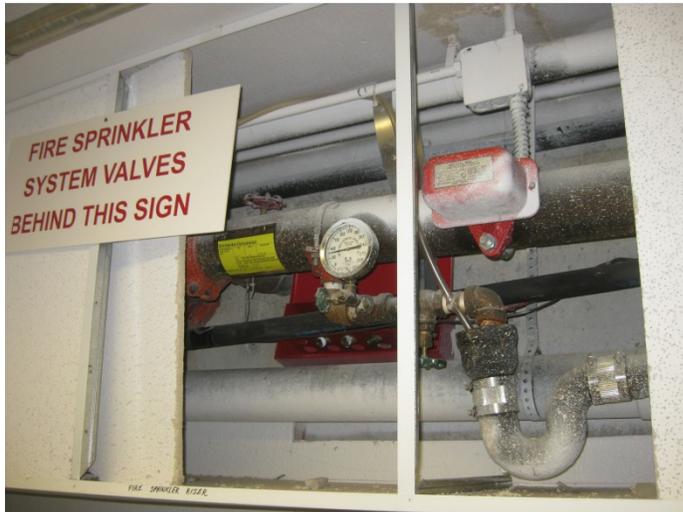
The building is not fire sprinklered except for an office area located in the basement. The alarm assembly for this has poor access which does not comply with current code (located high on wall behind cabinet door). A halon fire suppression system serves the basement server room. Halon is no longer allowed to be manufactured due to environmental issues, but is allowed to remain in place as a fire suppression agent. Current code would require that the entire building be fire sprinklered. We

Figure 5 Fire Sprinkler Valves

recommend that the halon system be phased out since its discharge is harmful to the environment.

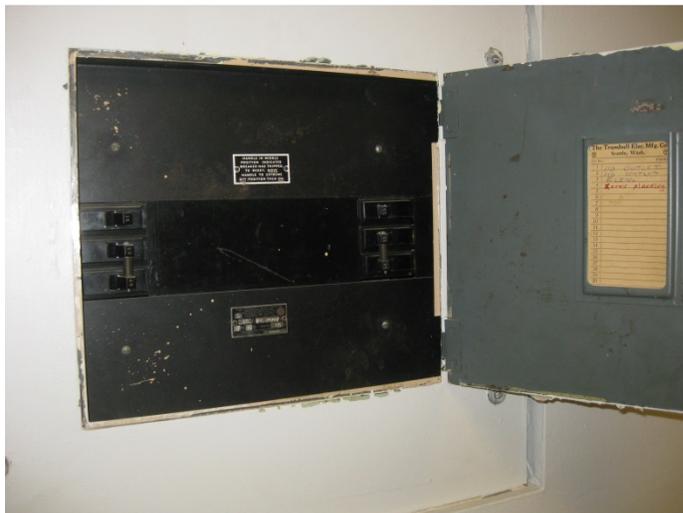
The building is served by a 500 kva pad mounted transformer located at the southwest corner of the building. This transformer serves a 1200 amp 480/277 volt 3-phase main distribution switchboard which serves the main HVAC loads and a 400 kva 120/208 volt indoor transformer. This transformer serves a 1200 amp sub-distribution switchboard for lighting, convenience outlets, and small mechanical loads. In addition the building is served by another pad mounted transformer located at the south side of the building, which is connected to a 2500 amp 120/208 3-phase main distribution switchboard. This panel serves the pre-1978 areas of the building.

Figure 6 Aged Electrical Panel

The building electrical panels are typically manufactured by Square D, with some aged Trumbell panels noted. This newest of this distribution equipment and panels were installed in 1978 and appear to be in fair good condition. However, with an economic useful life of 40 years should be considered for replacement, along with the other panels which are older.
