# Regulated Building Material Survey

**Kitsap County Public Works  
423 South National Avenue  
Bremerton, WA**

**Date Finalized: 4/28/2022**  
**PacRim#: 17384.01**

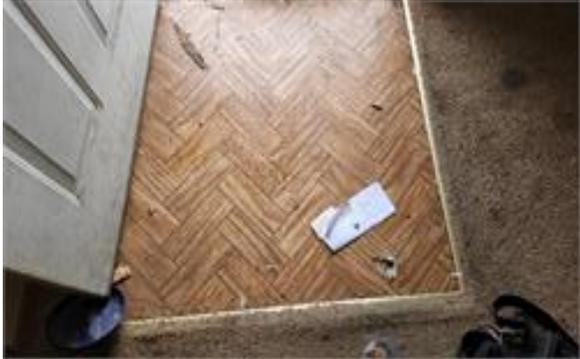
Sample		Sample Date	21-Apr-2022
<b>Project Name</b>	Kitsap County Public Works - 423 S. National Ave.		
<b>Sample Type</b>	Physical Sample	<b>AHERA Category</b>	Miscellaneous
<b>Sample Number</b>	423-01	<b>Homogenous Material Number</b>	1
<b>Material Description</b>	SVF type 1 brown wood pattern		
<b>Homogenous Mtl Area</b>	N/A		
<b>Sample Location</b>	Main floor Room 1 entry		
<b>Quantity</b>	12	<b>Unit of Measure</b>	Square Feet
<b>Asbestos Type/%</b>	<b>None Detected (All Layers)</b>		
<b>Sample Photo</b>

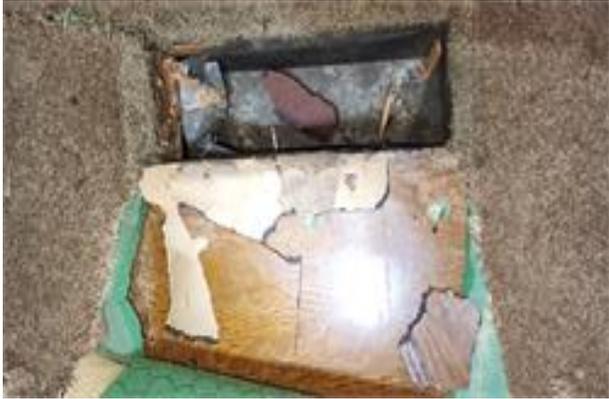
Sample		Sample Date	21-Apr-2022
<b>Project Name</b>	Kitsap County Public Works - 423 S. National Ave.		
<b>Sample Type</b>	Physical Sample	<b>AHERA Category</b>	Miscellaneous
<b>Sample Number</b>	423-02	<b>Homogenous Material Number</b>	2
<b>Material Description</b>	Buried SVF under carpet		
<b>Homogenous Mtl Area</b>	N/A		
<b>Sample Location</b>	Main floor Room 1 under carpet		
<b>Quantity</b>	300	<b>Unit of Measure</b>	Square Feet
<b>Asbestos Type/%</b>	<b>None Detected (Both Layers)</b>		
<b>Sample Photo</b>

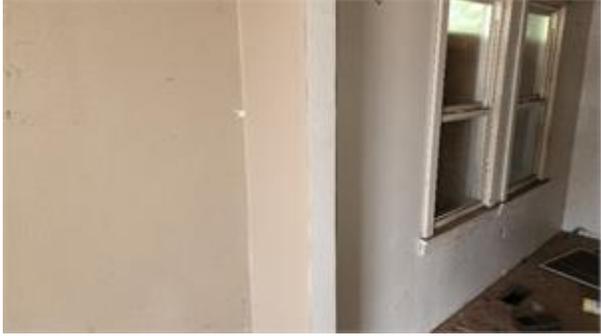
Sample		Sample Date	21-Apr-2022
<b>Project Name</b>	Kitsap County Public Works - 423 S. National Ave.		
<b>Sample Type</b>	Physical Sample	<b>AHERA Category</b>	Miscellaneous
<b>Sample Number</b>	423-03	<b>Homogenous Material Number</b>	3
<b>Material Description</b>	Gypsum Wall Board/Tape/Joint Compound		
<b>Homogenous Mtl Area</b>	N/A		
<b>Sample Location</b>	Main floor room 1		
<b>Quantity</b>	2400	<b>Unit of Measure</b>	Square Feet
<b>Asbestos Type/%</b>	<b>None Detected (All Layers)</b>		
<b>Sample Photo</b>

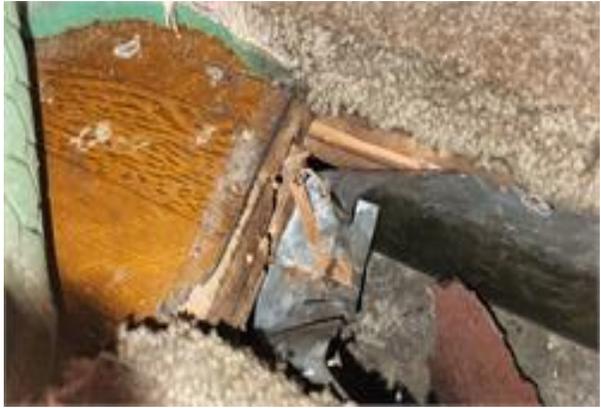
Sample		Sample Date	21-Apr-2022
<b>Project Name</b>	Kitsap County Public Works - 423 S. National Ave.		
<b>Sample Type</b>	Physical Sample	<b>AHERA Category</b>	Miscellaneous
<b>Sample Number</b>	423-04	<b>Homogenous Material Number</b>	4
<b>Material Description</b>	Vapor barrier		
<b>Homogenous Mtl Area</b>	N/A		
<b>Sample Location</b>	Main floor Room 1 under hardwood		
<b>Quantity</b>	1000	<b>Unit of Measure</b>	Square Feet
<b>Asbestos Type/%</b>	<b>None Detected</b>		
<b>Sample Photo</b>

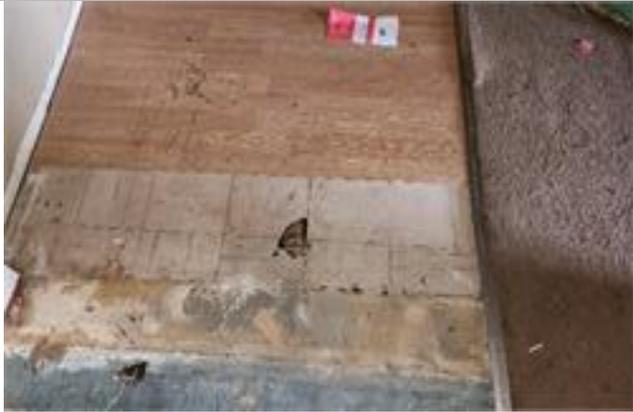
Sample		Sample Date	21-Apr-2022
<b>Project Name</b>	Kitsap County Public Works - 423 S. National Ave.		
<b>Sample Type</b>	Physical Sample	<b>AHERA Category</b>	Miscellaneous
<b>Sample Number</b>	423-05	<b>Homogenous Material Number</b>	5
<b>Material Description</b>	9x9 floor tile and mastic		
<b>Homogenous Mtl Area</b>	N/A		
<b>Sample Location</b>	Main floor Room 1		
<b>Quantity</b>	300	<b>Unit of Measure</b>	Square Feet
<b>Asbestos Type/%</b>	<b>Layer 1: (Vinyl floor tile) Chrysotile 3%</b> <b>Layer 2: (Mastic) None Detected</b> <b>Layer 3: (Vinyl sheet flooring) None Detected</b>		
<b>Sample Photo</b>

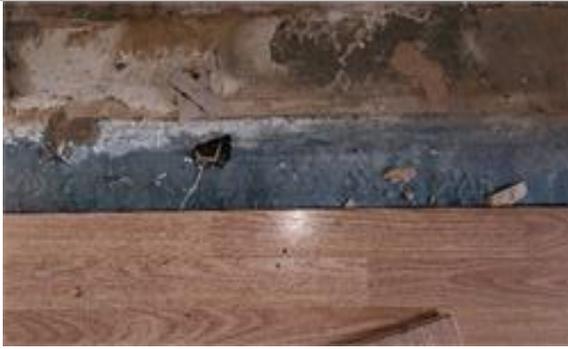
Sample		Sample Date	21-Apr-2022
<b>Project Name</b>	Kitsap County Public Works - 423 S. National Ave.		
<b>Sample Type</b>	Physical Sample	<b>AHERA Category</b>	Miscellaneous
<b>Sample Number</b>	423-06	<b>Homogenous Material Number</b>	6
<b>Material Description</b>	Buried blue svf		
<b>Homogenous Mtl Area</b>	And bathroom		
<b>Sample Location</b>	Main floor Room 1		
<b>Quantity</b>	200	<b>Unit of Measure</b>	Square Feet
<b>Asbestos Type/%</b>	<b>None Detected (Both Layers)</b>		
<b>Sample Photo</b>

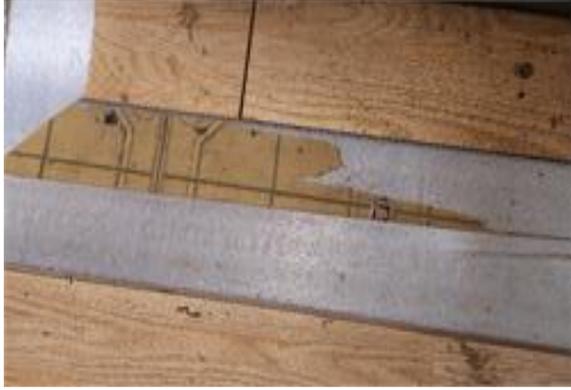
Sample		Sample Date	21-Apr-2022
<b>Project Name</b>	Kitsap County Public Works - 423 S. National Ave.		
<b>Sample Type</b>	Physical Sample	<b>AHERA Category</b>	Miscellaneous
<b>Sample Number</b>	423-07	<b>Homogenous Material Number</b>	7
<b>Material Description</b>	Buried kitchen floor tile and mastic		
<b>Homogenous Mtl Area</b>	N/A		
<b>Sample Location</b>	Kitchen		
<b>Quantity</b>	100	<b>Unit of Measure</b>	Square Feet
<b>Asbestos Type/%</b>	<b>None Detected (Both Layers)</b>		
<b>Sample Photo</b>

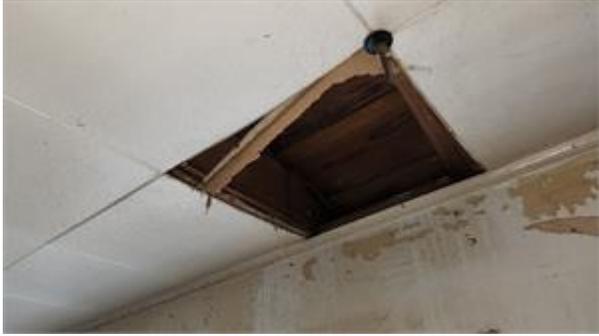
Sample		Sample Date	21-Apr-2022
<b>Project Name</b>	Kitsap County Public Works - 423 S. National Ave.		
<b>Sample Type</b>	Physical Sample	<b>AHERA Category</b>	Miscellaneous
<b>Sample Number</b>	423-08	<b>Homogenous Material Number</b>	8
<b>Material Description</b>	Ceiling tile		
<b>Homogenous Mtl Area</b>	Multiple rooms		
<b>Sample Location</b>	Kitchen		
<b>Quantity</b>	1600	<b>Unit of Measure</b>	Square Feet
<b>Asbestos Type/%</b>	<b>None Detected</b>		
<b>Sample Photo</b>

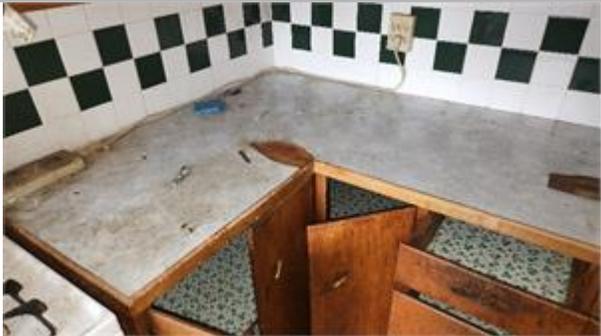
Sample		Sample Date	21-Apr-2022
<b>Project Name</b>	Kitsap County Public Works - 423 S. National Ave.		
<b>Sample Type</b>	Physical Sample	<b>AHERA Category</b>	Miscellaneous
<b>Sample Number</b>	423-09	<b>Homogenous Material Number</b>	9
<b>Material Description</b>	Formica counter mastic		
<b>Homogenous Mtl Area</b>	N/A		
<b>Sample Location</b>	Kitchen		
<b>Quantity</b>	20	<b>Unit of Measure</b>	Square Feet
<b>Asbestos Type/%</b>	<b>None Detected (Both Layers)</b>		
<b>Sample Photo</b>

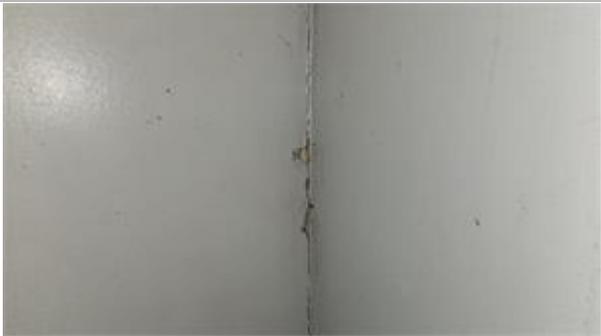
Sample		Sample Date	21-Apr-2022
<b>Project Name</b>	Kitsap County Public Works - 423 S. National Ave.		
<b>Sample Type</b>	Physical Sample	<b>AHERA Category</b>	Miscellaneous
<b>Sample Number</b>	423-10	<b>Homogenous Material Number</b>	3
<b>Material Description</b>	Gypsum Wall Board/Tape/Joint Compound		
<b>Homogenous Mtl Area</b>	N/A		
<b>Sample Location</b>	Kitchen		
<b>Quantity</b>	2400	<b>Unit of Measure</b>	Square Feet
<b>Asbestos Type/%</b>	<b>None Detected (All Layers)</b>		
<b>Sample Photo</b>

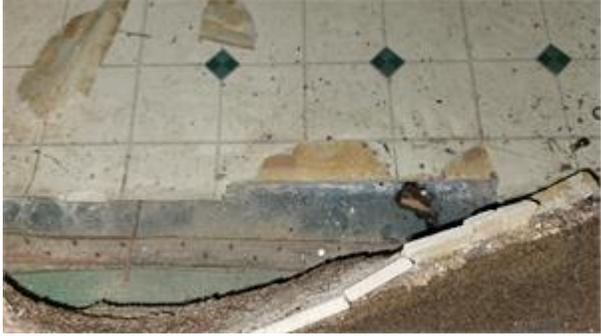
Sample		Sample Date	21-Apr-2022
<b>Project Name</b>	Kitsap County Public Works - 423 S. National Ave.		
<b>Sample Type</b>	Physical Sample	<b>AHERA Category</b>	Miscellaneous
<b>Sample Number</b>	423-11	<b>Homogenous Material Number</b>	6
<b>Material Description</b>	Buried blue SVF		
<b>Homogenous Mtl Area</b>	Room 1 and bathroom		
<b>Sample Location</b>	Bathroom under a sheet of plywood		
<b>Quantity</b>	200	<b>Unit of Measure</b>	Square Feet
<b>Asbestos Type/%</b>	<b>None Detected</b>		
<b>Sample Photo</b>

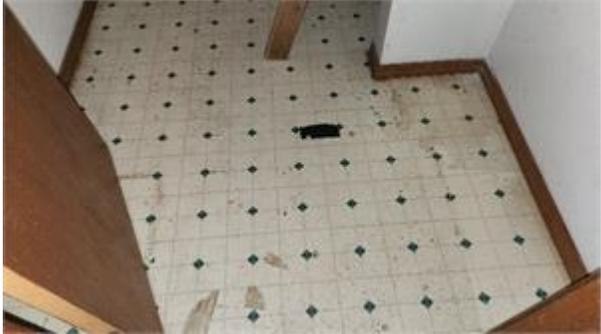
Sample		Sample Date	21-Apr-2022
<b>Project Name</b>	Kitsap County Public Works - 423 S. National Ave.		
<b>Sample Type</b>	Physical Sample	<b>AHERA Category</b>	Miscellaneous
<b>Sample Number</b>	423-12	<b>Homogenous Material Number</b>	10
<b>Material Description</b>	SVF type 2 bathroom		
<b>Homogenous Mtl Area</b>	N/A		
<b>Sample Location</b>	Bathroom		
<b>Quantity</b>	80	<b>Unit of Measure</b>	Square Feet
<b>Asbestos Type/%</b>	<b>None Detected (Both Layers)</b>		
<b>Sample Photo</b>

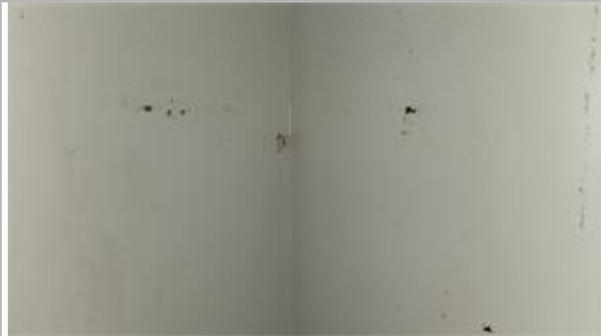
Sample		Sample Date	21-Apr-2022
<b>Project Name</b>	Kitsap County Public Works - 423 S. National Ave.		
<b>Sample Type</b>	Physical Sample	<b>AHERA Category</b>	Miscellaneous
<b>Sample Number</b>	423-13	<b>Homogenous Material Number</b>	3
<b>Material Description</b>	Gypsum Wall Board/Tape/Joint Compound		
<b>Homogenous Mtl Area</b>	N/A		
<b>Sample Location</b>	Bathroom		
<b>Quantity</b>	2400	<b>Unit of Measure</b>	Square Feet
<b>Asbestos Type/%</b>	<b>None Detected (All Layers)</b>		
<b>Sample Photo</b>

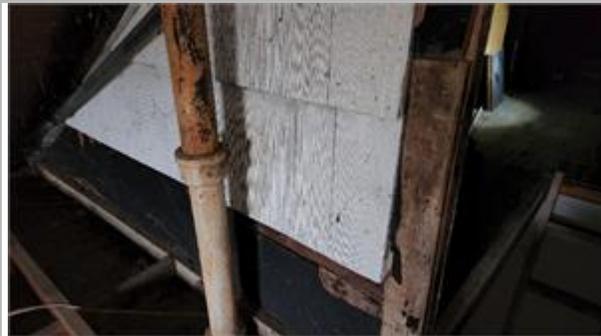
Sample		Sample Date	21-Apr-2022
<b>Project Name</b>	Kitsap County Public Works - 423 S. National Ave.		
<b>Sample Type</b>	Physical Sample	<b>AHERA Category</b>	Miscellaneous
<b>Sample Number</b>	423-14	<b>Homogenous Material Number</b>	11
<b>Material Description</b>	Siding Vapor barrier		
<b>Homogenous Mtl Area</b>	N/A		
<b>Sample Location</b>	Attic space		
<b>Quantity</b>	3000	<b>Unit of Measure</b>	Square Feet
<b>Asbestos Type/%</b>	<b>None Detected (Both Layers)</b>		
<b>Sample Photo</b>

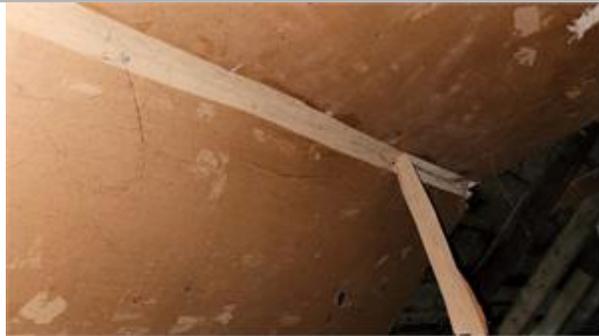
Sample		Sample Date	21-Apr-2022
<b>Project Name</b>	Kitsap County Public Works - 423 S. National Ave.		
<b>Sample Type</b>	Physical Sample	<b>AHERA Category</b>	Miscellaneous
<b>Sample Number</b>	423-15	<b>Homogenous Material Number</b>	12
<b>Material Description</b>	Gypsum Wall Board/Tape/Joint Compound		
<b>Homogenous Mtl Area</b>	N/A		
<b>Sample Location</b>	Attic space		
<b>Quantity</b>	600	<b>Unit of Measure</b>	Square Feet
<b>Asbestos Type/%</b>	<b>None Detected (Both Layers)</b>		
<b>Sample Photo</b>

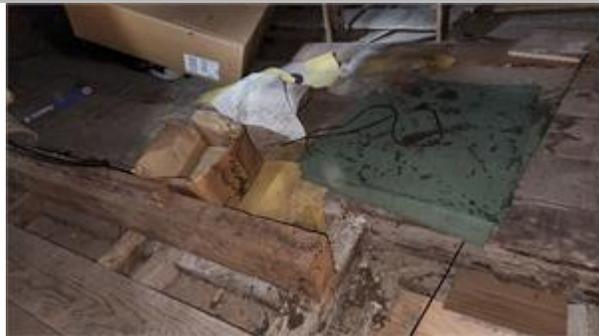
Sample		Sample Date	21-Apr-2022
<b>Project Name</b>	Kitsap County Public Works - 423 S. National Ave.		
<b>Sample Type</b>	Physical Sample	<b>AHERA Category</b>	Miscellaneous
<b>Sample Number</b>	423-16	<b>Homogenous Material Number</b>	13
<b>Material Description</b>	9x9 Flooring debris		
<b>Homogenous Mtl Area</b>	N/A		
<b>Sample Location</b>	Attic space		
<b>Quantity</b>	See Sample 17	<b>Unit of Measure</b>	Square Feet
<b>Asbestos Type/%</b>	<b>None Detected (Both Layers)* HM with ACM (See Sample 423-17)</b>		
<b>Sample Photo</b>

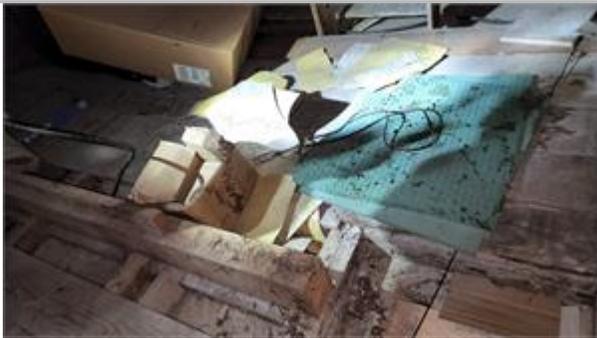
Sample		Sample Date	21-Apr-2022
<b>Project Name</b>	Kitsap County Public Works - 423 S. National Ave.		
<b>Sample Type</b>	Physical Sample	<b>AHERA Category</b>	Miscellaneous
<b>Sample Number</b>	423-17	<b>Homogenous Material Number</b>	13
<b>Material Description</b>	9x9 Flooring debris		
<b>Homogenous Mtl Area</b>	N/A		
<b>Sample Location</b>	Attic space		
<b>Quantity</b>	60	<b>Unit of Measure</b>	Square Feet
<b>Asbestos Type/%</b>	<b>Layer 1: (Vinyl floor tile) Chrysotile 2%</b> <b>Layer 2: (Mastic) None Detected</b>		
<b>Sample Photo</b>

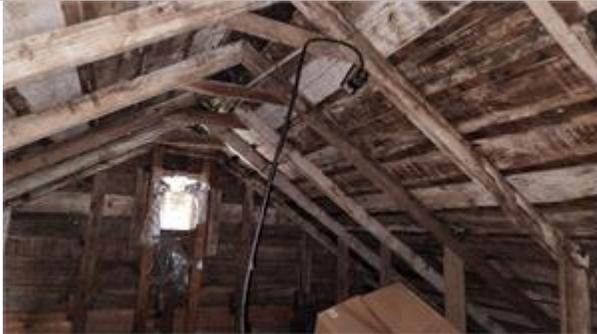
Sample		Sample Date	21-Apr-2022
<b>Project Name</b>	Kitsap County Public Works - 423 S. National Ave.		
<b>Sample Type</b>	Physical Sample	<b>AHERA Category</b>	Miscellaneous
<b>Sample Number</b>	423-18	<b>Homogenous Material Number</b>	14
<b>Material Description</b>	Electrical wire wrap		
<b>Homogenous Mtl Area</b>	Multiple locations		
<b>Sample Location</b>	Attic space		
<b>Quantity</b>	200	<b>Unit of Measure</b>	Lineal Feet
<b>Asbestos Type/%</b>	<b>None Detected</b>		
<b>Sample Photo</b>

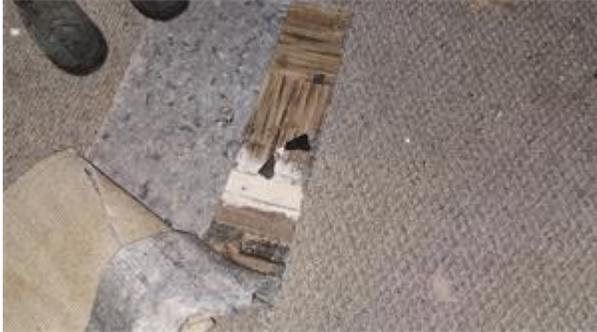
Sample		Sample Date	21-Apr-2022
<b>Project Name</b>	Kitsap County Public Works - 423 S. National Ave.		
<b>Sample Type</b>	Physical Sample	<b>AHERA Category</b>	Miscellaneous
<b>Sample Number</b>	423-19	<b>Homogenous Material Number</b>	5
<b>Material Description</b>	9x9 floor tile and mastic		
<b>Homogenous Mtl Area</b>	N/A		
<b>Sample Location</b>	Main floor Room 2		
<b>Quantity</b>	300	<b>Unit of Measure</b>	Square Feet
<b>Asbestos Type/%</b>	<b>None Detected (Both Layers)* HM with ACM (See Sample 423-05)</b>		
<b>Sample Photo</b>

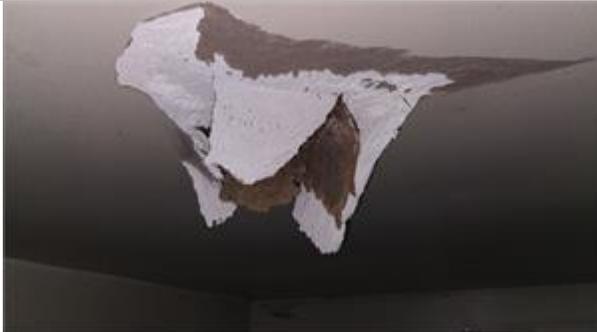
Sample		Sample Date	21-Apr-2022
<b>Project Name</b>	Kitsap County Public Works - 423 S. National Ave.		
<b>Sample Type</b>	Physical Sample	<b>AHERA Category</b>	Miscellaneous
<b>Sample Number</b>	423-20	<b>Homogenous Material Number</b>	8
<b>Material Description</b>	Ceiling tile		
<b>Homogenous Mtl Area</b>	Multiple locations		
<b>Sample Location</b>	Room 2 buried behind GWB		
<b>Quantity</b>	1600	<b>Unit of Measure</b>	Square Feet
<b>Asbestos Type/%</b>	<b>None Detected</b>		
<b>Sample Photo</b>

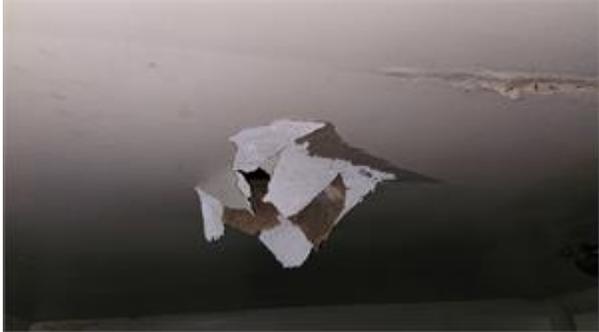
Sample		Sample Date	21-Apr-2022
<b>Project Name</b>	Kitsap County Public Works - 423 S. National Ave.		
<b>Sample Type</b>	Physical Sample	<b>AHERA Category</b>	Miscellaneous
<b>Sample Number</b>	423-21	<b>Homogenous Material Number</b>	3
<b>Material Description</b>	Gypsum Wall Board/Tape/Joint Compound		
<b>Homogenous Mtl Area</b>	N/A		
<b>Sample Location</b>	Main floor Room 2		
<b>Quantity</b>	2400	<b>Unit of Measure</b>	Square Feet
<b>Asbestos Type/%</b>	<b>None Detected</b>		
<b>Sample Photo</b>

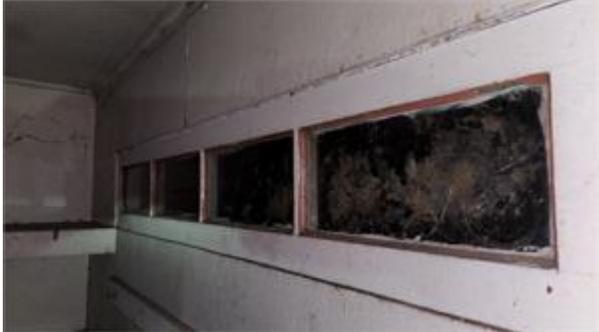
Sample		Sample Date	21-Apr-2022
<b>Project Name</b>	Kitsap County Public Works - 423 S. National Ave.		
<b>Sample Type</b>	Physical Sample	<b>AHERA Category</b>	Miscellaneous
<b>Sample Number</b>	423-22	<b>Homogenous Material Number</b>	15
<b>Material Description</b>	Window Putty		
<b>Homogenous Mtl Area</b>	N/A		
<b>Sample Location</b>	Interior window to stair well		
<b>Quantity</b>	6	<b>Unit of Measure</b>	Each
<b>Asbestos Type/%</b>	<b>None Detected</b>		
<b>Sample Photo</b>

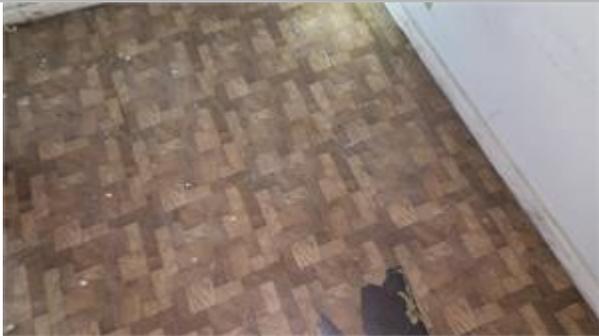
Sample			Sample Date	21-Apr-2022
<b>Project Name</b>	Kitsap County Public Works - 423 S. National Ave.			
<b>Sample Type</b>	Physical Sample	<b>AHERA Category</b>	Miscellaneous	
<b>Sample Number</b>	423-23	<b>Homogenous Material Number</b>	16	
<b>Material Description</b>	12x12 floor tile fake parque			
<b>Homogenous Mtl Area</b>	N/A			
<b>Sample Location</b>	Basement room 5			
<b>Quantity</b>	80	<b>Unit of Measure</b>	Square Feet	
<b>Asbestos Type/%</b>	<b>None Detected (Both Layers)</b>			
<b>Sample Photo</b>

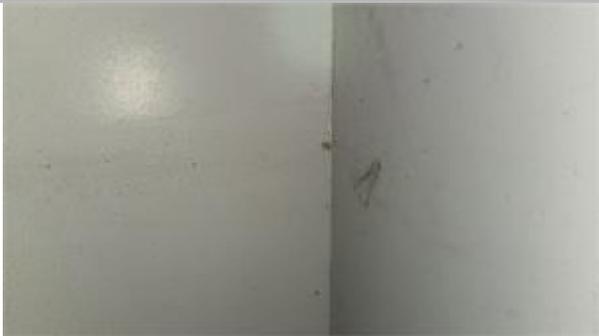
Sample			Sample Date	21-Apr-2022
<b>Project Name</b>	Kitsap County Public Works - 423 S. National Ave.			
<b>Sample Type</b>	Physical Sample	<b>AHERA Category</b>	Miscellaneous	
<b>Sample Number</b>	423-24	<b>Homogenous Material Number</b>	3	
<b>Material Description</b>	Gypsum Wall Board/Tape/Joint Compound			
<b>Homogenous Mtl Area</b>	N/A			
<b>Sample Location</b>	Basement room 5			
<b>Quantity</b>	2400	<b>Unit of Measure</b>	Square Feet	
<b>Asbestos Type/%</b>	<b>None Detected (Both Layers)</b>			
<b>Sample Photo</b>

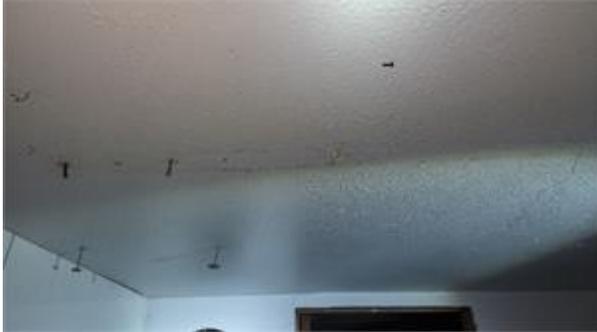
Sample			Sample Date	21-Apr-2022
<b>Project Name</b>	Kitsap County Public Works - 423 S. National Ave.			
<b>Sample Type</b>	Physical Sample	<b>AHERA Category</b>	Surfacing	
<b>Sample Number</b>	423-25	<b>Homogenous Material Number</b>	17	
<b>Material Description</b>	Texture on GWB			
<b>Homogenous Mtl Area</b>	N/A			
<b>Sample Location</b>	Basement room 5			
<b>Quantity</b>	80	<b>Unit of Measure</b>	Square Feet	
<b>Asbestos Type/%</b>	<b>None Detected (Both Layers)</b>			
<b>Sample Photo</b>

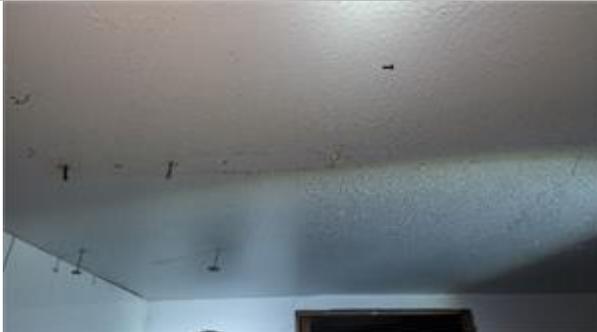
Sample			Sample Date	21-Apr-2022
<b>Project Name</b>	Kitsap County Public Works - 423 S. National Ave.			
<b>Sample Type</b>	Physical Sample	<b>AHERA Category</b>	Surfacing	
<b>Sample Number</b>	423-26	<b>Homogenous Material Number</b>	17	
<b>Material Description</b>	Texture on GWB			
<b>Homogenous Mtl Area</b>	N/A			
<b>Sample Location</b>	Basement room 5			
<b>Quantity</b>	80	<b>Unit of Measure</b>	Square Feet	
<b>Asbestos Type/%</b>	<b>None Detected (Both Layers)</b>			
<b>Sample Photo</b>

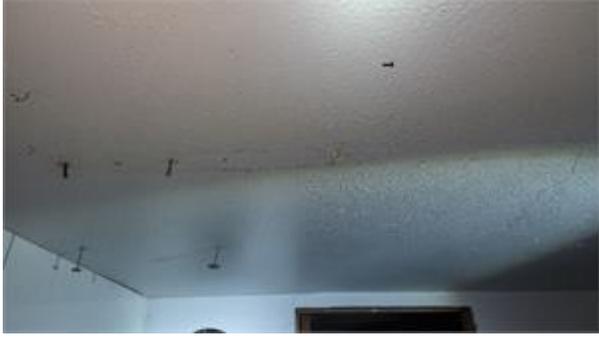
Sample			Sample Date	21-Apr-2022
<b>Project Name</b>	Kitsap County Public Works - 423 S. National Ave.			
<b>Sample Type</b>	Physical Sample	<b>AHERA Category</b>	Surfacing	
<b>Sample Number</b>	423-27	<b>Homogenous Material Number</b>	17	
<b>Material Description</b>	Texture on GWB			
<b>Homogenous Mtl Area</b>	N/A			
<b>Sample Location</b>	Basement room 5			
<b>Quantity</b>	80	<b>Unit of Measure</b>	Square Feet	
<b>Asbestos Type/%</b>	<b>None Detected (All Layers)</b>			
<b>Sample Photo</b>

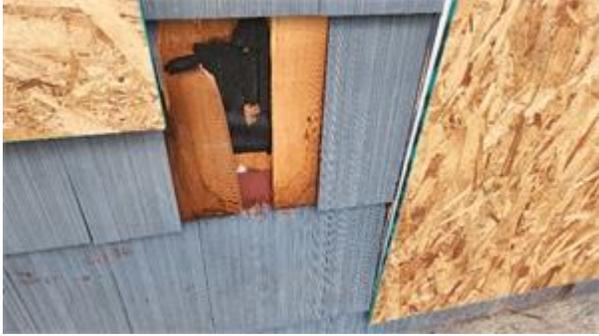
Sample			Sample Date	21-Apr-2022
<b>Project Name</b>	Kitsap County Public Works - 423 S. National Ave.			
<b>Sample Type</b>	Physical Sample	<b>AHERA Category</b>	Miscellaneous	
<b>Sample Number</b>	423-28	<b>Homogenous Material Number</b>	11	
<b>Material Description</b>	Siding Vapor barrier			
<b>Homogenous Mtl Area</b>	N/A			
<b>Sample Location</b>	Exterior east wall			
<b>Quantity</b>	3000	<b>Unit of Measure</b>	Square Feet	
<b>Asbestos Type/%</b>	<b>None Detected</b>			
<b>Sample Photo</b>

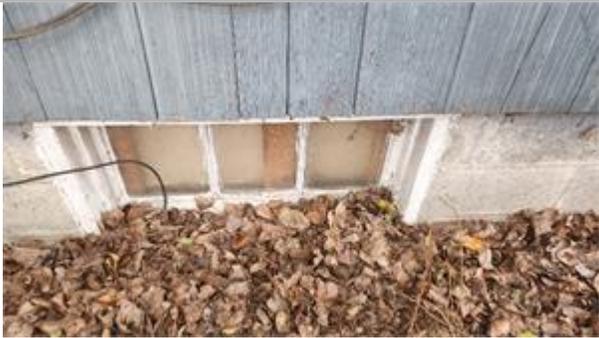
Sample		Sample Date	21-Apr-2022
<b>Project Name</b>	Kitsap County Public Works - 423 S. National Ave.		
<b>Sample Type</b>	Physical Sample	<b>AHERA Category</b>	Miscellaneous
<b>Sample Number</b>	423-29	<b>Homogenous Material Number</b>	15
<b>Material Description</b>	Window Putty		
<b>Homogenous Mtl Area</b>	N/A		
<b>Sample Location</b>	Exterior South wall		
<b>Quantity</b>	6	<b>Unit of Measure</b>	Each
<b>Asbestos Type/%</b>	<b>None Detected (Both Layers)</b>		
<b>Sample Photo</b>

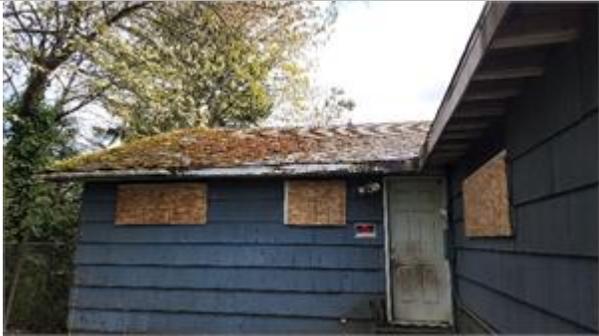
Sample		Sample Date	21-Apr-2022
<b>Project Name</b>	Kitsap County Public Works - 423 S. National Ave.		
<b>Sample Type</b>	Physical Sample	<b>AHERA Category</b>	Miscellaneous
<b>Sample Number</b>	423-30	<b>Homogenous Material Number</b>	18
<b>Material Description</b>	3-tab Roofing and Vapor barrier		
<b>Homogenous Mtl Area</b>	N/A		
<b>Sample Location</b>	West side roof		
<b>Quantity</b>	1700	<b>Unit of Measure</b>	Square Feet
<b>Asbestos Type/%</b>	<b>None Detected (Both Layers)</b>		
<b>Sample Photo</b>

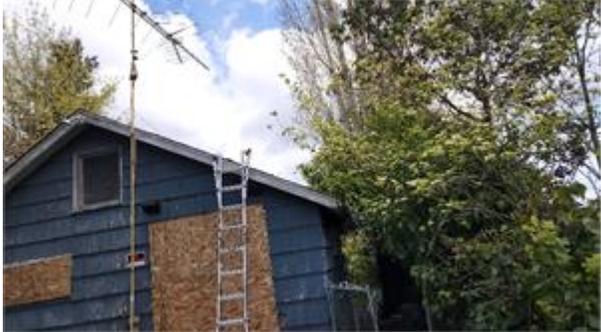
Sample		Sample Date	21-Apr-2022
<b>Project Name</b>	Kitsap County Public Works - 423 S. National Ave.		
<b>Sample Type</b>	Physical Sample	<b>AHERA Category</b>	Miscellaneous
<b>Sample Number</b>	423-31	<b>Homogenous Material Number</b>	18
<b>Material Description</b>	3-tab Roofing and Vapor barrier		
<b>Homogenous Mtl Area</b>	N/A		
<b>Sample Location</b>	South side roof		
<b>Quantity</b>	1700	<b>Unit of Measure</b>	Square Feet
<b>Asbestos Type/%</b>	<b>None Detected (Both Layers)</b>		
<b>Sample Photo</b>

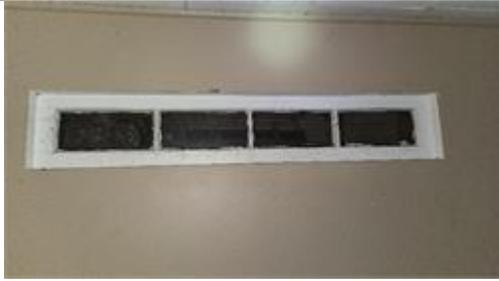
Test #	Substrate	Component / Side	Description / Location	Color	Pbc mg/cm2
183	Wood	Window frame	Main floor room 4 window to stairwell	White	10.01
191	Metal	Pipe	Room 2	White	2.2

Samples	
Sample Number	183
Calibration	
Substrate Description	Wood
Component	Window frame
Color	White
Sample Location	Main floor Room 4 window to stair well
XRF Reading (Mg/cm2 lead)	10.1
Result	<b>Positive</b>
Sample Photo

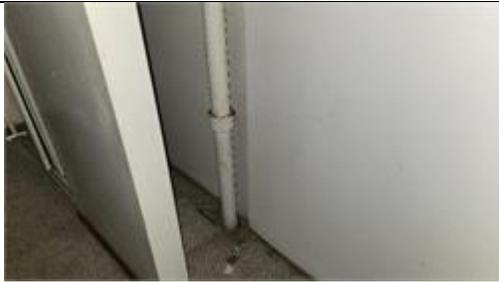
Samples	
Sample Number	191
Calibration	
Substrate Description	Metal
Component	Pipe
Color	White
Sample Location	Room 2
XRF Reading (Mg/cm <sup>2</sup> lead)	2.2
Result	<b>Positive</b>
Sample Photo
