Regulated Building Materials Survey

**Kitsap County Public Works
417 South National Avenue
Bremerton, WA**

Date Finalized: 4/29/2022

PacRim#: 17384.02

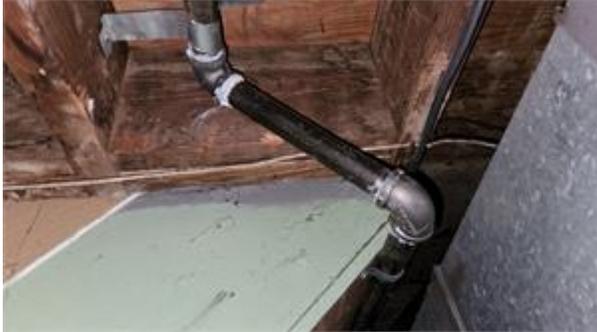
Sample		Sample Date	21-Apr-2022
Project Name	Kitsap County Public Works - 417 S. National Ave.		
Sample Type	Physical Sample	AHERA Category	Miscellaneous
Sample Number	417-01	Homogenous Material Number	1
Material Description	Gas line fitting mastic		
Homogenous Mtl Area	N/A		
Sample Location	Basement Room 1		
Quantity	45	Unit of Measure	Each
Asbestos Type/%	None Detected		
Sample Photo

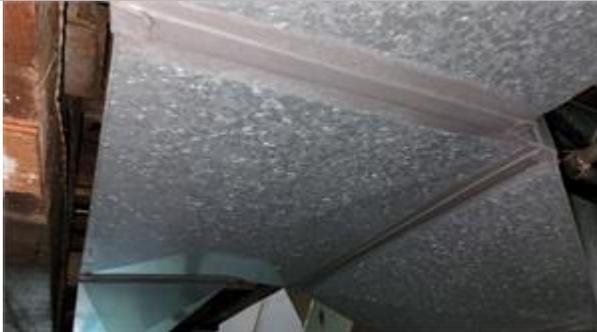
Sample		Sample Date	21-Apr-2022
Project Name	Kitsap County Public Works - 417 S. National Ave.		
Sample Type	Physical Sample	AHERA Category	Miscellaneous
Sample Number	417-02	Homogenous Material Number	2
Material Description	Grey Duct sealant		
Homogenous Mtl Area	N/A		
Sample Location	Basement room 1		
Quantity	30	Unit of Measure	Lineal Feet
Asbestos Type/%	None Detected		
Sample Photo

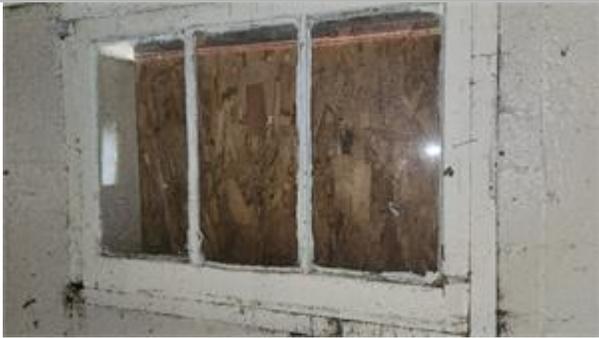
Sample		Sample Date	21-Apr-2022
Project Name	Kitsap County Public Works - 417 S. National Ave.		
Sample Type	Physical Sample	AHERA Category	Miscellaneous
Sample Number	417-03	Homogenous Material Number	3
Material Description	Window Putty		
Homogenous Mtl Area	N/A		
Sample Location	Room 2 south wall		
Quantity	8	Unit of Measure	Each
Asbestos Type/%	None Detected		
Sample Photo

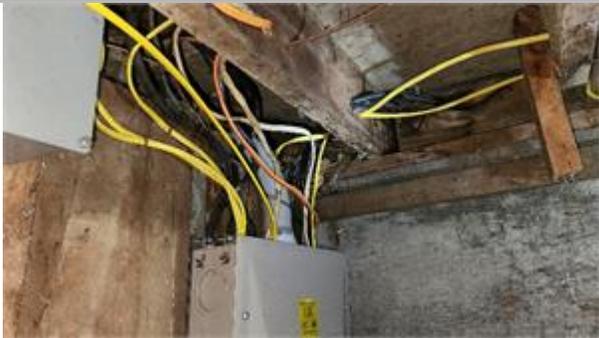
Sample		Sample Date	21-Apr-2022
Project Name	Kitsap County Public Works - 417 S. National Ave.		
Sample Type	Physical Sample	AHERA Category	Miscellaneous
Sample Number	417-04	Homogenous Material Number	4
Material Description	Electrical wire wrap		
Homogenous Mtl Area	N/A		
Sample Location	Basement room 1		
Quantity	500	Unit of Measure	Lineal Feet
Asbestos Type/%	None Detected		
Sample Photo

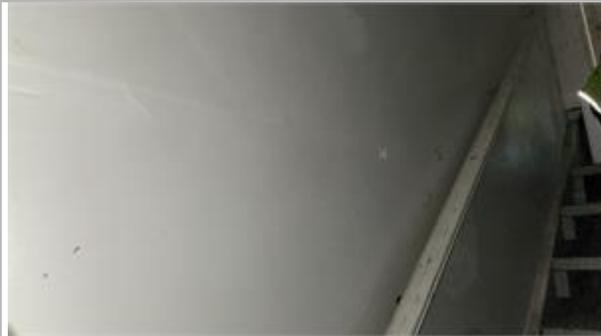
Sample		Sample Date	21-Apr-2022
Project Name	Kitsap County Public Works - 417 S. National Ave.		
Sample Type	Physical Sample	AHERA Category	Miscellaneous
Sample Number	417-05	Homogenous Material Number	5
Material Description	Gypsum Wall Board/Tape/Joint Compound		
Homogenous Mtl Area	N/A		
Sample Location	Basement stair well wall		
Quantity	250	Unit of Measure	Square Feet
Asbestos Type/%	None Detected (All Layers)		
Sample Photo

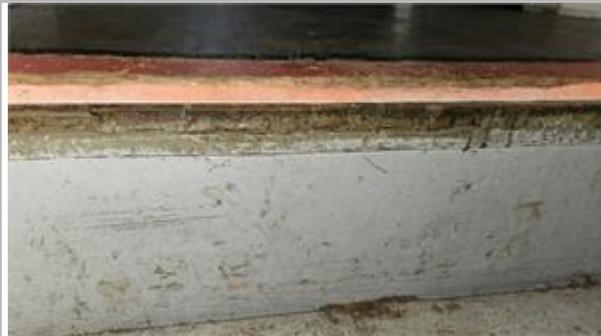
Sample		Sample Date	21-Apr-2022
Project Name	Kitsap County Public Works - 417 S. National Ave.		
Sample Type	Physical Sample	AHERA Category	Miscellaneous
Sample Number	417-06	Homogenous Material Number	6
Material Description	Vapor barrier		
Homogenous Mtl Area	Also on 2nd floor		
Sample Location	Main floor under hardwood flooring		
Quantity	2000	Unit of Measure	Square Feet
Asbestos Type/%	None Detected		
Sample Photo

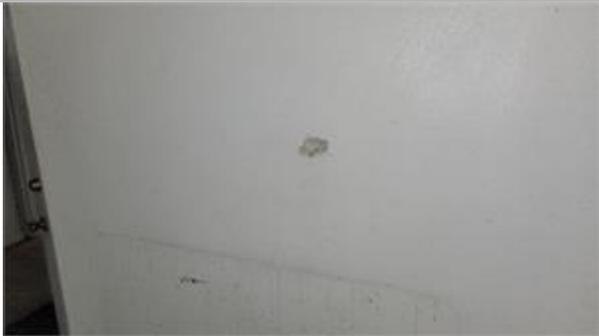
Sample		Sample Date	21-Apr-2022
Project Name	Kitsap County Public Works - 417 S. National Ave.		
Sample Type	Physical Sample	AHERA Category	Surfacing
Sample Number	417-07	Homogenous Material Number	7
Material Description	Hard Plaster Walls and Ceilings		
Homogenous Mtl Area	N/A		
Sample Location	Kitchen 1 wall		
Quantity	4000	Unit of Measure	Square Feet
Asbestos Type/%	None Detected (Both Layers)		
Sample Photo

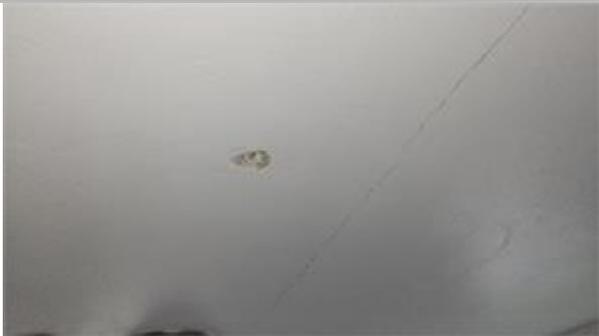
Sample		Sample Date	21-Apr-2022
Project Name	Kitsap County Public Works - 417 S. National Ave.		
Sample Type	Physical Sample	AHERA Category	Surfacing
Sample Number	417-08	Homogenous Material Number	7
Material Description	Hard Plaster Walls and Ceilings		
Homogenous Mtl Area	N/A		
Sample Location	Main floor Room 2 ceiling		
Quantity	4000	Unit of Measure	Square Feet
Asbestos Type/%	None Detected (All Layers)		
Sample Photo

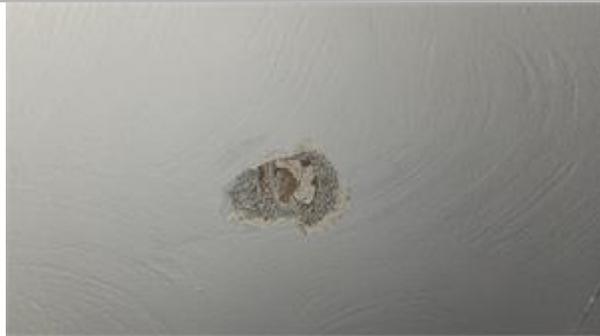
Sample		Sample Date	21-Apr-2022
Project Name	Kitsap County Public Works - 417 S. National Ave.		
Sample Type	Physical Sample	AHERA Category	Miscellaneous
Sample Number	417-09	Homogenous Material Number	8
Material Description	Drywall as Plaster backing		
Homogenous Mtl Area	N/A		
Sample Location	Main floor Room 2 ceiling		
Quantity	4000	Unit of Measure	Square Feet
Asbestos Type/%	None Detected (Both Layers)		
Sample Photo

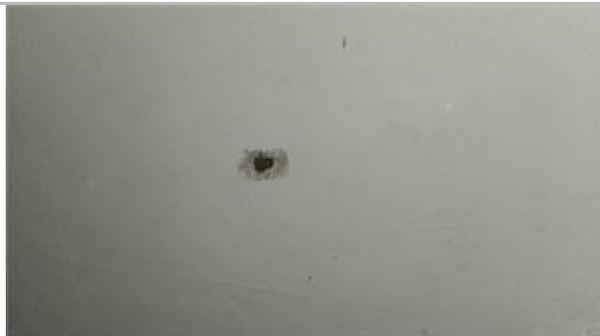
Sample		Sample Date	21-Apr-2022
Project Name	Kitsap County Public Works - 417 S. National Ave.		
Sample Type	Physical Sample	AHERA Category	Surfacing
Sample Number	417-10	Homogenous Material Number	7
Material Description	Hard Plaster Walls and Ceilings		
Homogenous Mtl Area	N/A		
Sample Location	Main floor Room 3 wall		
Quantity	4000	Unit of Measure	Square Feet
Asbestos Type/%	None Detected (Both Layers)		
Sample Photo

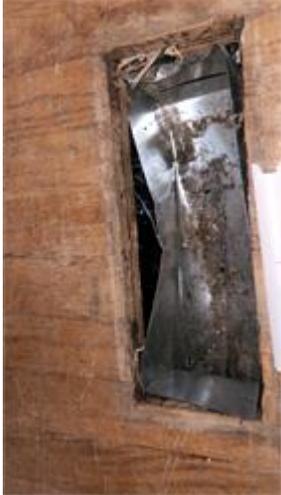
Sample		Sample Date	21-Apr-2022
Project Name	Kitsap County Public Works - 417 S. National Ave.		
Sample Type	Physical Sample	AHERA Category	Miscellaneous
Sample Number	417-11	Homogenous Material Number	6
Material Description	Vapor barrier for hardwood floor		
Homogenous Mtl Area	N/A		
Sample Location	Main floor Room 3 floor		
Quantity	2000	Unit of Measure	Square Feet
Asbestos Type/%	None Detected		
Sample Photo

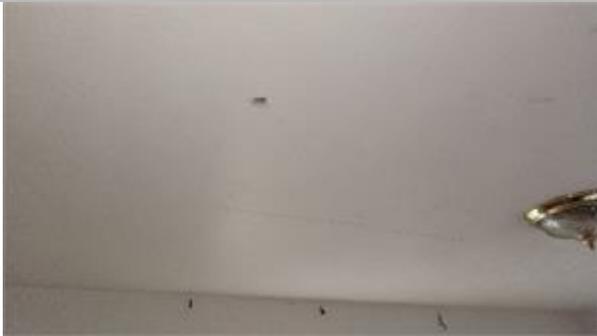
Sample		Sample Date	21-Apr-2022
Project Name	Kitsap County Public Works - 417 S. National Ave.		
Sample Type	Physical Sample	AHERA Category	Surfacing
Sample Number	417-12	Homogenous Material Number	7
Material Description	Hard Plaster Walls and Ceilings		
Homogenous Mtl Area	N/A		
Sample Location	Main floor Room 1 ceiling		
Quantity	4000	Unit of Measure	Square Feet
Asbestos Type/%	None Detected (Both Layers)		
Sample Photo

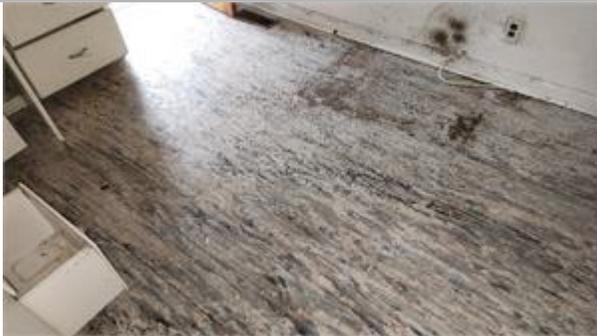
Sample		Sample Date	21-Apr-2022
Project Name	Kitsap County Public Works - 417 S. National Ave.		
Sample Type	Physical Sample	AHERA Category	Miscellaneous
Sample Number	417-13	Homogenous Material Number	9
Material Description	SVF type 1 kitchen 1		
Homogenous Mtl Area	N/A		
Sample Location	Kitchen floor		
Quantity	80	Unit of Measure	Square Feet
Asbestos Type/%	None Detected (All Layers)		
Sample Photo

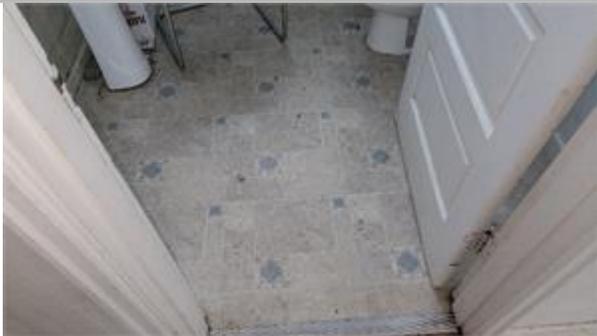
Sample		Sample Date	21-Apr-2022
Project Name	Kitsap County Public Works - 417 S. National Ave.		
Sample Type	Physical Sample	AHERA Category	Miscellaneous
Sample Number	417-14	Homogenous Material Number	10
Material Description	SVF type 2 bathroom		
Homogenous Mtl Area	N/A		
Sample Location	Main floor bathroom		
Quantity	30	Unit of Measure	Square Feet
Asbestos Type/%	None Detected (Both Layers)		
Sample Photo

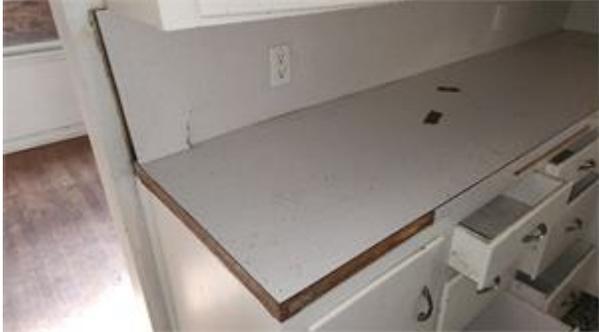
Sample		Sample Date	21-Apr-2022
Project Name	Kitsap County Public Works - 417 S. National Ave.		
Sample Type	Physical Sample	AHERA Category	Miscellaneous
Sample Number	417-15	Homogenous Material Number	12
Material Description	Formica counter mastic		
Homogenous Mtl Area	N/A		
Sample Location	Kitchen 1		
Quantity	20	Unit of Measure	Square Feet
Asbestos Type/%	None Detected (Both Layers)		
Sample Photo

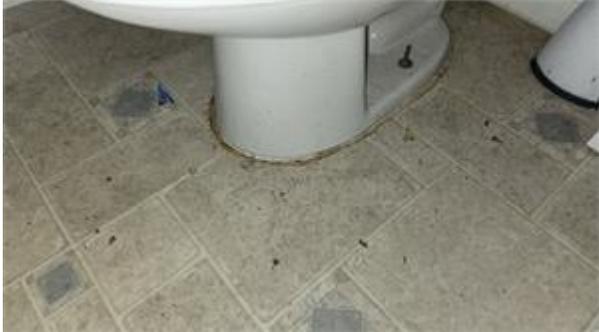
Sample		Sample Date	21-Apr-2022
Project Name	Kitsap County Public Works - 417 S. National Ave.		
Sample Type	Physical Sample	AHERA Category	Miscellaneous
Sample Number	417-16	Homogenous Material Number	11
Material Description	Bathroom fixture caulk		
Homogenous Mtl Area	N/A		
Sample Location	Main floor bathroom		
Quantity	4	Unit of Measure	Lineal Feet
Asbestos Type/%	None Detected		
Sample Photo

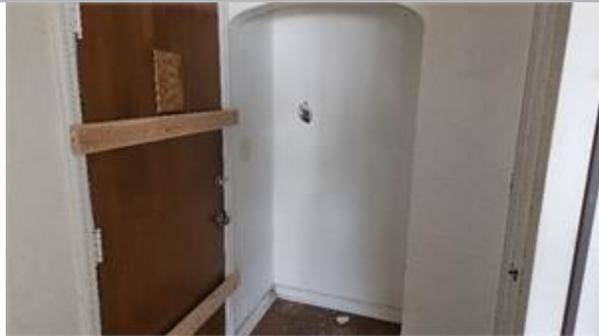
Sample			Sample Date	21-Apr-2022
Project Name	Kitsap County Public Works - 417 S. National Ave.			
Sample Type	Physical Sample	AHERA Category	Surfacing	
Sample Number	417-17	Homogenous Material Number	13	
Material Description	Texture on GWB			
Homogenous Mtl Area	N/A			
Sample Location	Front entrance room main floor			
Quantity	300	Unit of Measure	Square Feet	
Asbestos Type/%	None Detected (Both Layers)			
Sample Photo

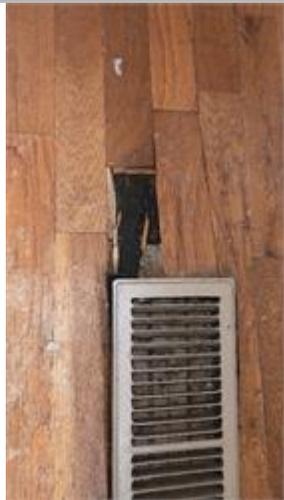
Sample			Sample Date	21-Apr-2022
Project Name	Kitsap County Public Works - 417 S. National Ave.			
Sample Type	Physical Sample	AHERA Category	Miscellaneous	
Sample Number	417-18	Homogenous Material Number	6	
Material Description	Vapor barrier			
Homogenous Mtl Area	N/A			
Sample Location	2nd floor Room 1			
Quantity	2000	Unit of Measure	Square Feet	
Asbestos Type/%	None Detected			
Sample Photo

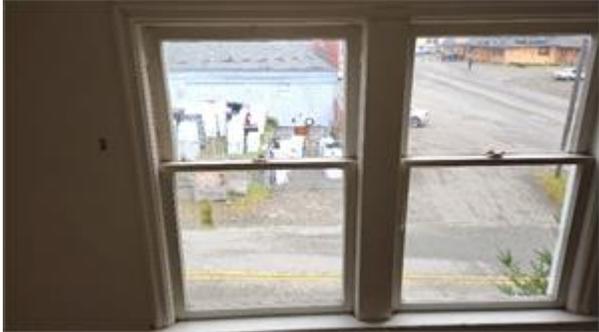
Sample		Sample Date	21-Apr-2022
Project Name	Kitsap County Public Works - 417 S. National Ave.		
Sample Type	Physical Sample	AHERA Category	Miscellaneous
Sample Number	417-19	Homogenous Material Number	14
Material Description	Window Putty		
Homogenous Mtl Area	N/A		
Sample Location	2nd floor Room 1		
Quantity	20	Unit of Measure	Each
Asbestos Type/%	None Detected		
Sample Photo

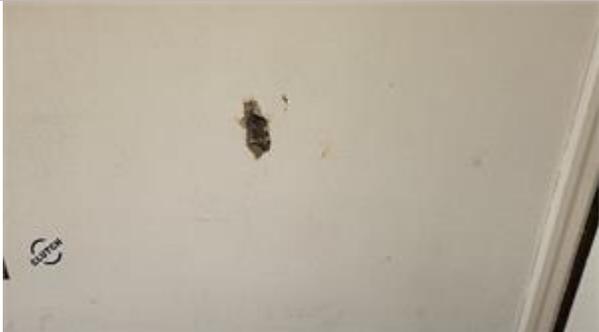
Sample		Sample Date	21-Apr-2022
Project Name	Kitsap County Public Works - 417 S. National Ave.		
Sample Type	Physical Sample	AHERA Category	Surfacing
Sample Number	417-20	Homogenous Material Number	7
Material Description	Hard Plaster Walls and Ceilings		
Homogenous Mtl Area	N/A		
Sample Location	2nd floor Room 1 wall		
Quantity	4000	Unit of Measure	Square Feet
Asbestos Type/%	None Detected (Both Layers)		
Sample Photo

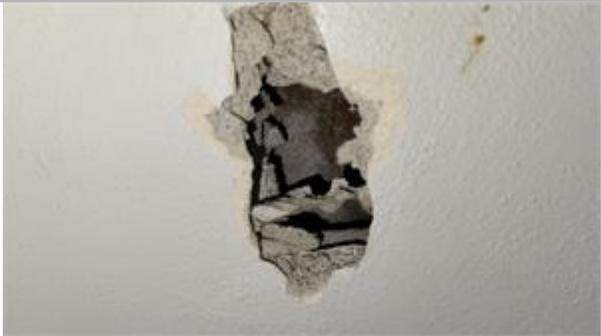
Sample		Sample Date	21-Apr-2022
Project Name	Kitsap County Public Works - 417 S. National Ave.		
Sample Type	Physical Sample	AHERA Category	Miscellaneous
Sample Number	417-21	Homogenous Material Number	8
Material Description	Sheetrock (GWB) as Plaster backing		
Homogenous Mtl Area	N/A		
Sample Location	2nd floor Room 1		
Quantity	4000	Unit of Measure	Square Feet
Asbestos Type/%	None Detected		
Sample Photo

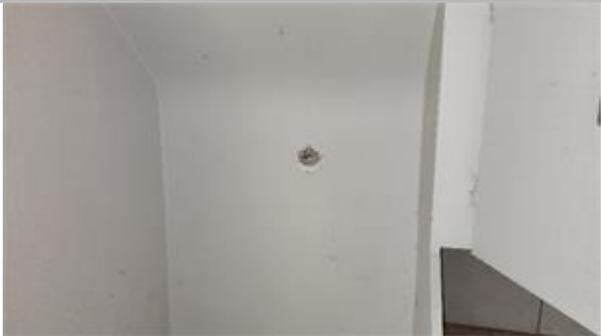
Sample		Sample Date	21-Apr-2022
Project Name	Kitsap County Public Works - 417 S. National Ave.		
Sample Type	Physical Sample	AHERA Category	Surfacing
Sample Number	417-22	Homogenous Material Number	7
Material Description	Hard Plaster Walls and Ceilings		
Homogenous Mtl Area	N/A		
Sample Location	Kitchen 2		
Quantity	4000	Unit of Measure	Square Feet
Asbestos Type/%	None Detected (All Layers)		
Sample Photo

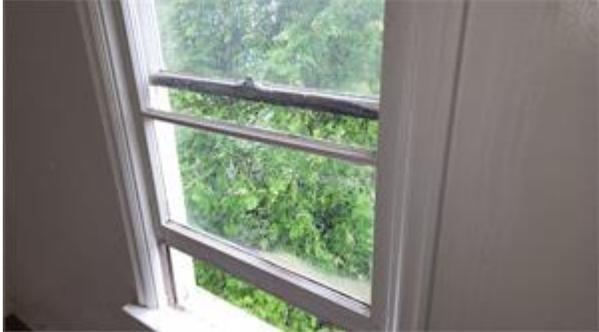
Sample		Sample Date	21-Apr-2022
Project Name	Kitsap County Public Works - 417 S. National Ave.		
Sample Type	Physical Sample	AHERA Category	Miscellaneous
Sample Number	417-23	Homogenous Material Number	14
Material Description	Window Putty		
Homogenous Mtl Area	N/A		
Sample Location	Kitchen 2		
Quantity	20	Unit of Measure	Each
Asbestos Type/%	None Detected		
Sample Photo

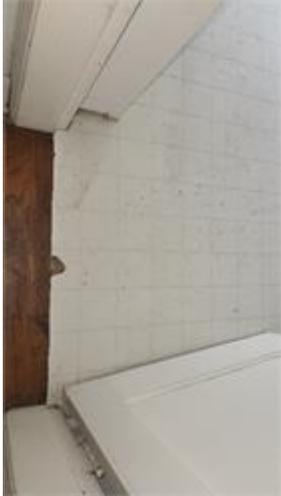
Sample		Sample Date	21-Apr-2022
Project Name	Kitsap County Public Works - 417 S. National Ave.		
Sample Type	Physical Sample	AHERA Category	Miscellaneous
Sample Number	417-24	Homogenous Material Number	15
Material Description	SVF type 3		
Homogenous Mtl Area	N/A		
Sample Location	2nd floor bathroom		
Quantity	40	Unit of Measure	Square Feet
Asbestos Type/%	None Detected (All Layers)		
Sample Photo

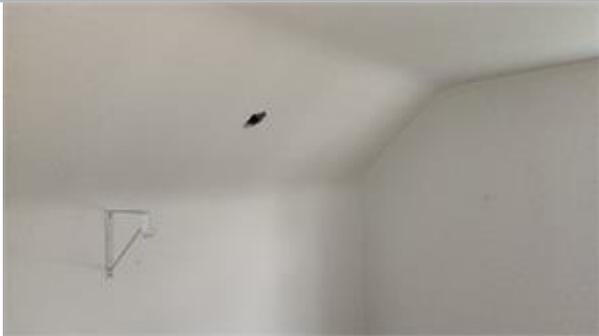
Sample		Sample Date	21-Apr-2022
Project Name	Kitsap County Public Works - 417 S. National Ave.		
Sample Type	Physical Sample	AHERA Category	Surfacing
Sample Number	417-25	Homogenous Material Number	7
Material Description	Hard Plaster Walls and Ceilings		
Homogenous Mtl Area	N/A		
Sample Location	2nd floor Room 3		
Quantity	4000	Unit of Measure	Square Feet
Asbestos Type/%	None Detected (Both Layers)		
Sample Photo

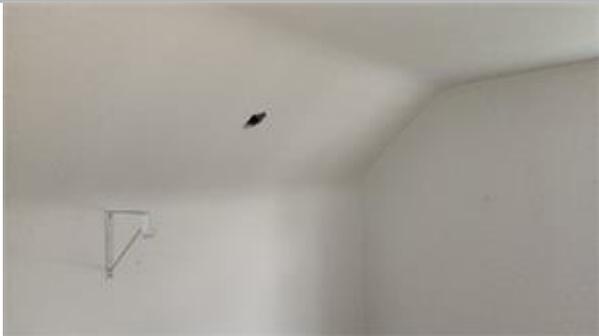
Sample		Sample Date	21-Apr-2022
Project Name	Kitsap County Public Works - 417 S. National Ave.		
Sample Type	Physical Sample	AHERA Category	Miscellaneous
Sample Number	417-26	Homogenous Material Number	8
Material Description	GWB as Plaster backing		
Homogenous Mtl Area	N/A		
Sample Location	2nd floor Room 2		
Quantity	4000	Unit of Measure	Square Feet
Asbestos Type/%	None Detected		
Sample Photo

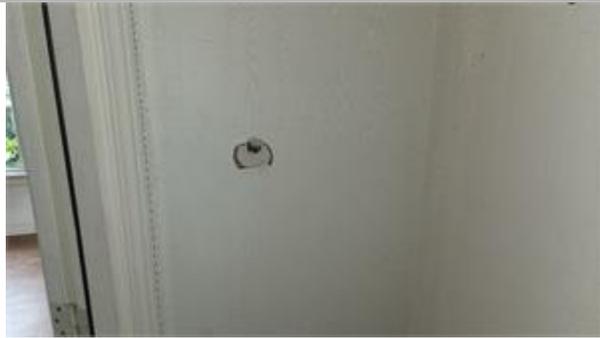
Sample		Sample Date	21-Apr-2022
Project Name	Kitsap County Public Works - 417 S. National Ave.		
Sample Type	Physical Sample	AHERA Category	Surfacing
Sample Number	417-27	Homogenous Material Number	13
Material Description	Texture on GWB		
Homogenous Mtl Area	N/A		
Sample Location	Front entrance area		
Quantity	300	Unit of Measure	Square Feet
Asbestos Type/%	None Detected (Both Layers)		
Sample Photo

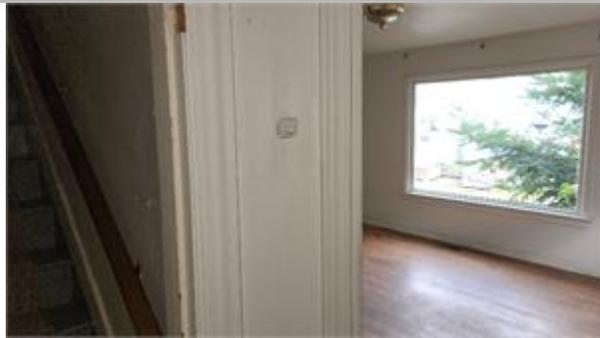
Sample		Sample Date	21-Apr-2022
Project Name	Kitsap County Public Works - 417 S. National Ave.		
Sample Type	Physical Sample	AHERA Category	Surfacing
Sample Number	417-28	Homogenous Material Number	13
Material Description	Texture on GWB		
Homogenous Mtl Area	N/A		
Sample Location	Front entrance area		
Quantity	300	Unit of Measure	Square Feet
Asbestos Type/%	None Detected (Both Layers)		
Sample Photo

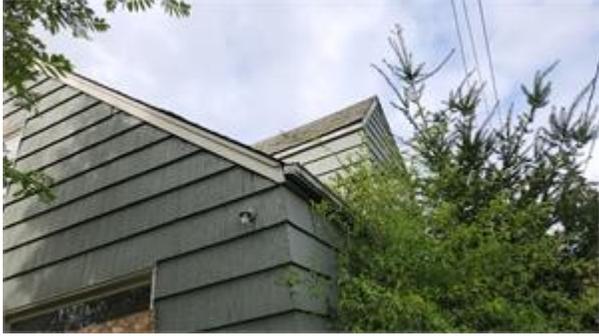
Sample		Sample Date	21-Apr-2022
Project Name	Kitsap County Public Works - 417 S. National Ave.		
Sample Type	Physical Sample	AHERA Category	Miscellaneous
Sample Number	417-29	Homogenous Material Number	16
Material Description	3-tab Roofing and Vapor barrier		
Homogenous Mtl Area	N/A		
Sample Location	Roof north side		
Quantity	1500	Unit of Measure	Square Feet
Asbestos Type/%	None Detected (Both Layers)		
Sample Photo

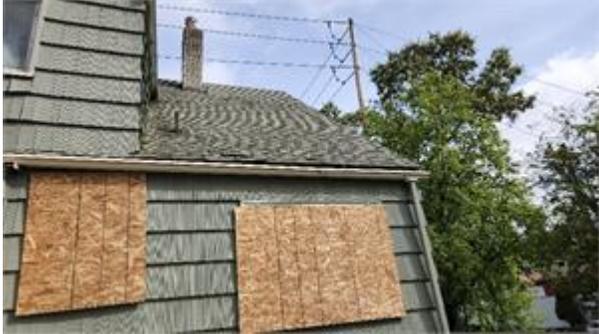
Sample		Sample Date	21-Apr-2022
Project Name	Kitsap County Public Works - 417 S. National Ave.		
Sample Type	Physical Sample	AHERA Category	Miscellaneous
Sample Number	417-30	Homogenous Material Number	16
Material Description	3-tab Roofing with Vapor barrier		
Homogenous Mtl Area	N/A		
Sample Location	roof south side		
Quantity	1500	Unit of Measure	Square Feet
Asbestos Type/%	None Detected (Both Layers)		
Sample Photo

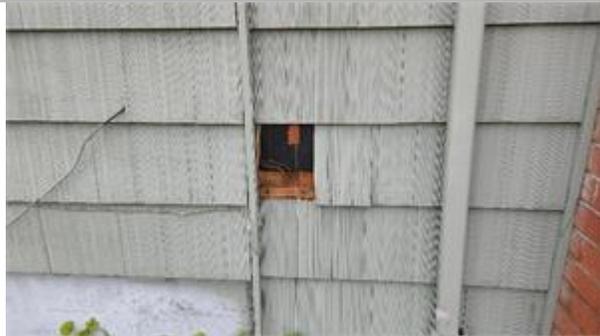
Sample		Sample Date	21-Apr-2022
Project Name	Kitsap County Public Works - 417 S. National Ave.		
Sample Type	Physical Sample	AHERA Category	Miscellaneous
Sample Number	417-31	Homogenous Material Number	17
Material Description	Siding Vapor barrier		
Homogenous Mtl Area	N/A		
Sample Location	Exterior West wall		
Quantity	2000	Unit of Measure	Square Feet
Asbestos Type/%	None Detected		
Sample Photo

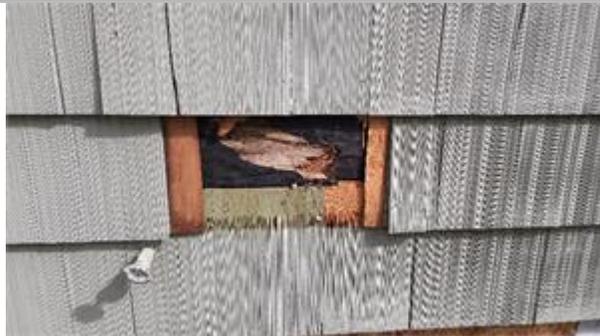
Sample		Sample Date	21-Apr-2022
Project Name	Kitsap County Public Works - 417 S. National Ave.		
Sample Type	Physical Sample	AHERA Category	Miscellaneous
Sample Number	417-32	Homogenous Material Number	17
Material Description	Siding Vapor barrier		
Homogenous Mtl Area	N/A		
Sample Location	Exterior South wall		
Quantity	2000	Unit of Measure	Square Feet
Asbestos Type/%	None Detected		
Sample Photo
