Regulated Building Material Inspection Report

Silverdale Recycling and Garbage Facility

April 10, 2023

Terracon Project No.81227638

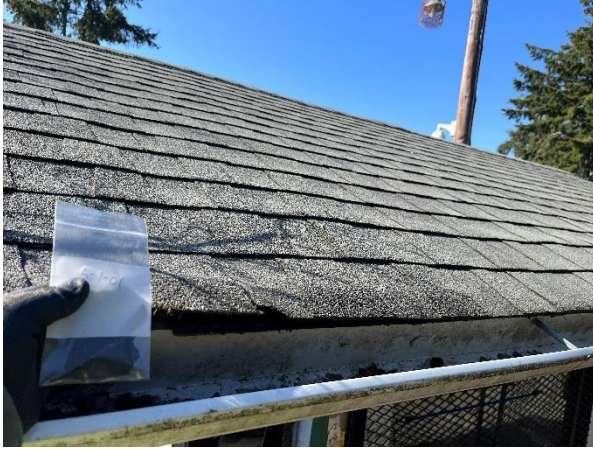
Material 1

Material No.	Material Description	Material Location	Results
1 (M)	■ Grey 3-tab asphaltic roofing shingles	Roof of guard shack	ND (all layers)
2 (M)	■ Black sealant	Associated with windowpane seams and door frame seams of guard Shack	ND (all layers)
3 (M)	■ White sealant ■ Brown sealant	Associated with guard shack wall penetrations	White sealant: ND Brown sealant: 4% Chrysotile
4 (M)	■ Black sealant	Associated with base of light post adjacent to the guard shack	ND (all layers)

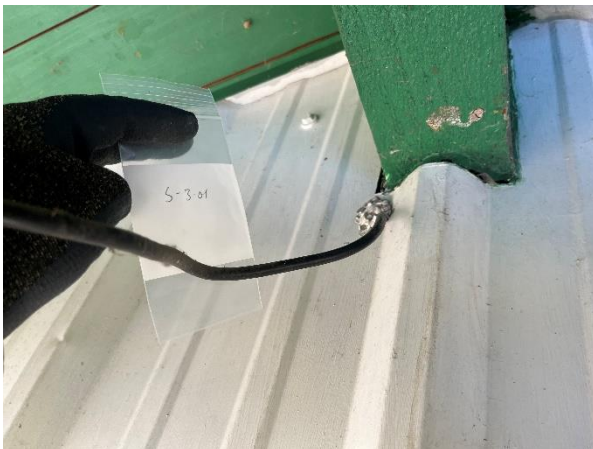
Material 3

Material No.	Material Description	Material Location	Approximate Quantity
3 (M)	<ul style="list-style-type: none"> ■ White sealant ■ Brown sealant 	Associated with guard shack wall penetrations	15 LF
5 (M)	<ul style="list-style-type: none"> ■ Brown Sealant 	Associated with electrical box siding and exterior sheet metal seams on guard shack	80 LF
11 (M)	<ul style="list-style-type: none"> ■ Grey sealant 	Penetration sealant associated with walls of the three storage sheds	4 EA

Asbestos-related work must be performed in compliance with Washington State worker protection and environmental protection regulations. See WAC 296-62, WAC 296-65, and PSCAA Regulation III, Article 4 for additional information.

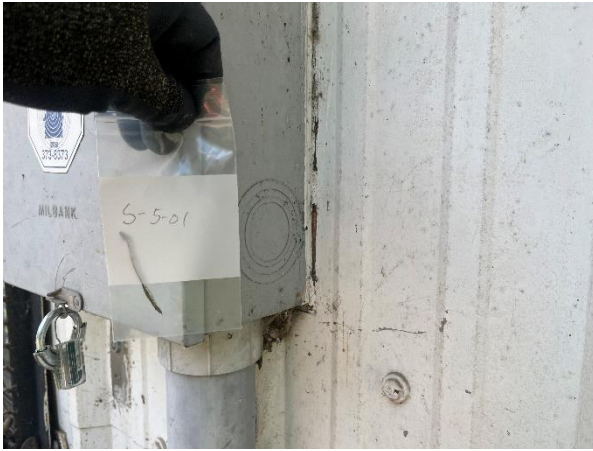
Material 5

Material No.	Material Description	Material Location	Results
5 (M)	■ Brown Sealant	Associated with electrical box siding and exterior sheet metal seams on guard shack	5%-7% Chrysotile
6 (M)	■ Concrete slab	Foundation associated with the guard shack	ND (all layers)
7 (M)	■ Yellow insulation foam ■ Silver foil	Interior roof insulation within the guard shack	ND (all layers)
11 (M)	■ Grey sealant	Penetration sealant associated with walls of the three storage sheds	5%-7% Chrysotile
12 (M)	■ Assumed electrical panel components	Associated with guard shack	Assumed to contain asbestos

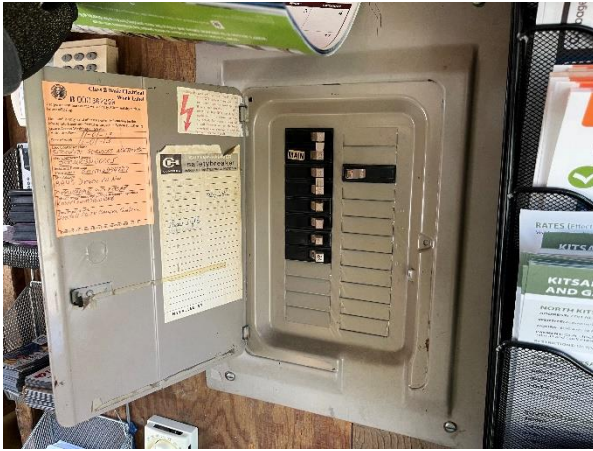
Material 12

Material No.	Material Description	Material Location	Approximate Quantity
12 (M)	■ Assumed electrical panel components	Associated with guard shack	1 EA
