### **INSPECTION REPORT**

This is a report from an inspection performed July 15, 2024, at the request of **Kitsap County Parks Department** of multiple buildings at 2485 McWilliams Road, Bremerton, WA. Known as Rolling Hills Golf Course.

The main structure, Restaurant and Pro Shop is a wood framed building built in the 1960's with a separate golf cart storage and 3 separate maintenance buildings.

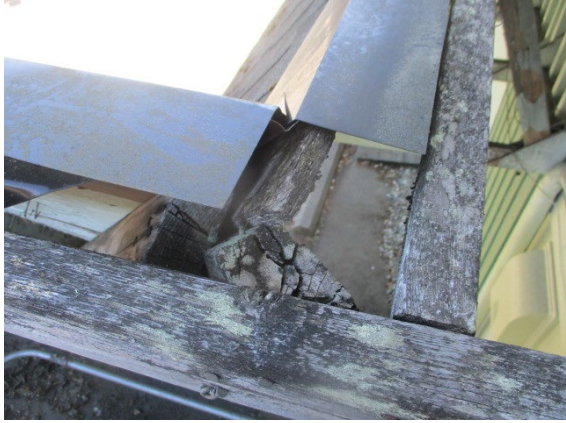
Gap in flashing above entry

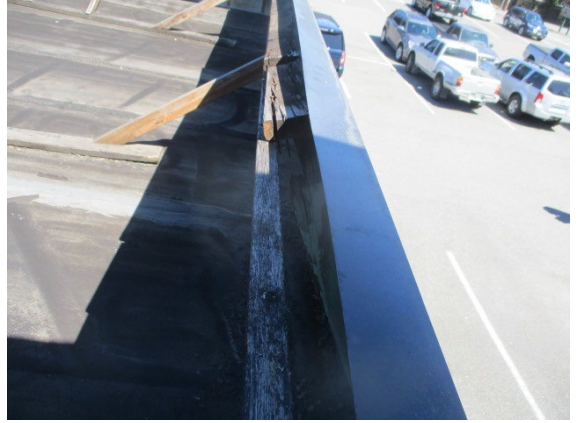
12. The top plate on the north screen wall has wood decay running along much of the length of the wall. (RF7), the damaged materials should be removed and replaced using treated materials.

Loose flashing and some wood decay at top of screen wall on the north side

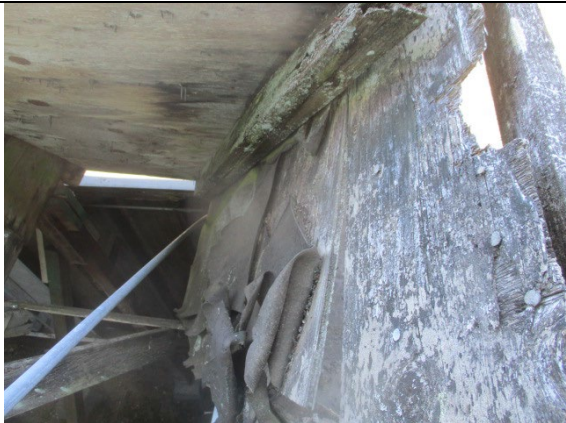
Wood decay in top of screen wall at Northside

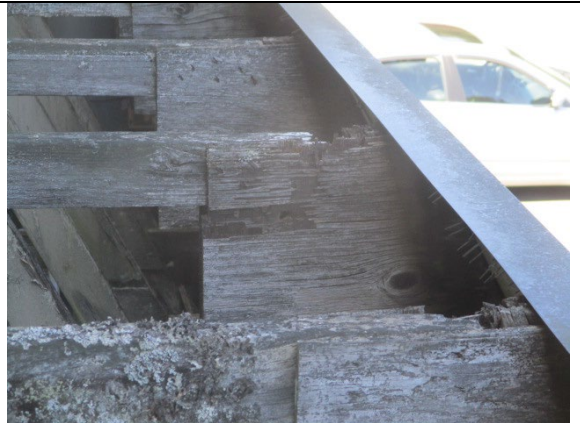
Wood decay in framing at screen wall and north side

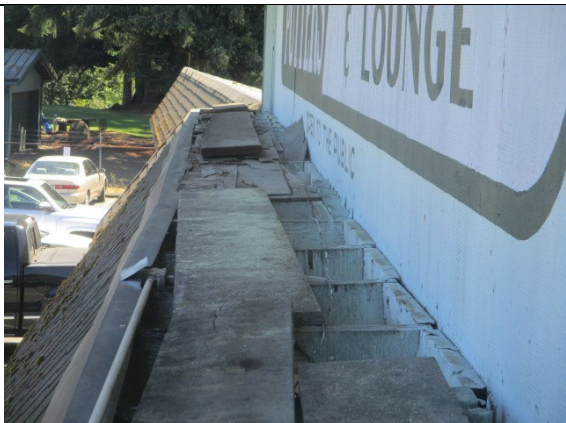
10. There is a mansard roof installed over a portion of the screen wall that has been built along the north side of the restaurant. The roof was a simple façade and is open on the top that has allowed rainwater and weather to enter into the open area that has caused some deterioration and decay in the framing (RF1). The decayed materials will need to be replaced and consideration should be given to using treated materials for the replacement or considering some installing a cover and protect the wood in the area behind the screen wall.

Open area at top of screen wall

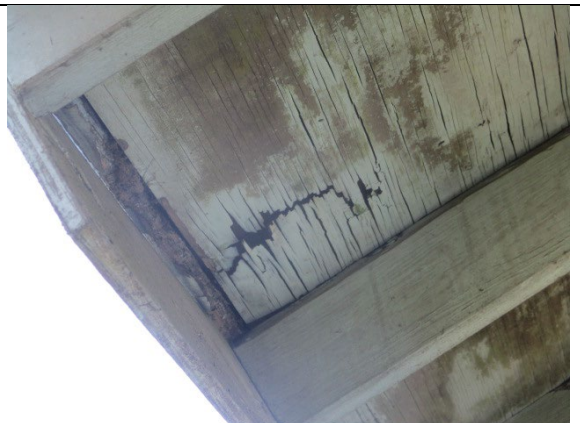
Damage sheathing at mansard

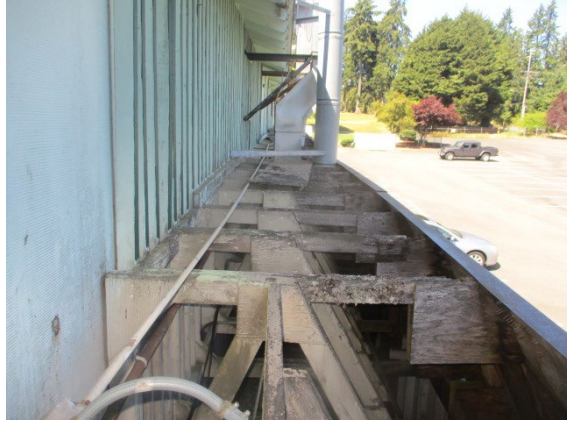
11. There is no flashing at the top of the mansard roof. A U-shaped flashing should be installed to seal the top of the mansard to prevent water intrusion.

Open top of screen wall and mansard roof

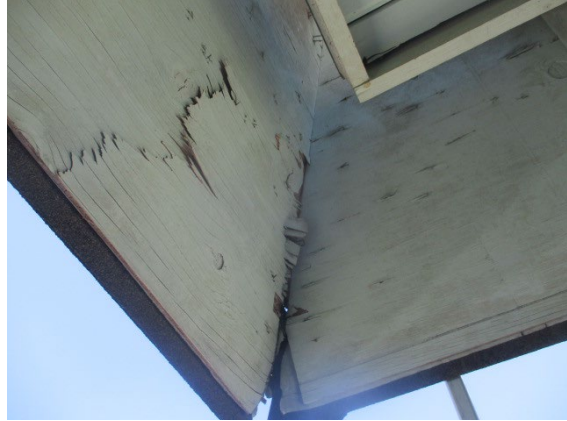
18. The northwest corner of the roof over the entry walkway (D1) is damaged from what appears to be vehicle contact. The area should be repaired.
19. There is some wood decay in the soffit car decking at the roof over the entry walkway (RF2) near the north end of the roof. The damage materials should be removed and replaced.

Damage at northwest corner of entry roof from vehicle, contact

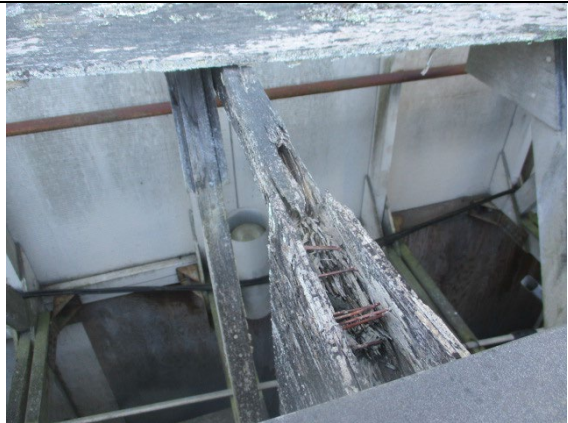
Wood decay in framing at screen wall

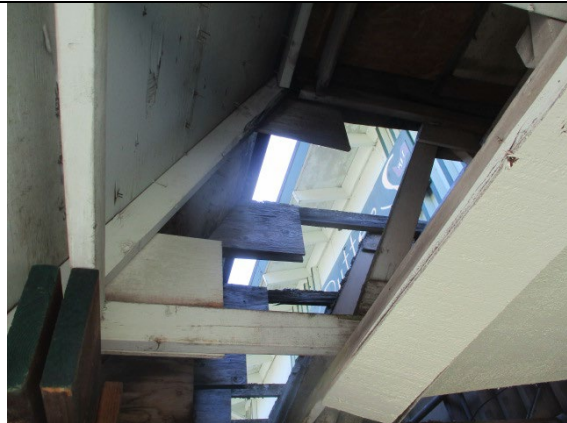
22. There are multiple areas of damaged soffit screen around the restaurant area and there are areas where the soffits are open on the ends. The open soffits and damage screens have allowed for bird and pest access. Consideration should be given to closing off the soffit areas and repairing the screens to allow for ventilation and restrict pest, bird or rodent access.

Open soffit area along the north side

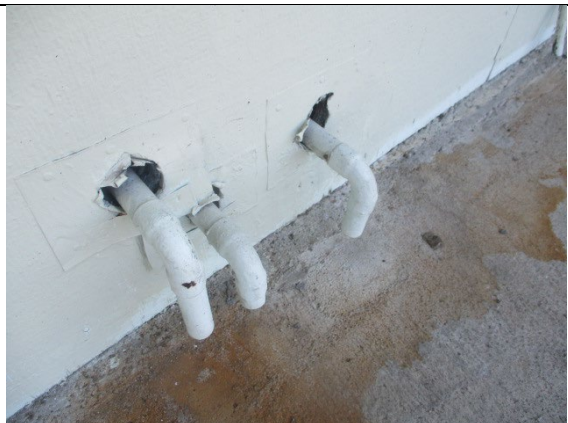
21. There are multiple drain lines and conduits along the west side that should all be caulked and sealed where they pass through the siding to prevent water intrusion and prevent wood decay.

Westside lines need to be caulked and sealed at siding

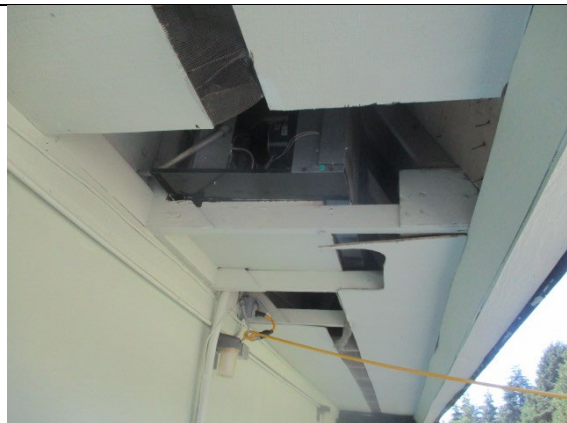
Open soffit on west side

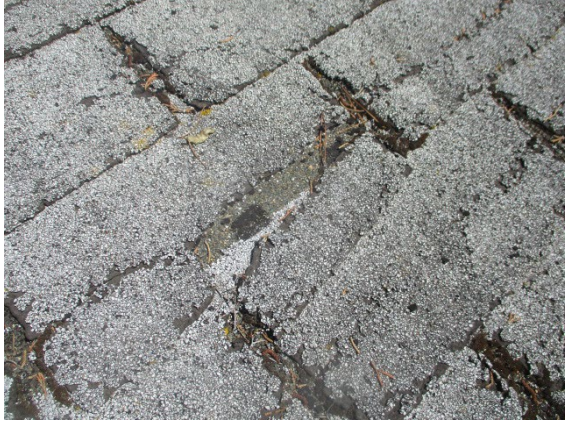
Deteriorated roofing at cart storage

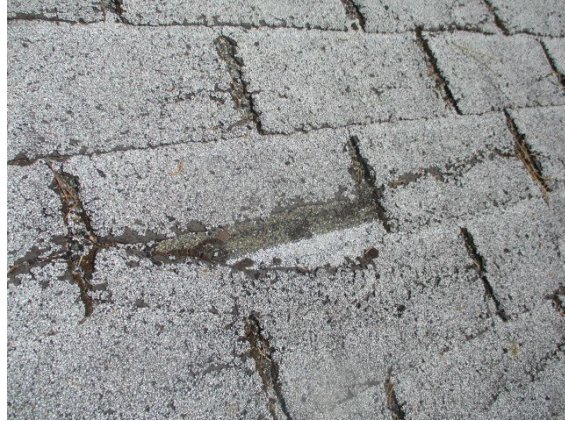
Deteriorated roofing at cart storage

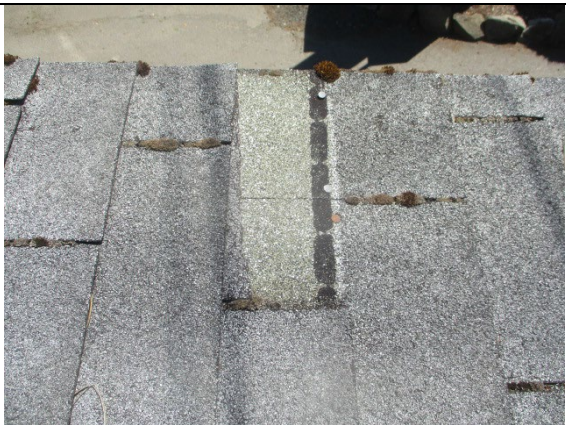
Missing roofing at cart storage

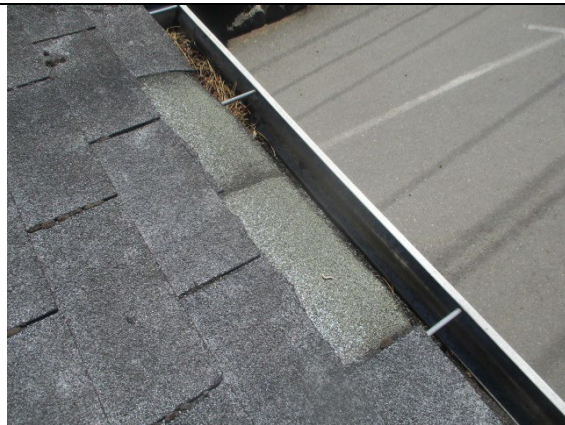
Missing roofing at the gutter line at cart storage

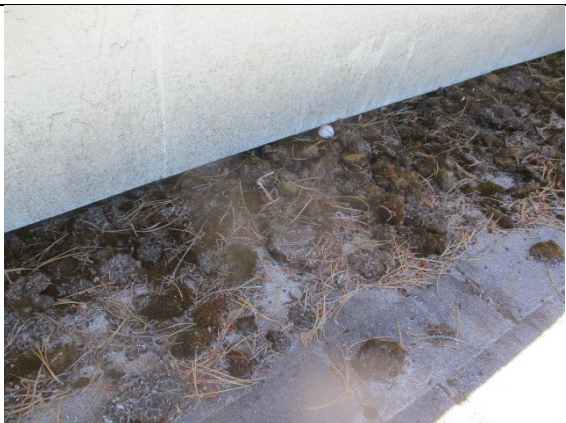
28. The roof on the breezeway area is at the end of its expected service life. Consideration should be given to replacing the roof which would include removing all of the existing roofing, repairing any damaged sheathing and installing a new roof to current construction standards.

Deteriorated roof at breezeway

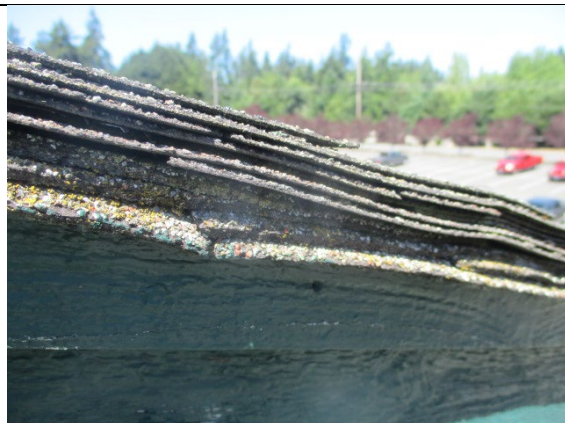
27. The last roof that was installed on the cart storage area appears to of been done in 2005. This was 1/3 layer of roofing. Codes restrict the maximum number of layers to 2. When the building is reroofed all of the existing roofing will need to be removed prior to the installation of a new roof. Portions of the roof over the cart storage area has missing or broken tabs. Consideration should be given to having the roof evaluated by a licensed professional roofer to determine the exact service life remaining.

Multiple layers of roofing at cart storage area

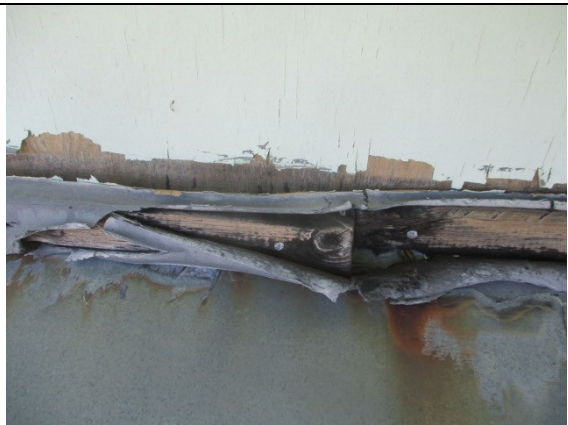
Gap in flashing at parapet wall

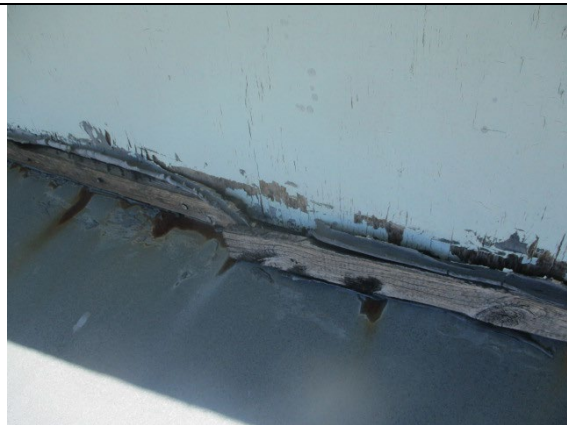
Gap in flashing at gable wall

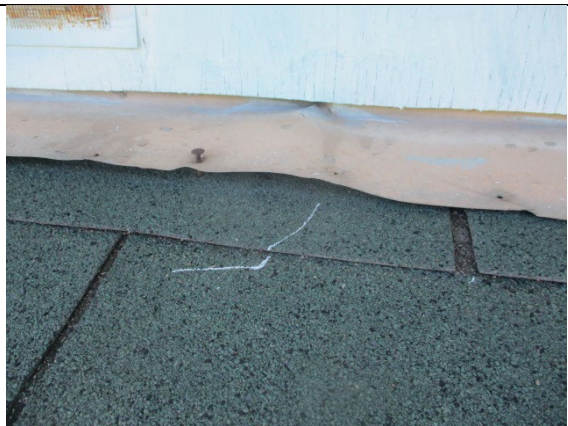
30. The south gable flashing between the wall and the roof is loose at the roof needs to be fastened down in place to prevent water intrusion.
31. The west gable flashing between wall and the roof is loose at the roofing needs to be fastened down in place to prevent water intrusion.

Loose flashing at the gable end

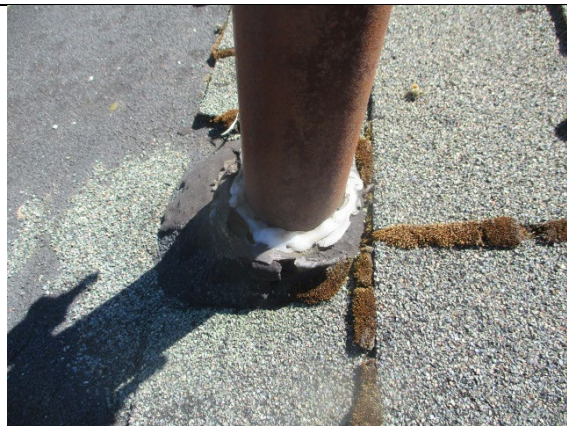
Deteriorated plumbing vent pipe boot that should be replaced

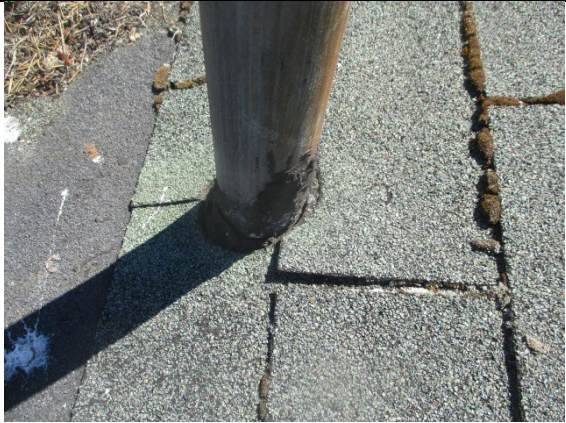
Plumbing vent pipe the needs to have a boot installed that is above the roofing to drain properly

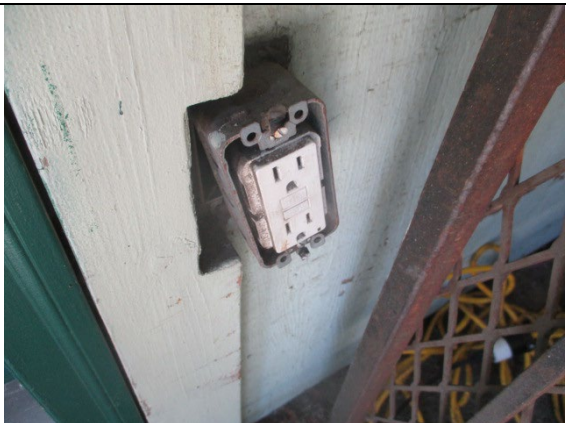
23. The storage area at the north side of the breezeway needs to have weatherproof covers installed on the electrical outlets for user safety.
24. The cart storage area needs to have weatherproof covers installed on the electrical outlets for user safety.

Electrical outlets at storage area that needs weatherproof cover.

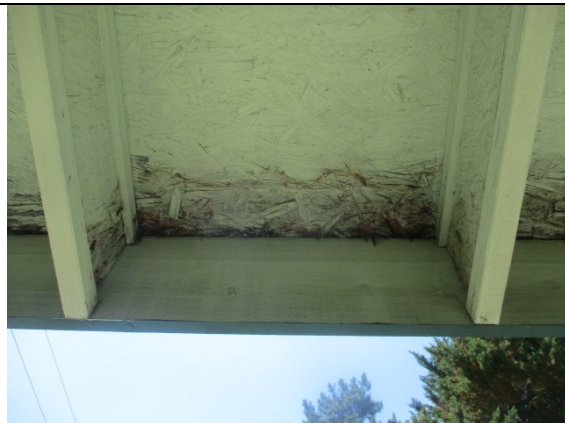
25. The screen mesh at the east side of the cart storage area (D2) is damaged and should be repaired.
26. There is wood decay along the gutter line at the south side of the cart area (RF3), the damage materials should be removed and replaced.

Wood decay in the soffit at cart storage

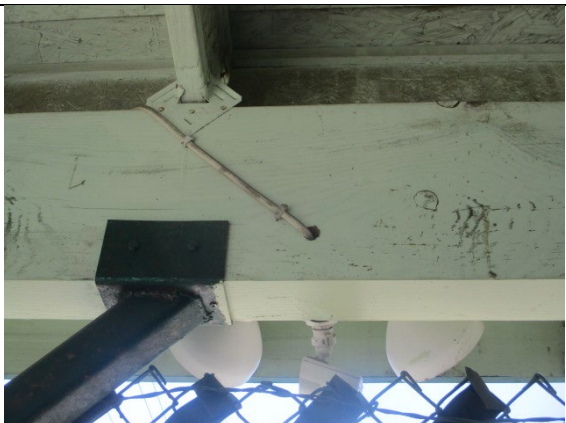
32. There is some unprotected electrical wire that is run along the south saw for the cart storage area. The wires should be placed inside of an approved conduit to protect it from damage.

Exposed electrical wires at cart storage

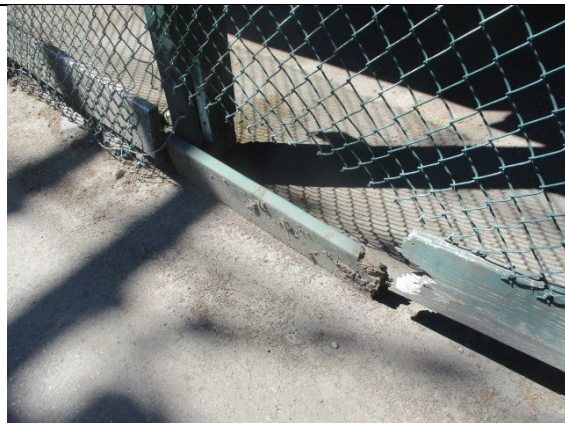
Damage screen at east side of cart storage

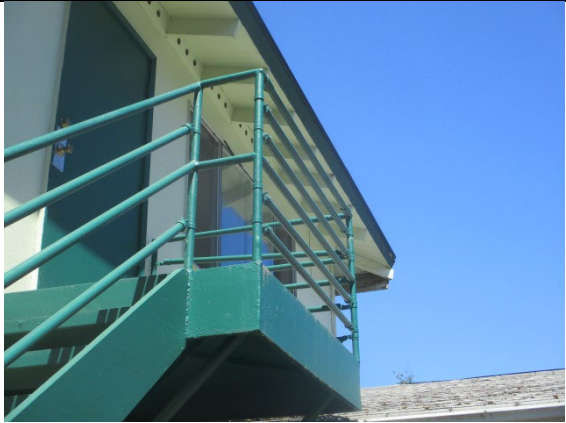
33. The horizontal rail at the top of the east stairway landing is loose and needs to be fastened down in place.
34. There is a section of open railing at the east stairway landing. The railing should have spaced so that a 4" diameter sphere cannot pass through the openings for user safety.

Open railing at east stairway

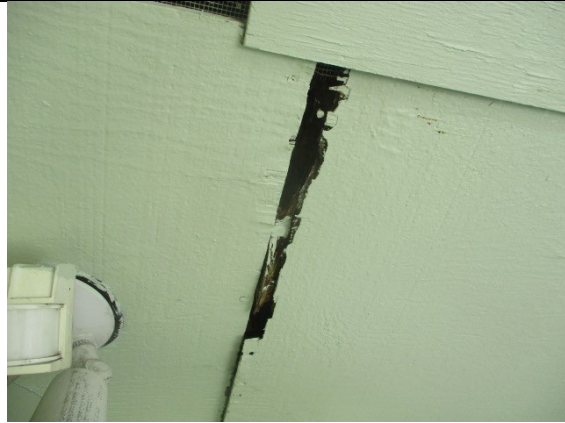
39. There is some wood decay in the soffit material at the southwest corner of the restaurant (RF4): the damage materials should be removed and replaced.

Loose soffit at southwest corner of restaurant

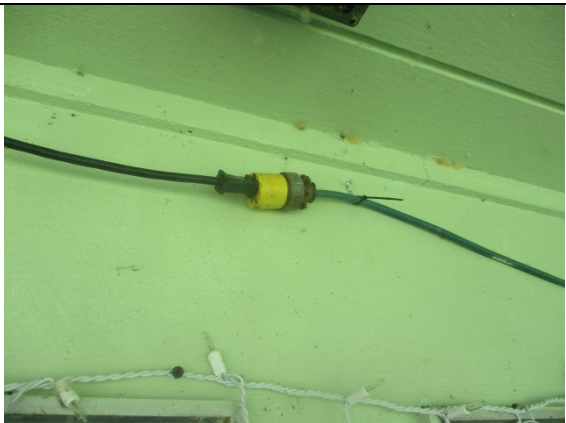
38. There are multiple decorative soffit lights run with extension cords along the south side of the restaurant. This is a safety and fire hazard issue. The extension cord should be removed and if a power supply is needed it should be hardwired to a GFCI protected outlets for the lights to plug directly into.

Extension cords along South soffit

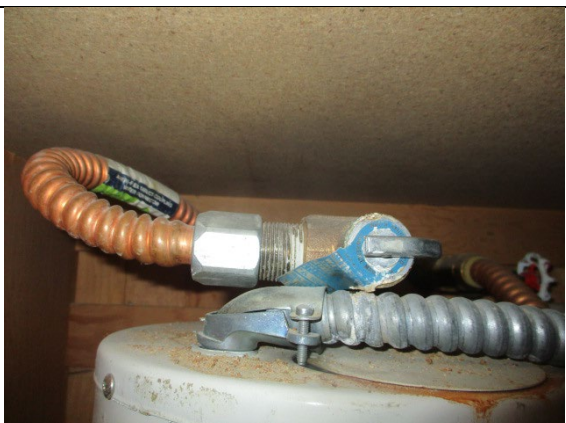
55. The upper-level restroom area has a 1.5-gallon point of use water heater. The temperature and pressure relief valve discharge line on the unit runs in an uphill direction which can trap water and creates a hazardous condition. The discharge line needs to be rerouted so that it runs in a downward hill direction only for user safety.

Upper bath water heater with temperature and pressure relief valve that runs uphill

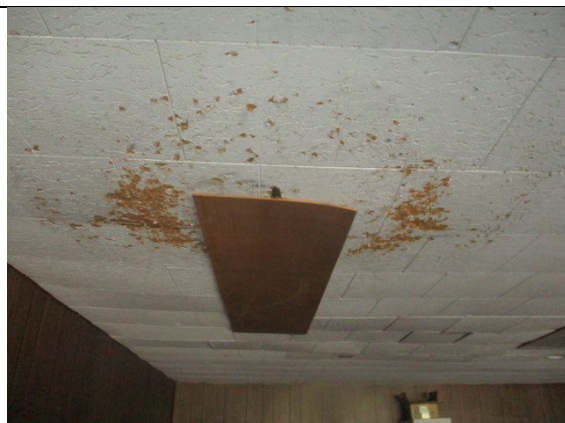
Older staining at upper ceiling

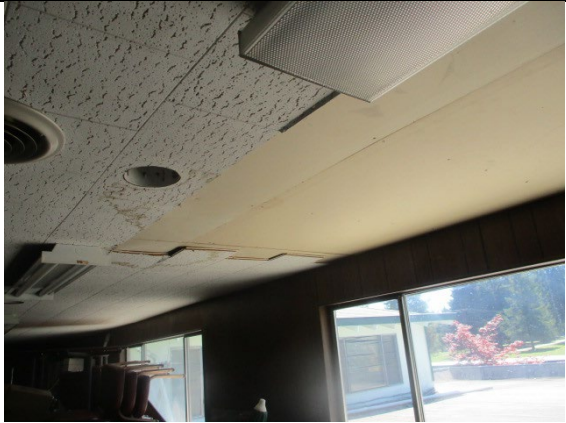
Missing ceiling tiles at the upper level

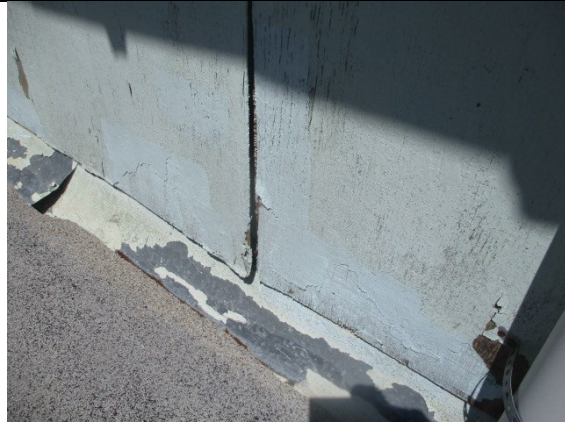
45. There is some loose and delaminating siding along the south side of the upper wall above the restaurant (S1), the delaminated siding should be replaced and the loose siding fast down in place to prevent water intrusion.

Loose siding and flashing at parapet above restaurant

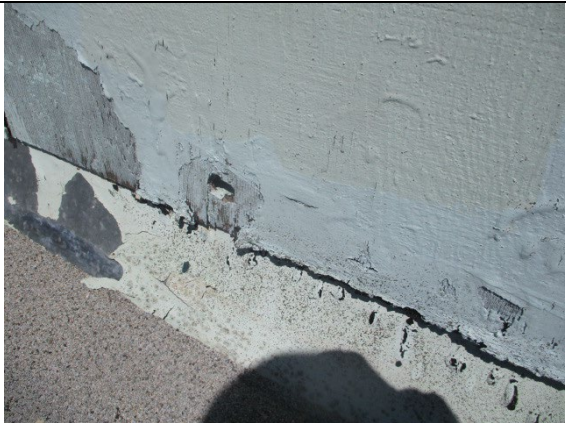
Damage siding and loose flashing at parapet

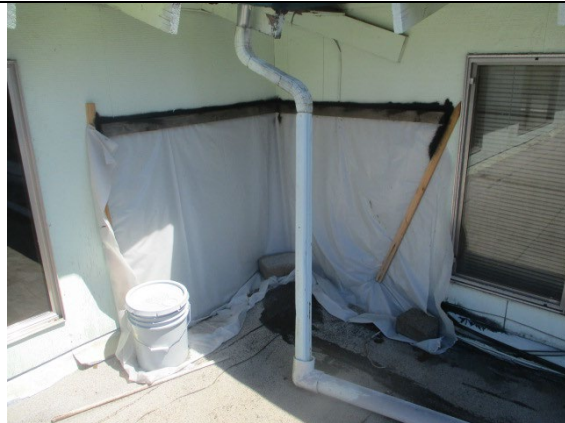
Upper northeast corner parapet that is not sealed or finished

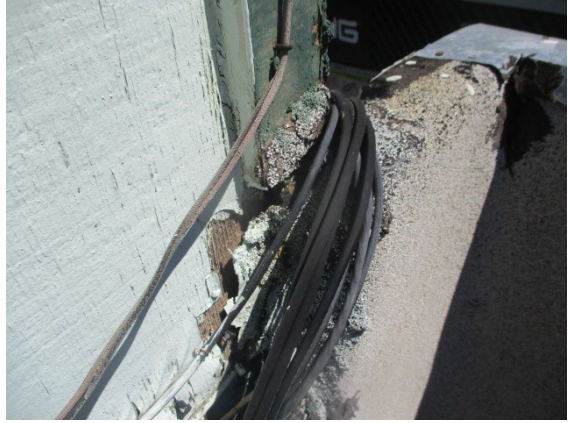
Wiring in the upper corner of roof that need serious sealed to prevent water intrusion

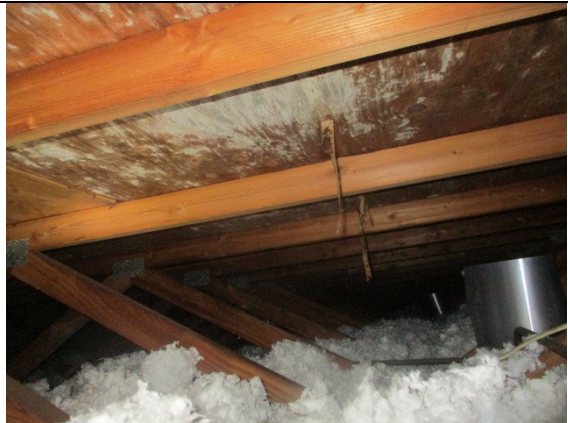
51. There is some staining on the bottom of the roof sheathing that appears to be older and from prior to the current roof being installed. No action recommended at this time.

Staining at roof sheathing in attic

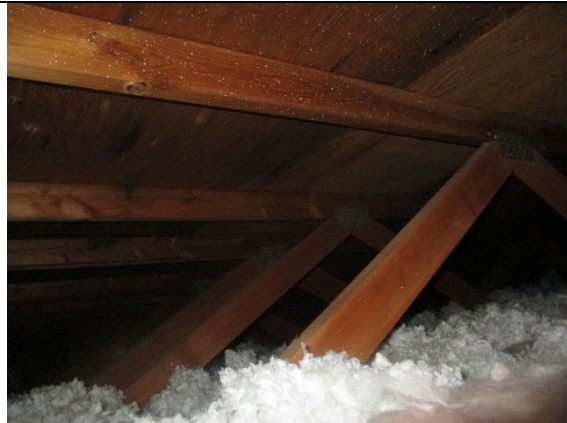
Old staining at attic area

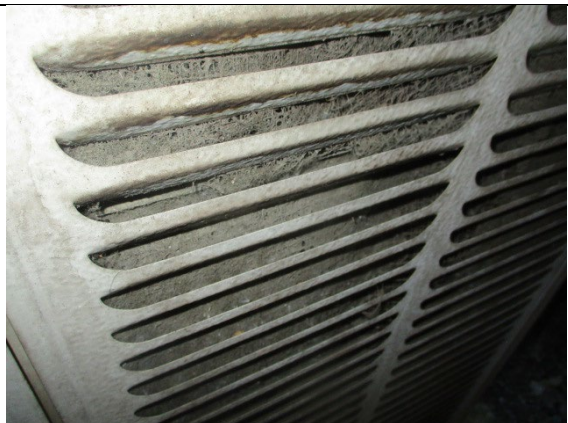
14. The older original typed HVAC unit has an air screen that is completely plugged which restricts the efficiency of the unit. The unit should be serviced by licensed professional with a receipt provided.

Plug vent at older HVAC unit on the north side

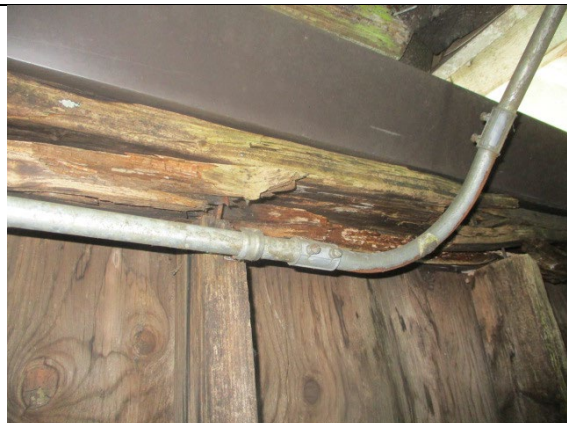
Wood decay in top plate at screen wall on the north side

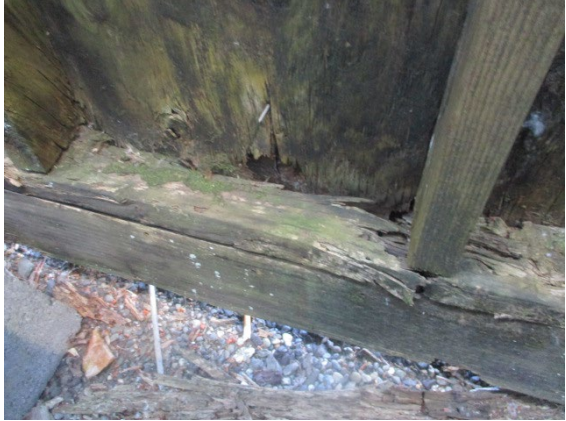
13. The bottom of the siding and some of the sill plate at the north screen wall has wood decay (RF8), the damaged materials should be removed and replaced using treated materials for the plates.

Wood decay in the sill plate and siding at north screen wall

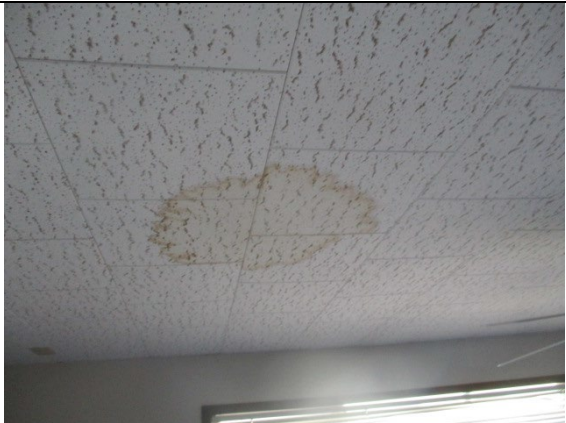
Stains from old roof leak

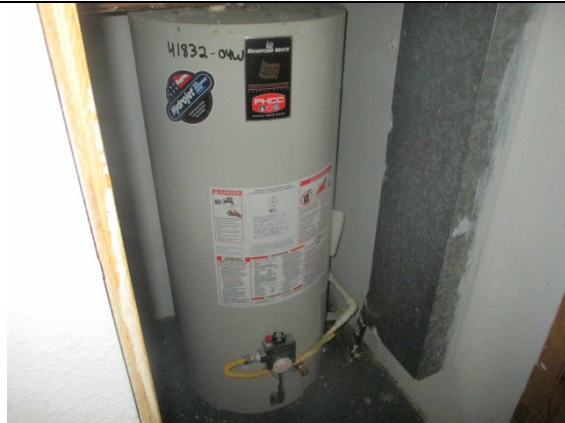
Upper-level gas water heater without seismic restraint straps and no thermal expansion tank

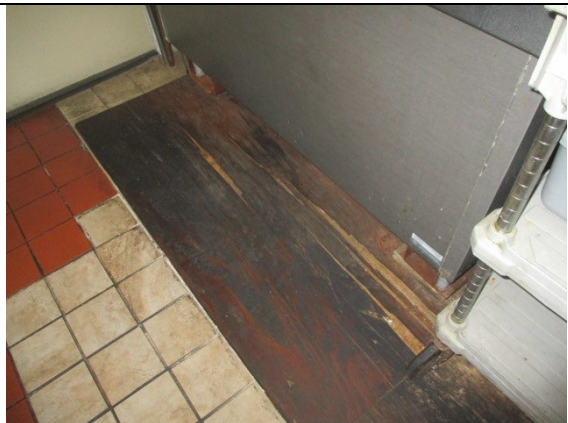
65. The floor under the icemaker in the kitchen (RF6) is completely decayed. A plywood sheet has been placed under the icemaker with a metal support along the wall to support the unit. The floor area needs to be removed and any damage materials replaced and a new floor covering installed. Consideration should be given to placing a pan under the icemaker with a drain to the exterior. *While repairing the floor in this area it may be a good location to add an additional crawlspace access opening to be able to periodically check under the kitchen.*

Missing flooring and extensive wood decay under icemaker at kitchen

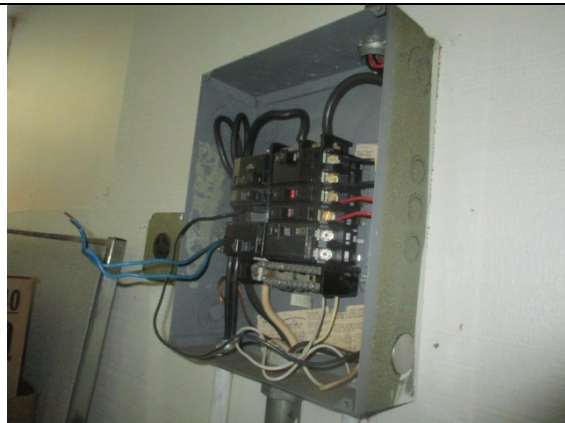
67. The small power panel at the upper-level west office area has the faceplate and cover removed. The cover needs to be replaced for user safety as there are exposed live wires.

Open power panel at office above West End of restaurant

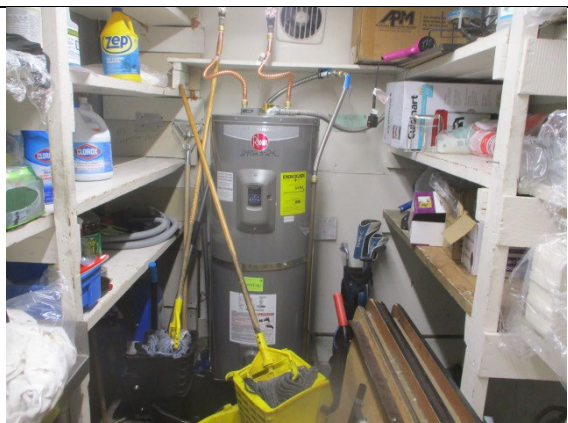
68. The 50-gallon Rheem water heater in the kitchen area has a single seismic restraint strap. An additional strap should be installed so that there is one in the upper one third one in the lower one third of the tank for code compliance.

69. The 50-gallon Rheem water heater in the kitchen area was replaced in 2024 and is required by code to have a thermal expansion tank. It is recommended that a thermal expansion tank be installed on the cold-water supply line.

Restaurant water heater with a single seismic restraint strap and no thermal expansion tank or discharge line from temperature and pressure relief valve

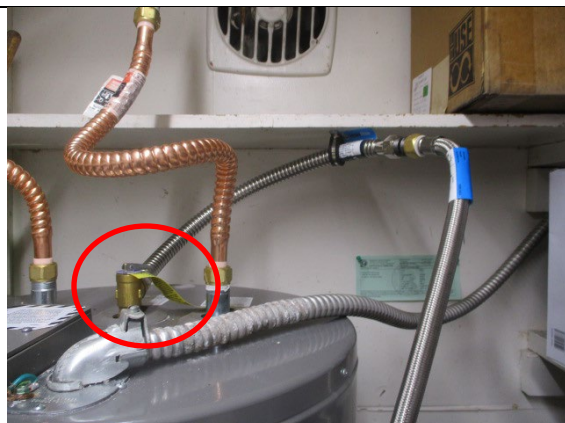
70. The temperature and pressure relief valve discharge line on the 50-gallon Rheem water heater in the kitchen runs in an uphill direction that can trap water and cause an

explosion in the event of a discharge. The line needs to be modified so that it runs in a downward direction only as required by code for user safety.

restaurant water heater missing thermal expansion tank and discharge line from temperature pressure relief valve

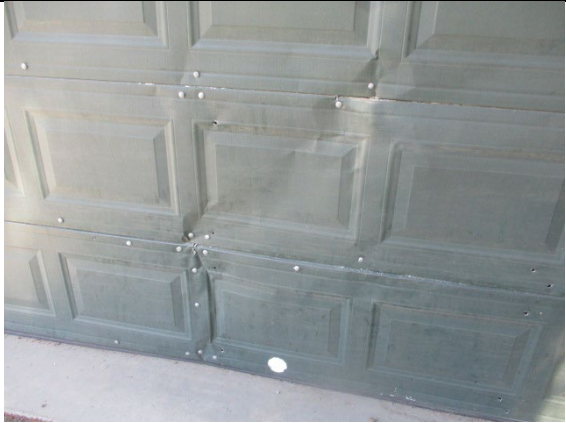
Damage at south overhead door

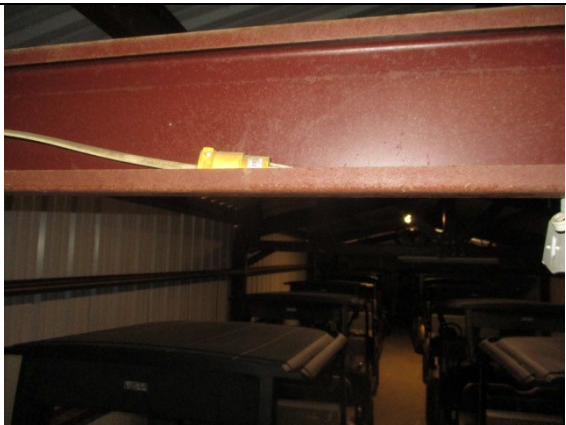
Romex extension cords

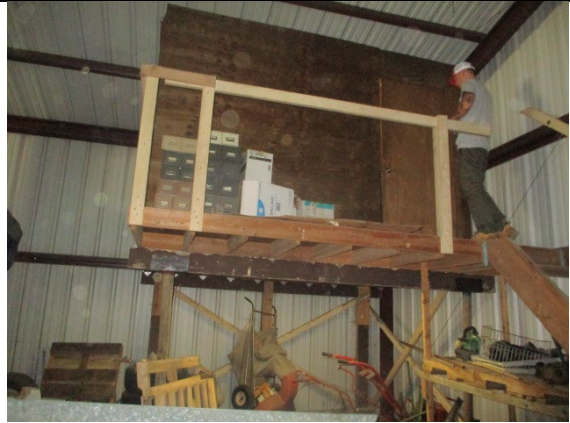
Loft without handrail on stairs
