2022 Annual Bridge Report

Prepared by Kitsap County Public Works
Engineering Division

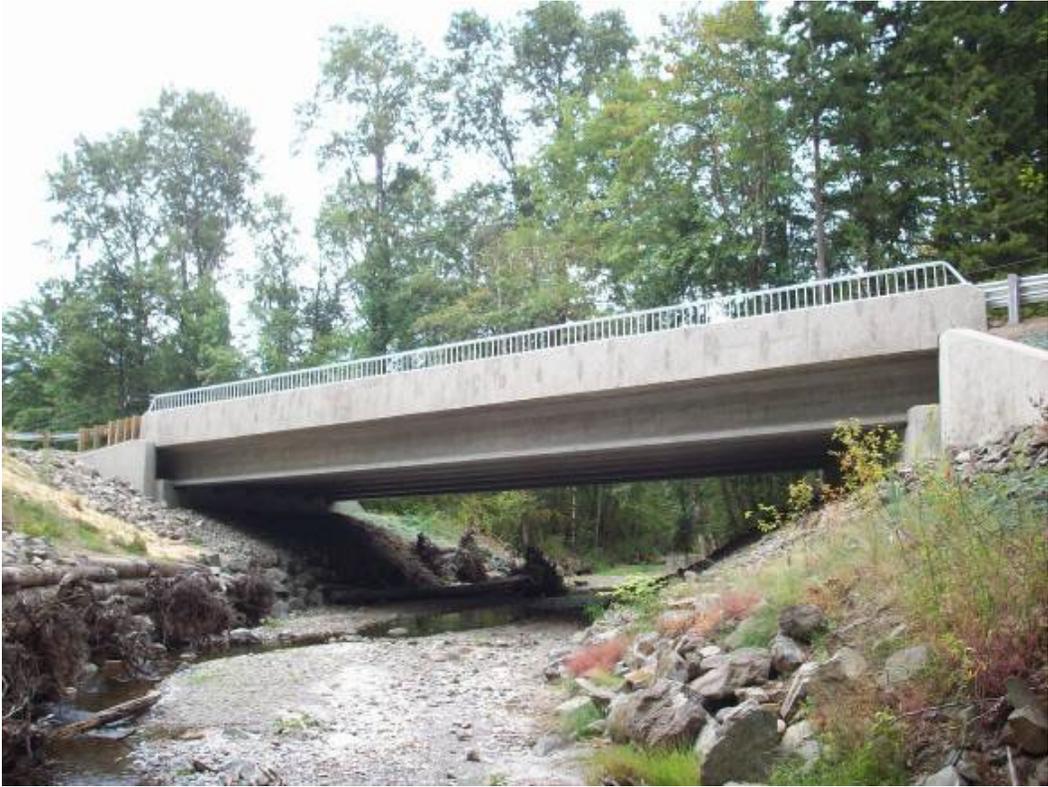
Bridge 03 – Chico Bridge

Superstructure	Girder	Prestressed, precast bulb-tee girders (WF50G) in good condition.
	Deck	Cast-in-place concrete deck with cast-in-place sidewalks. Hairline cracks beginning to appear in deck at SW quadrant as well as the sidewalk and barrier along East& West sides of bridge.
	Other	Concrete Bridge and Metal Pedestrian Railing is in like-new condition.
Substructure	Foundation	Driven steel H12x63 piles.
	Abutments	Cast-in-place concrete abutment. Girder seats are 36" with elastomeric bearing pads. In Summer of 2020, maintenance crews repaired sloughing bank armor. Appears to be holding up.
Scour and Load Rating	<p>Bridge has been load rated as per FHWA requirements by TranTech Engineering in 2018. Scour analysis has not yet been performed for this structure.</p> <p>Minor repair work performed to stabilize log boles in December of 2010 upstream. Minor bank armor repair in summer 2020.</p>	
Photo

Recommendations	Monitor bank repair under the bridge. Monitor hole in log weir 35' & 75' upstream from bridge at NW quadrant. Broken locate wire for water line at splice point in the NE corner.
------------------------	---

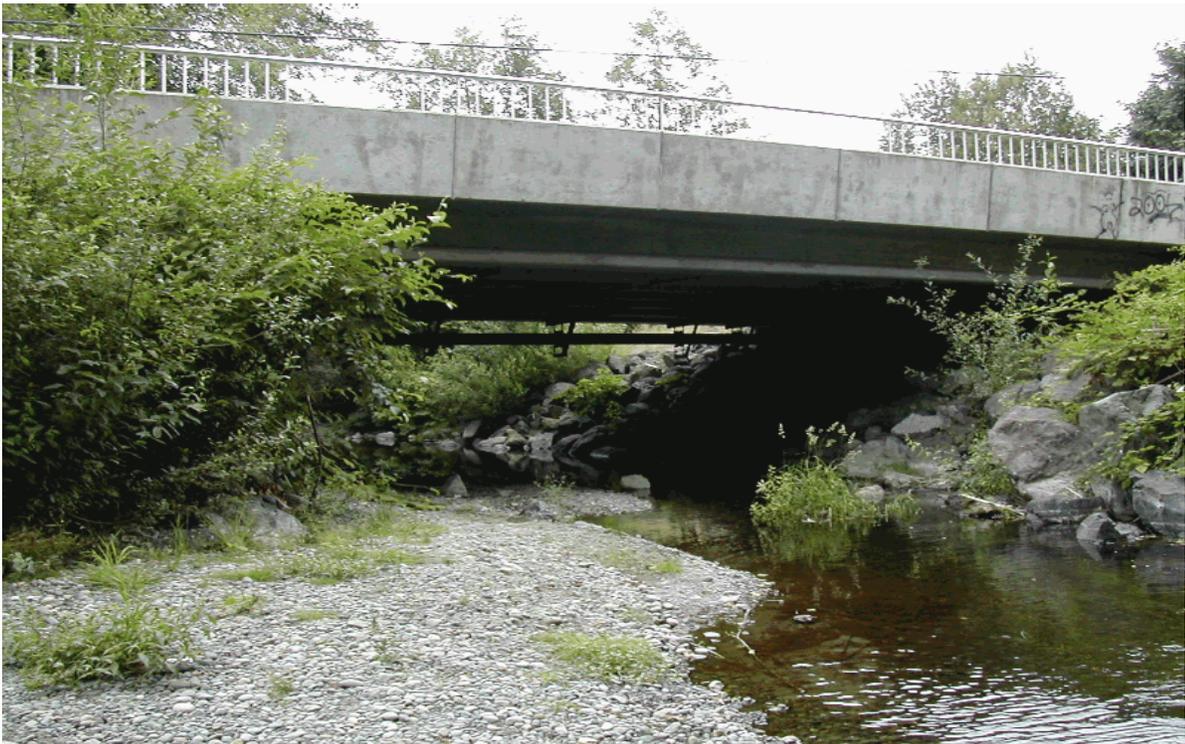
Bridge 04 – Erlands Point Bridge

Superstructure	Girder	Prestressed, precast bulb-tee girders (W35G) in good condition.
	Deck	2" ACP Overlay with waterproof membrane.
	Other	Concrete bridge railing beginning to show hairline cracks at attachments to metal pedestrian railing. Traffic attenuator pad at SW corner has been repaired with rebar stakes and timber lagging in 2020.
Substructure	Foundation	Driven steel 18" pipe piles filled with concrete.
	Abutments	Cast-in-place concrete abutment. Girder seats are 46" with elastomeric bearing pads. Slope armor is working well at this time. No defects found.
Scour and Load Rating	<p>Bridge has been load rated as per FHWA requirements by TranTech Engineering in 2018. Scour evaluation and analysis was performed by Entranco Engineering in 1998.</p> <p>Upstream beaver dam is no longer intact and there is significant sediment and debris build-up at upstream end of bridge.</p> <p>This bridge is not scour critical.</p>

Monitor slope armor at SE corner of bridge. The coating on the ductile iron pipe on the south side of the structure is beginning to rust. The ACP overlay is beginning to show perpendicular cracking at bridge joints due to continued settlement.

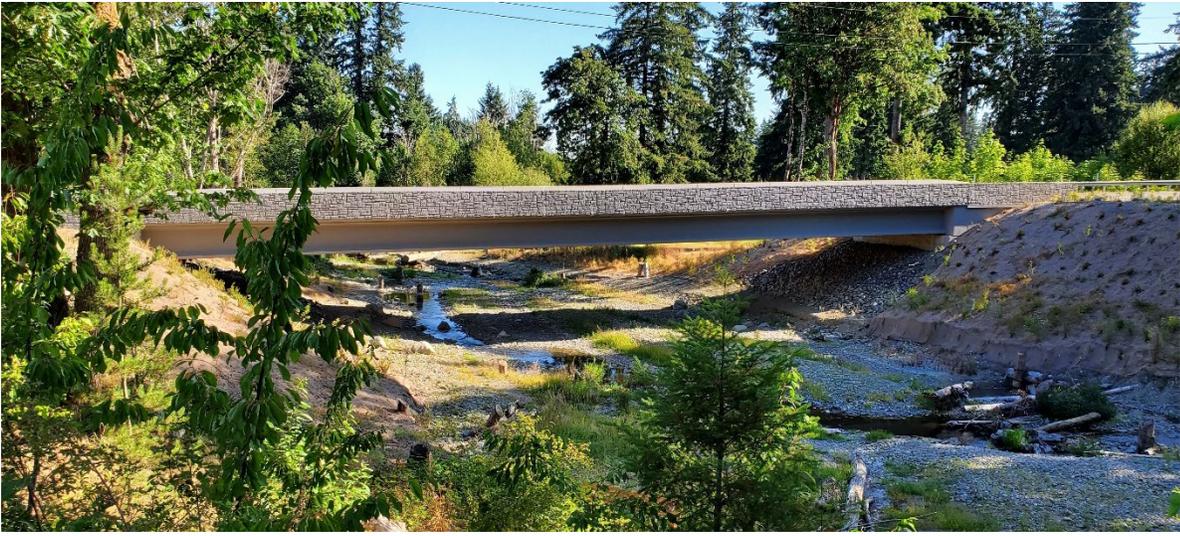
Bridge 07 – Golf Club Hill Bridge

Superstructure	Girder	WF58G Precast prestressed bulb-tee girders in good condition. 4 girders at approximately 136' in length.
	Deck	Cast-in-place 7.5" concrete deck with epoxy coated rebar in good condition.
	Other	Cast-in-place concrete bridge railing in good condition. Railing has pigmented sealer. Uniform vertical cracking along barrier with effloresce leaching.
Substructure	Foundation	Driven 18" steel piles filled with rebar and concrete. 5 piles per pier. Tip elevation on Pier 1 varies from 5.8 to 9.0 and at Pier 2 varies from 5.2 to 5.9.
	Abutments	Cast-in-place concrete abutment with attached wing walls in good condition. Girder seats are 12".
Scour and Load Rating	Bridge was load rated as per FHWA requirements by Shearer Design in 2019. This bridge is not scour critical.	
Photo

Recommendations Monitor flows during high water events.

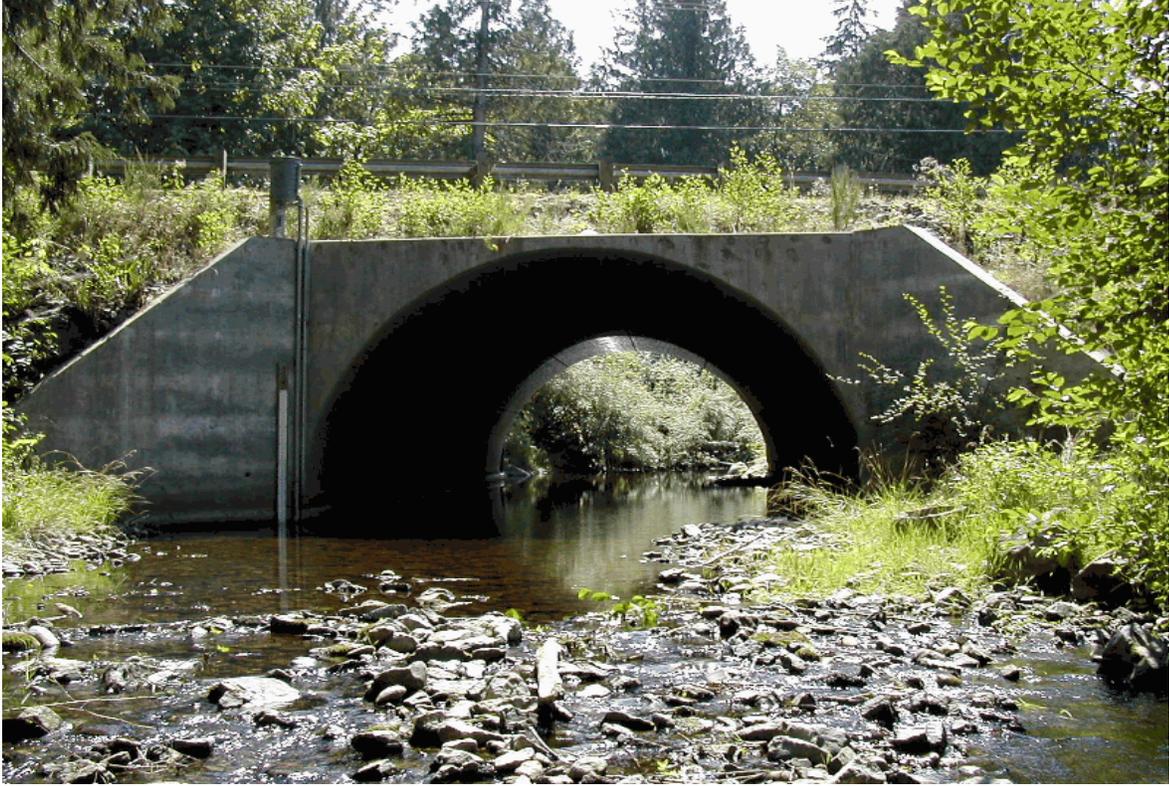
Bridge 08 – Holly Arch Culvert

<i>Superstructure</i>	<i>Culvert</i>	Galvanized steel arch culvert in fair condition. 6” to 8” of rusting is evident at connection point between steel panels and concrete footing. In mid-span in ceiling of arch 3 dented areas found within an 18”x18” area affected. Roadway ACP overlaid cy CRP 5036 in 2022. Roadway guardrail replaced by CRP 5035 in 2020.
<i>Substructure</i>	<i>Foundation</i>	Cast-in-place concrete spread footings. Scour repair performed in late summer of 2012. Footings are now protected by streambed gravel.
<i>Scour and Load Rating</i>	<p>Bridge has been load rated as per FHWA requirements by TranTech Engineering in 2018. Scour evaluation and analysis phase 2 was performed by Tetra Tech / KCM in 2004. County roads performed scour repair in late summer of 2012.</p> <p>This bridge is scour critical.</p>	
<i>Photo</i>

Recommendations	Monitor scour repair area for continued material loss at SW quadrant. Monitor wood debris upstream and bank sloughing at SW corner.
------------------------	---

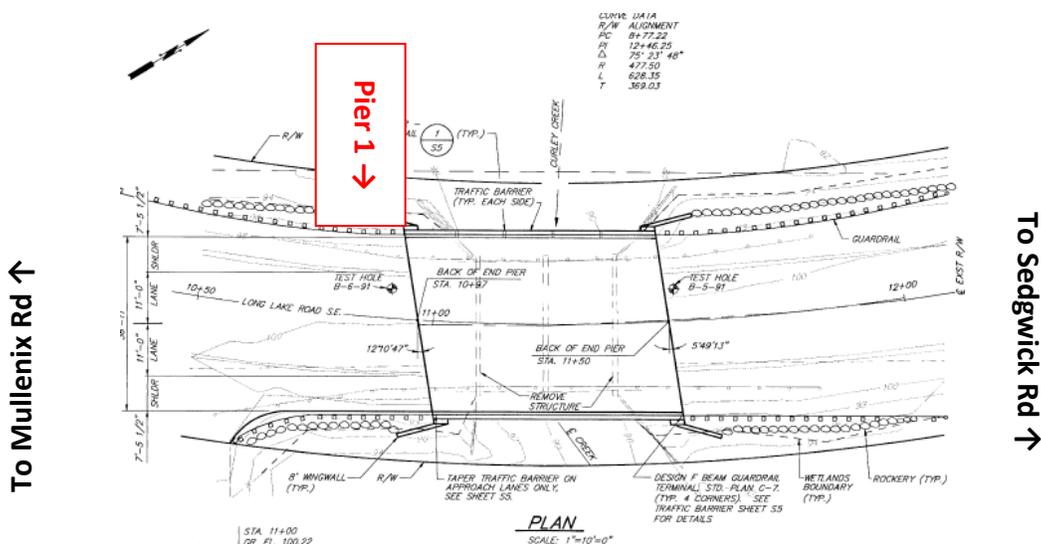
Superstructure	Girder	Prestressed, precast voided concrete slabs (4'ω x 2'-2" h) in good condition.
	Deck	3" ACP overlay with waterproof membrane is in fair condition. Cracking throughout needs sealing. ACP at bridge joints need repairs.
	Other	Concrete bridge railing transitions & terminals do not meet current standards.
Substructure	Foundation	Driven steel 12" pipe piles filled with concrete.
	Abutments	Cast-in-place concrete abutment in fair condition with undermining happening. Girder seats are 24". NE corner, scour is under the pile cap - 2" void height x 10' long x 2' distance under the cap. SE corner, scour is under the pile cap – 2" void height x 13' long. Pier 2 abutment has soil on top from between slabs and/or voids at pavement seat.
Scour and Load Rating	<p>Bridge has been load rated as per FHWA requirements by TranTech Engineering in 2019. Scour analysis has not yet been performed for this structure. SE & NE corners of pile cap are showing signs of back water scour due to large beaver dam at mid span that was removed Summer 2013. Heavily overgrown outlet end contributing to backwater scour.</p> <p>Beaver dam rebuilt at centerline of bridge between old wooden pilings. This is contributing to back water causing scour at abutments.</p> <p>This bridge is not scour critical.</p>

Cracking in ACP and at bridge joints

Repair ACP at both bridge joints and seal cracking in ACP Roadway. Monitor settlement and cracked ACP at the NE & SE corners at bridge ends in the embankment areas. Monitor void areas under both abutment walls. Monitor sloughed rockwall at NE embankment 15' to 20' of wall has toppled and recommend repair. Remove beaver dam under bridge adding to back water scour.

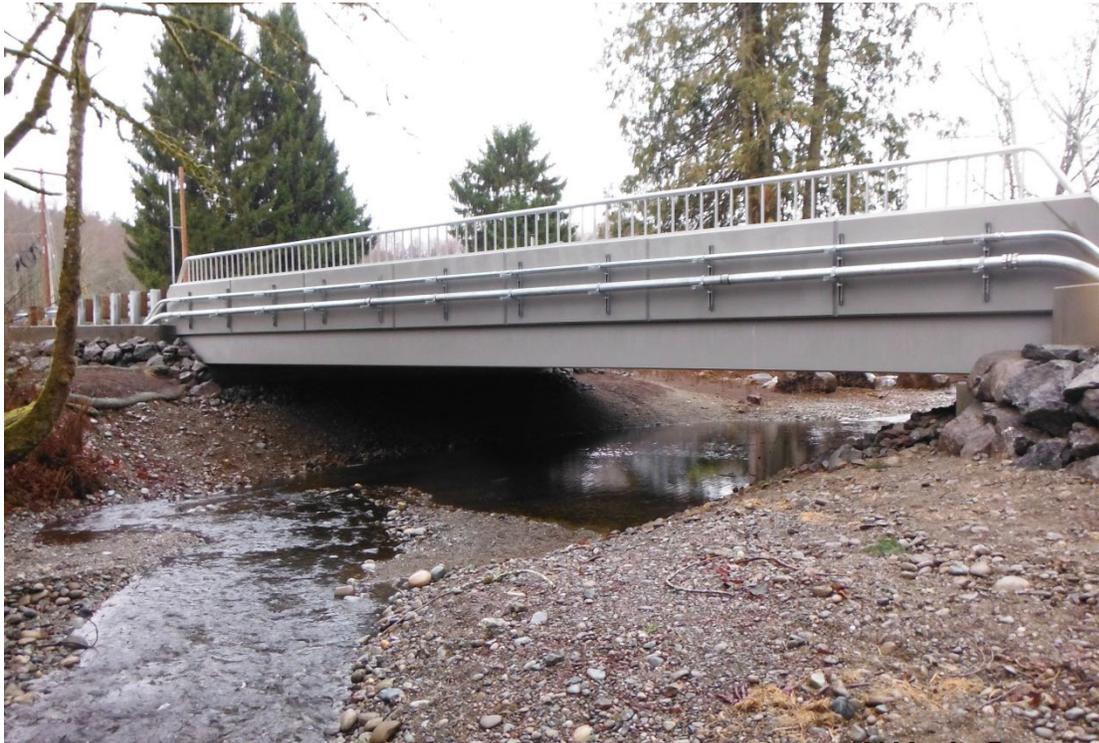
Bridge 11 – Miami Beach Bridge

Superstructure	Girder	Prestressed, precast voided concrete slabs (4'ω x 2'-2" h) in good condition.
	Deck	Cast-in-place 8" concrete deck with epoxy rebar mat. In good condition beginning to show signs of minor pitting throughout the deck.
	Other	Concrete bridge railing sealed with pigmented sealer in good condition. Metal pedestrian railing in good condition. Small section replaced on the South side after tree fell down in late winter 2016.
Substructure	Foundation	Driven steel 2' pipe piles filled with concrete and rebar to depths of 50-52' in length.
	Abutments	Cast-in-place concrete abutment in good condition. Elastomeric bearing pads and large rip rap protection. Elastomeric bearing pads show minor bulging throughout Pier 1.
Scour and Load Rating	<p>Bridge has been load rated as per FHWA requirements by TranTech Engineering in 2019. Scour analysis has not yet been performed for this structure.</p> <p>This bridge is not scour critical.</p>

Recommendations	Bridge is in good condition. Monitor material moving from abutment embankments to stream bed during high flows. Monitor stream bank beginning to cut at the East side just downstream from the structure.
------------------------	---

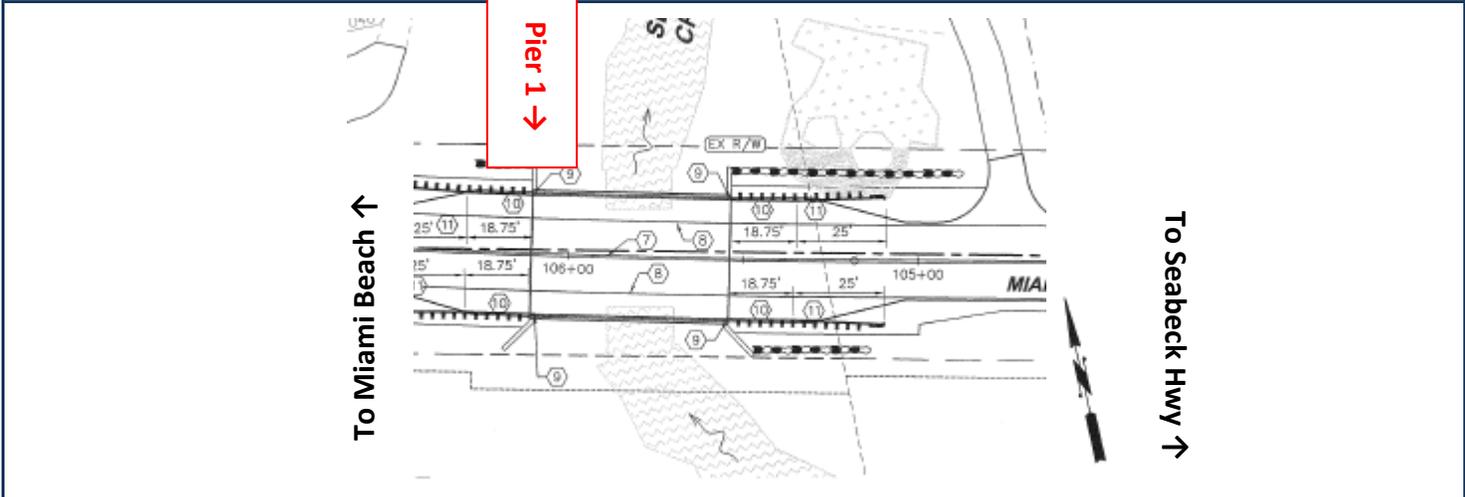
Debris getting caught on anabranch at downstream end of bridge

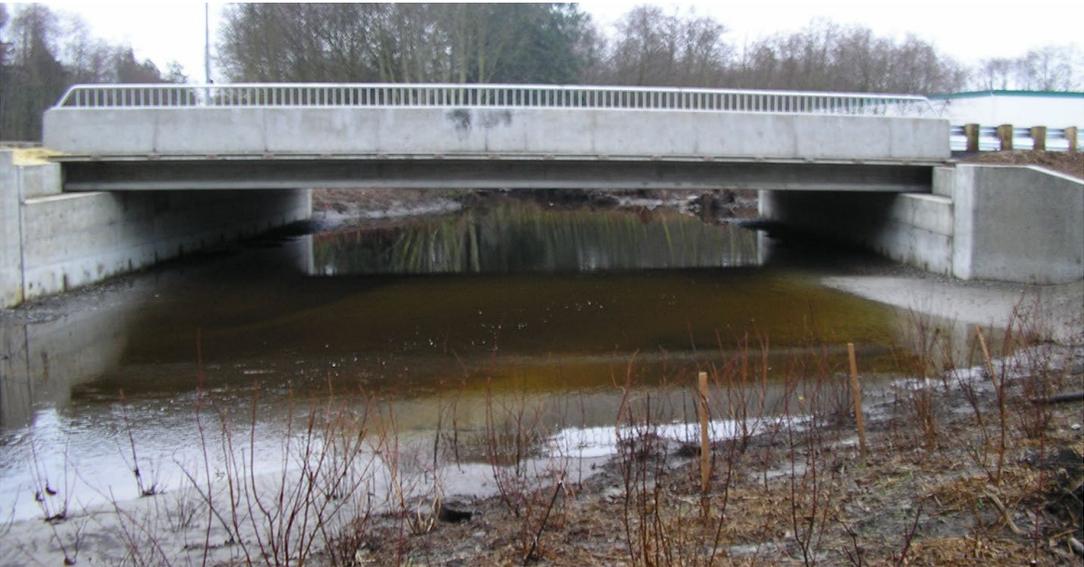
Bridge 12 – Myhre Bridge

Superstructure	Girder	Precast prestressed (35" DBT with 72" Flange) bulb-tee girders in good condition. Minor moisture present at both exterior girders.
	Deck	2" ACP overlay with waterproof membrane is in good condition. Cracking appearing at both bridge joints in need of sealing.
	Other	Concrete bridge & metal pedestrian railing in good condition. Hairline vertical cracking beginning to appear in concrete railing at connection to metal pedestrian rail.
Substructure	Foundation	Driven steel 14" HP14x117 pile foundation under abutment and HP12x63 piles under wing walls.
	Abutments	Cast-in-place concrete abutment in good condition. Girder seats are 25". Both abutment walls now have minor hairline vertical cracks at the bearing seats. SE wing wall top – small crack where wall meets outside flange of girder 45-degree angle x 6" long. Small voids now present between wing walls and abutments due to deterioration of fiber expansion material.

Scour and Load Rating	Bridge has been load rated as per FHWA requirements by TranTech Engineering in 2018. Scour analysis has not yet been performed for this structure. This bridge is not scour critical.	
Photo

Heavy vegetation growing and siltation deposits at inlet & outlet ends and should be removed. Seal cracking in ACP at both bridge joints. NE & SW sidewalk panels settling up to 1/2". Monitor settlement along Pier 2 joint.

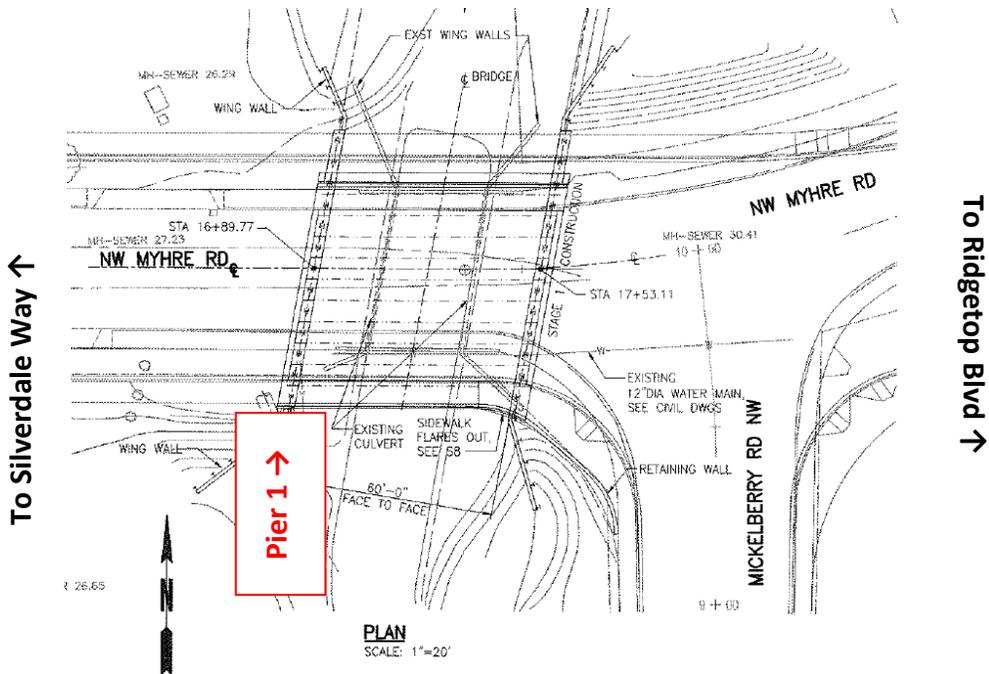
Seal Cracking in ACP at Bridge Joints

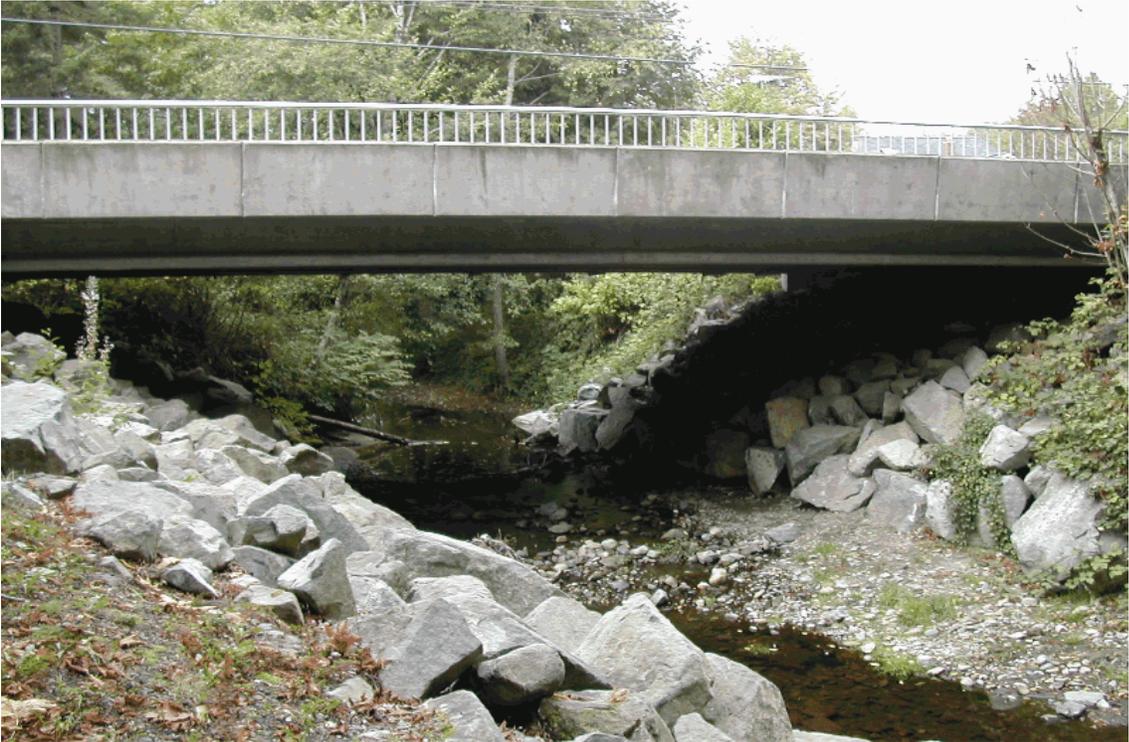
Bridge 13 – Northlake Bridge

Superstructure	Girder	Precast prestressed (W35DG) bulb-tee girders in good condition.
	Deck	2.5" ACP overlay with waterproof membrane is in repaired condition (milled and repaved in summer 2020 in travel lanes). Repair of ACP overlay has resolved previous problem of significant moisture between girders at deck underside.
	Other	Concrete bridge & metal pedestrian railing in good condition.
Substructure	Foundation	Driven steel 18" pipe piles filled with concrete. Additional rip rap was added at both side of inlet end in spring of 2009 by county forces and is working well.
	Abutments	Cast-in-place concrete abutment in good condition. Girder seats are 46" .
Scour and Load Rating	<p>Bridge has been load rated as per FHWA requirements by TranTech Engineering in 2018. Scour evaluation and analysis was performed by West Consultants in 1997. Additional rock armor placed at inlet end is working well.</p> <p>This bridge is not scour critical.</p>

Monitor bank armor at SW & NW corners.

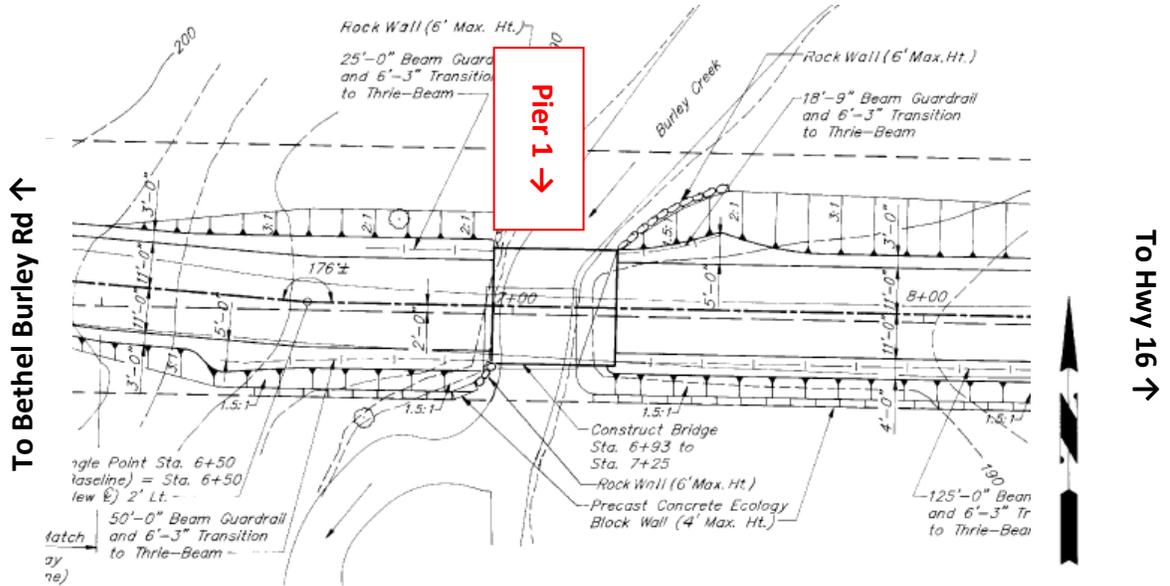
Failing ACP Curb

Cracking in ACP due to roadway settlement

3 areas of failing ACP curb should be repaired: NE, NW, and SE corners. Monitor rip rap at NE & SW corners with evidence of bank loss at this time.

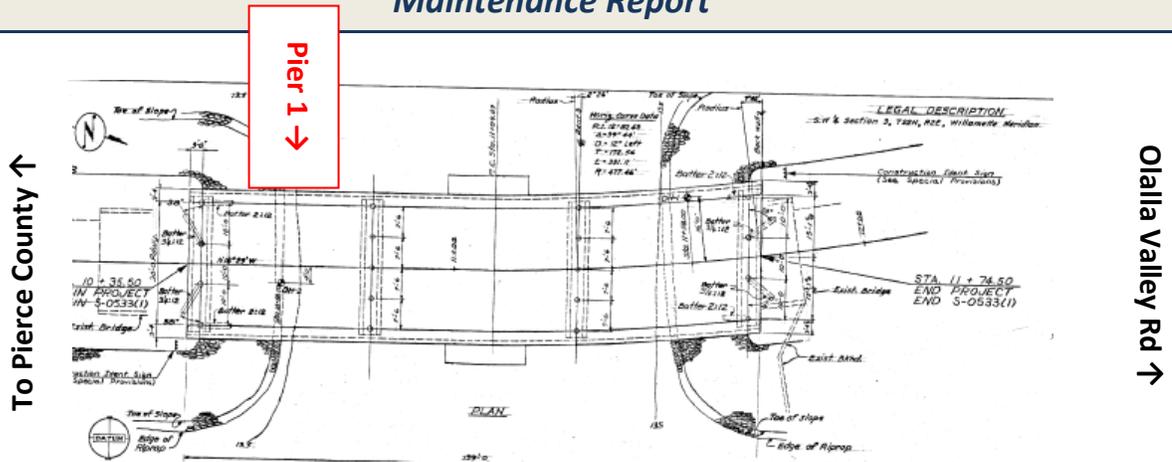
Sidewalk Spall

Current bridge rail and transitions do not meet current standards. Monitor settlement at bridge ends and approach roadways. Monitor scaling in wheel tracks of the concrete deck as well as 3/4" pipes appearing in deck 1-1.5' from curb in both lanes. Repair sidewalk spalls west side at observation area. Clean and reseal North (P2) bridge joint. Repair ACP at South (P1) Bridge Joint. Repair sidewalk panels at all four corners caused by settlement.

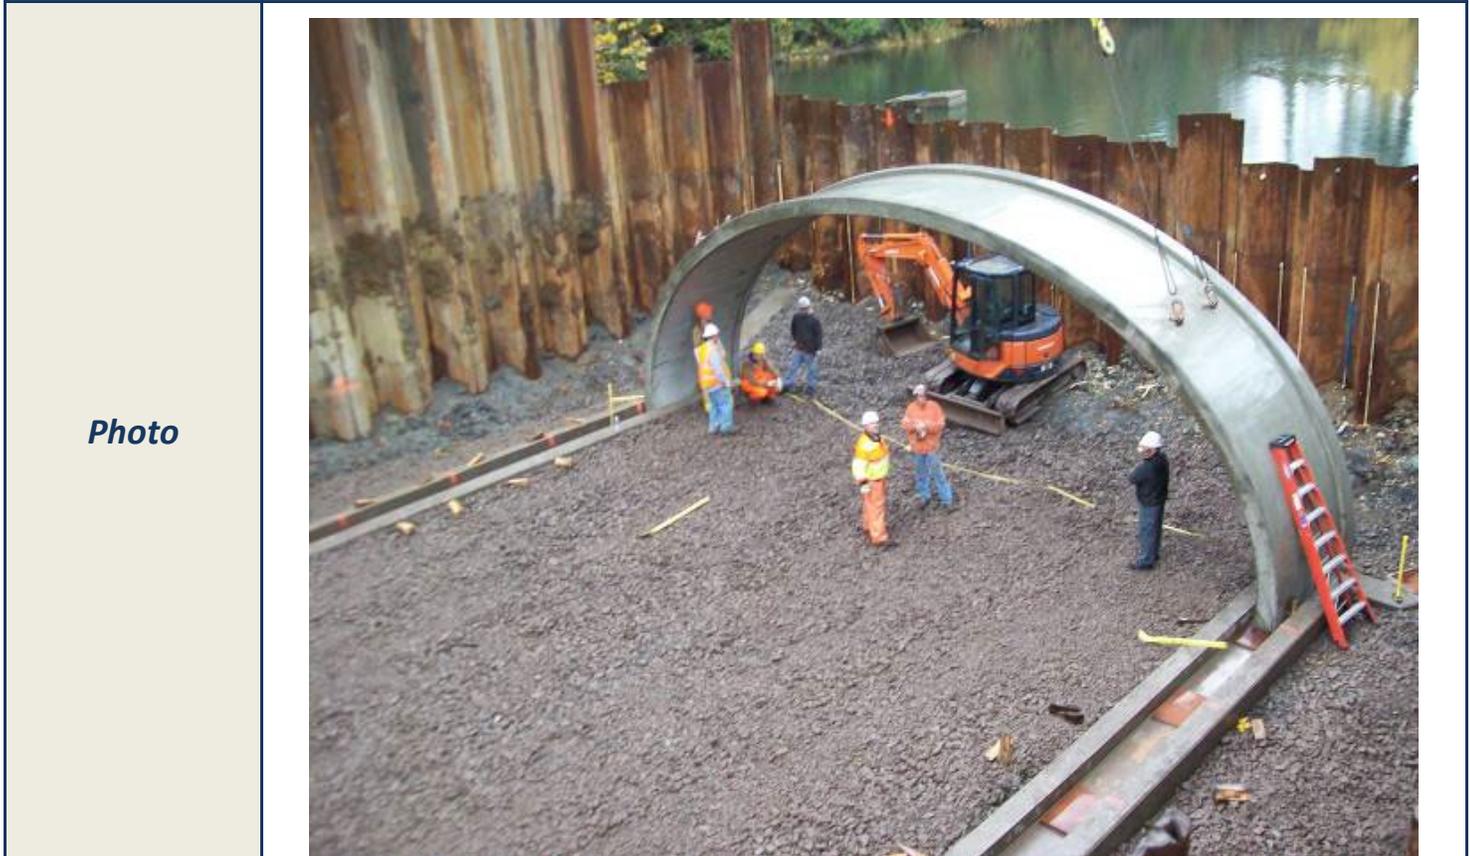
Bridge 32 – Barker Culvert

<i>Superstructure</i>	<i>Culvert</i>	Precast concrete arch culvert with precast MSE wing walls in good condition. Several joints between wing wall and headwall showing signs of rotational movement or settlement: Previous measurements at NE corner is 1 ¼" gap; previous measurements at SE corner has 2" horizontal and vertical movement; current measurement at SW corner has 2" movement horizontal with the headwall tipped.
<i>Substructure</i>	<i>Foundation</i>	Cast-in-place footings with rebar reinforcement. Arch seat is 1.5' wide.
<i>Scour and Load Rating</i>	In 2018 it was determined by TranTech Engineering that this structure has sufficient fill, in excess of 8' and does not require a load rating. Scour analysis has not yet been performed for this structure.

Recommendations	Monitor rotational movement and or settlement at wing wall connections. Monitor flows through structure concentrated in the south side, no exposure of the footing at this time.
------------------------	--

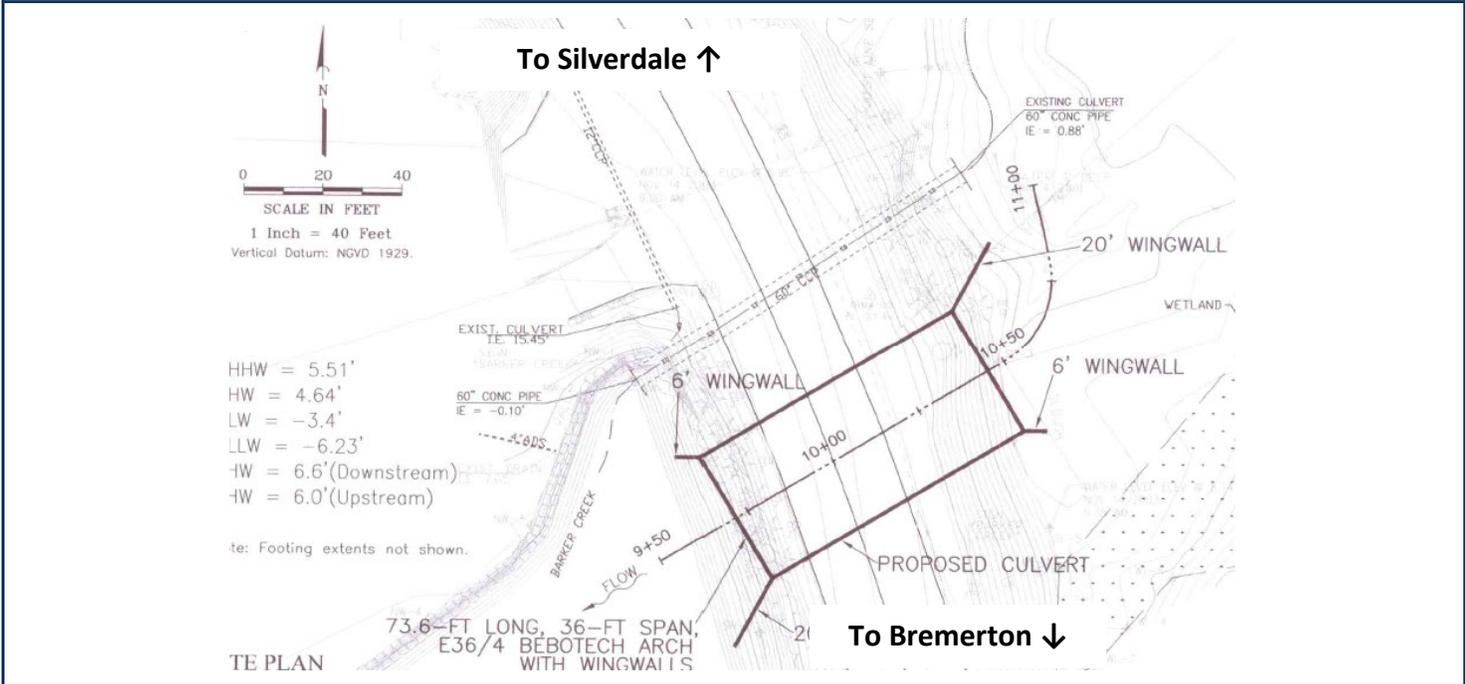
Upstream concrete storm pipe, last section disconnected	Flows along southern pier and sediment buildup along north pier
--	--

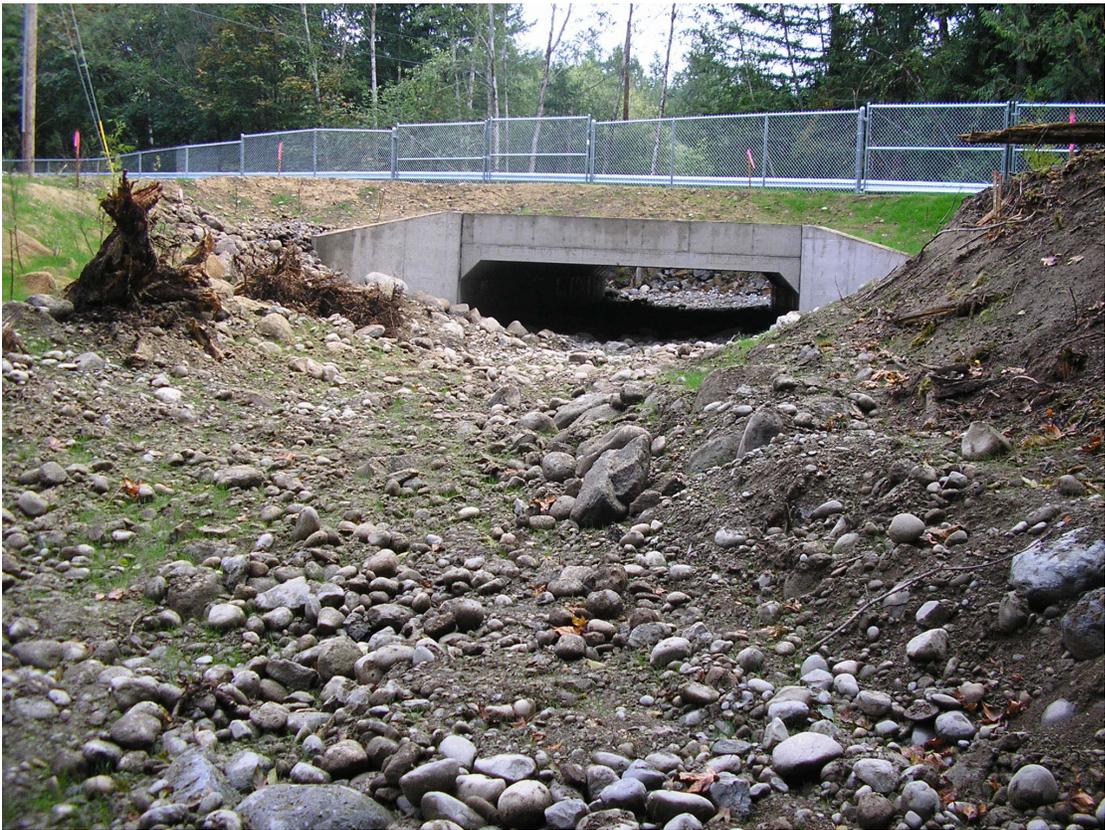
Bridge 33 – Foley Lane Culvert

<i>Superstructure</i>	<i>Culvert</i>	3-side precast concrete culvert 22' Span x 10' Rise. Moisture present in at some seams with leaks in the joints. 6th panel in from the west on south side, 2"x4" spall at panel joint near ground elevation. 3 rd panel seam from the West has a small spall in the ceiling. 2 nd Joint from the West on the North side has a spall at ground level 2"x4"x0.5" deep. Grout at NE wing wall connection is cracking.
<i>Substructure</i>	<i>Foundation</i>	Precast footings and wing walls with rebar reinforcement.
<i>Scour and Load Rating</i>	Bridge has been load rated as per FHWA requirements by TranTech Engineering in 2019. Scour analysis has not yet been performed for this structure.	
<i>Photo</i>

Recommendations Monitor off site flows near wing wall at SE corner. Seasonal flows only.

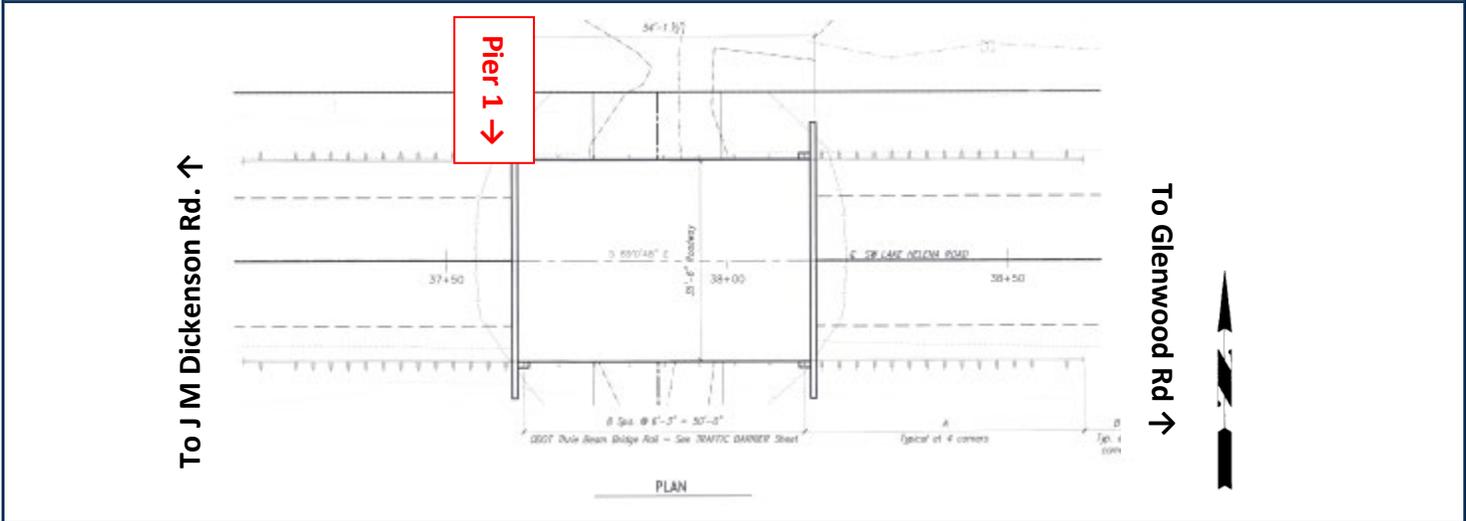
**ACP wearing down in wheel tracks.
Alligatoring in some spots.**

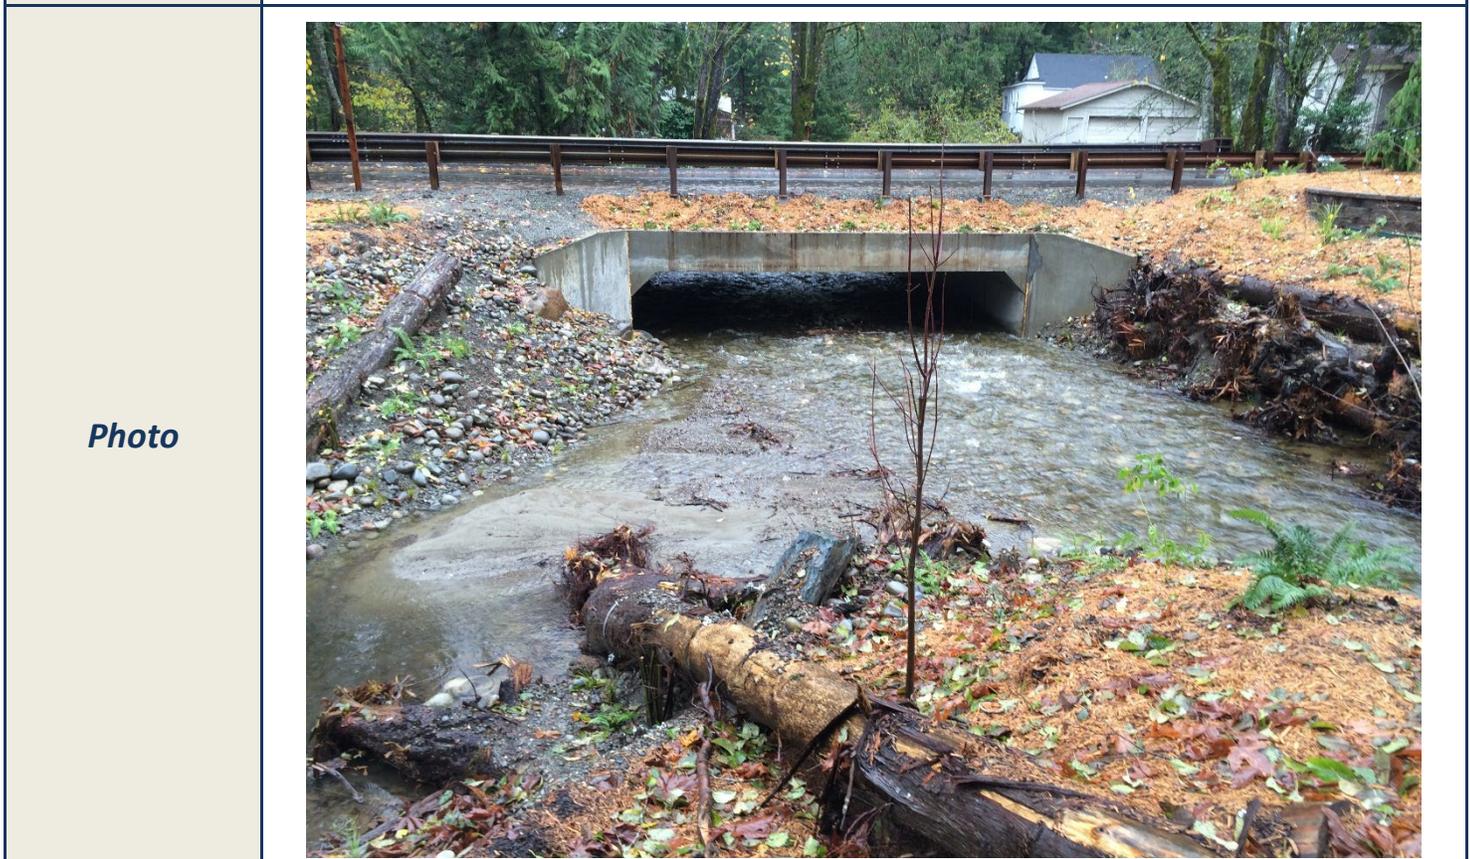
Bridge 39 – David Road Culvert

<i>Superstructure</i>	<i>Culvert</i>	3-side precast concrete culvert 35' length with a 23' span x 9'-10" rise. Components are all in good condition. Minor moisture present at joints including leaking in spots with efflorescence.
<i>Substructure</i>	<i>Foundation</i>	Precast footings and wing walls with rebar reinforcement.
<i>Scour and Load Rating</i>	Bridge has been load rated as per FHWA requirements by TranTech Engineering in 2019. Scour analysis has not yet been performed for this structure.

Recommendations	Monitor moisture at joints. Monitor bank at SW corner wing wall. No notable changes since last inspections. Beaver sticks present but no beaver dam at this time.
------------------------	---

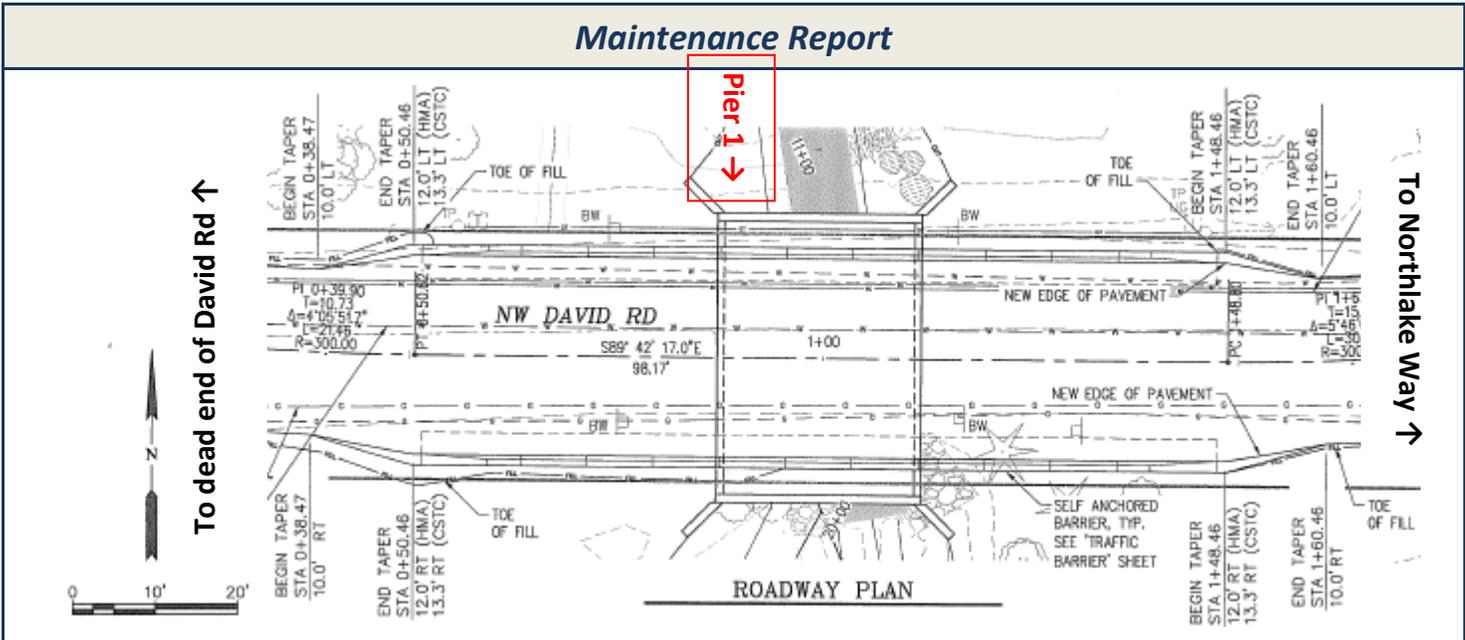
Wall & ceiling seams with moisture & efflorescence
