Port Gamble 2025 Stewardship and Restoration Project

Post-treatment Monitoring Report

Kevin Ceder, Stewardship Forester, Kitsap County Parks

May 6, 2026

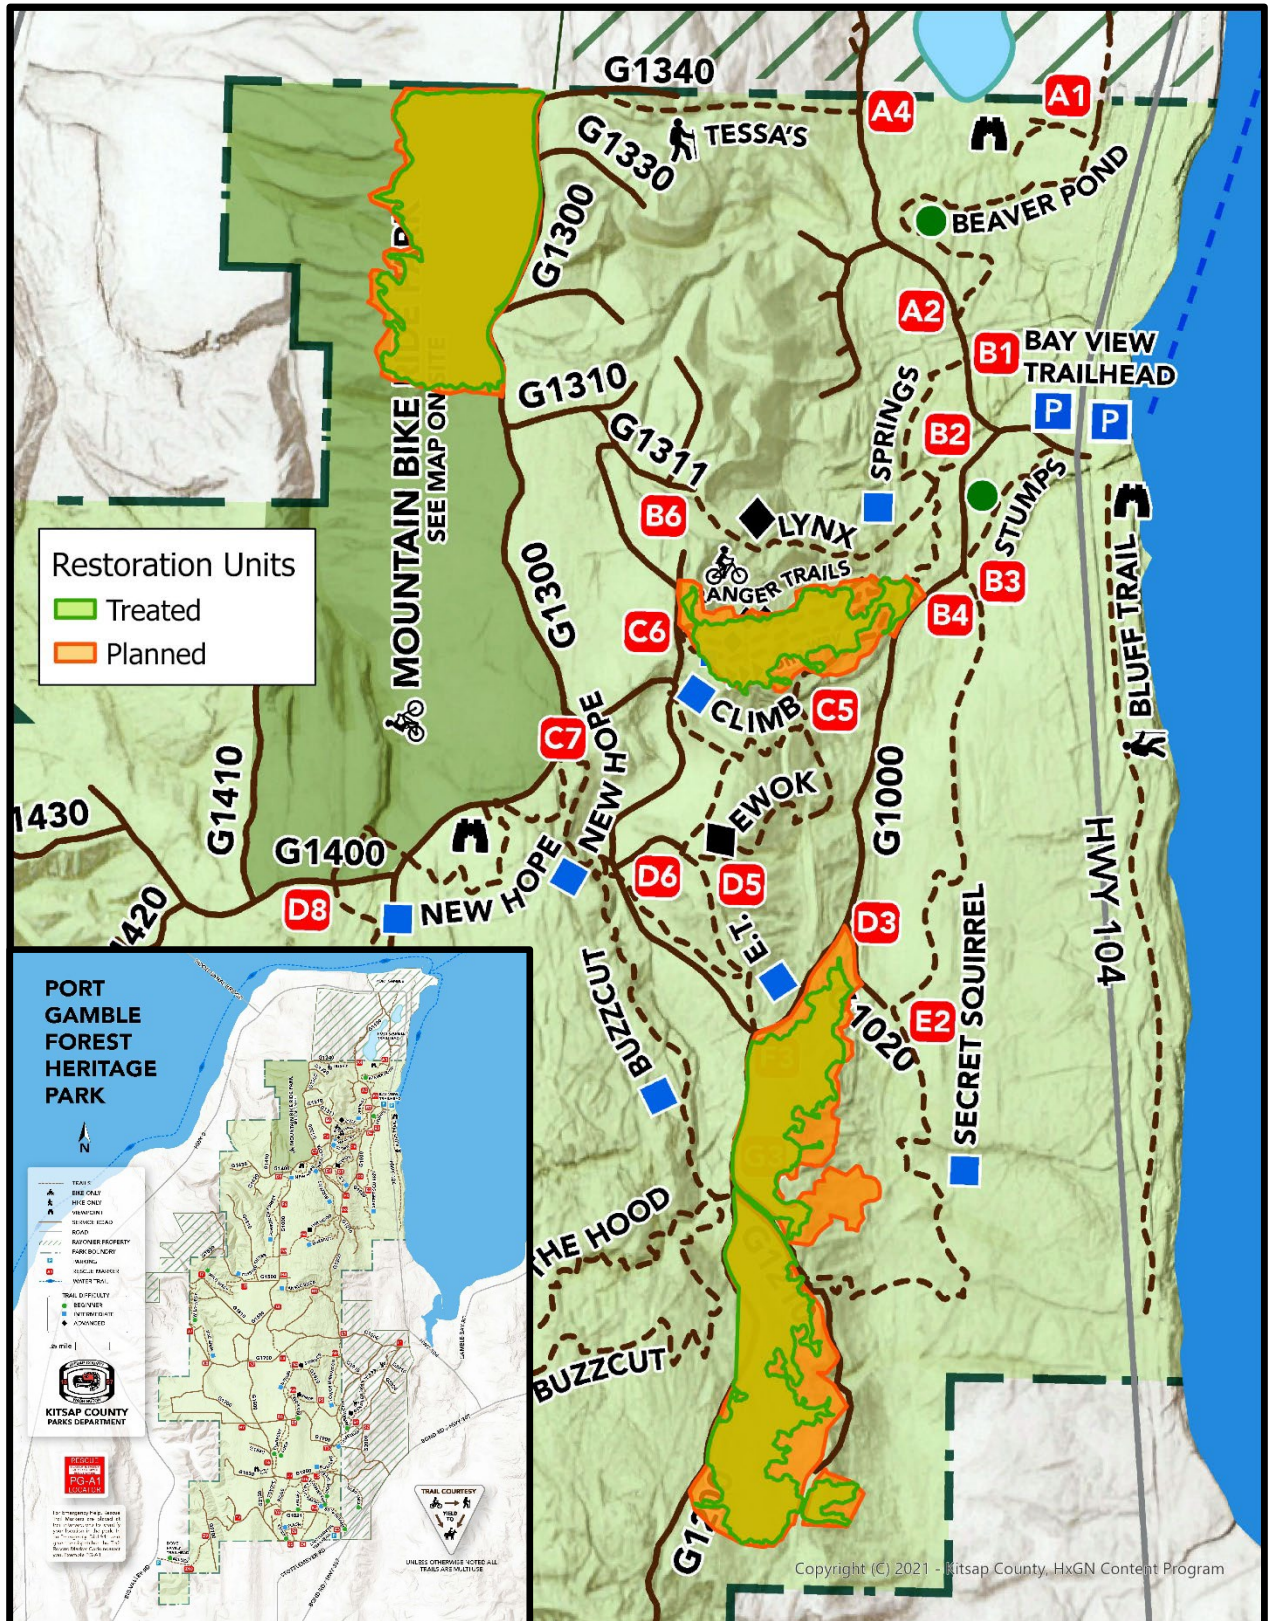
Figure 0-1: Location of the planned Port Gamble 2025 Stewardship and Restoration Project units within Port Gamble Heritage Park (orange/orange outline) and the areas that were treated during the project (green/green outline).

approximately 17 acres (19%) less than planned. Factors that reduced restoration treatment area included terrain limitations, species composition variability, and limiting damage to developed trails. The limitations type and scale of impacts varied by unit. The Ride Park North unit had the smallest deviation from planned acreage with only a small amount of area, primarily along the western side of the unit, untreated. This unit has relatively gentle topography until the slopes become steeper on the western and southern sides of the unit providing few operability limitations. The Ranger unit had the largest percentage deviation from planned acreage – a 33% reduction. This unit is relatively steep with four developed mountain bike trails through the unit. Minimizing damage to trails and excessively steep terrain, which the restoration contractor was not comfortable operating on, limited the area that was treated. Reductions in treated area on the 1200 East units were driven by a combination of excessively steep terrain and diverse species compositions. Areas along the east side of the units have relatively steep draws where the contractor was not comfortable working down into many of these areas. These units also had a larger proportion of western hemlock, western redcedar, and red alder, in the southern part of the southern unit, areas that had received thinning sometime in the past. Species compositions and prior thinning left areas that had insufficient take trees to make operating in those areas worthwhile.

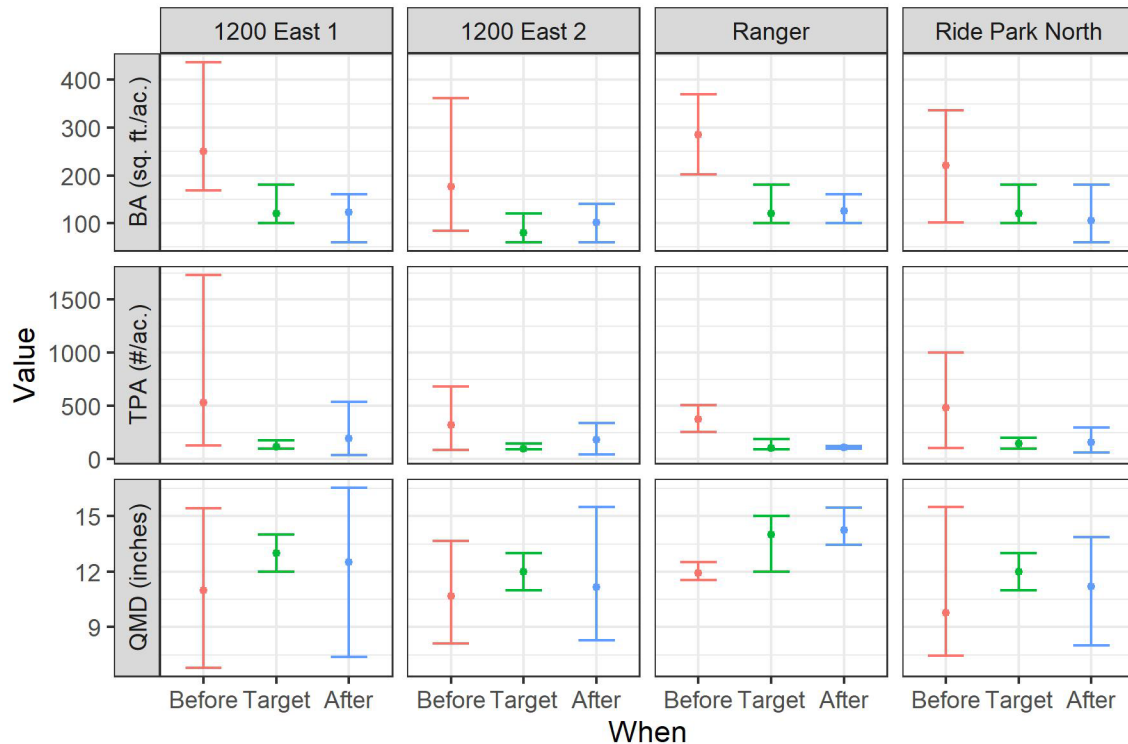
Tree removals in restoration treatments decreased the number of trees per acre (TPA) and basal area per acre (BA, sq. ft./ac) in the units and increased average tree size (QMD, inches) (Figure 2). Average conditions in each unit are close to, or fall within the range of, conditions expected from the treatment prescriptions (Ceder 2025). However, ranges of conditions were often wider than expected. At several plots both basal area and trees per acre were lower than the minimum expected values. Several plots were located in or near skid trails, which resulted in lower TPA and BA values. Other plots were located in or near areas with many required leave trees, such as western hemlock, western redcedar, and/or red alder, which resulted in higher TPA and BA because fewer trees could be removed. These differences were expected because monitoring data were collected across all inventory plot locations to capture the range of conditions created by the restoration treatments, but prescription ranges were specified for areas outside skid trails, gaps (areas where all trees were cut), and skips (areas where few or no trees were cut).

Figure 0-1: Comparisons of stand metrics before restoration treatments (red), restoration treatment targets (green), and after restoration treatments. Bars cover the range of metrics across all inventory and monitoring plots throughout the treated area or the expected range from treatment prescriptions. Dots are the mean values.

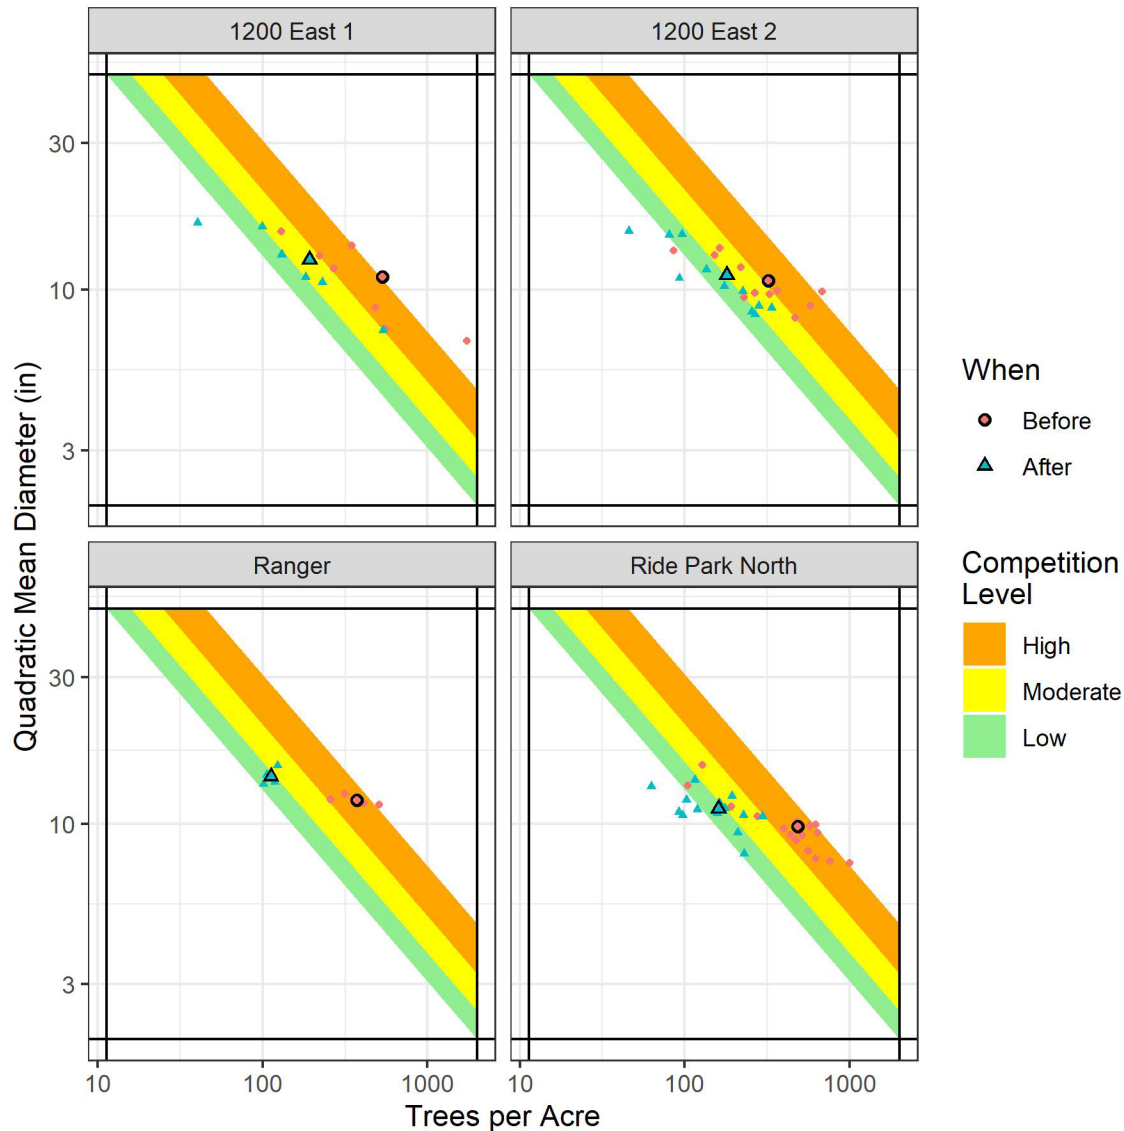
Restoration treatments reduced competition levels within treatment units (Figure 3), providing opportunities for the remaining trees to increase their growth and allowing light to reach the forest floor. Increasing the space between trees reduced the inter-tree competition levels from very high and high to moderate and low. At lower competition levels, there is room between tree crowns which will give space for branches to grow into and increase the amount of food (carbohydrates) the trees can produce for themselves. Extra food will allow trees to increase in vigor and size. Increased vigor will help trees fight insects and diseases as trees growth begins to increase. However, it may take some time – several years – before growth is seen at breast height (4.5 feet above the ground) because the tree stem will get larger closer to the tree’s crown first before there enough food is produced to allow additional growth closer to the ground.

Figure 0-2: Density management diagrams showing competition levels of each plot within individual restoration units both before (red markers) and after (blue markers) restoration treatments. Small points represent individual plots. Large points represent average conditions.

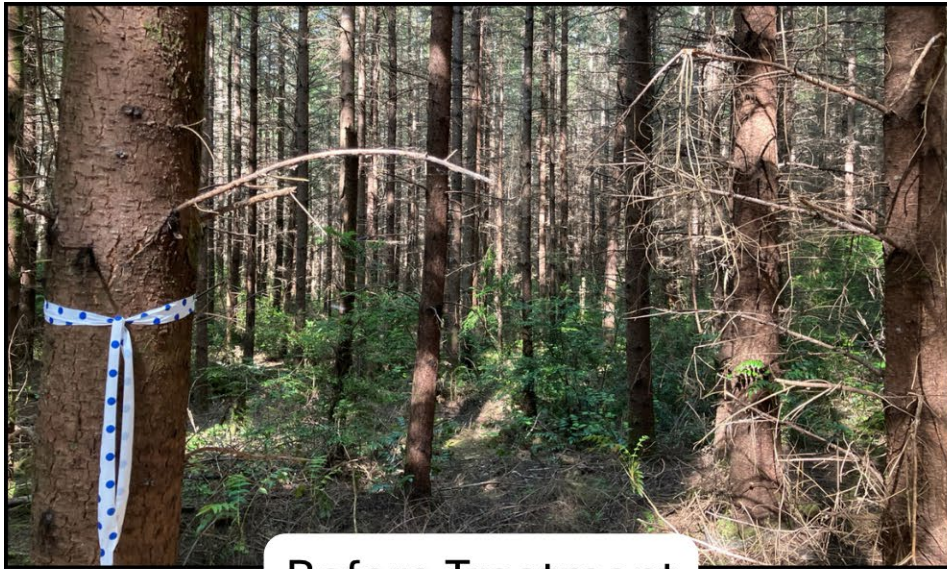
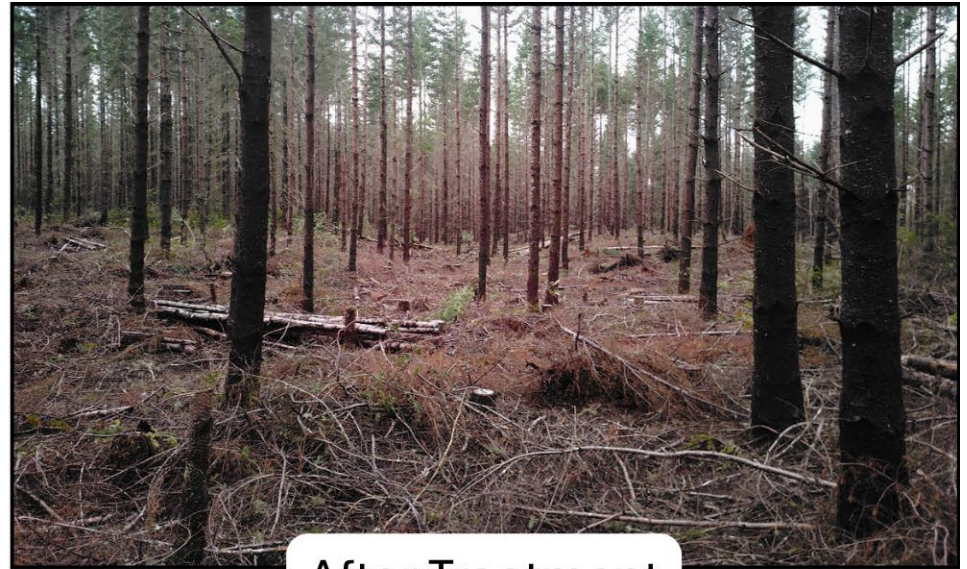
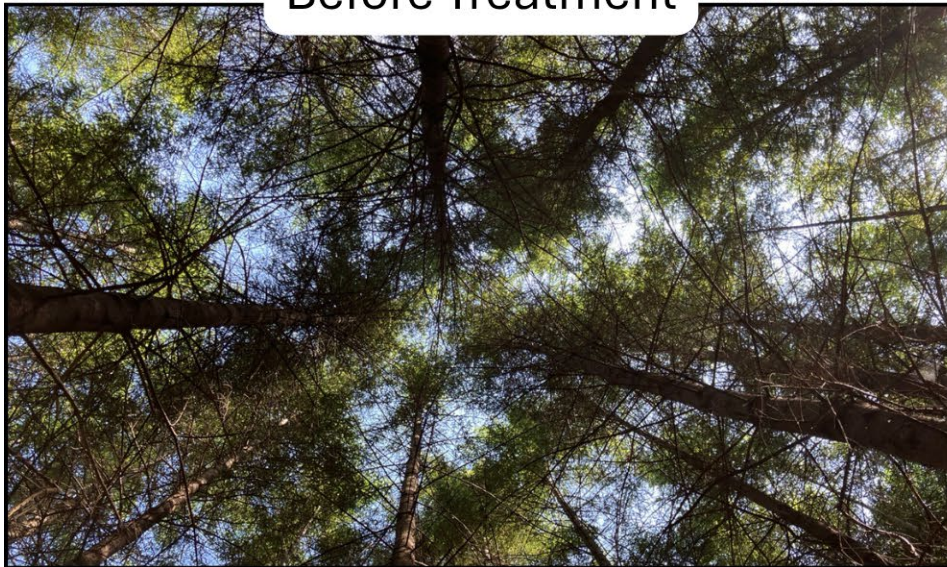
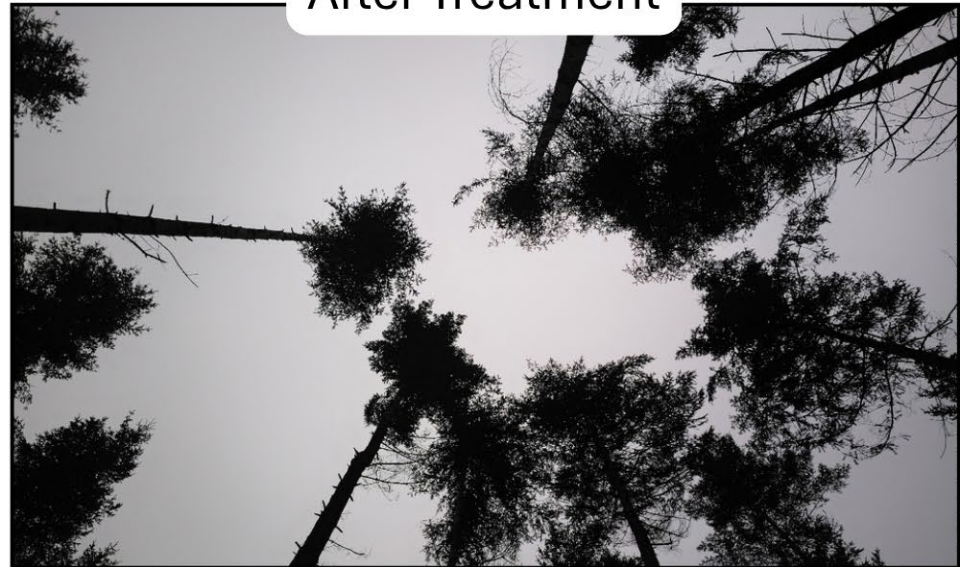
Figure Appendix B-1: Examples of conditions before and after treatment in the Ride Park North unit. Photos were taken at approximately the same place and approximately the same direction.

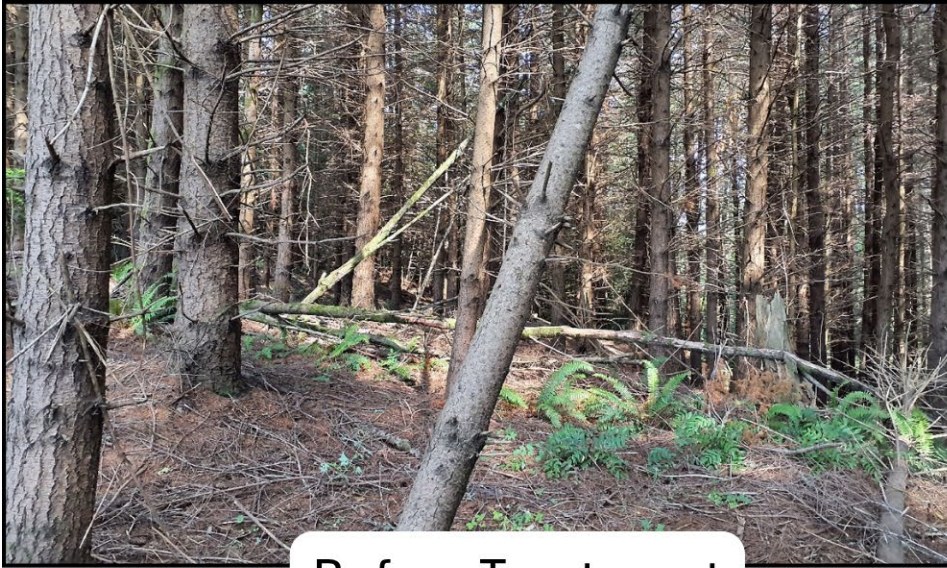
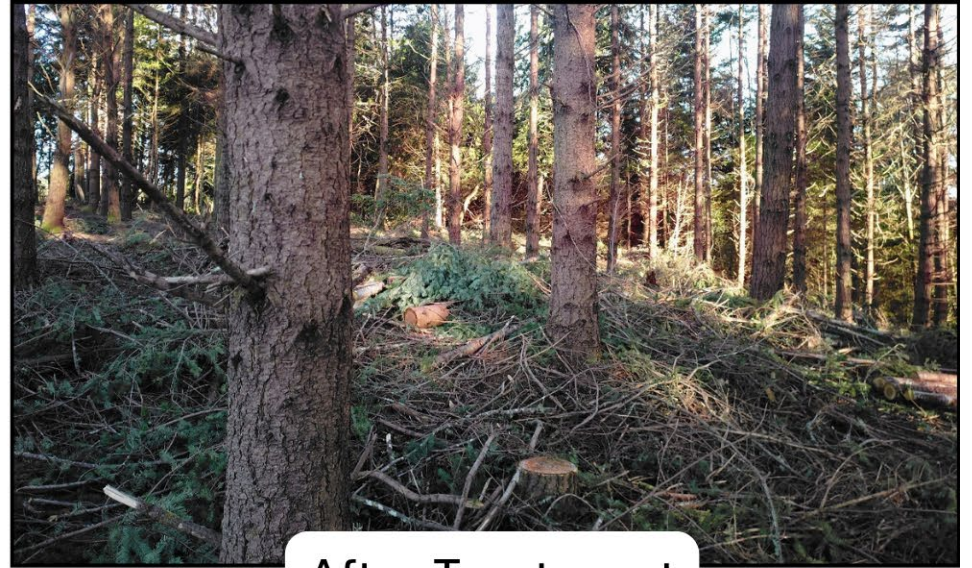
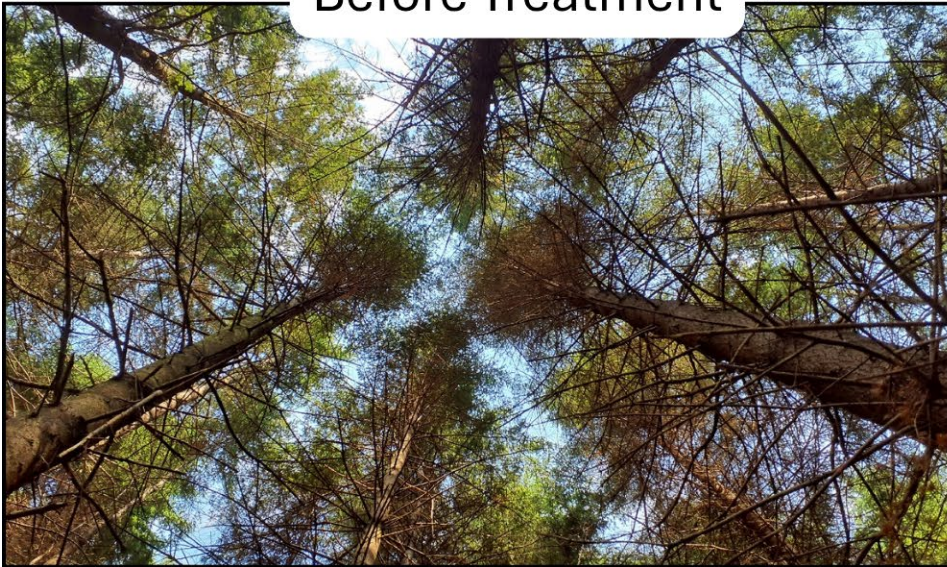
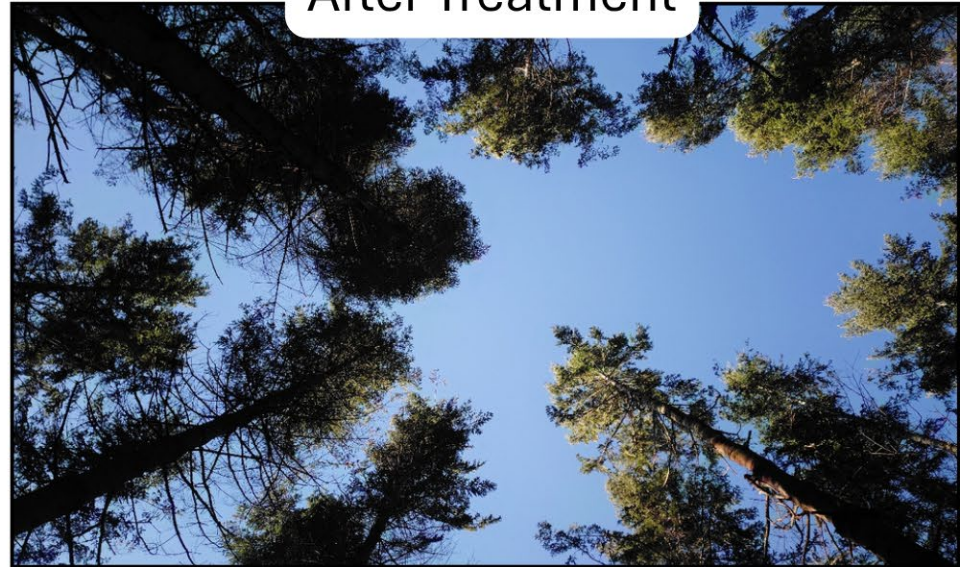
Figure Appendix B-2: Examples of conditions before and after treatment in the Ranger unit. Photos were taken at approximately the same place and approximately the same direction.

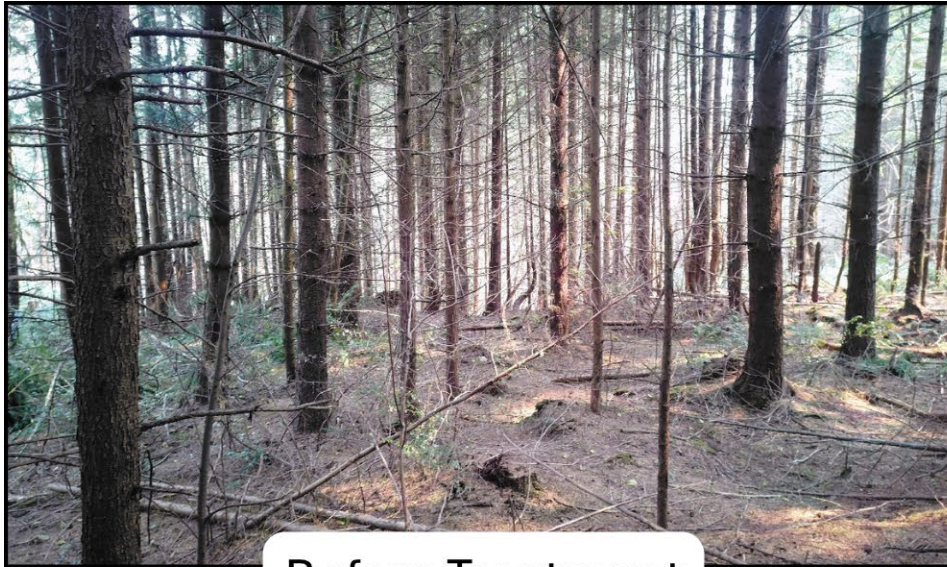
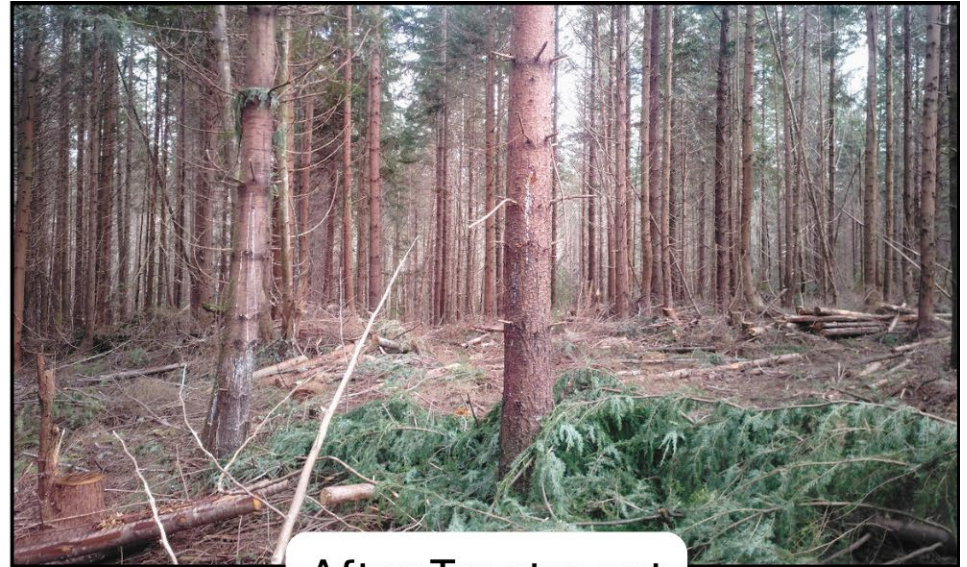
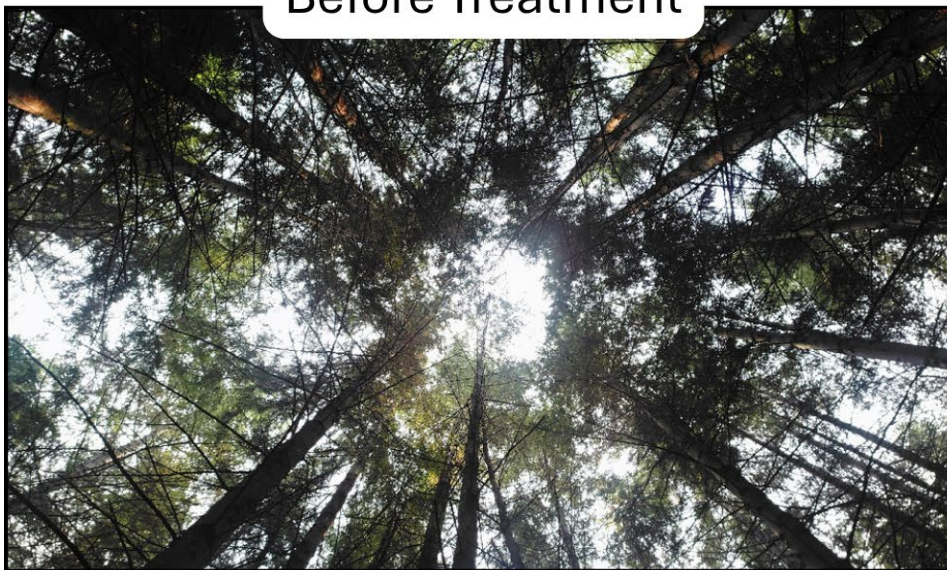
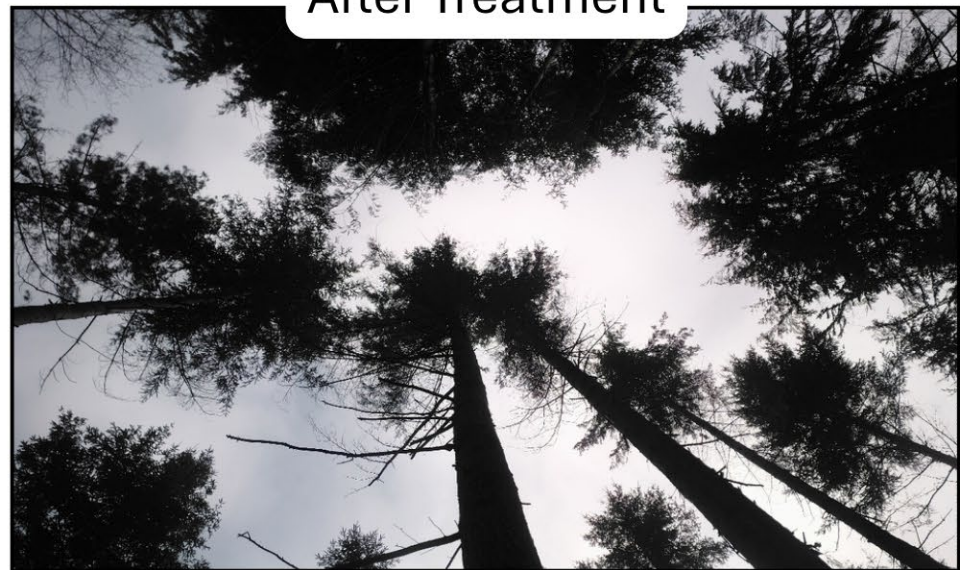
Figure Appendix-3: Examples of conditions before and after treatment in the 1200 East 1 unit. Photos were taken at approximately the same place and approximately the same direction.
