2023 Annual Bridge Report

Prepared by Kitsap County Public Works Engineering Division This sheet intentionally left blank.

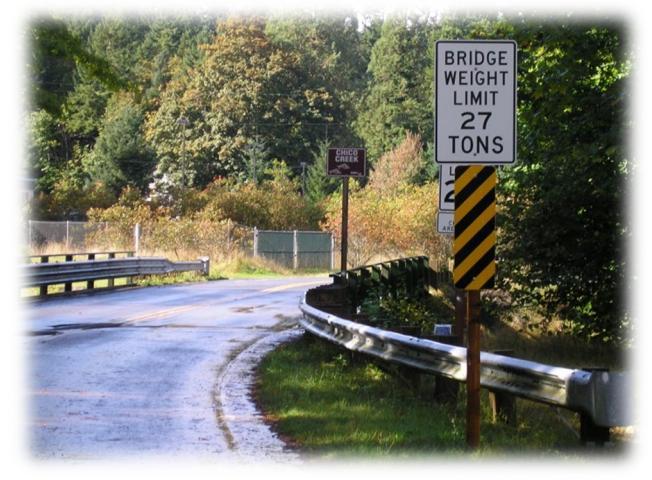
Taylor Road Bridge posted with weight restriction.

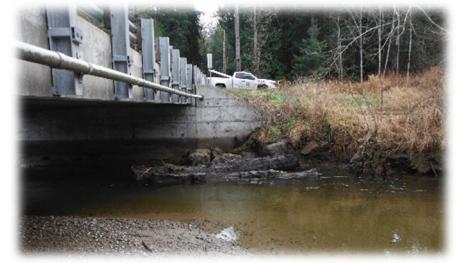
Stavis Bay Bridge BEFORE 2016

In February of 2016, county forces performed temporary scour countermeasure repairs on Stavis Bay Bridge #23. This was followed by permanent scour countermeasures installed in August of 2018.

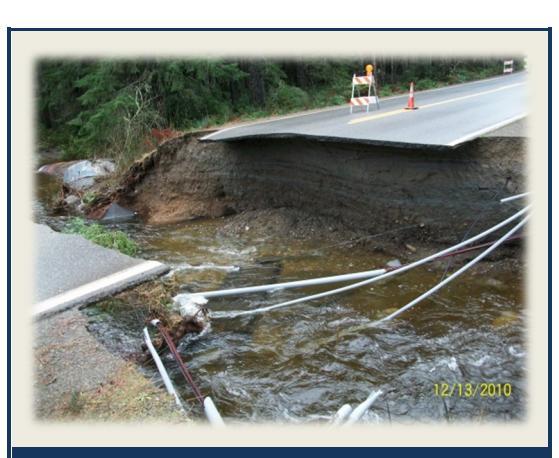
Storm washout of culvert on Lake Helena Dec. 2010

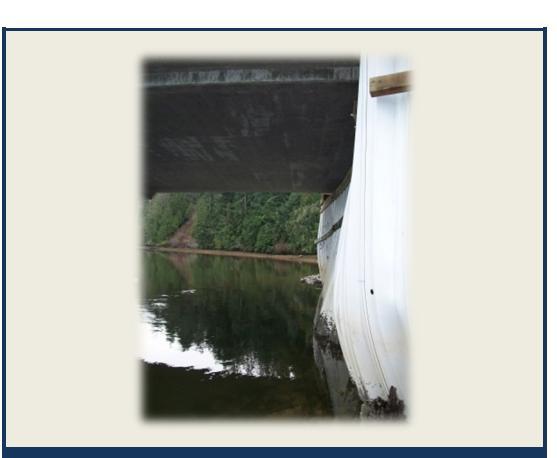
Bulging of vinyl sheeting at abutment from material migration Jan. 2010

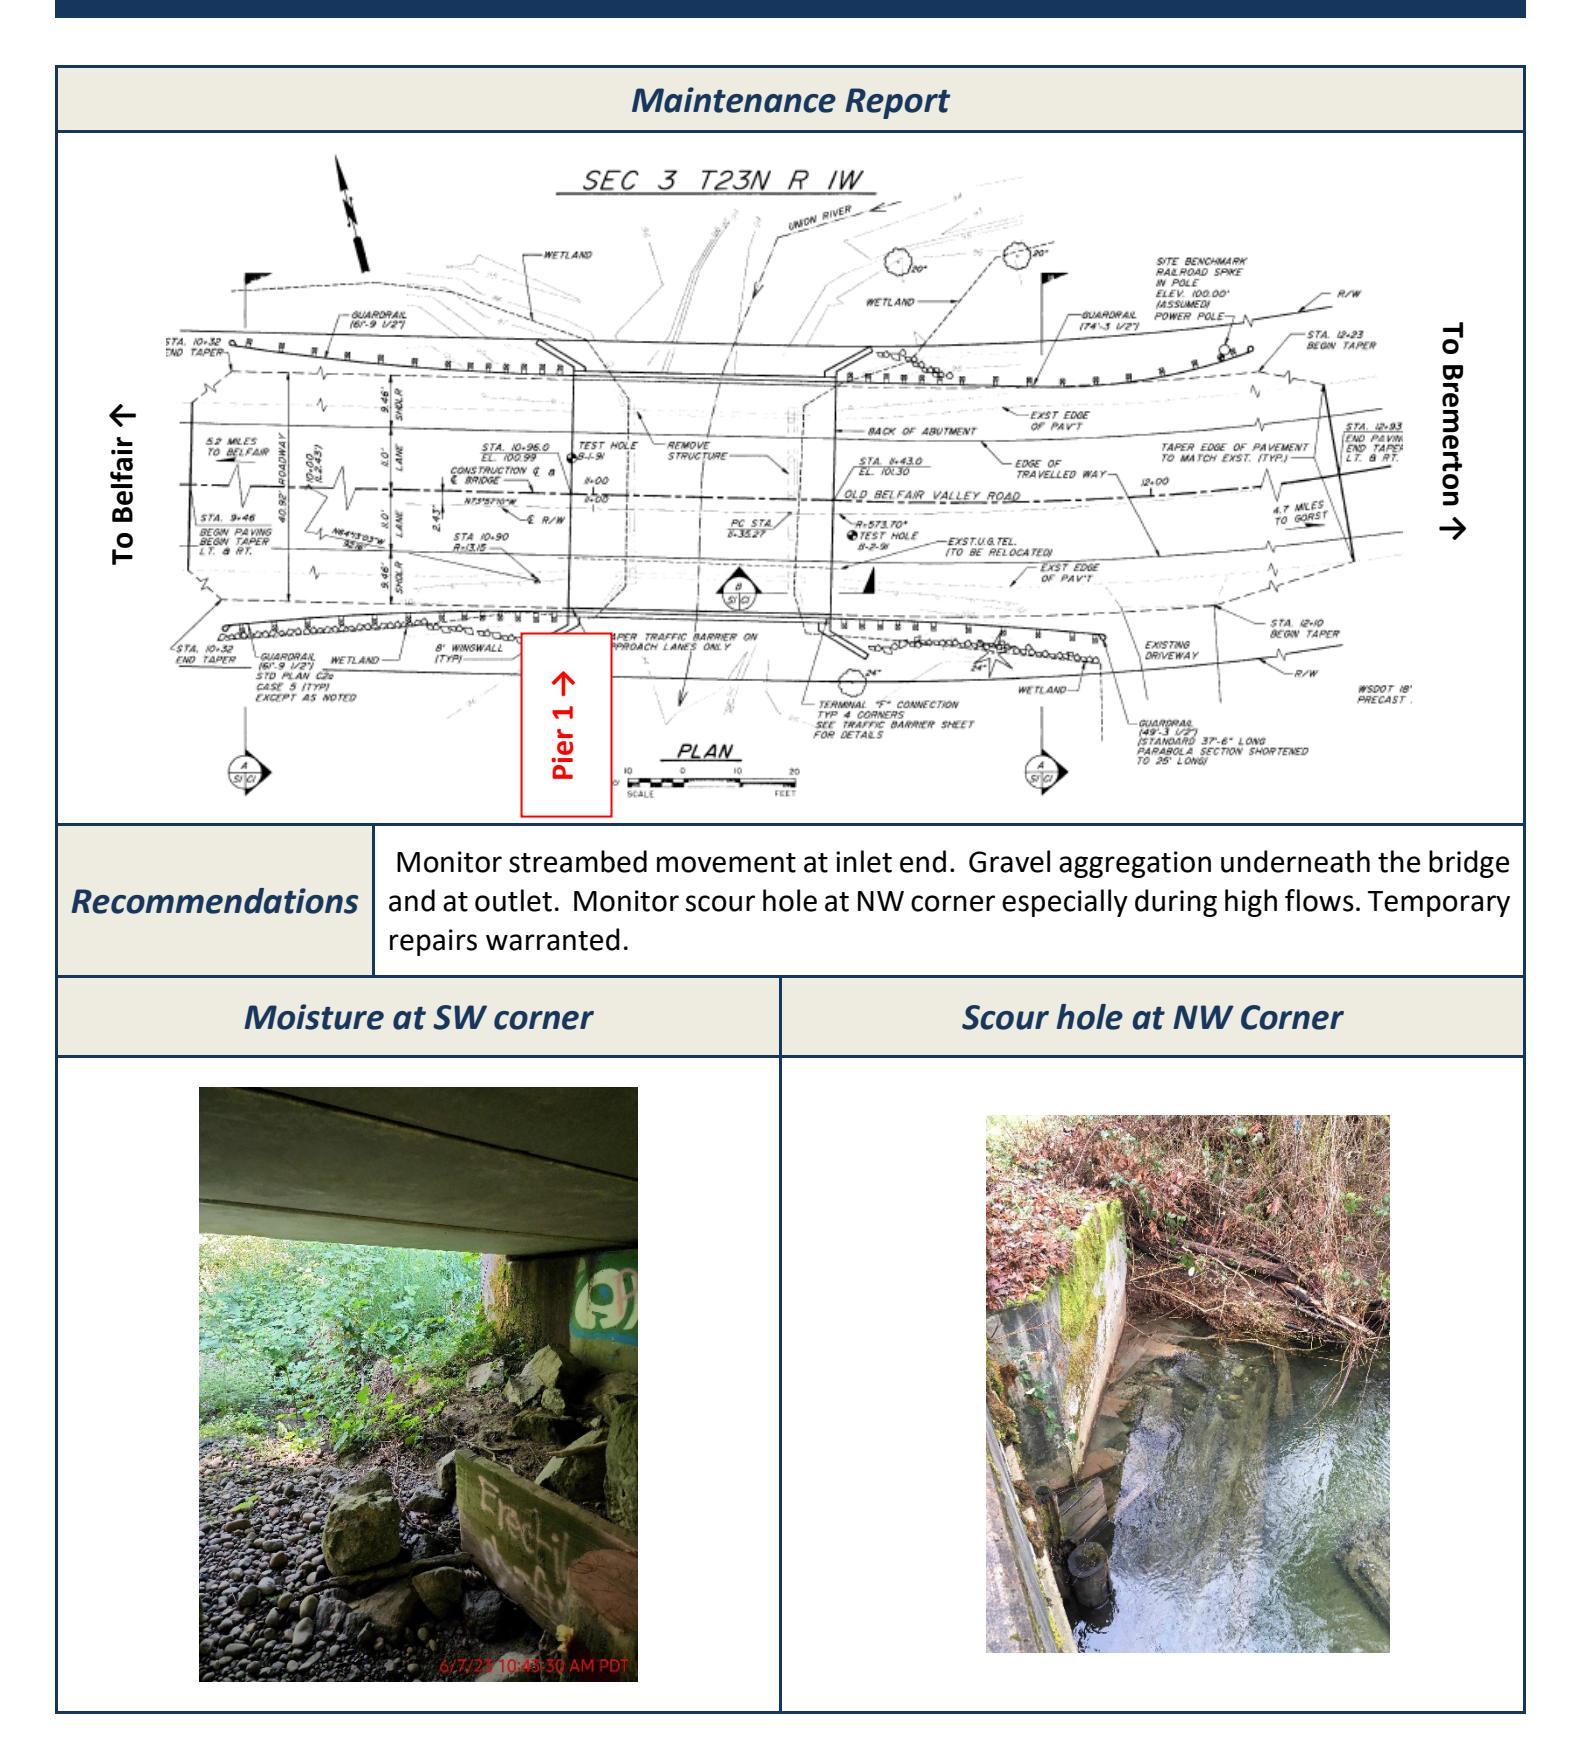
Bridge 01 – West Belfair Bridge								
West Belfair Valley Road			Union River	1992	Good (G)	Jun. 7, 2023		
Route Na	те		Feature Intersected	Year Built	Overall Condition	Last Inspection		
	Girder	Pr Sn 3″ M	Prestressed, precast voided concrete slabs (4'ω x 1'-6" h) in good condition. Small spall on exterior flange at south side 8.5' from west abutment – 5"L x 3"ω x ¾"d. 3 spalls visible between panels F & G center span 4"L X 4"ω X ¼"d. Minor moisture evident at SW corner.					
Superstructure	Deck	Deck 3" ACP Overlay with waterproof membrane. ACP in travel way has been replaced since last inspection (2019). Small settlement noted in the roadw at the NE corner.						
	Other	Сс	oncrete Bridge Railing s	howing no signs	of impact			
	Foundatic	on	Driven 12" steel pipe piles filled with rebar & concrete with no visible defects noted.					
Substructure	Abutmen	ts	Cast-in-place concrete pile cap/abutment. Slab seat is 25" with elastomeric bearing pads. Moisture present at NW and SW corners with evidence of water and sediment seeping through cracked joint over face of abutment. NW corner at connection from deck to wing wall has minor cracking evident, appears to be the deck pushing against the wing wall.

Scour and	Bridge has been load rated as per FHWA requirements by TranTech Engineering in Scour evaluation and analysis as well as hydraulic analysis was performed by Engineering in 1992.							
Load Rating	Scour hole developing at NW corner (P1 inlet). Scour is currently under wing w foundation. Large woody debris trapped in the bottom. Roads is working on design temporary repair. Silt deposit anabranch at NE corner forcing water to the West.							
	This bridge is not scour critical. (No history of scour)							
Photo

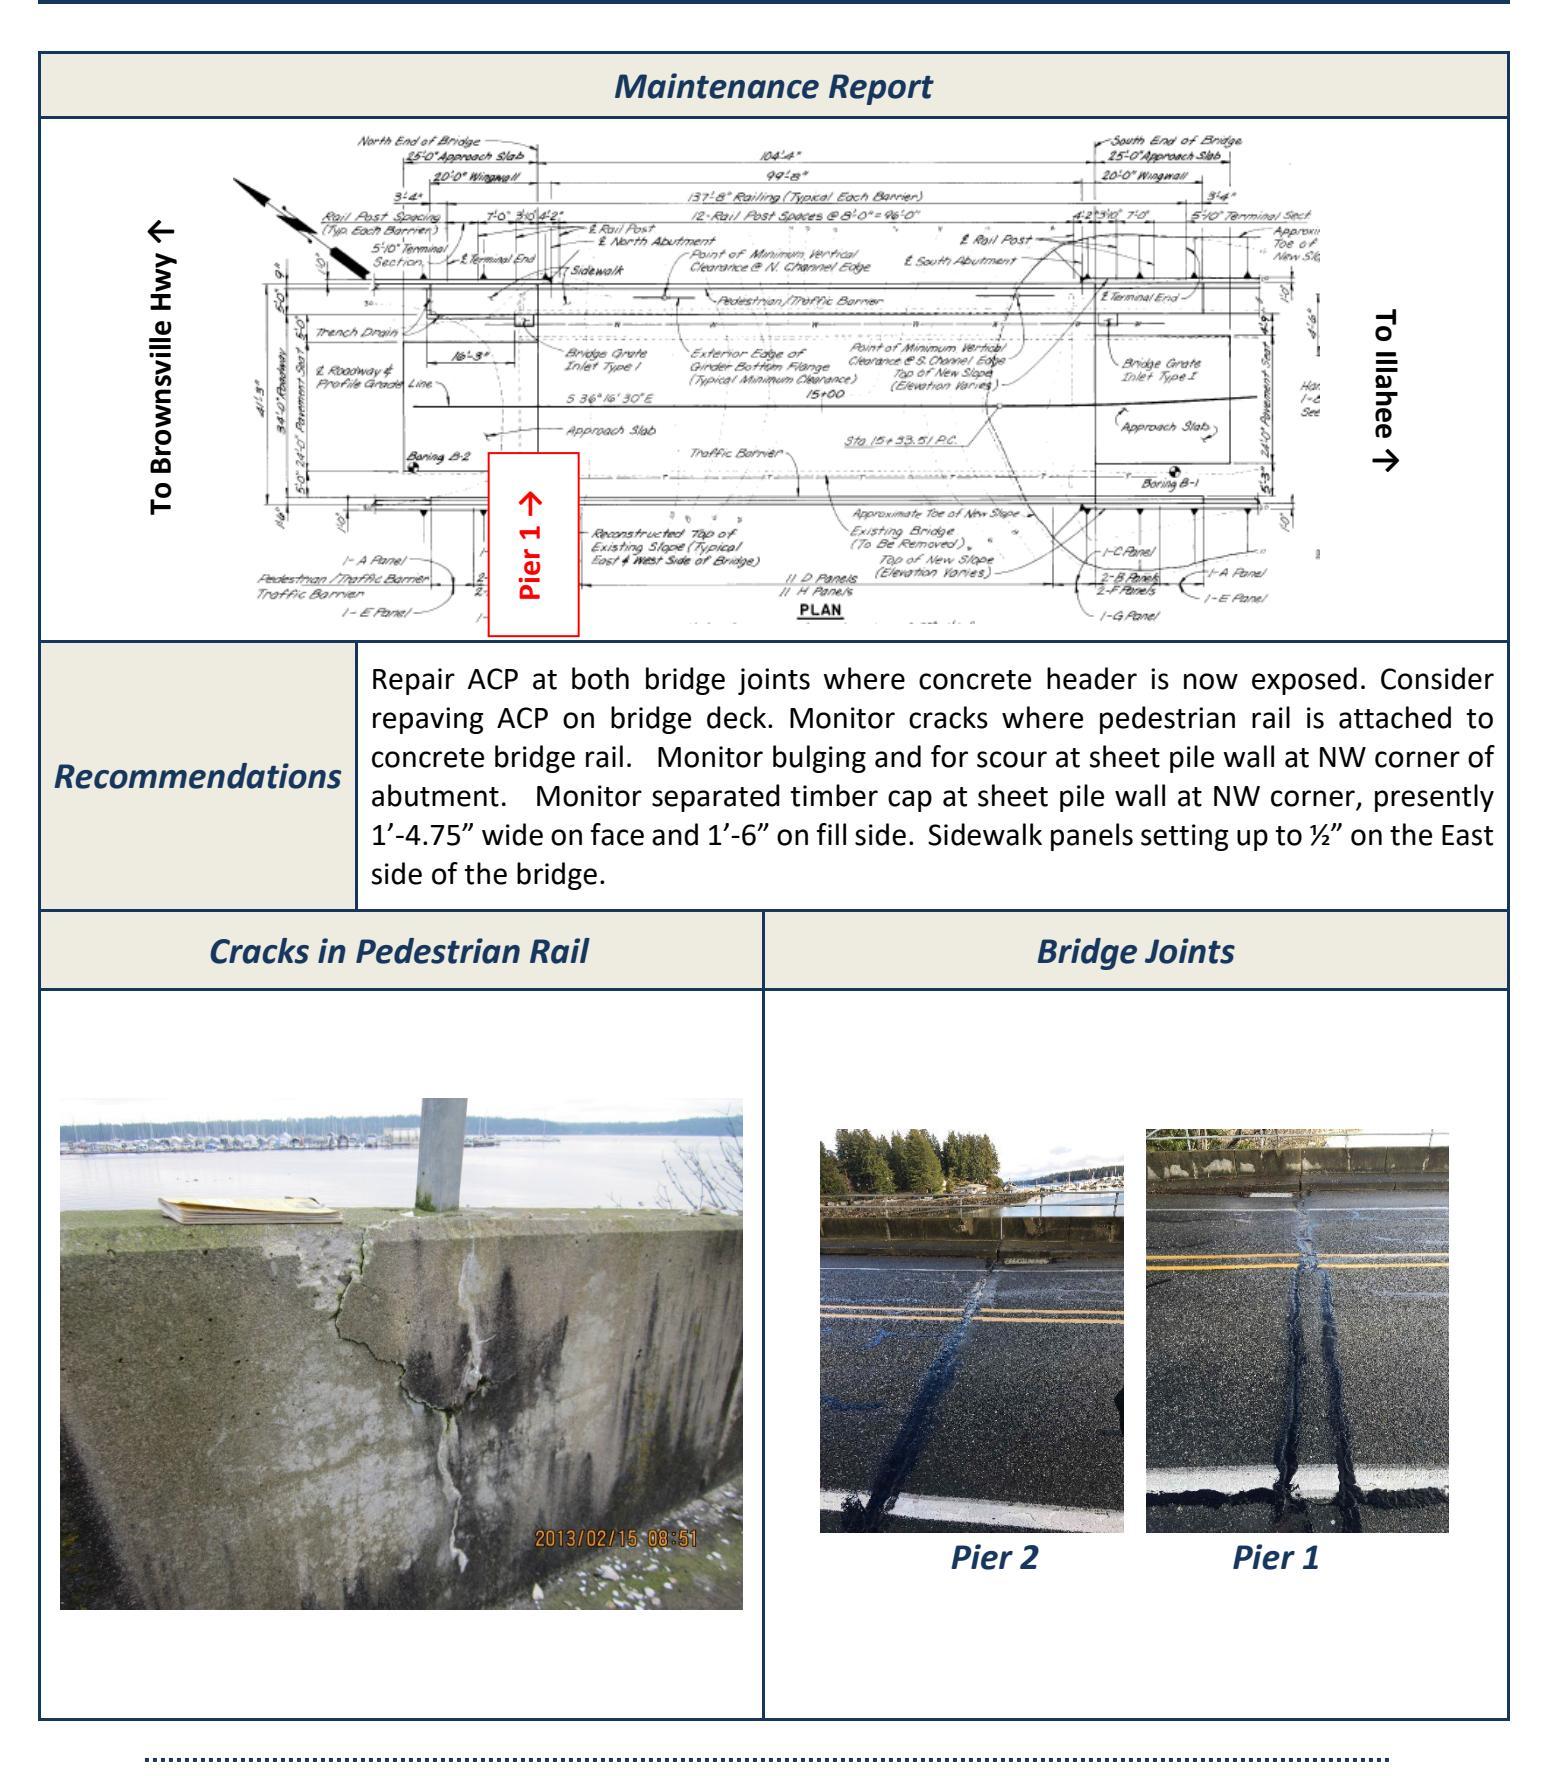
Bridge 02 – Brownsville-Gilberton Bridge							
Illahee Roa	d	St	eele Creek	1986	Fair (F)	Jul. 24, 2023	
Route Name		Fed	iture Intersected	Year Built	Overall Condition	Last Inspection	
	Girder	Pro Sp no bra int	Prestressed, precast bulb-tee girders (6'-10½"' ω x 4'-6" h) in good condition. Spall 6"L x 6" ω x1/2"d evident at end diaphragm between girders A & B at north end. Spall 3"L x 3" ω x ½"d between girders A & B near southerly cross- brace. Minor moisture present between all girders and top flanges. All steel intermediate diaphragm braces are missing ¾" bolts & nuts.				
Superstructure	Deck	AC the se	CP Overlay in poor of e wheel tracks. Wa am. ACP needs rep	condition with lo ater seeping betw air along with re	ngitudinal cracks beg veen girders at all sea pairs at joints.	inning to show in ams except center	
	Other	Co ati sh	Concrete Bridge Railing is cracking around where each pedestrian rail post is attached. Cracking and spalling accelerating with signs of efflorescence showing.

Founda	tion	n Driven 14" steel pipe piles filled with lean concrete.				
Substructure	Abutme	ents	 Cast-in-place concrete pile cap/abutment. Girder seat are 30" with elastomeric bearing pads. Signs of some crushing of the bearing pads at Pier 2. Both abutments have hairline vertical cracks running from girder seat to bottom of abutment. Girder seat C at south abutment has small delamination spall evident 3"x 3" at bearing pad. Vinyl sheet wall at NW corner top cap separated 1'-4.75" at connection with broken support whaler on face of wall. 				
Scour and Load Rating	Bridge ha Scour ev Scour cou	Bridge has been load rated as per FHWA requirements by TranTech Engineering in 2018. Scour evaluation and analysis phase 2 was performed by Entranco Engineering in 1997. Scour countermeasure work for north abutment was performed in June 1999.					
	This brid	ge is s	cour critical.				
Photo

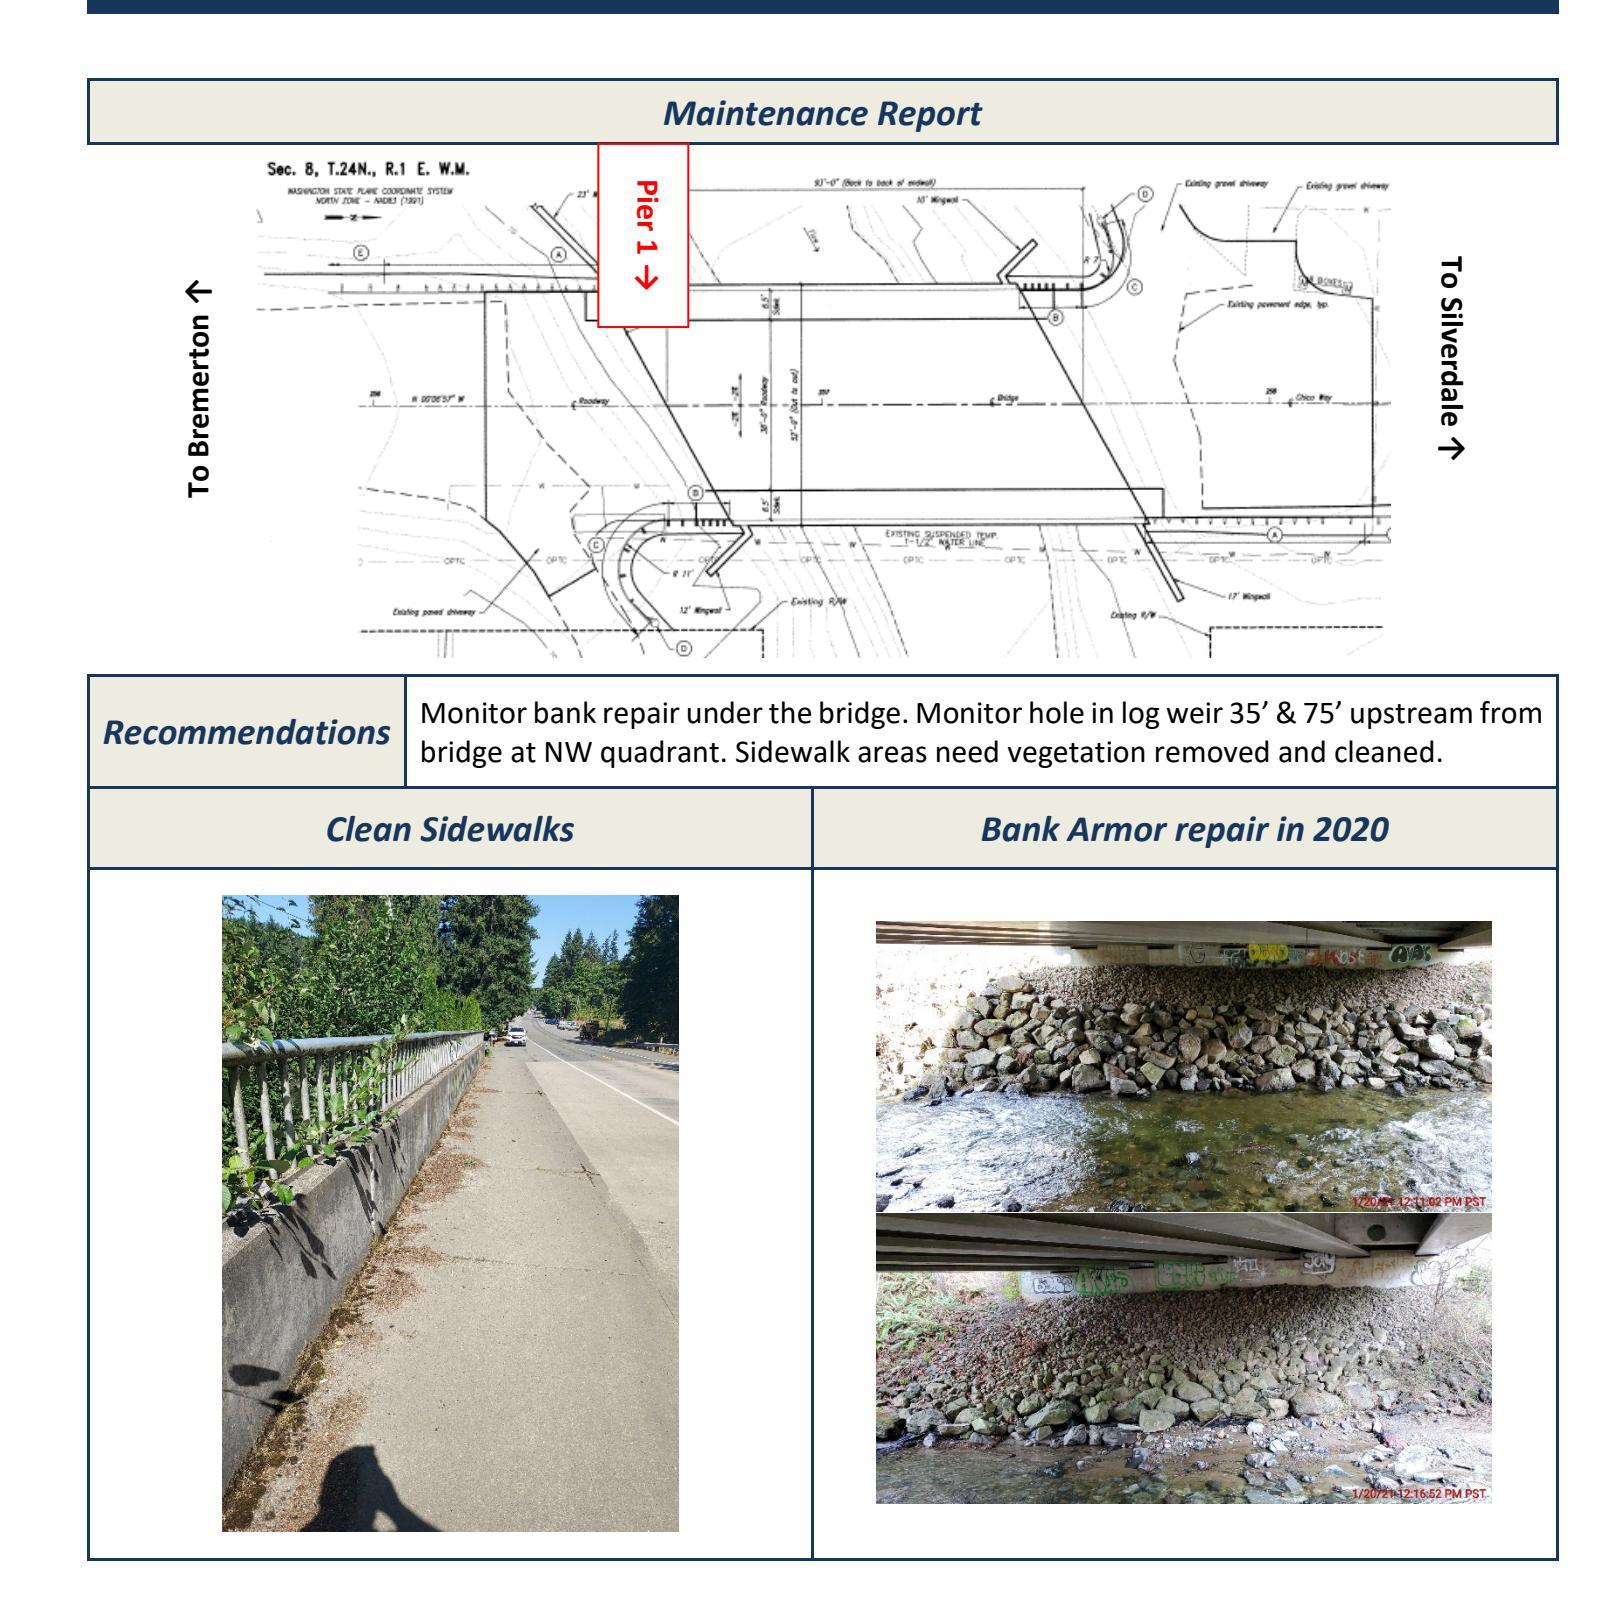
Bridge 03 – Chico Bridge

Superstructure	Girder	Pre	Prestressed, precast bulb-tee girders (WF50G) in good condition.					
	Deck	Cast-in-place concrete deck with cast-in-place sidewalks. Hairline cracks beginning to appear in deck at SW quadrant as well as the sidewalk and barrier along East& West sides of bridge.						
	Other	Со	ncrete Bridge and Metal Pedestrian Railing is in like-new condition.					
	Foundatio	on	Driven steel H12x63 piles.					
Substructure	Abutmen	ts	Cast-in-place concrete abutment. Girder seats are 36" with elastomeric bearing pads. In Summer of 2020, maintenance crews repaired sloughing bank armor. Appears to be holding up.					
Scour and	Bridge has Scour analy	bee vsis ł	n load rated as per FHWA requirements by TranTech Engineering in 2018. has not yet been performed for this structure.					
Load Rating	Minor repa Minor bank	inor repair work performed to stabilize log boles in December of 2010 upstream. inor bank armor repair in summer 2020.

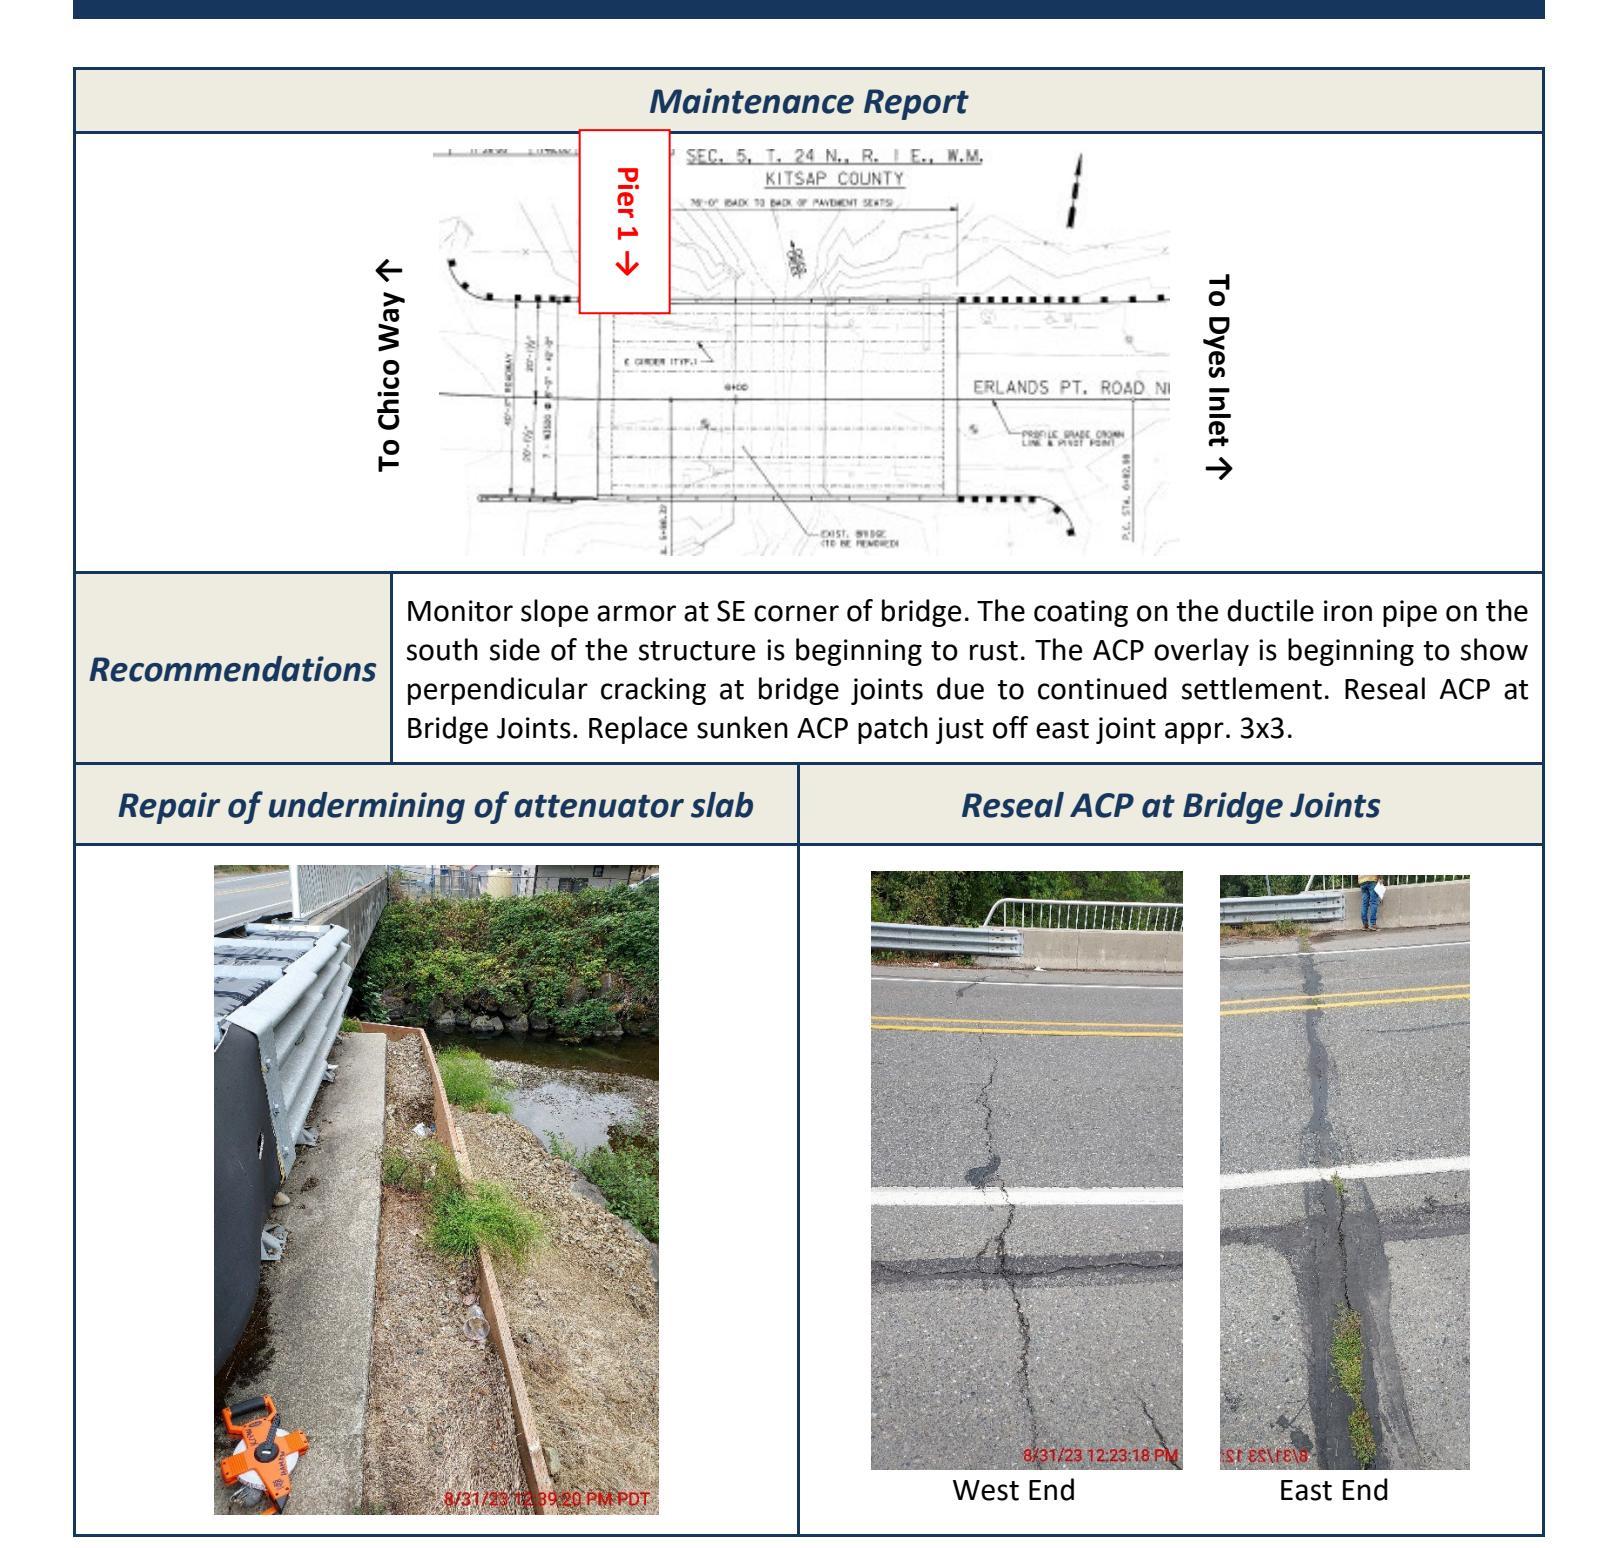
Bridge 04 – Erlands Point Bridge

Girder	Prestressed, precast bulb-tee girders (W35G) in good condition.					
Superstructure	Deck	2" ACP Overlay with waterproof membrane.					
	Other	Concre to met been re	ete bridge railing beginning to show hairline cracks at attachments al pedestrian railing. Traffic attenuator pad at SW corner has epaired with rebar stakes and timber lagging in 2020.				
	Foundation	Di	riven steel 18" pipe piles filled with concrete.				
Substructure	Abutments	Ca el No	Cast-in-place concrete abutment. Girder seats are 46" with elastomeric bearing pads. Slope armor is working well at this time. No defects found.				
Scour and	Bridge has been Scour evaluation	oad rat Ind ana	ed as per FHWA requirements by TranTech Engineering in 2018. Iysis was performed by Entranco Engineering in 1998.				
Load Rating	Upstream beaver dam is no longer intact and there is significant sediment and debris build- up at upstream end of bridge. Low flow channel is along the east side.

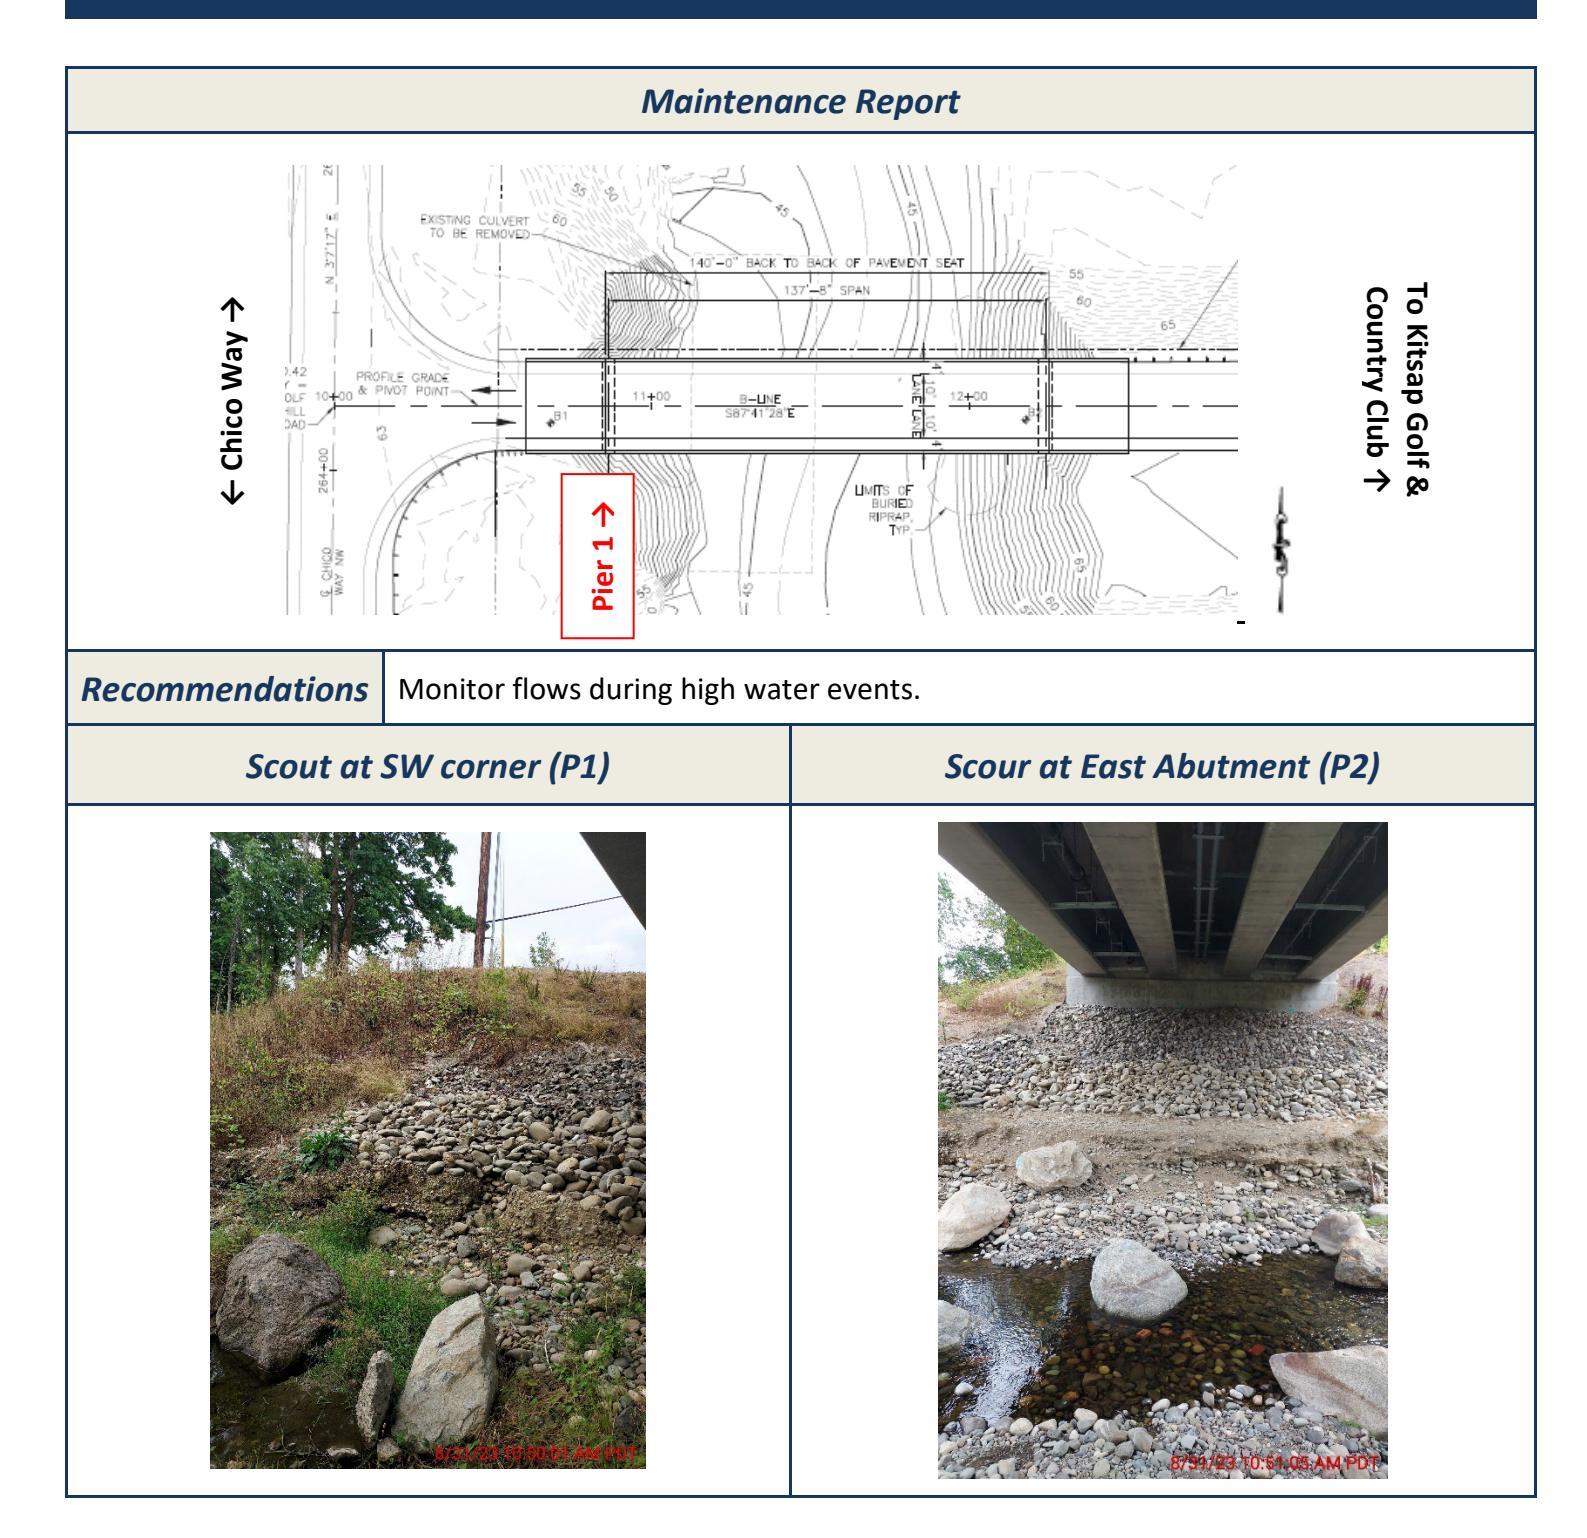
Bridge 07 – Golf Club Hill Bridge

Girder	WF58G Precast prestressed bulb-tee girders in good condition. 4 girders at approximately 136' in length.			
Superstructure	Deck	Cast-in-place 7.5" concrete deck with epoxy coated rebar in good con			
	Other	Ca sea	st-in-place concrete bridge railing in good condition. Railing has pigmented aler. Uniform vertical cracking along barrier with effloresce leaching.		
Substructure	Foundation		Driven 18" steel piles filled with rebar and concrete. 5 piles per pier. Tip elevation on Pier 1 varies from 5.8 to 9.0 and at Pier 2 varies from 5.2 to 5.9.		
	Abutments		Cast-in-place concrete abutment with attached wing walls in good condition. Girder seats are 12".		
Scour and Load Rating	Bridge was load rated as per FHWA requirements by Shearer Design in 2019. Bank erosion at East side approximately 3' with large Rip Rap toppling. Large anabranch of gravel present at midspan, center of channel (±3 feet high). Minor bank cutting on west slope area at inlet corner. This bridge is not scour critical.

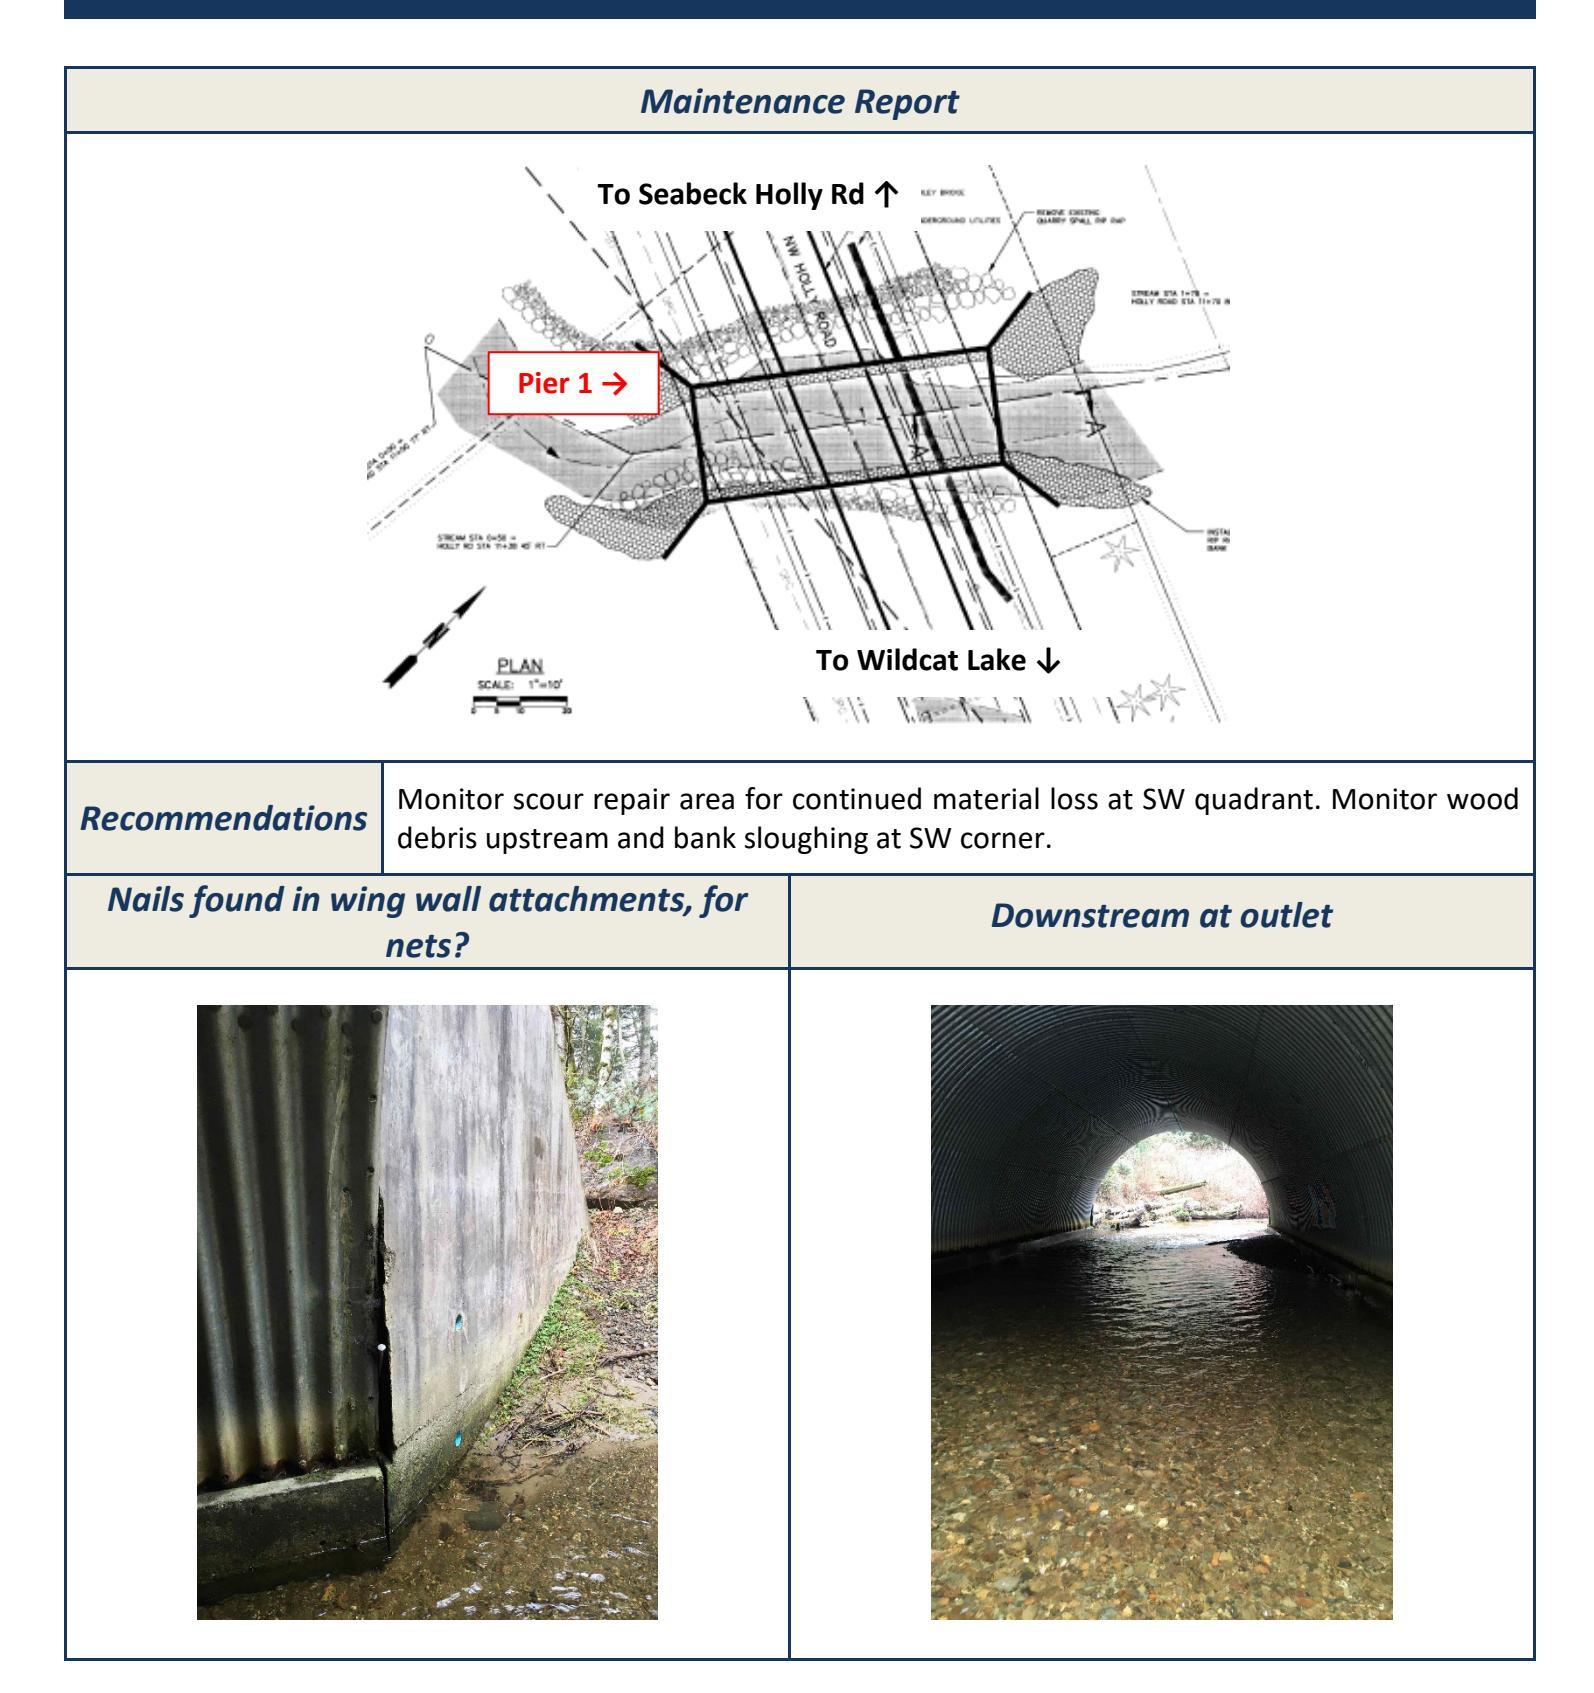
Bridge 08 – Holly Arch Culvert						
NW Holly Road		Big Beef Creek		1995	Good (G)	May. 9, 2023
Route Name		Fea	iture Intersected	Year Built	Overall Condition	Last Inspection
Superstructure	Culvert	Ga co ce AC in	alvanized steel arch culvert in fair condition. 6" to 8" of rusting is evident at onnection point between steel panels and concrete footing. In mid-span in eiling of arch 3 dented areas found within an 18"x18" area affected. Roadway CP overlayed cy CRP 5036 in 2022. Roadway guardrail replaced by CRP 5035 o 2020.			
Substructure	Foundati	on	Cast-in-place con summer of 2012.	crete spread fo Footings are nov	ootings. Scour repair v protected by strean	performed in late nbed gravel.
Scour and Load Rating	Bridge has been load rated as per FHWA requirements by TranTech Engineering in 2 Scour evaluation and analysis phase 2 was performed by Tetra Tech / KCM in 2004. Co roads performed scour repair in late summer of 2012. This bridge is scour critical.					Engineering in 2018. CM in 2004. County

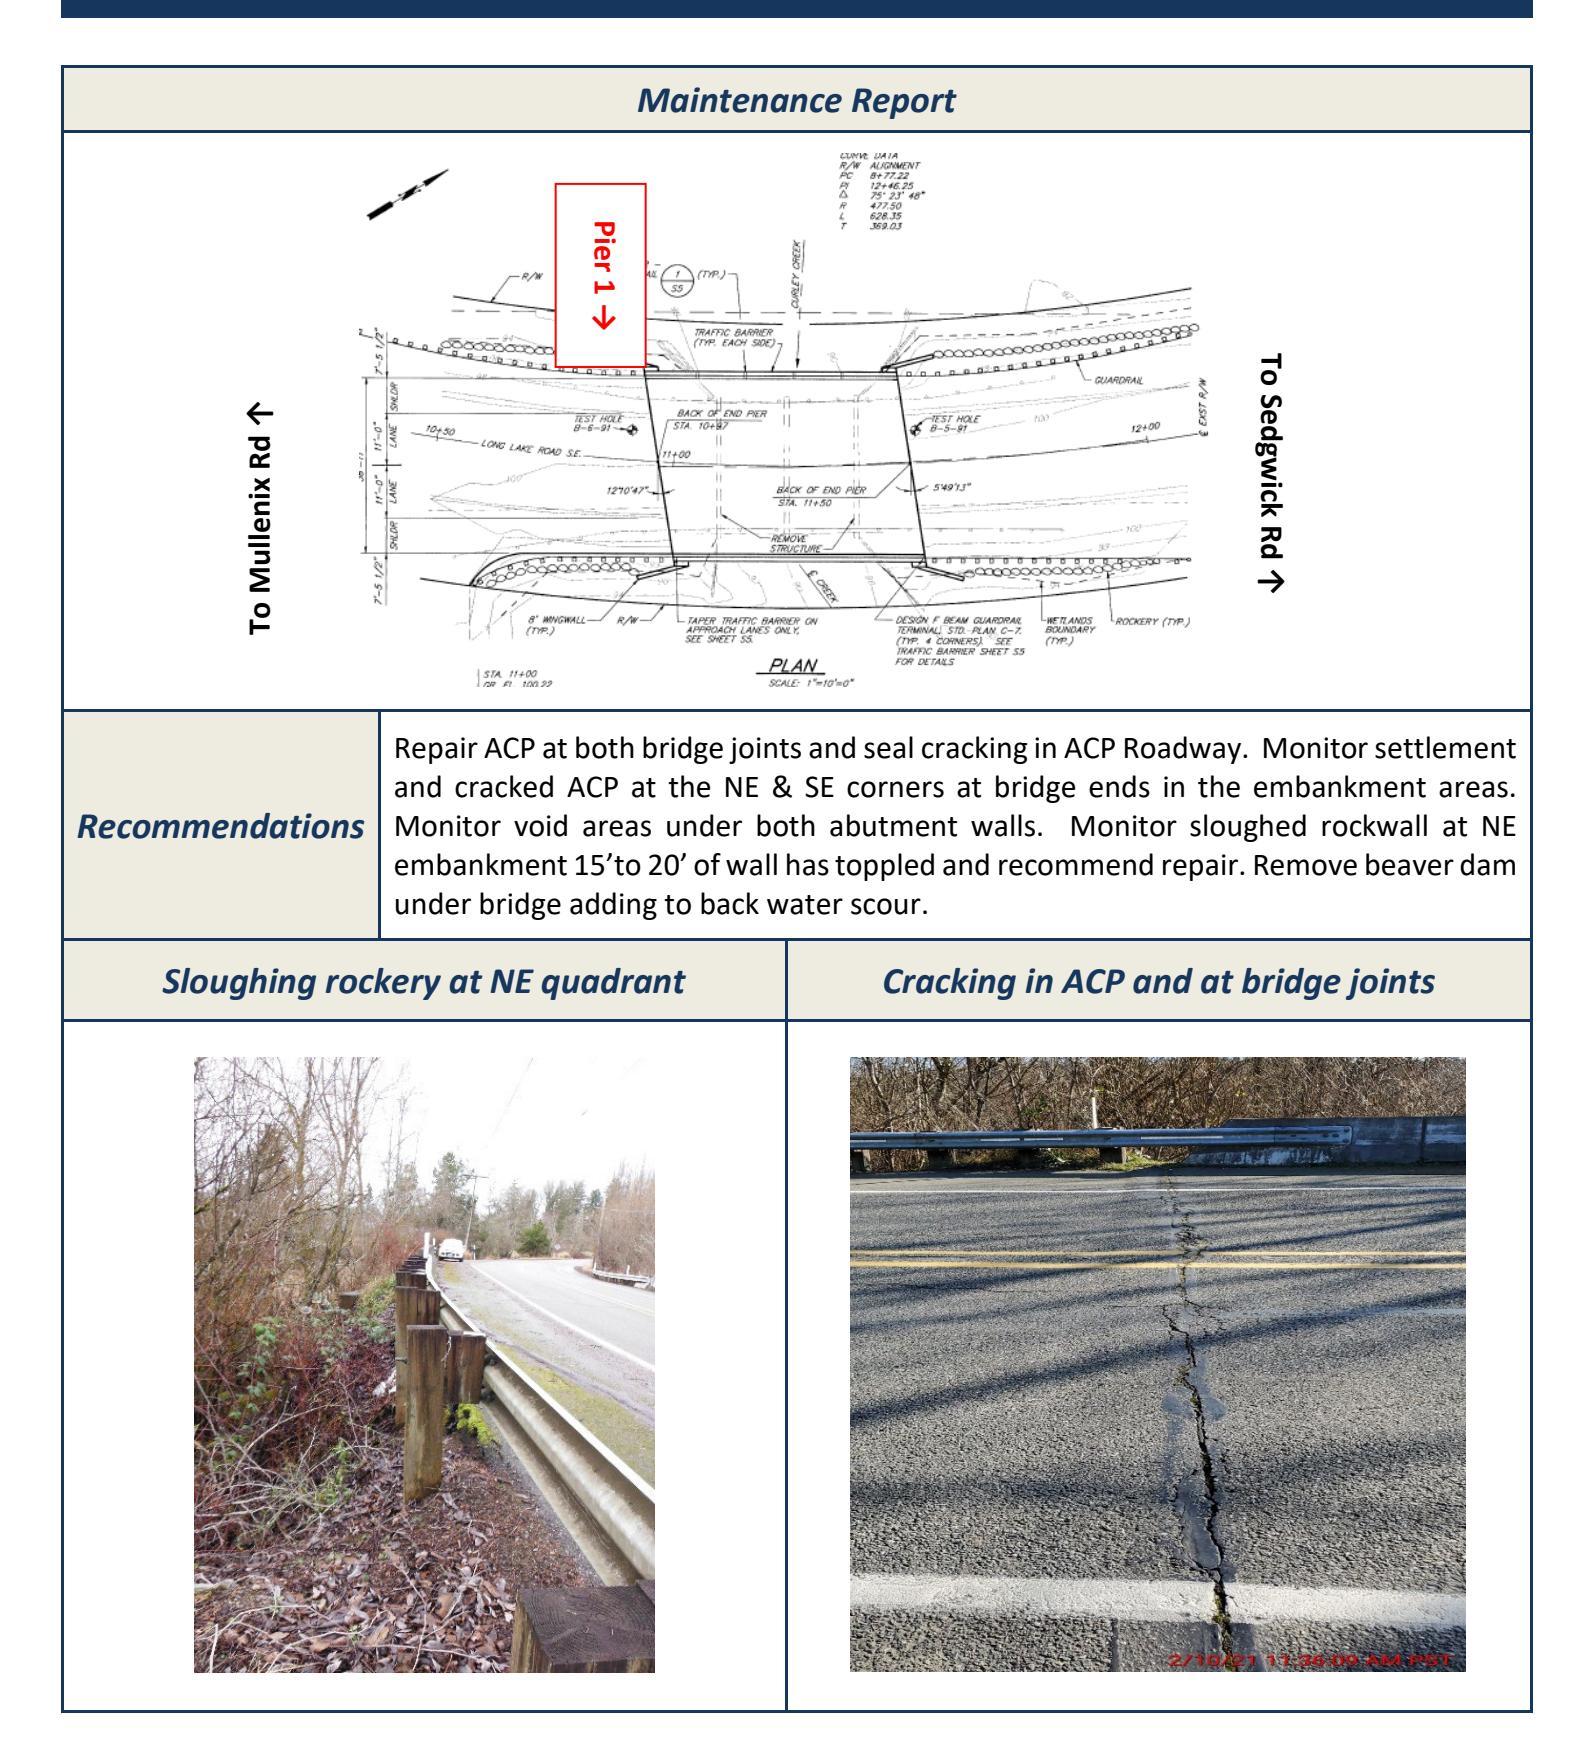
Bridge 09 – Long Lake Bridge

Girder	Pr	Prestressed, precast voided concrete slabs (4' ω x 2'-2" h) in good condition.			
Superstructure	Deck	3" ACP overlay with waterproof membrane is in fair condition. Cracking throughout needs sealing. ACP at bridge joints need repairs.				
	Other	Cc	Concrete bridge railing transitions & terminals do not meet current standards			
	Foundatio	on	Driven steel 12" pipe piles filled with concrete.			
Substructure	Abutments		Cast-in-place concrete abutment in fair condition with undermining happening. Girder seats are 24". NE corner, scour is under the pile cap - 2" void height x 10' long x 2' distance under the cap. SE corner, scour is under the pile cap – 2" void height x 13' long. Pier 2 abutment has soil on top from between slabs and/or voids at pavement seat.			
Scour and Load Rating	Bridge has been load rated as per FHWA requirements by TranTech Engineering in 2019. Scour analysis has not yet been performed for this structure. SE & NE corners of pile cap are showing signs of back water scour due to large beaver dam at mid span that was removed Summer 2013. Heavily overgrown outlet end contributing to backwater scour. Beaver dam rebuilt at centerline of bridge between old wooden pilings. This is contributing to back water causing scour at abutments.
