2023 Annual Bridge Report

Prepared by Kitsap County Public Works Engineering Division This sheet intentionally left blank.

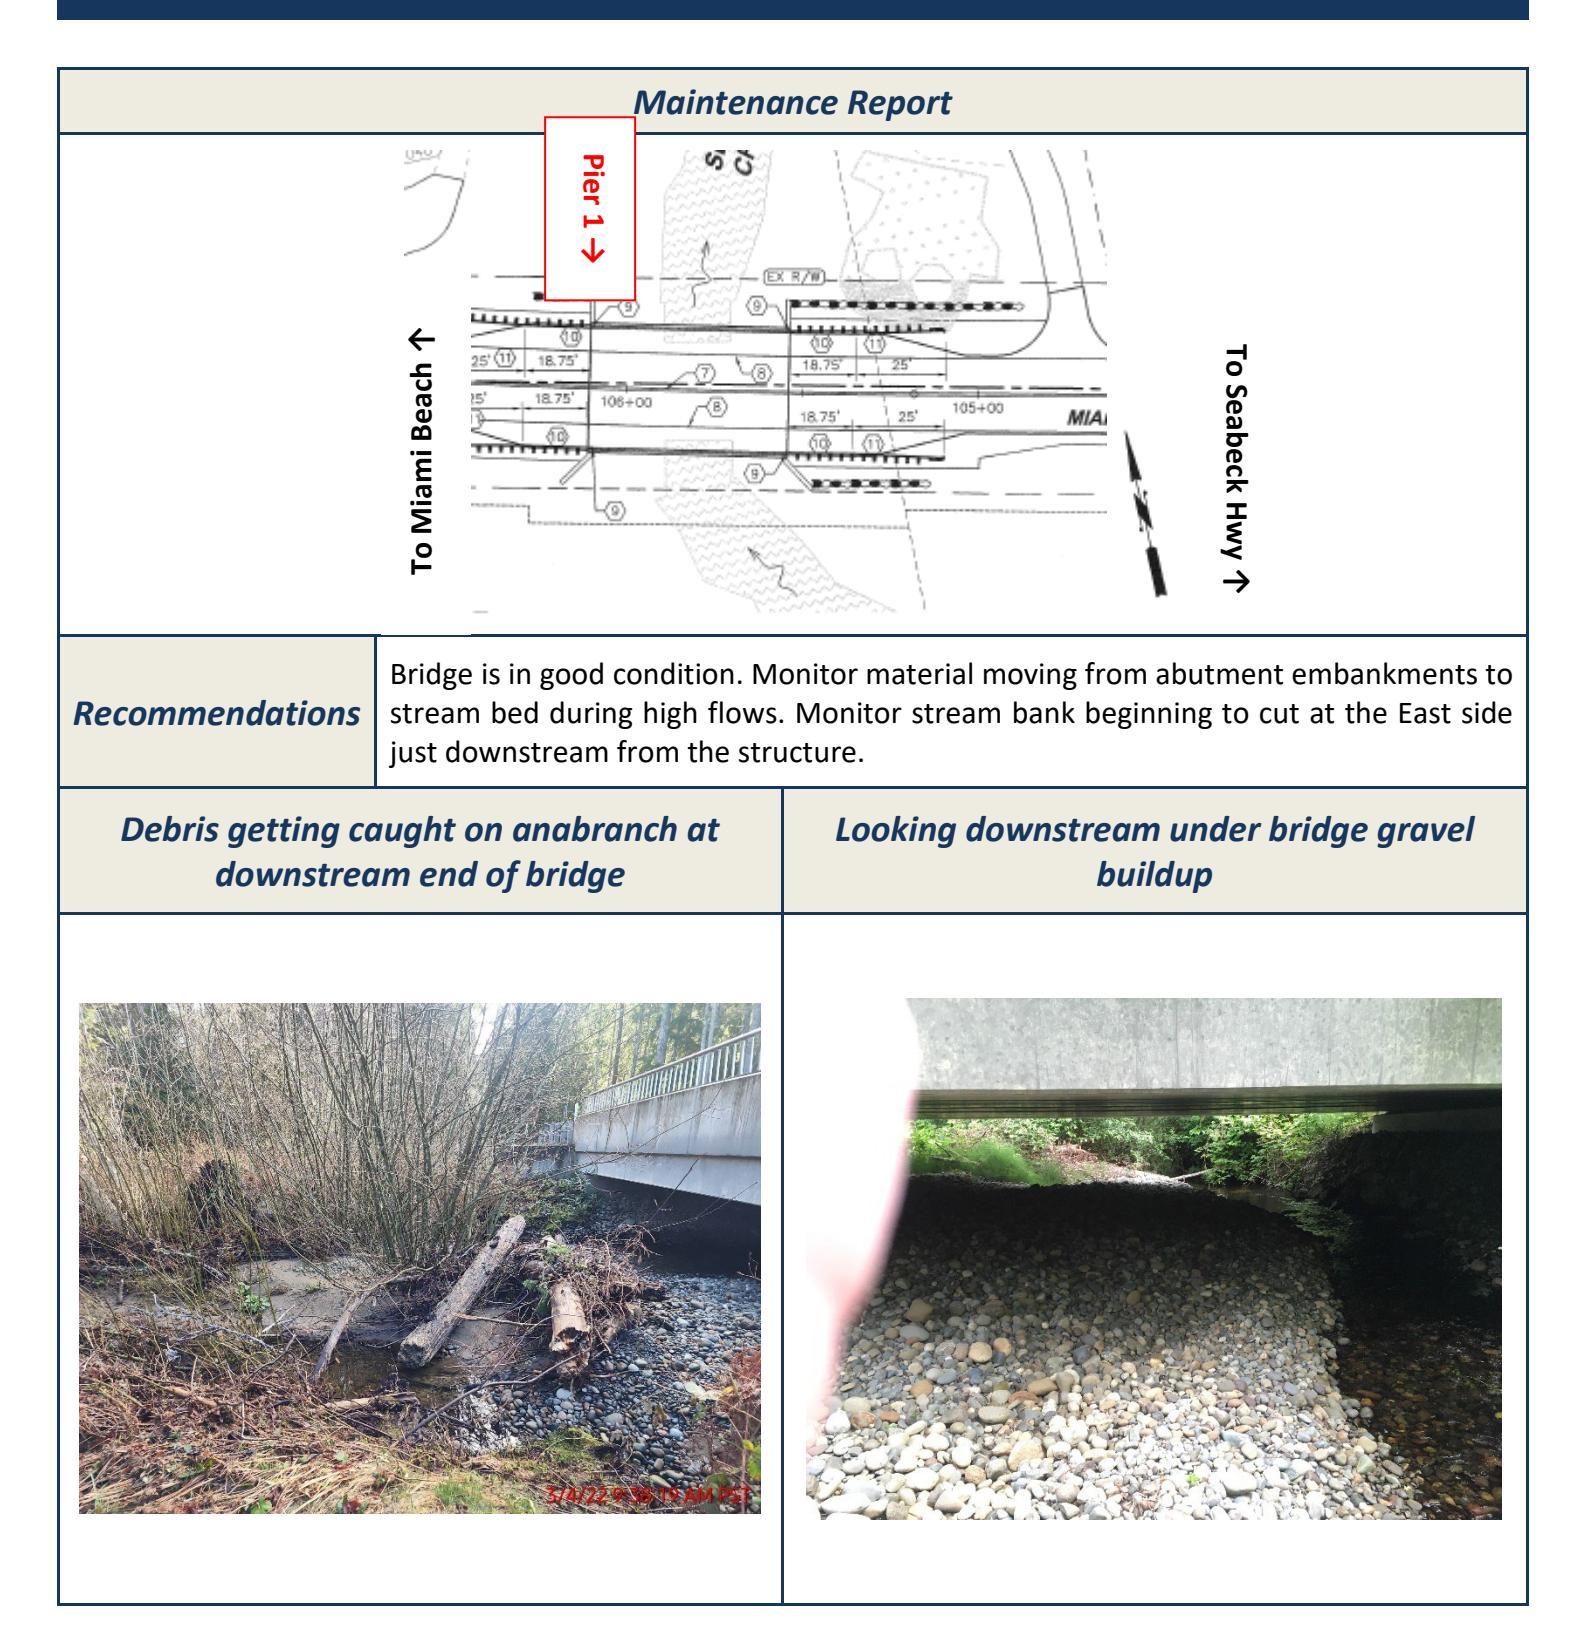
Photo	<image/>				
Bridge 11 – Miami Beach Bridge

Girder	Prestressed, precast voided concrete slabs (4' ω x 2'-2" h) in good condition.			
Superstructure	Deck	Cast-in-place 8" concrete deck with epoxy rebar mat. In good condition beginning to show signs of minor pitting throughout the deck.			
	Other	Concrete bridge railing sealed with pigmented sealer in good condition. Meta pedestrian railing in good condition. Small section replaced on the South side after tree fell down in late winter 2016. Top ped rail on south side is bent at midspan.			
Founda		on	Driven steel 2' pipe piles filled with concrete and rebar to depths of 50-52' in length.		
Substructure	Abutments		Cast-in-place concrete abutment in good condition. Elastomeric bearing pads and large rip rap protection. Elastomeric bearing pads show minor bulging throughout Pier 1.		
Scour and Load Rating	Bridge has been load rated as per FHWA requirements by TranTech Enginering in 2019. Scour analysis has not yet been performed for this structure. This bridge is not scour critical.

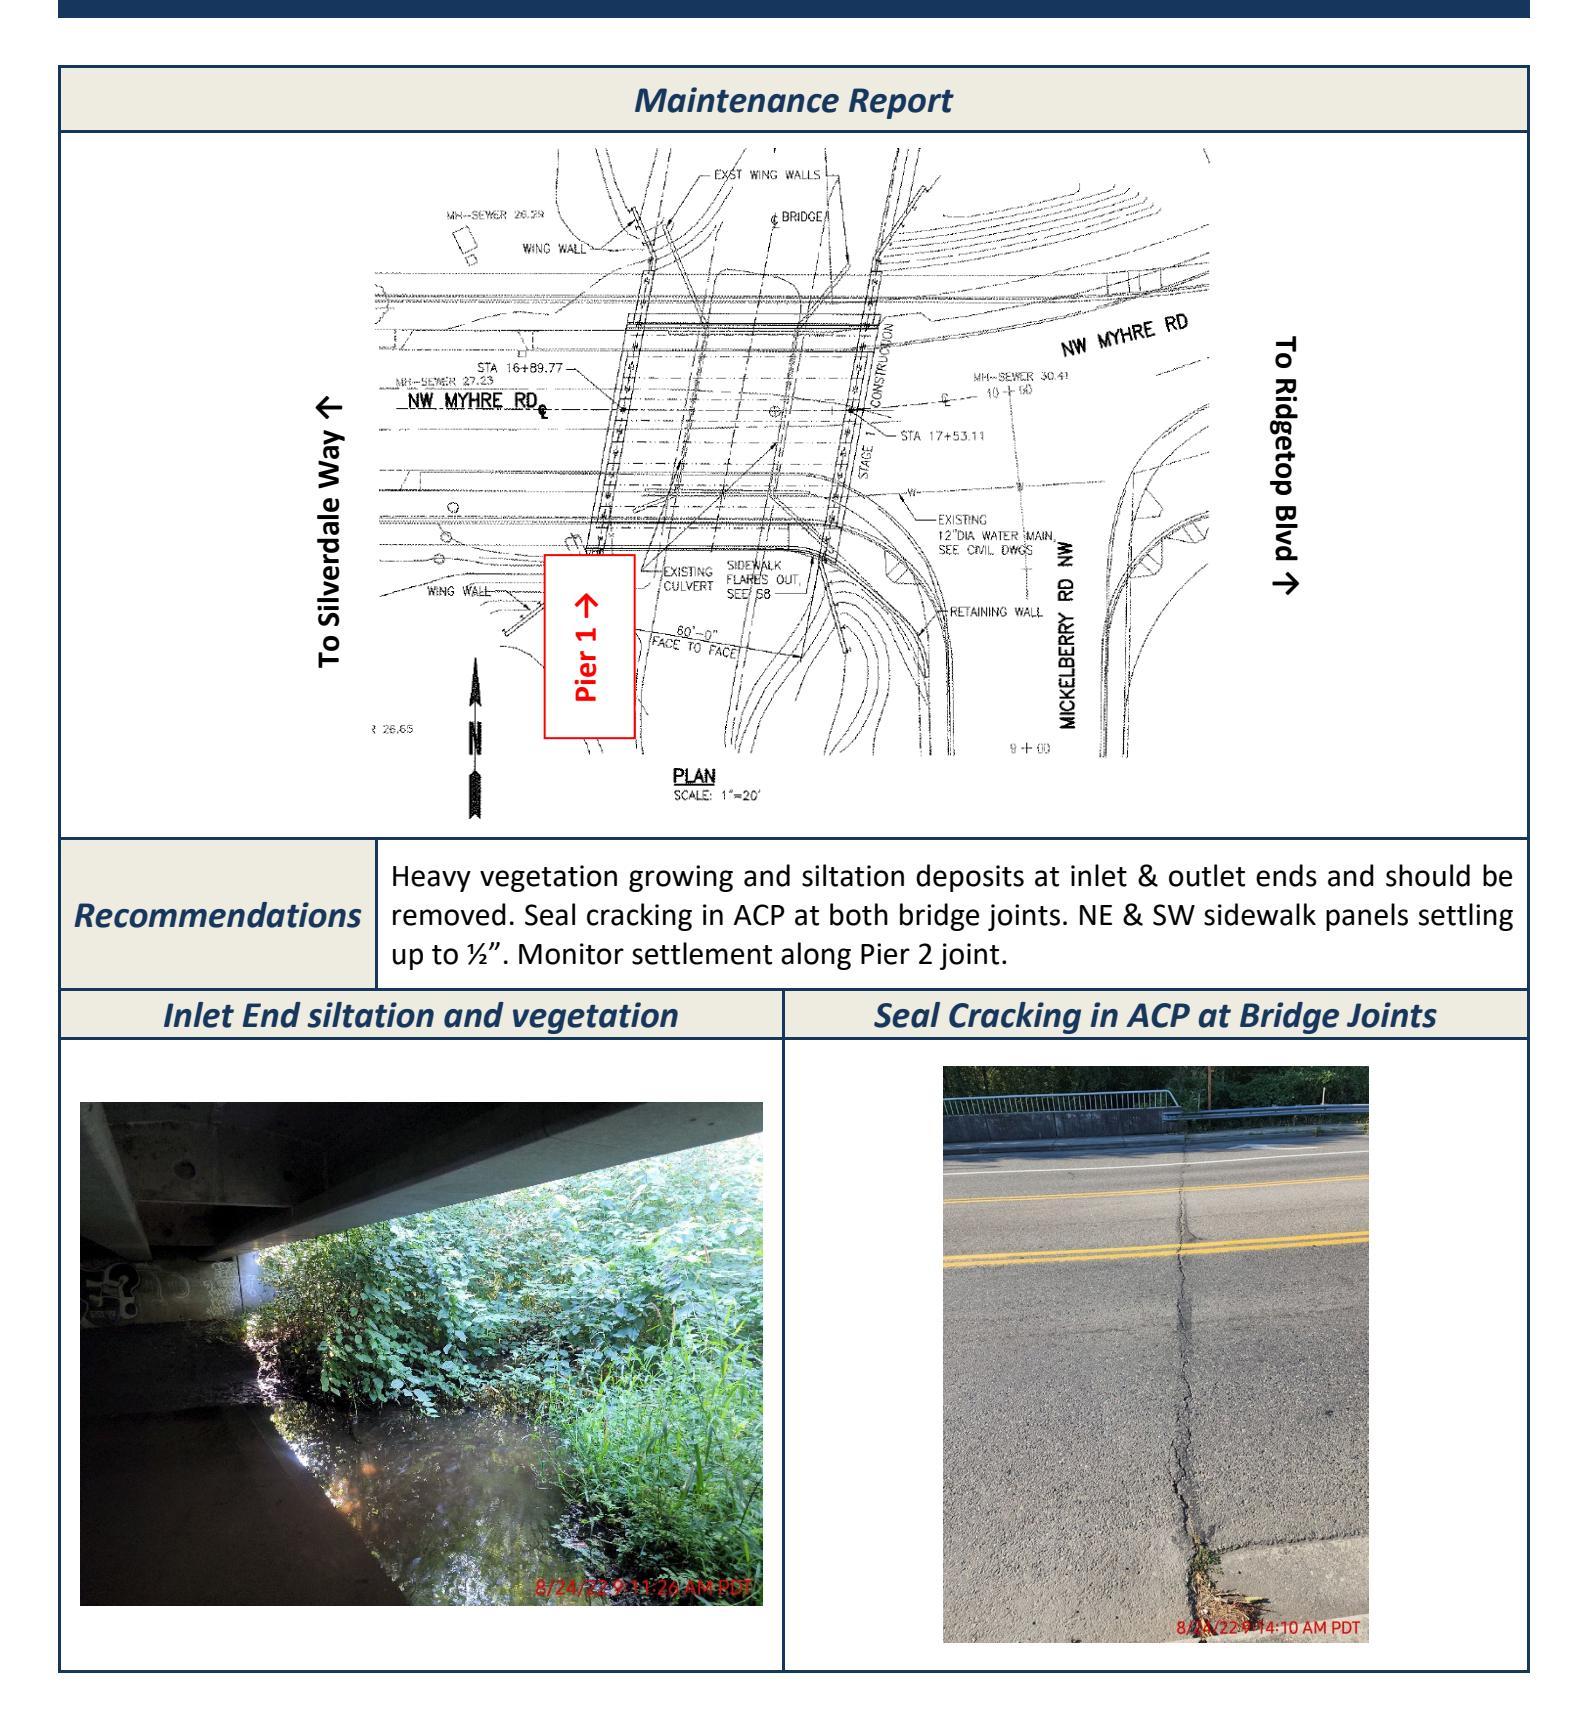
Bridge 12 – Myhre Bridge

Girder	Precast prestressed (35" DBT with 72" Flange) bulb-tee girders in good condition. Minor moisture present at both exterior girders.			
Superstructure	Deck	2" ACP overlay with waterproof membrane is in good condition. Cracking appearing at both bridge joints in need of sealing.			
	Other	Concrete bridge & metal pedestrian railing in good condition. Hairline vertical cracking beginning to appear in concrete railing at connection to metal pedestrian rail.			
	Foundatio	Driven steel 14" HP14x117 pile foundation under abutment and HP12x63 piles under wing walls.			
Substructure Abutments		Cast-in-place concrete abutment in good condition. Girder seats are 25". Both abutment walls now have minor hairline vertical cracks at the bearing seats. SE wing wall top – small crack where wall meets outside flange of girder 45-degree angle x 6" long. Small voids now present between wing walls and abutments due to deterioration of fiber expansion material.

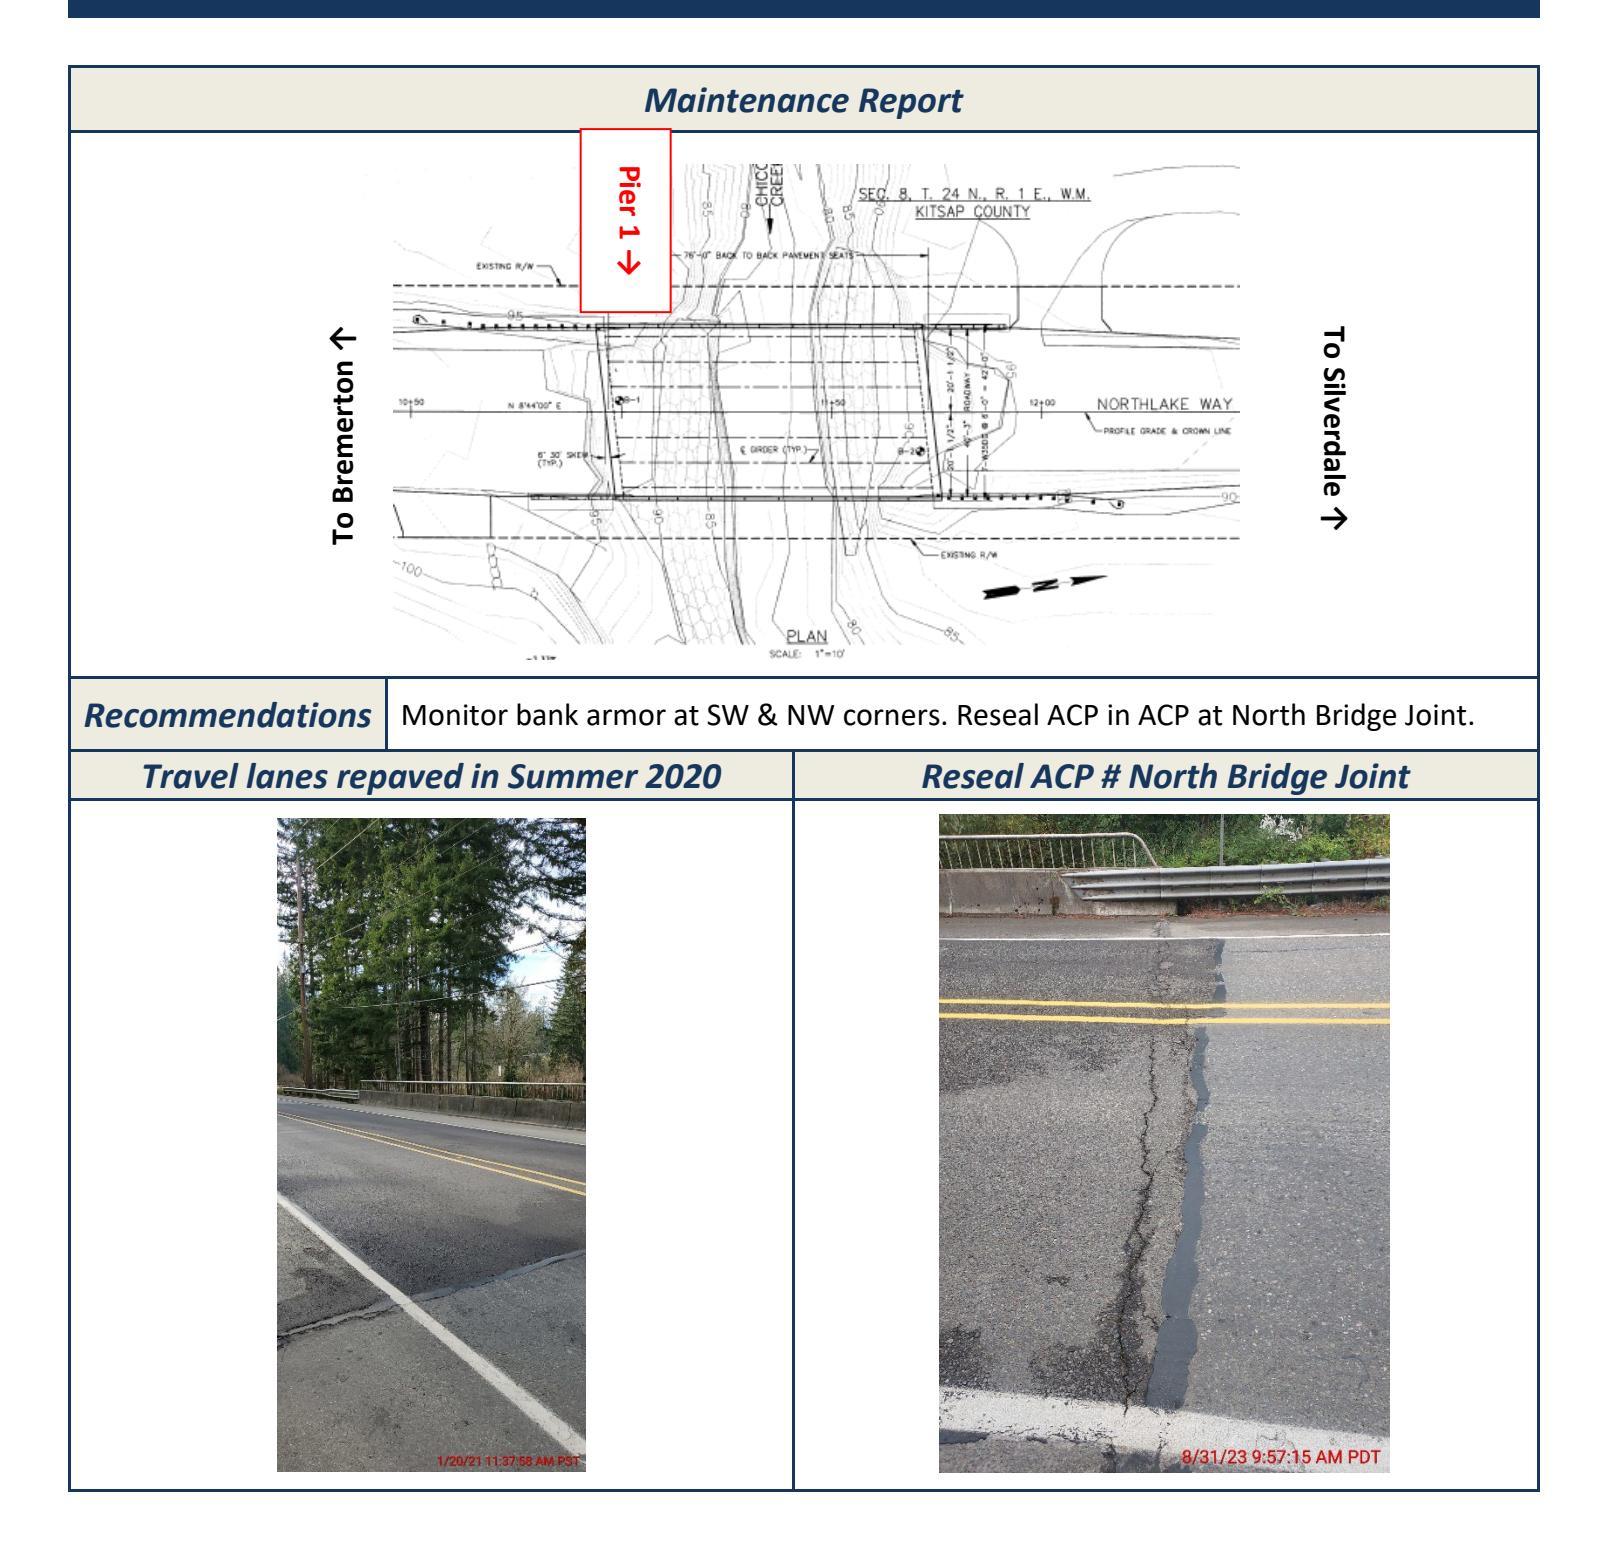
Bridge 13 – Northlake Bridge

Girder	Pr	ecast prestressed (W35DG) bulb-tee girders in good condition.		
Superstructure	Deck	2.5" ACP overlay with waterproof membrane is in repaired condition (milled and repaved in summer 2020 in travel lanes). Repair of ACP overlay has resolved previous problem of significant moisture between girders at deck underside.			
	Other	Co	ncrete bridge & metal pedestrian railing in good condition.		
Substructure	Foundatio	on	Driven steel 18" pipe piles filled with concrete. Additional rip rap was added at both side of inlet end in spring of 2009 by county forces and is working well.		
	Abutmen	ts	Cast-in-place concrete abutment in good condition. Girder seats are 46".		
Scour and Load Rating	Bridge has been load rated as per FHWA requirements by TranTech Engineering in 2018. Scour evaluation and analysis was performed by West Consultants in 1997. Additional rock armor placed at inlet end is working well. Low flow is in center of channel

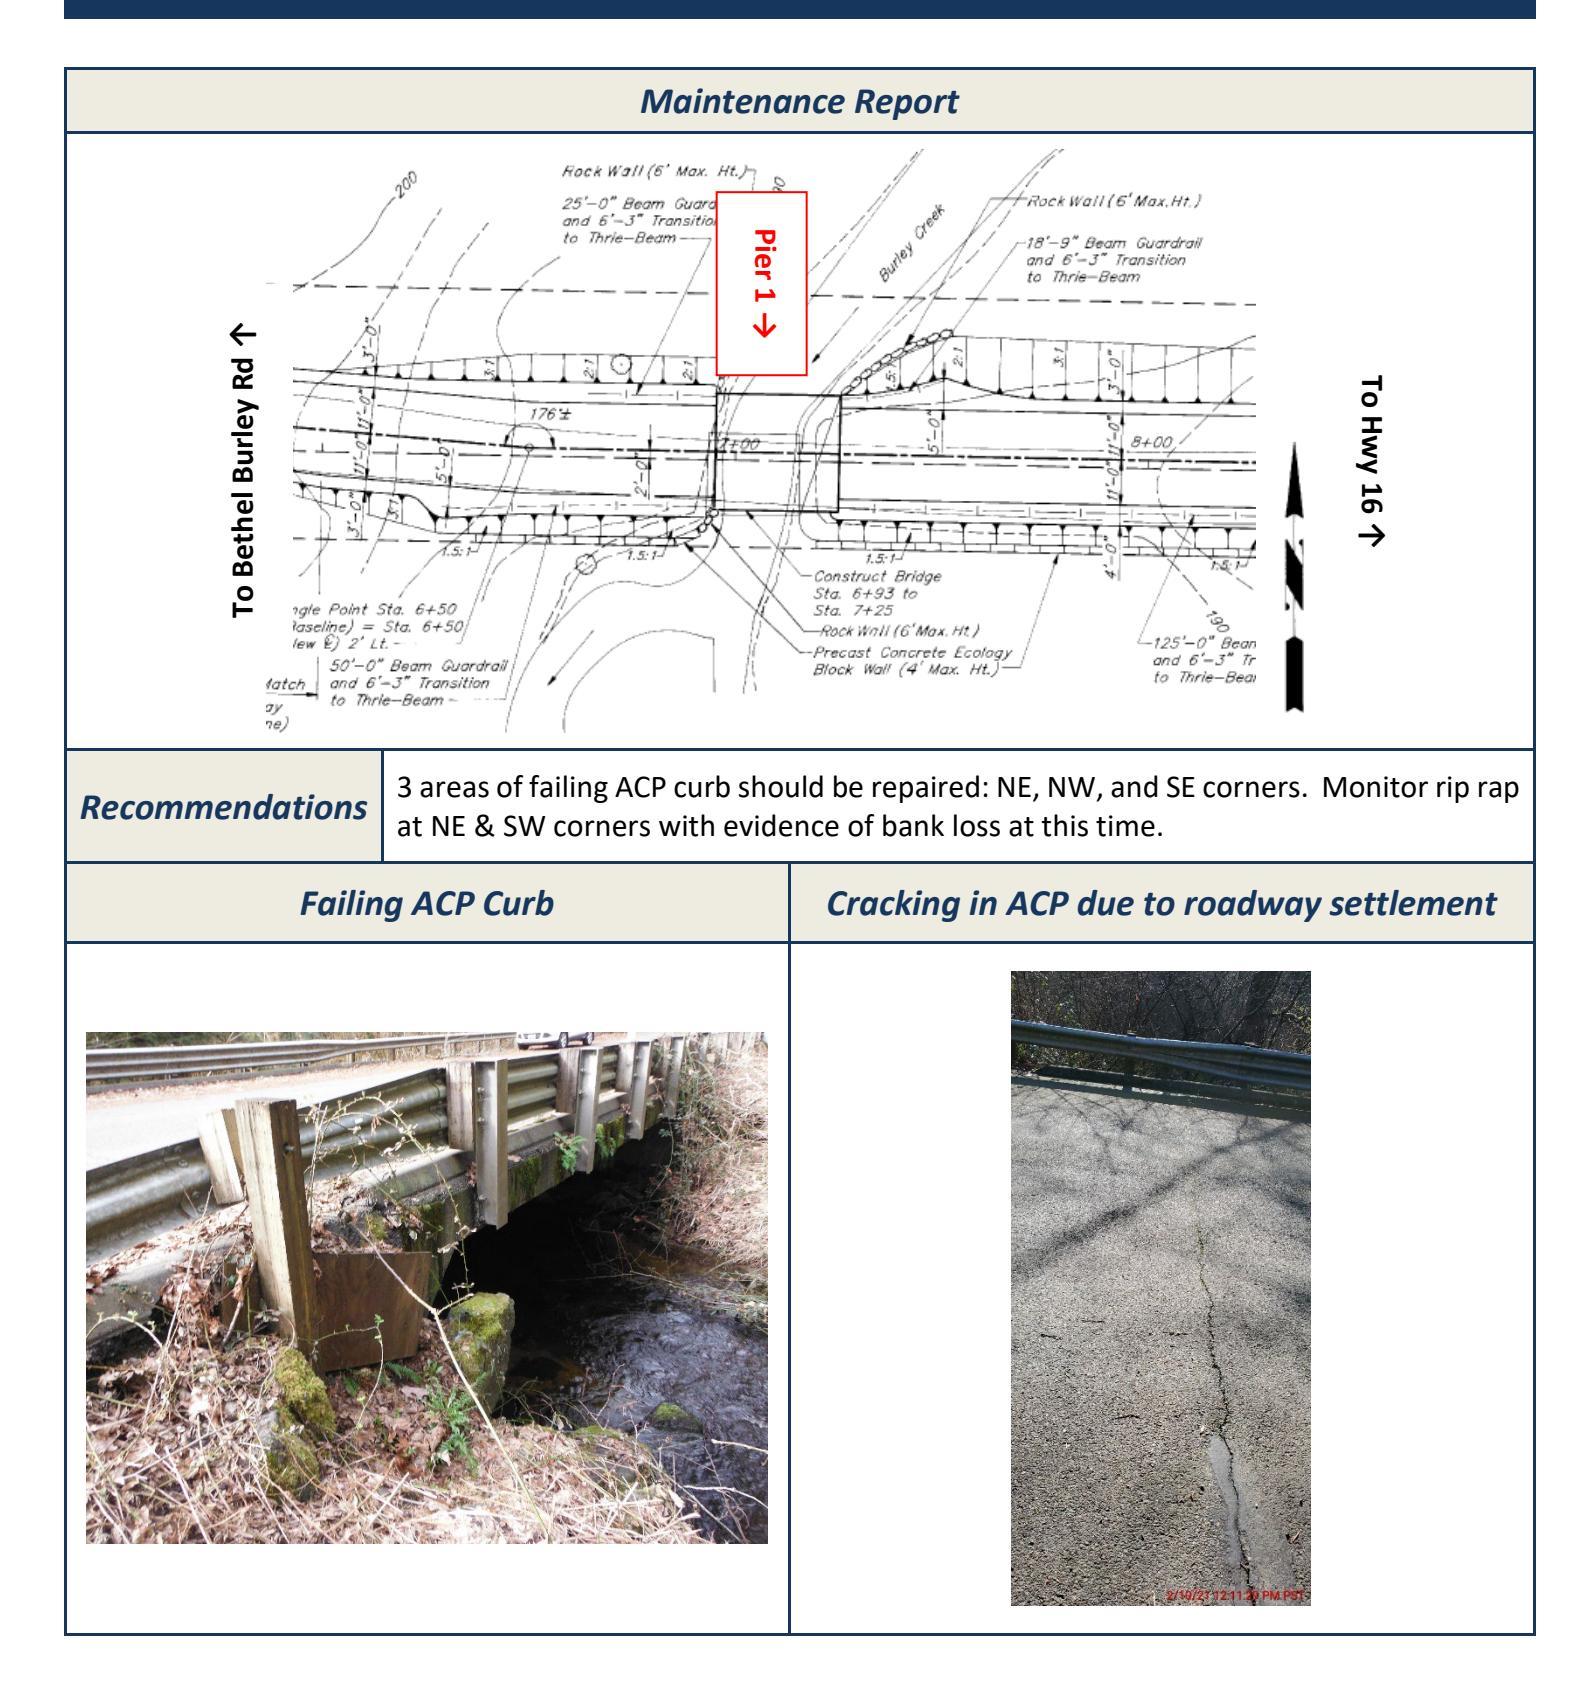
Bridge 14 – Oak Street Bridge

Superstructure	Culvert	3 s sea abu sea	pan concrete box culvert in good condition. Minor moisture is present at ms only. Leachate and Stalactite formation noted in between all slabs, and tment walls. Efflorescence is accelerating. Backer rod is exposed at 2nd m in from South on East side at ground elevation.		
Superstructure	Other	Bric app at N at r	dge rail transitions do not meet current standards. Roadway settlement is parent at East pier with cracking across roadway and about 1" crack in ACP North end. Settlement at West joint also noted with only cracking appearing oadway shoulders at this time.		
Substructure	Foundati	ion	Cast-in-place concrete footings. Scour holes that have formed under the footing have begun to fill back in with the stream channel returning to the center of the structure. No girder seat – spread footings.		
Scour and Load Rating	Bridge ha Scour an This brid	Bridge has been load rated as per FHWA requirements by Entranco Engineering in 1996. Scour analysis has not yet been performed for this structure.

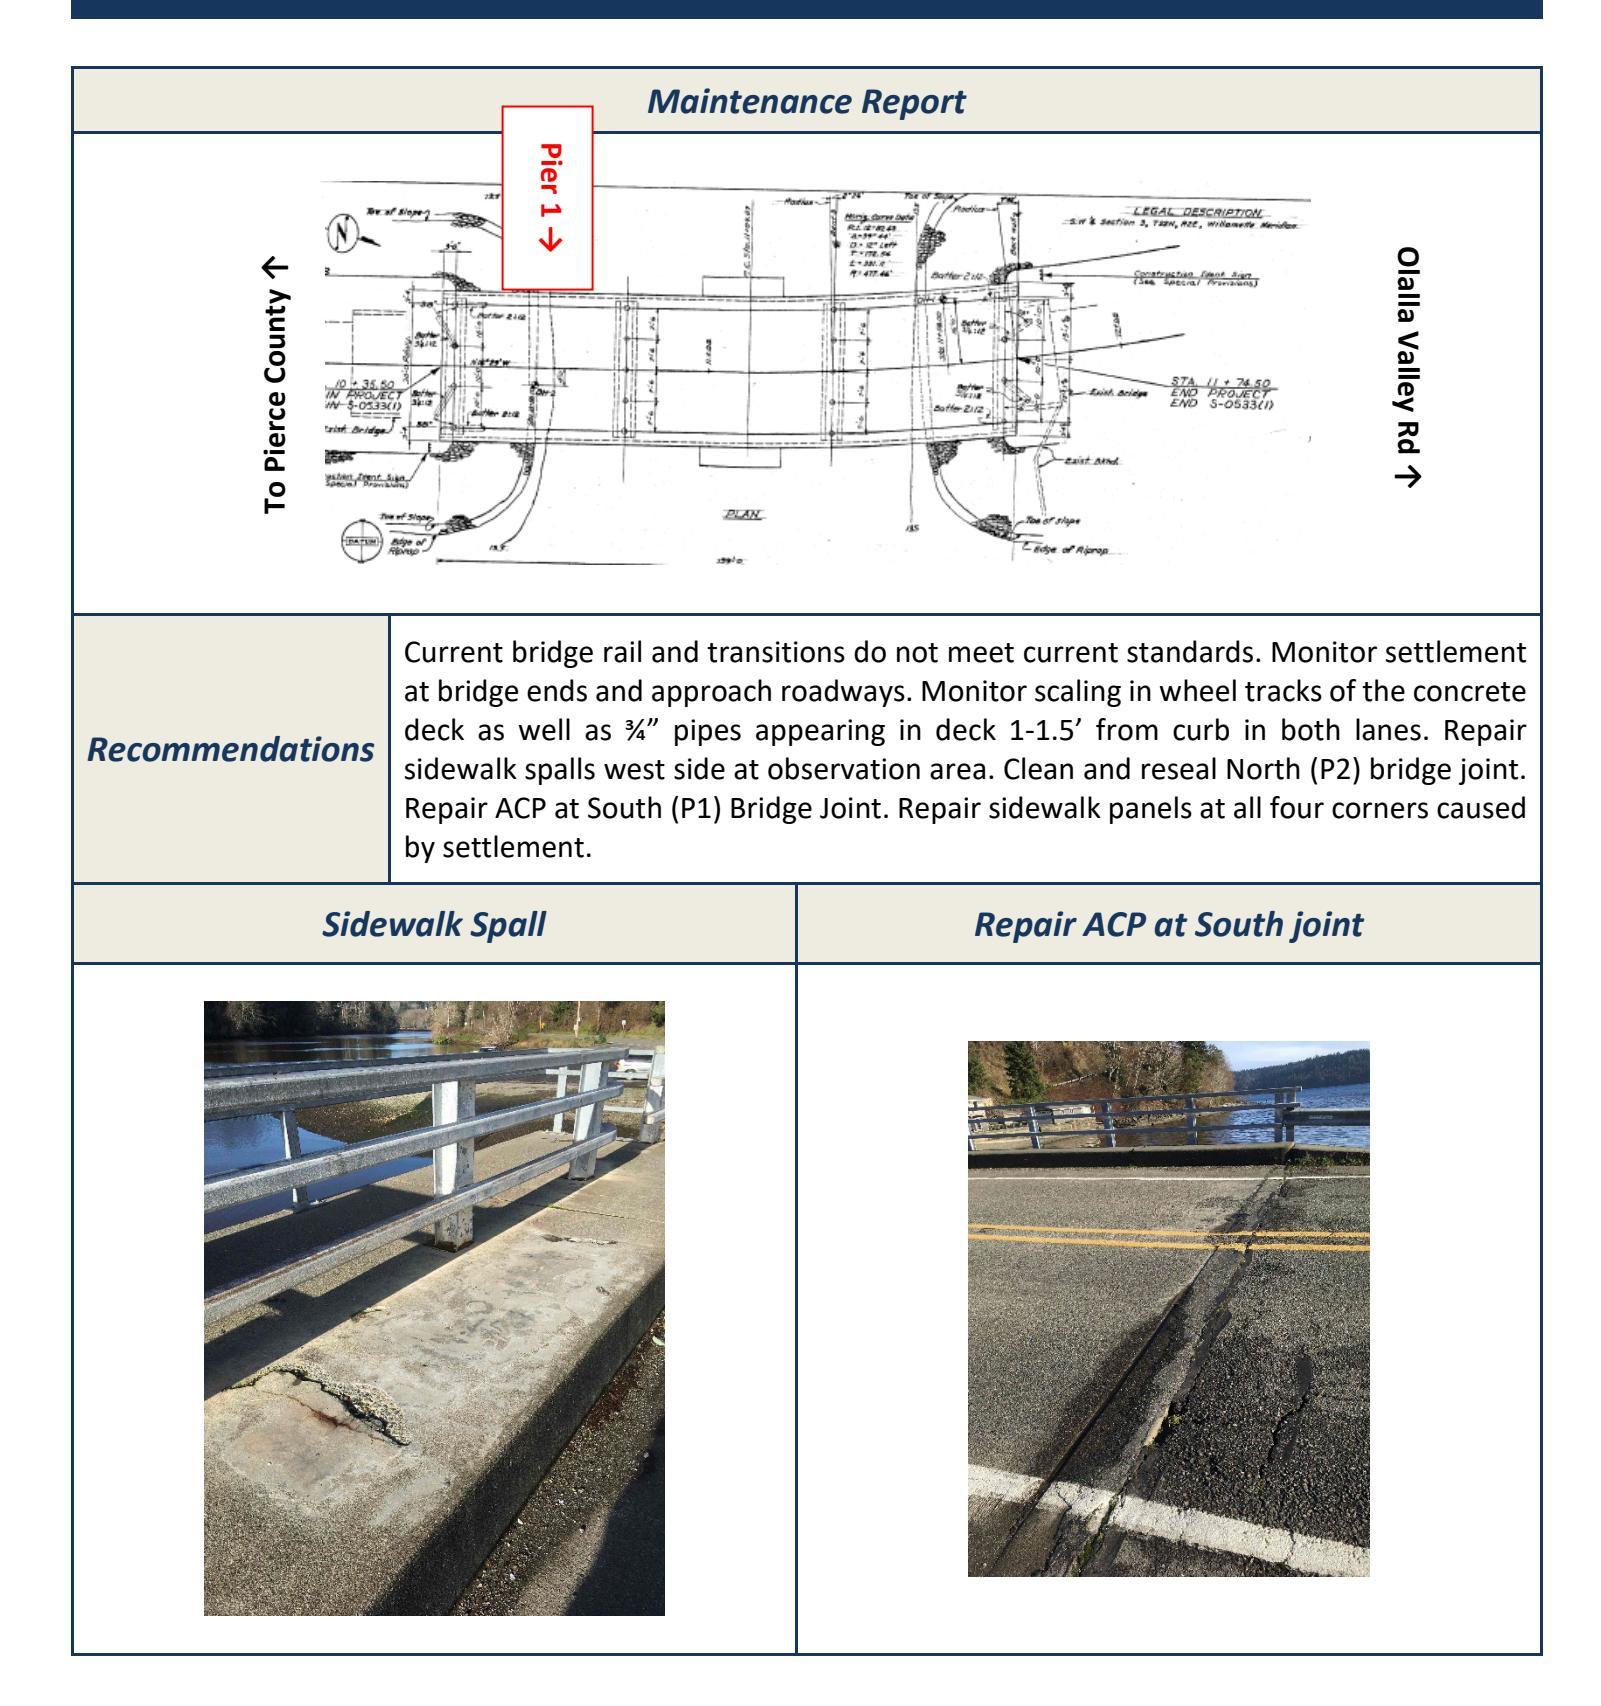
Bridge 15 – Crescent Valley Bridge

Girder	Cast-in-place post-tensioned slab in satisfactory condition.		
Superstructure	Deck	Cast-in-place post-tensioned slab with deck showing signs of accelerated scaling. Iron pipe showing through the deck along the sidewalk entire length, both sides – 1' from curb.		
	Other	All 4 corners under the sidewalk panels, material is starting to slough away again. Sidewalk repair on the west side observation area [midspan] is starting to spall $3'x 6'x 1/4''$ deep. 4 sidewalk panels at bridge joints have settled and are in need of repair. Metal bridge rail and transitions do not meet current standards. Some areas of delamination in sidewalk at bridge railing attachments.		
Fo Substructure A	Foundatio	Driven 16" precast concrete piles. Rust staining evident at Bent #3 pile cap at easterly pile connection to the deck. Barnacle build-up to 4' from ground elevation of all piles in the water.		
	Abutmen	Cast-in-place concrete abutments are protected by vinyl sheet piling walls. Vertical hairline cracking in the Pier 4 carrying up to the deck underside. A 4"x 4" hole in vinyl sheet pile wall below header wall on NW corner. Slab seat is 45".

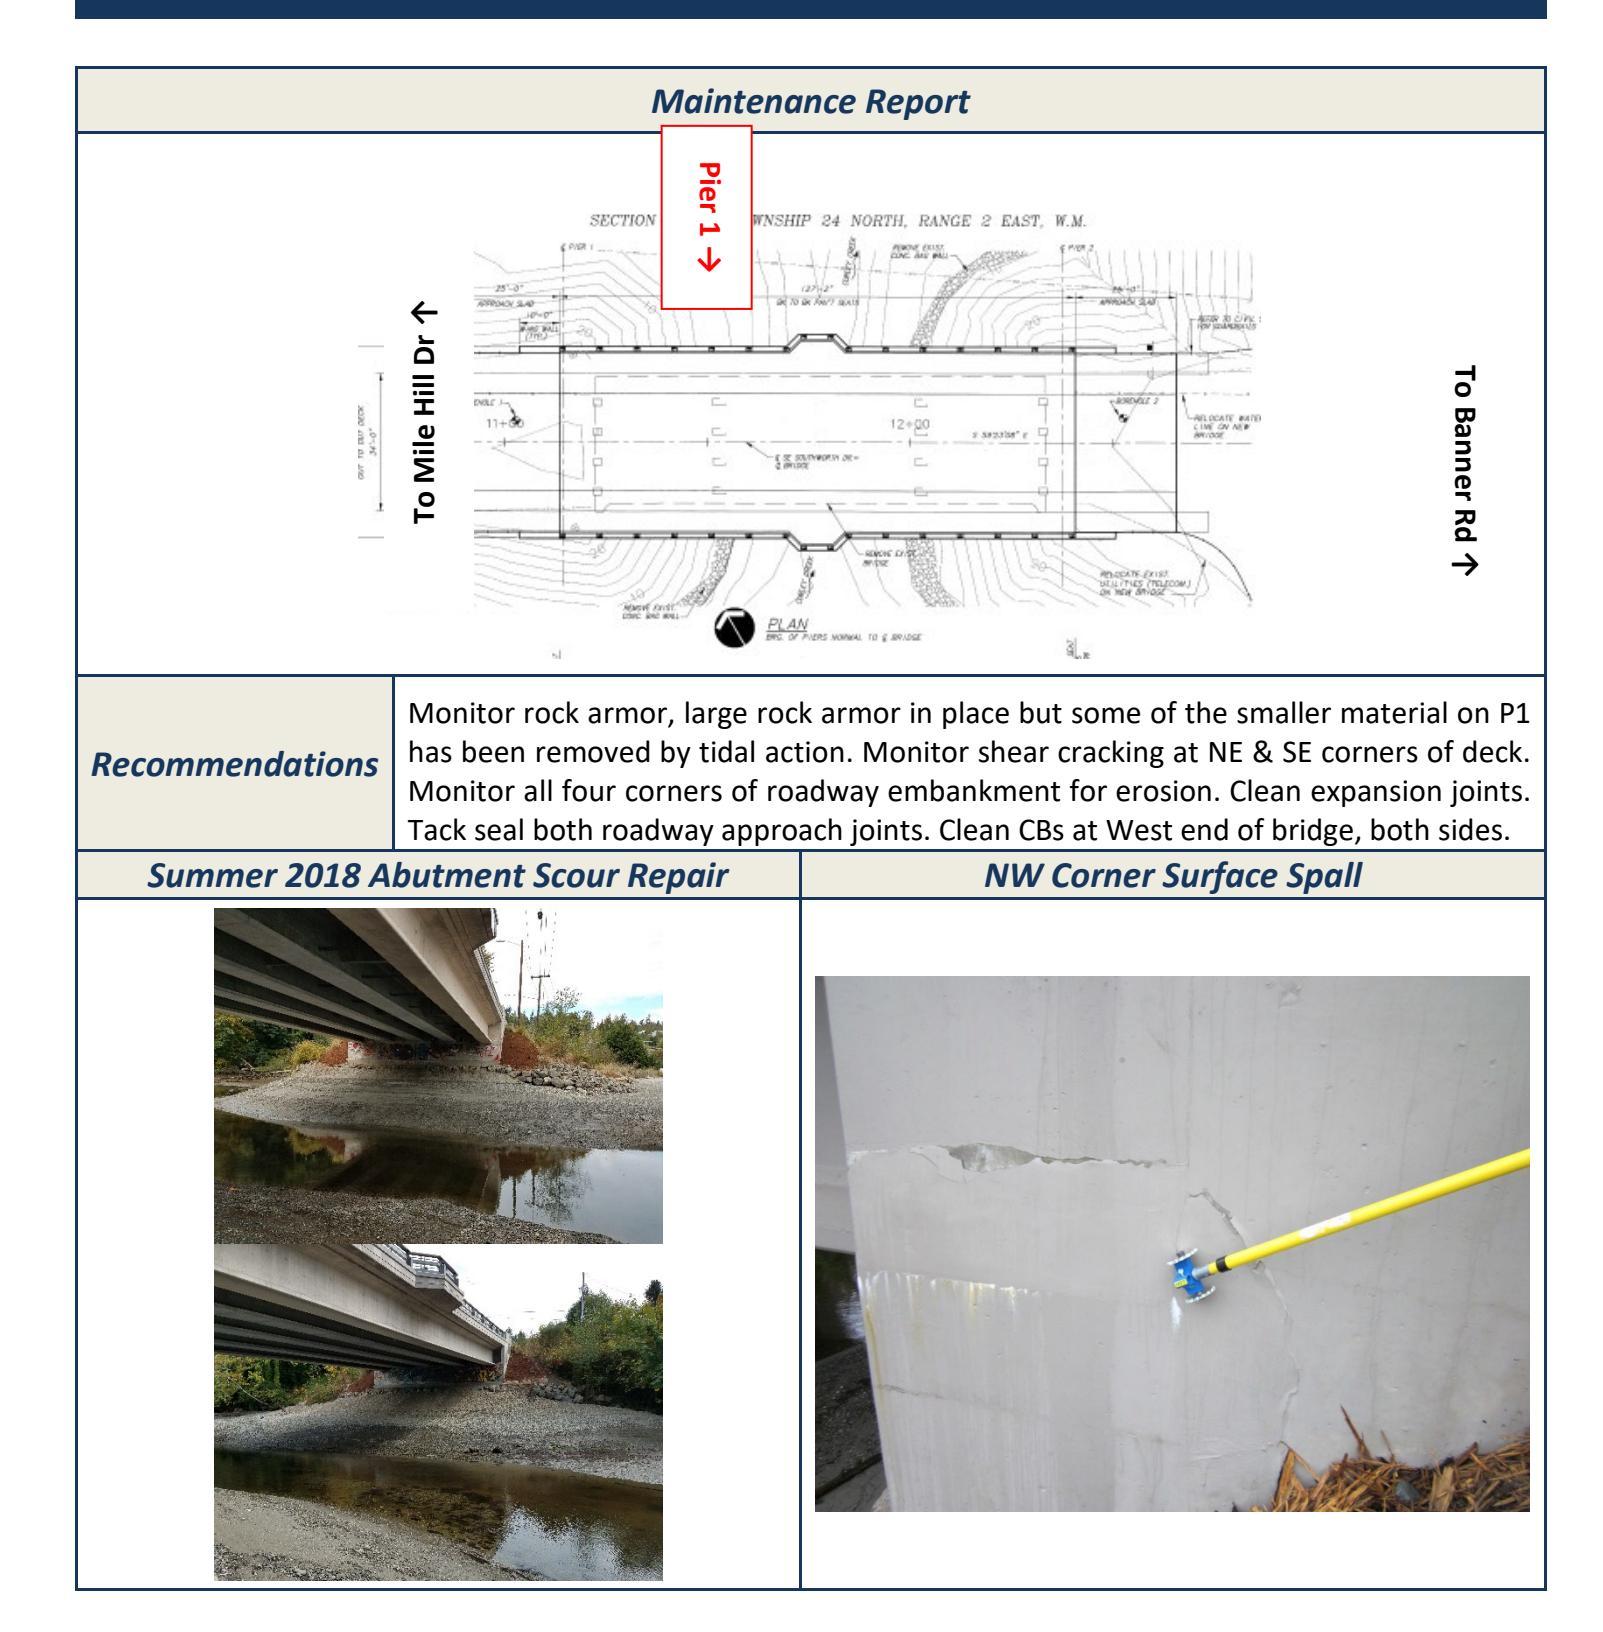
Bridge 21 – Southworth Bridge

Girder	Pr in	ecast prestressed concrete (WF66G) bulb-tee girders, approx. length of 127' good/new condition.			
Superstructure	Deck	10" cast-in-place deck and epoxy coated reinforcement. Hairline cracks state to show in gutter pan and sidewalks. East end of bridge has uniform diag shear cracking of deck at 3' and 10' from East bridge end. Hairline perpendi cracking beginning to show along sidewalk on South side of bridge.				
	Other	Ga cra	alvanized metal pedestrian railing in good condition. Accelerated map acking at all 4 quadrants on the concrete barrier sections.			
	Foundatio	dation Drilled shaft foundation 5' in diameter with rebar encased in concress shafts per pier to approx. length of 40' in depth.				
Substructure	Abutmen	 Cast-in-place concrete abutment with pigmented sealer. Rock a abutments was rebuilt along with shotcrete wall installed as part countermeasure repair performed in summer 2018. NW wing wa has surface spall 4' x 2' x 8" and SW exterior abutment wall has surface spalls located at construction joint locations between pier wing wall. The conduits at the SE corner steadily leaking at couplers. Beam Seat – 36".

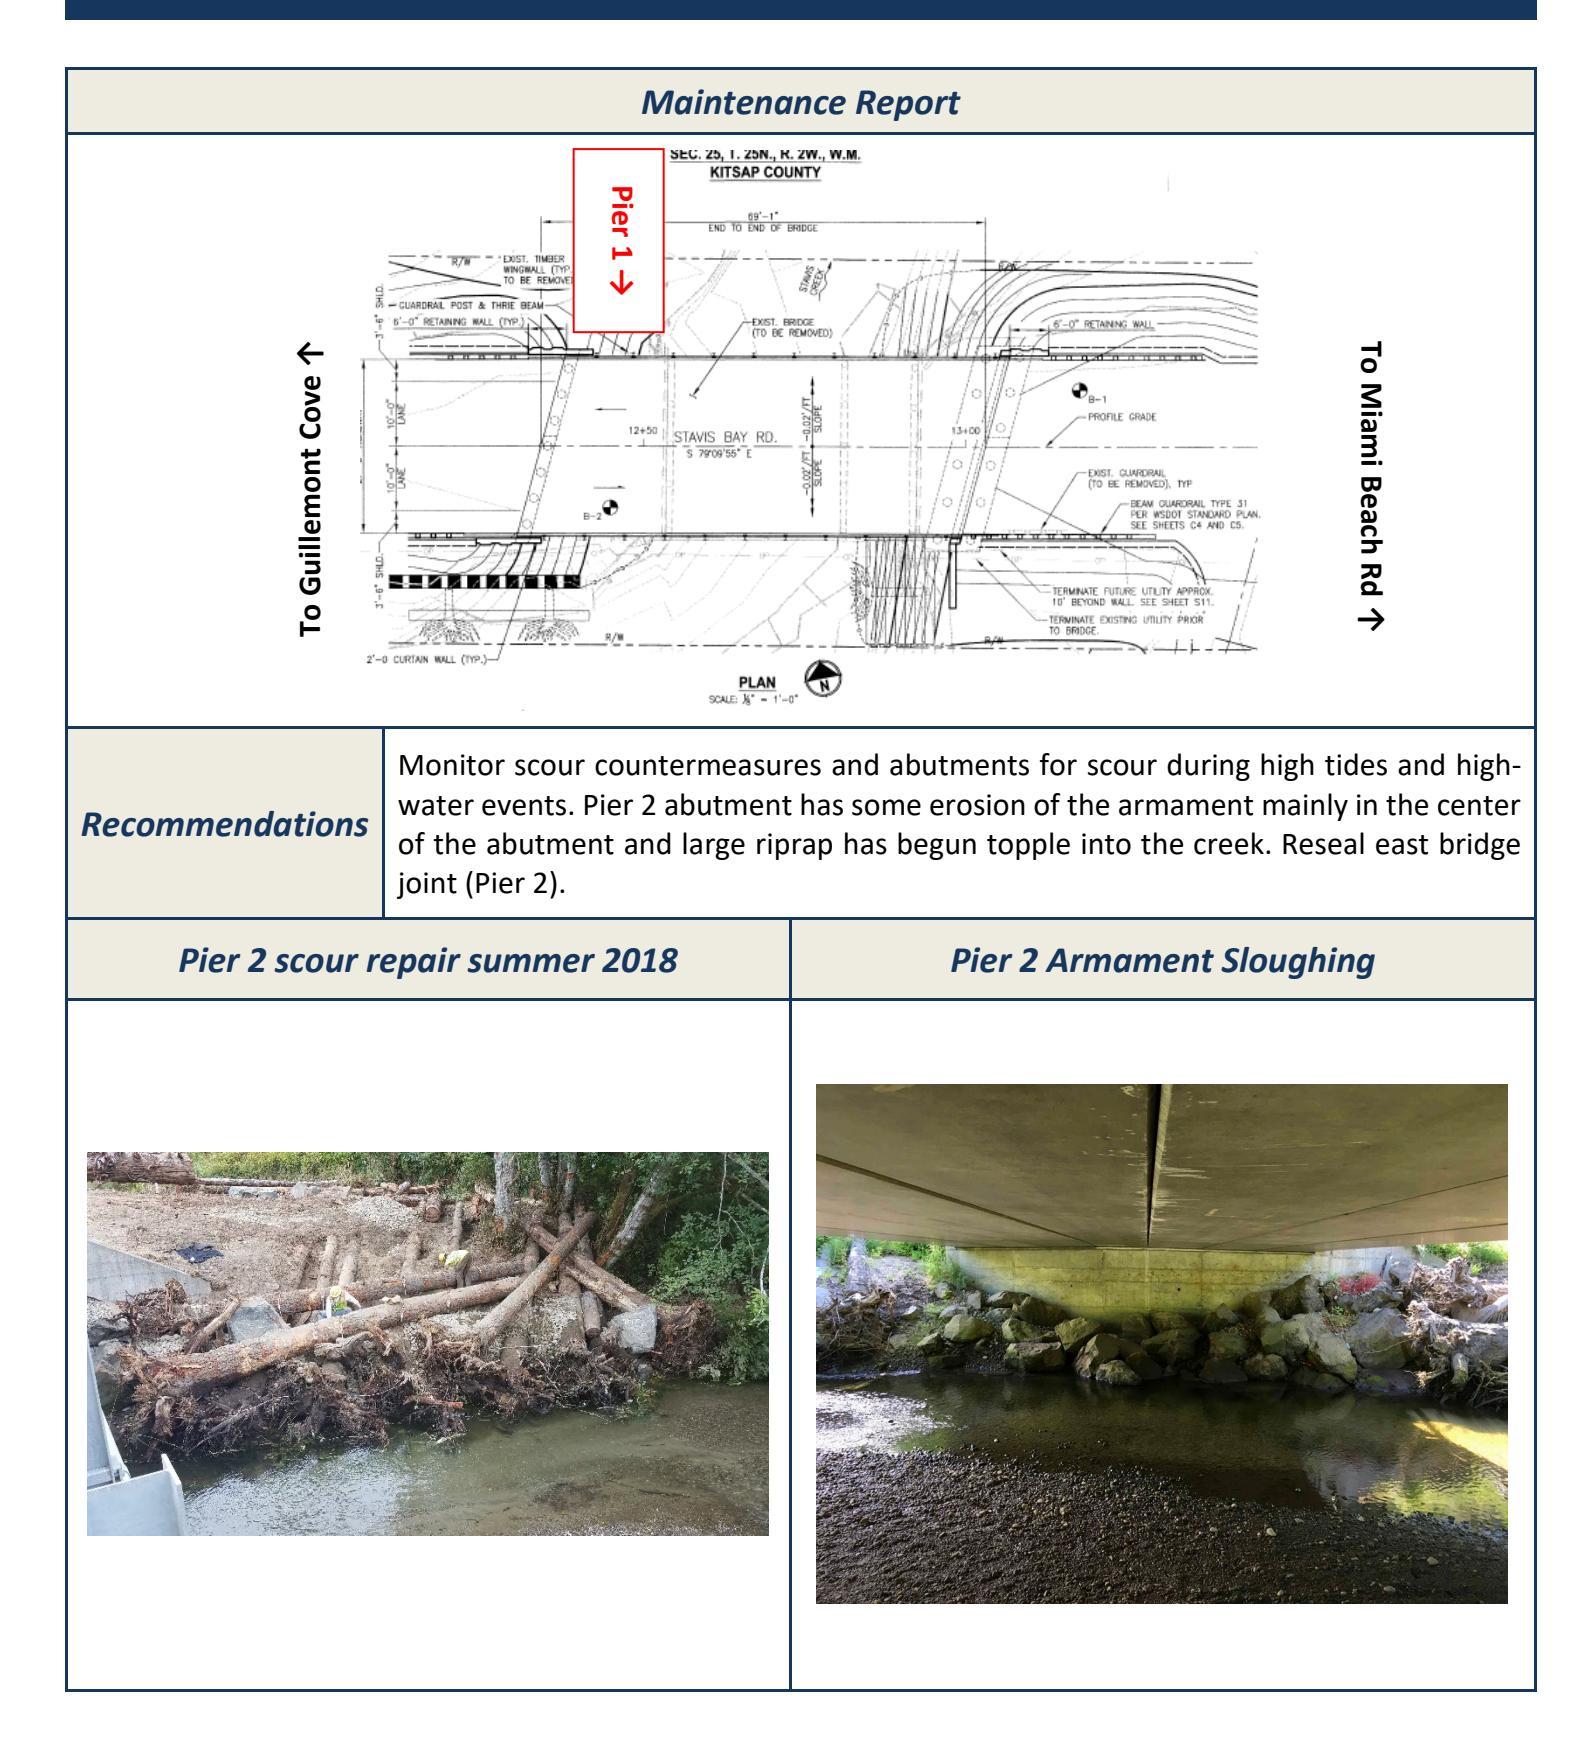
Bridge 23 – Stavis Bay Bridge

Girder	GirderPrecast prestressed 26" concrete voided slabs in good condition. Small spall on exterior slab at north side, likely from scour repair activities.Deck3" ACP overlay with waterproof membrane in good condition.					
Superstructure	Deck						
	Other	М	etal bridge railing and elastomeric bearing pads in good condition.				
	Foundatio	on	Driven 16" steel pipe piles with filled with concrete and rebar to depth of approx. 40'.				
Substructure	Abutments		Cast-in-place concrete abutments. Beam seat – 24". County road department installed permanent scour countermeasures at the SE & SW quadrants in summer 2018.				
Scour and Load Rating	Bridge has Scour analy Scour repai leaving 3.7	bee /sis r ha 5' bi	en load rated as per FHWA requirements by TranTech Engineering in 2019. has not yet been performed for this structure. Pier 2 rock armament from is been toppling into the creek with 6.25' exposed abutment at center of pier uried.
