2023 Annual Bridge Report

Prepared by Kitsap County Public Works Engineering Division This sheet intentionally left blank.

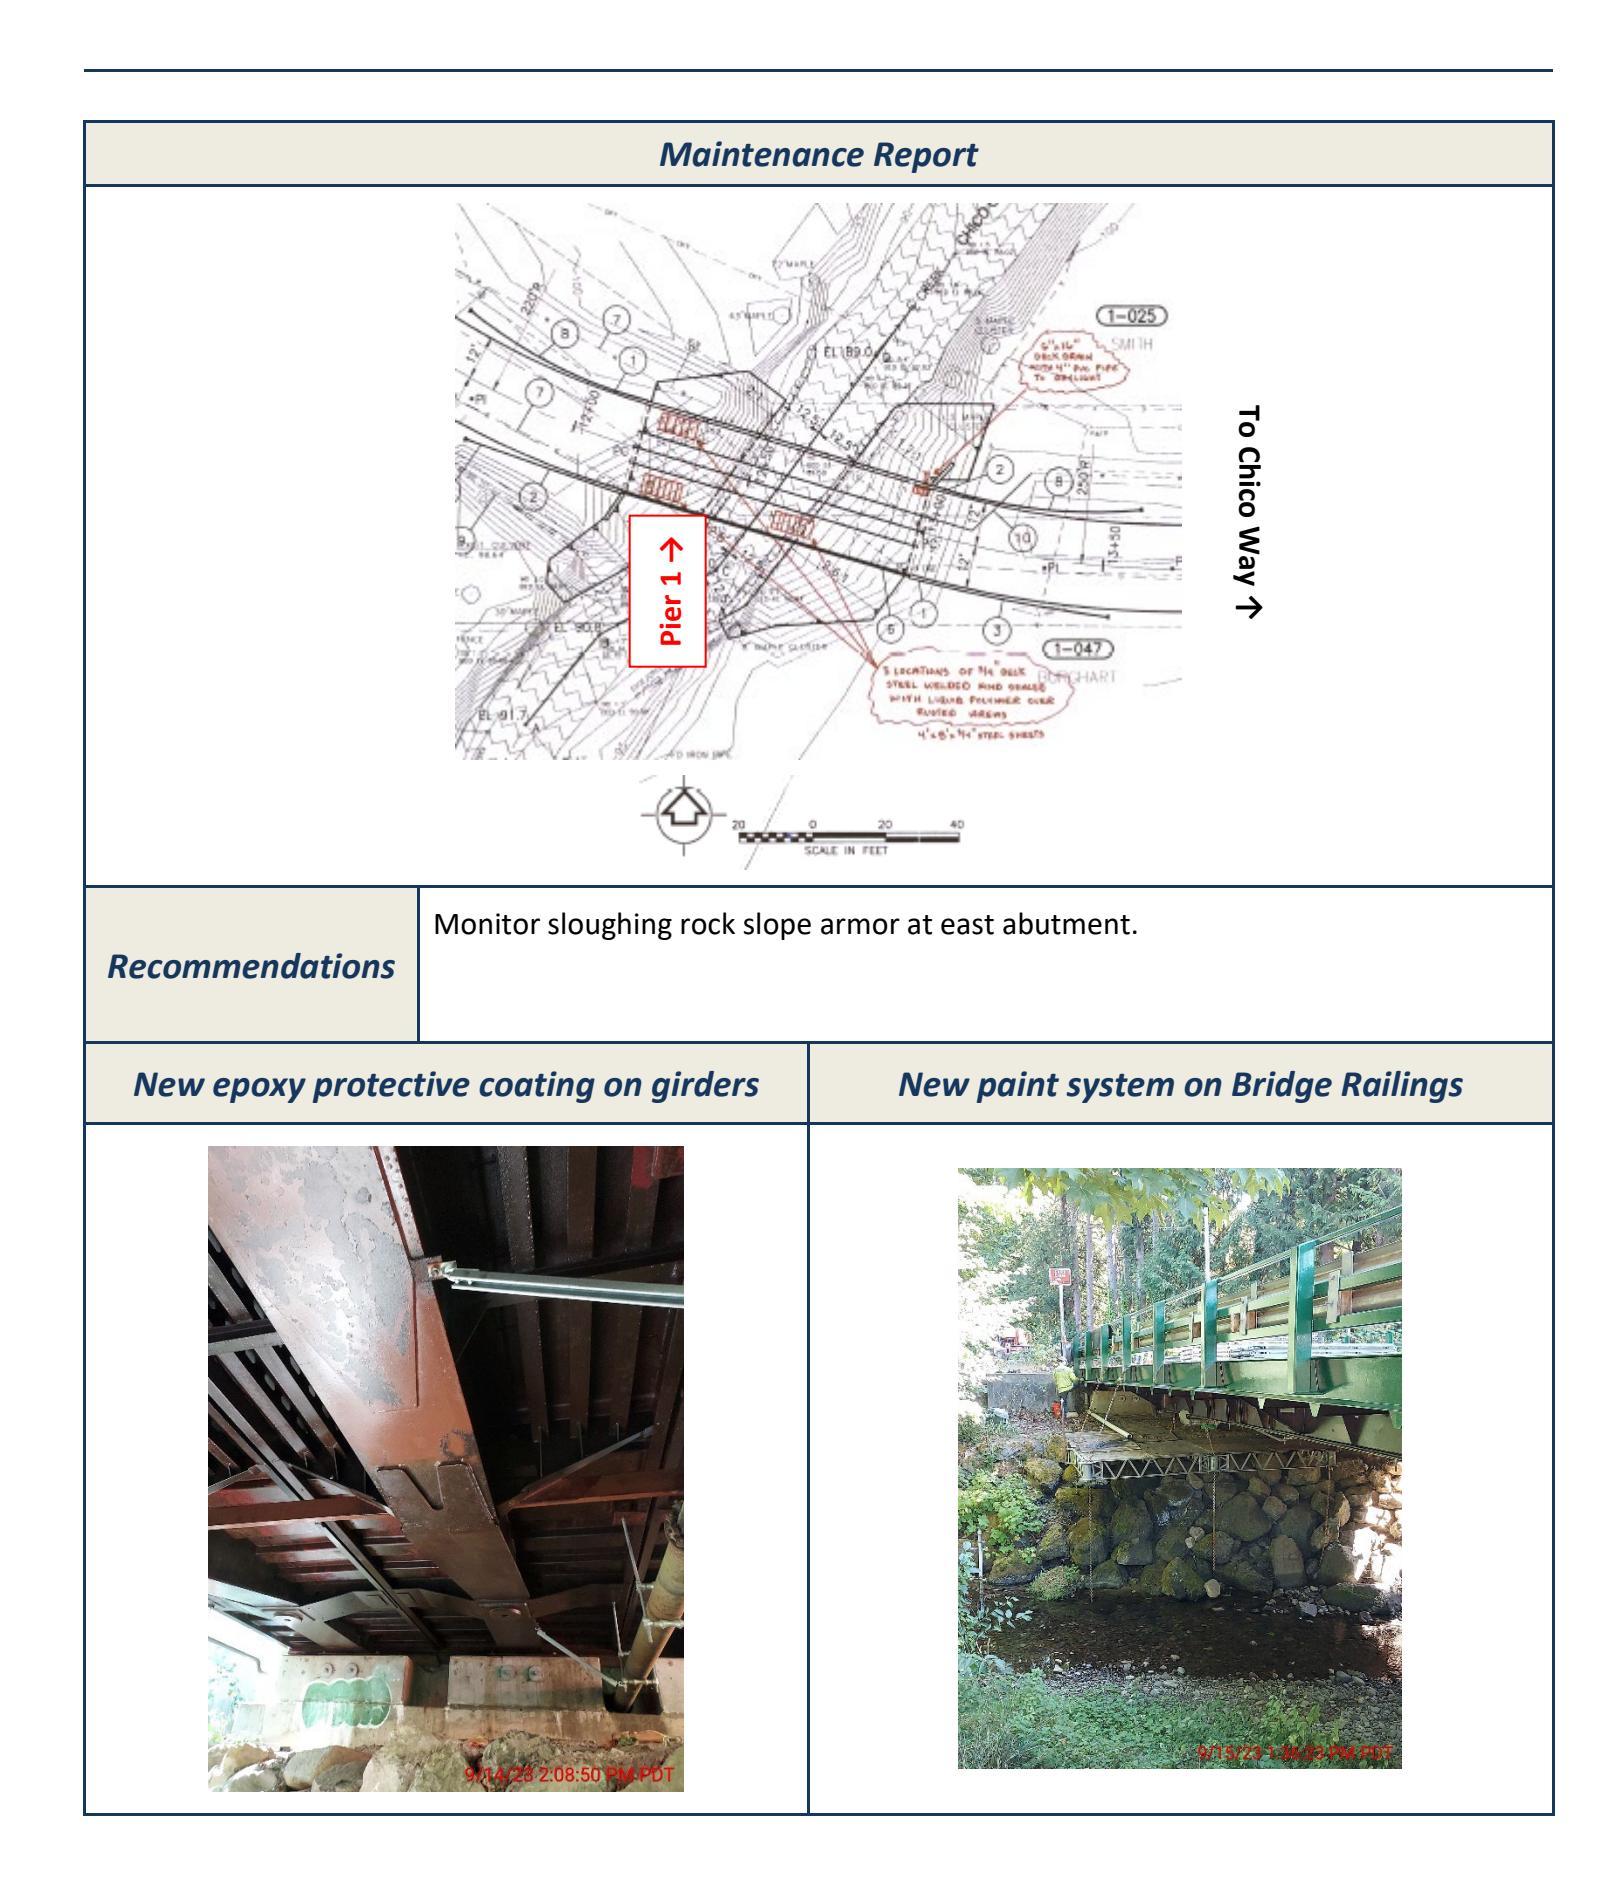
Girder	Stee supe	el box cars (railroad flats), 3 sections, 82' span in good condition. Steel erstructure had epoxy coating applied to underside in 2023.				
Superstructure	Deck	2.5- Nor of b cone	2.5-5" ACP overlay, thickness varies to provide average 1% slope from Sout North and West to East to CB at NE corner. New asphalt placed in 2023 as of bridge painting project. Steel deck of box cars was determined to be in a condition upon removal of existing ACP ad no repairs were warranted.				
	Other	Met raili	al bridge railing and elastomeric bearing pads in good condition. Bridge ngs were repainted in 2023.				
	Foundat	tion	Driven HP12x53 steel piles to approximately 30' in depth.				
Substructure	Abutments		Cast-in-place concrete abutment in good condition. Hairline cracks evident at grout pads at Pier 2 (east side joint). Bearing seats – 26".				
	Bridge has been load rated as per FHWA requirements TranTech Engineering in 2017. Bridge requires posting for the SU7 vehicle.

Scour and Load Rating	Scour analysis has not yet been performed for this structure. New bridge constructed in 2/2002 replacing a washed-out culvert. In December-2007 the west abutment was repaired, and upstream channel was realigned and armored with woody materials following the flood event.						
Photo		This bridge is scour critical.					
Bridge 25 – Taylor Bridge

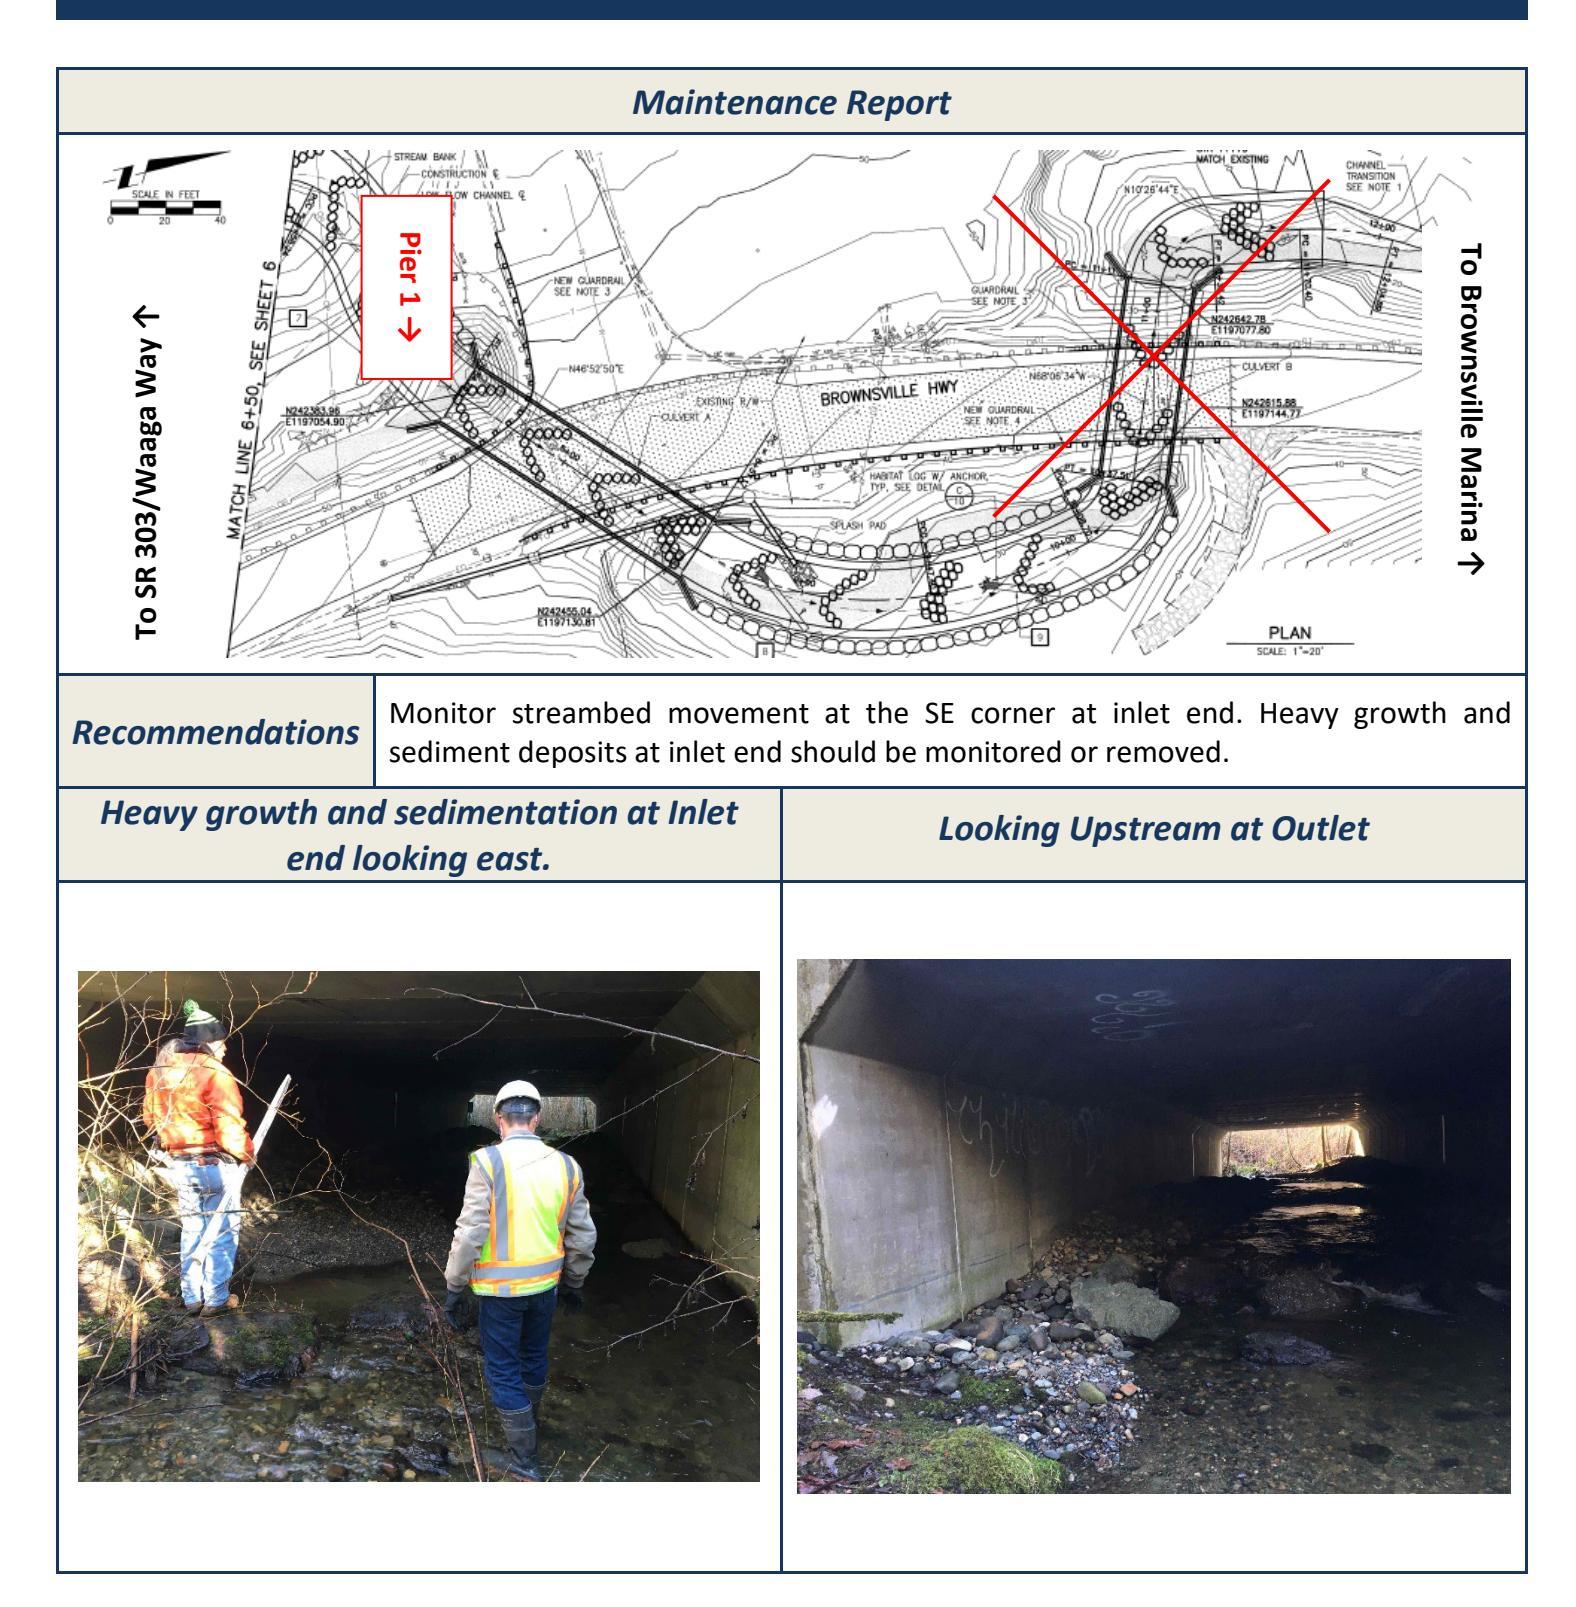
Bridge 29 – Gluds Pond South Culvert								
Brownsville Highway			eele Creek	2007	Good (G)	Jul. 14, 2022		
Route Name		Fec	Feature Intersected Year Built Overall Condition Last Inspec			Last Inspection		
Superstructure	Culvert	3-s ef	sided Precast Conc florescence presen	ided Precast Concrete Culvert unit in good condition. Minor moisture and lorescence present in all seams.				
Substructure	Founda	tion	Precast Concrete Spread Footings. No signs of settlement or movement. Flow meter was installed at outlet end at the NW corner. Inlet flows are concentrated at Pier 1 corner with no exposure of the footing at this time. Flow is redirected to center of span through structure to outlet.					
Scour and Load Rating	In 2018 it excess of Scour and come apa This bridg	In 2018 it was determined by TranTech Engineering that this structure has sufficient fill, in excess of 8' and does not require a load rating. Scour analysis has not yet been performed for this structure. Upstream rock weirs have come apart and are lying in the channel.

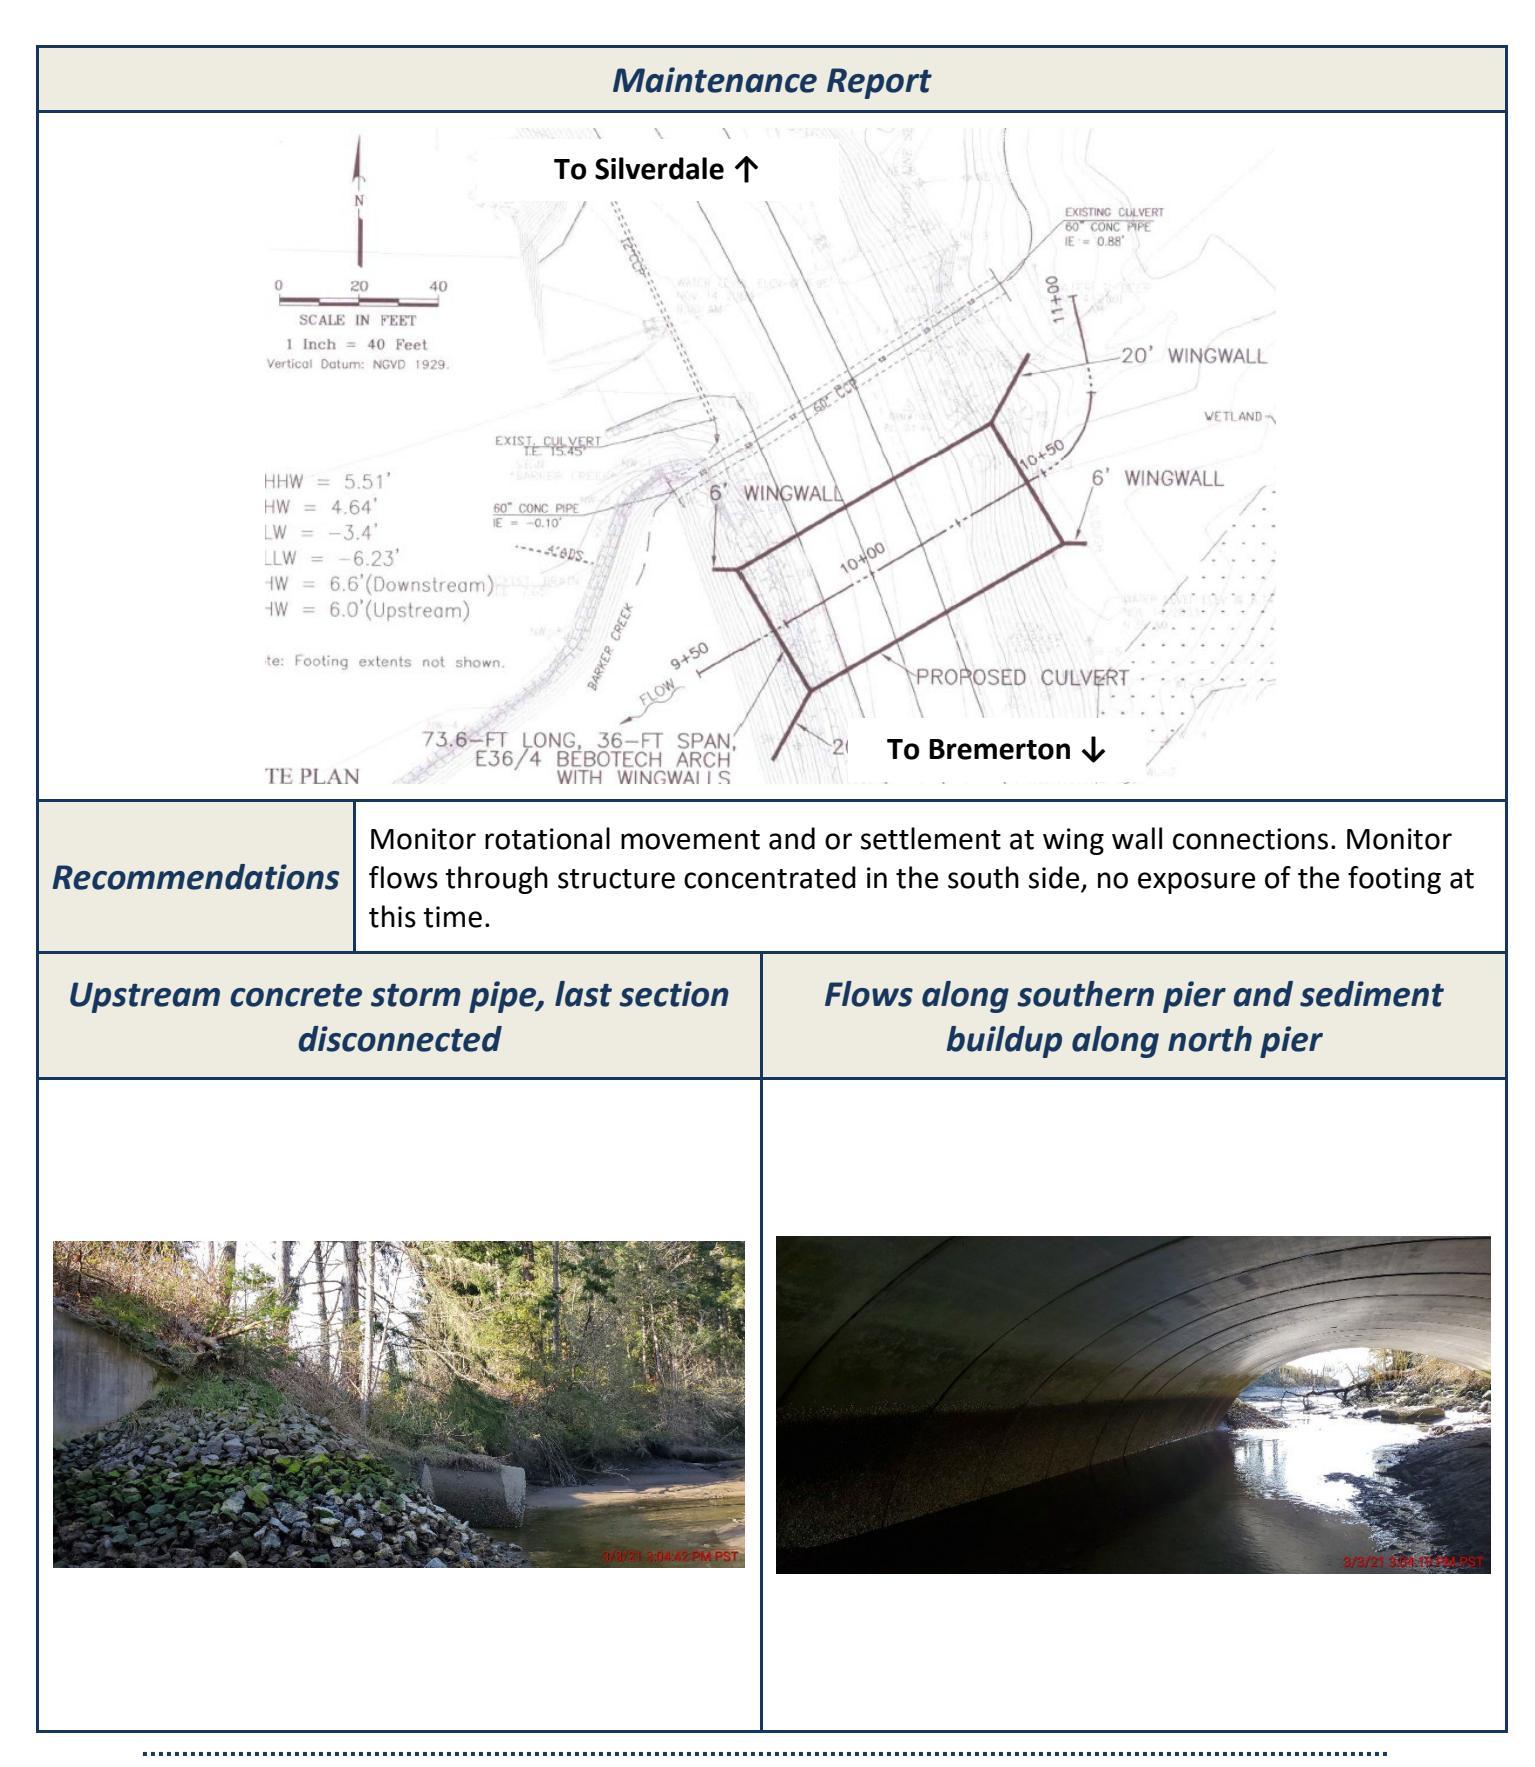
Bridge 32 – Barker Culvert						
Tracyton Boule	evard	Barker Creek	2008	Good (G)	Aug. 24, 2022	
Route Name		Feature Intersected	Year Built	Overall Condition	Last Inspection	
		1				
Superstructure	Culvert	Ivert Precast concrete arch culvert with precast MSE wing walls in good cond Several joints between wing wall and headwall showing signs of rotat movement or settlement: Previous measurements at NE corner is 1 ¼" previous measurements at SE corner has 2" horizontal and vertical mover current measurement at SW corner has 2" movement horizontal with headwall tipped.				
Substructure	Foundati	on Cast-in-place foot	tings with rebar r	einforcement. Arch s	eat is 1.5' wide.	
Scour and Load Rating	In 2018 it v excess of 8 for this stru	In 2018 it was determined by TranTech Engineering that this structure has sufficient fill, in excess of 8' and does not require a load rating. Scour analysis has not yet been performed for this structure.
