HANSVILLE WETLAND RESTORATION PLAN BASELINE REPORT

HANSVILLE, Kitsap County, Washington

Wiltermood Associates, Inc.
1015 SW Harper Road
Port Orchard, WA 98367
(360) 876-2403

July 28, 1997

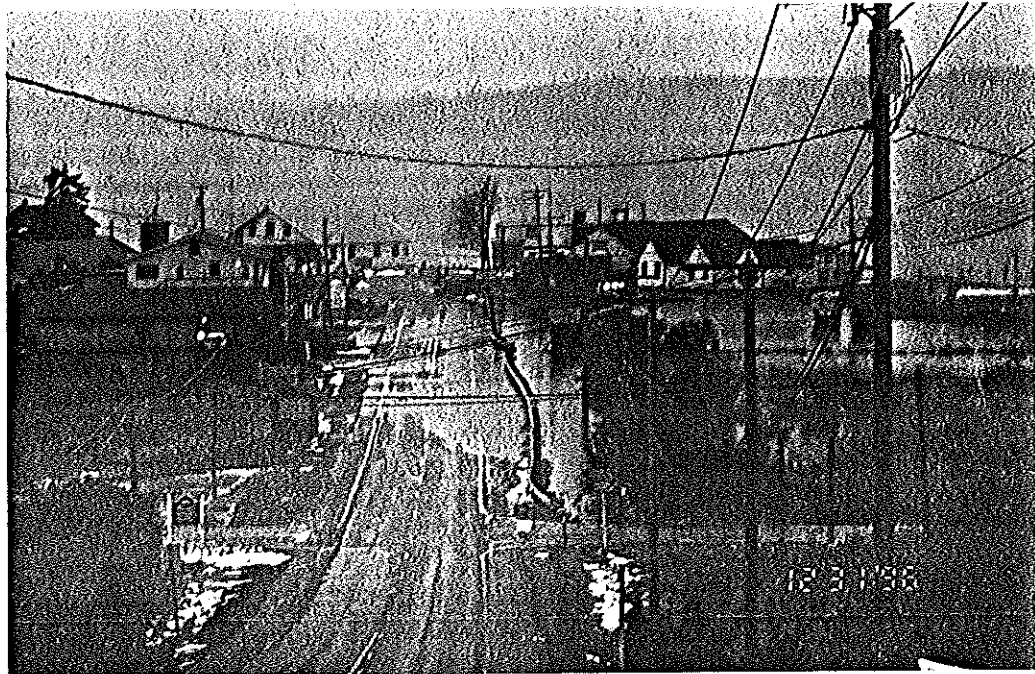
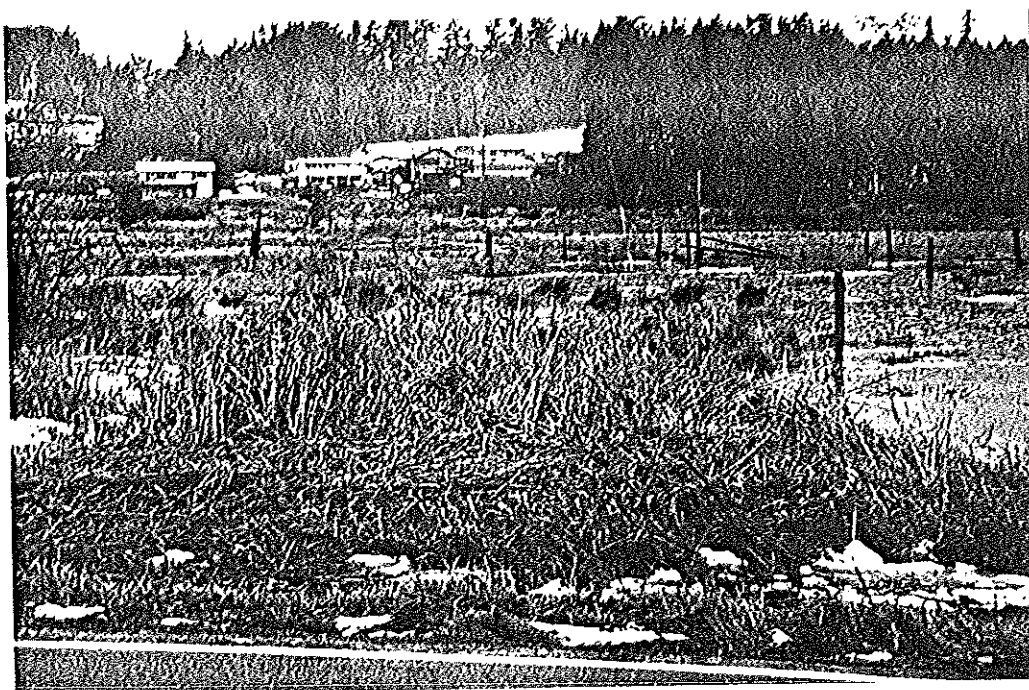
This photo was taken looking north from the top of the hill along Hansville Road. Note that the area east of the road is full of water and that water flows across the road into the Hansville wetland north of the tall building in the background.

This photo was taken looking south from Twin Spits Road into the Hansville Wetland to document the presence of standing water during the flood and tide event. Much of the area in the background did not contain obvious standing water in additional photos of the area.
