INFORMAL BID 2023-044

Kitsap County Parks Department

Demolition of Houses and Removal of Materials located at 4 Properties within Kitsap County Park Facilities located at:

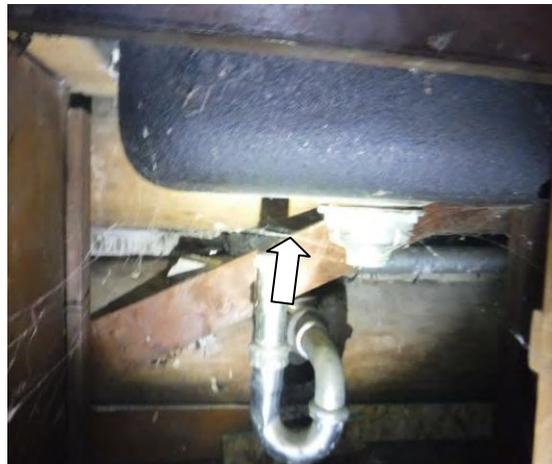
In summary, the survey and laboratory results revealed approximately 10 square feet of black sink undercoating, found on underside of the metal sink in the Kitchen, contained 3% chrysotile asbestos.

Photo: Black Sink Undercoating in Kitchen:

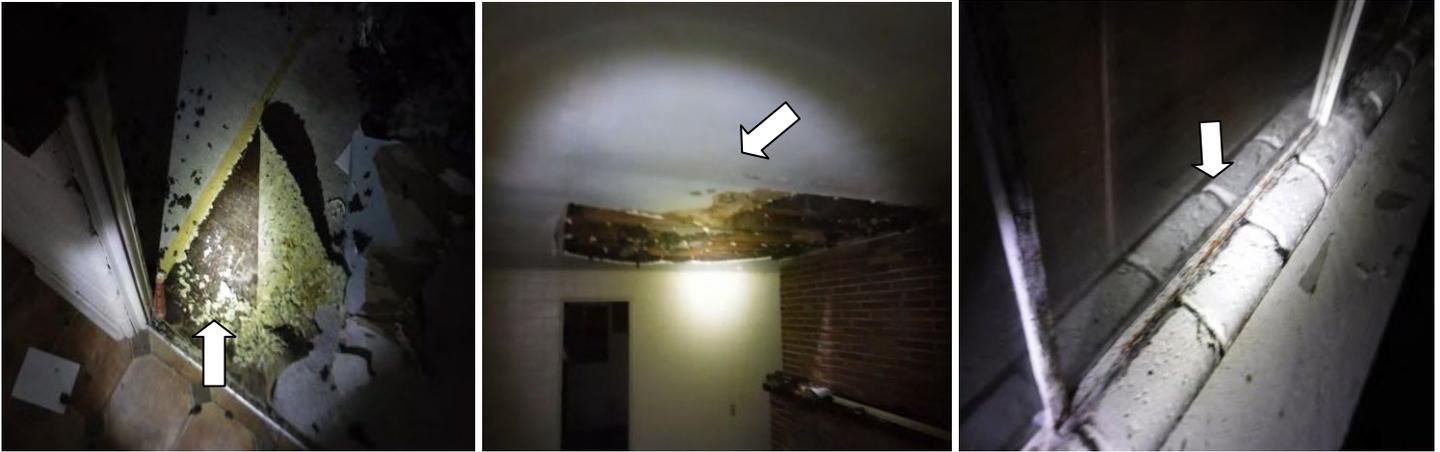
- A) Approximately 800 square feet in total of **brown with yellow-streaks and/or green 9-inch by 9-inch VCT flooring**, as found concealed under carpet throughout the Living Room and Dining Room, as well as concealed under newer vinyl flooring layers in the Kitchen and Bathroom, **contained 4% to 5% chrysotile asbestos in the 9” x 9” VCT layer.**

- B) Approximately 20 to 50 lineal feet *per window* of **white-painted window glazing**, found on metal-framed windows throughout the house **contained 13% chrysotile asbestos**.
- C) Approximately 1,200 square feet of **light blue-painted GWB with skim coat**, found on the ceilings throughout, **contained 3% chrysotile asbestos in the skim coat layer**.

Photos 1-3: Representative Photos of Concealed 9x9 VCT as Found in Living Room, Kitchen, and Bathroom (L), GWB Ceiling System, as Found Throughout (C), and White-Painted Window Glazing as Found on Metal-Framed Windows throughout the Dwelling (R):

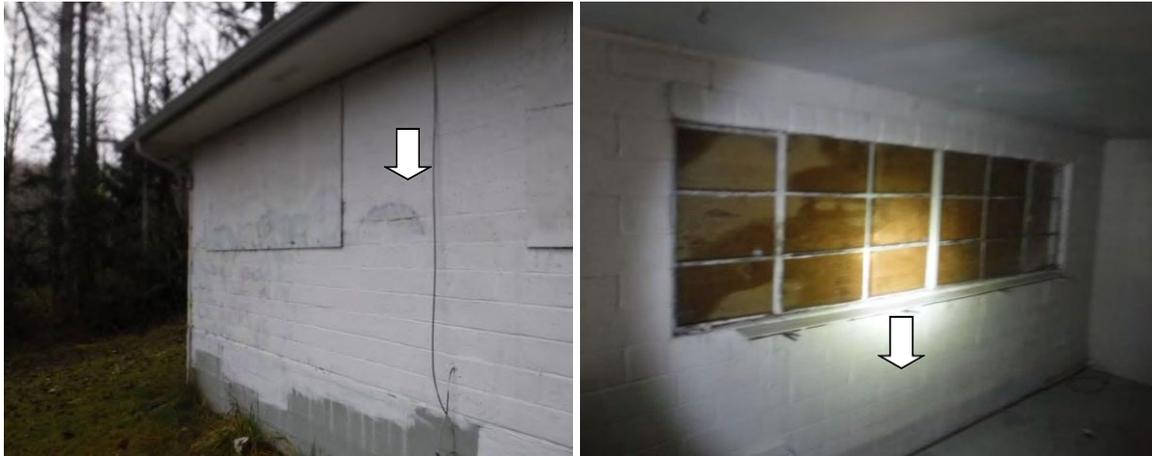
1. Concrete Foundation walls and Patios, as found at the building exterior.
2. Concrete masonry unit (CMU) bricks and mortar, comprising the exterior building walls and the majority of interior walls.
3. Brick masonry and associated grout and mortar, comprising the fireplace and chimney.

Photos 4-5: Painted CMU Walls with Mortar at Exterior and Interior of Residence (R):
