# **Historic Resources Report**

# **PORT GAMBLE REDEVELOPMENT PROJECT EIS**

*HISTORIC PROPERTIES*

*TECHNICAL REPORT*

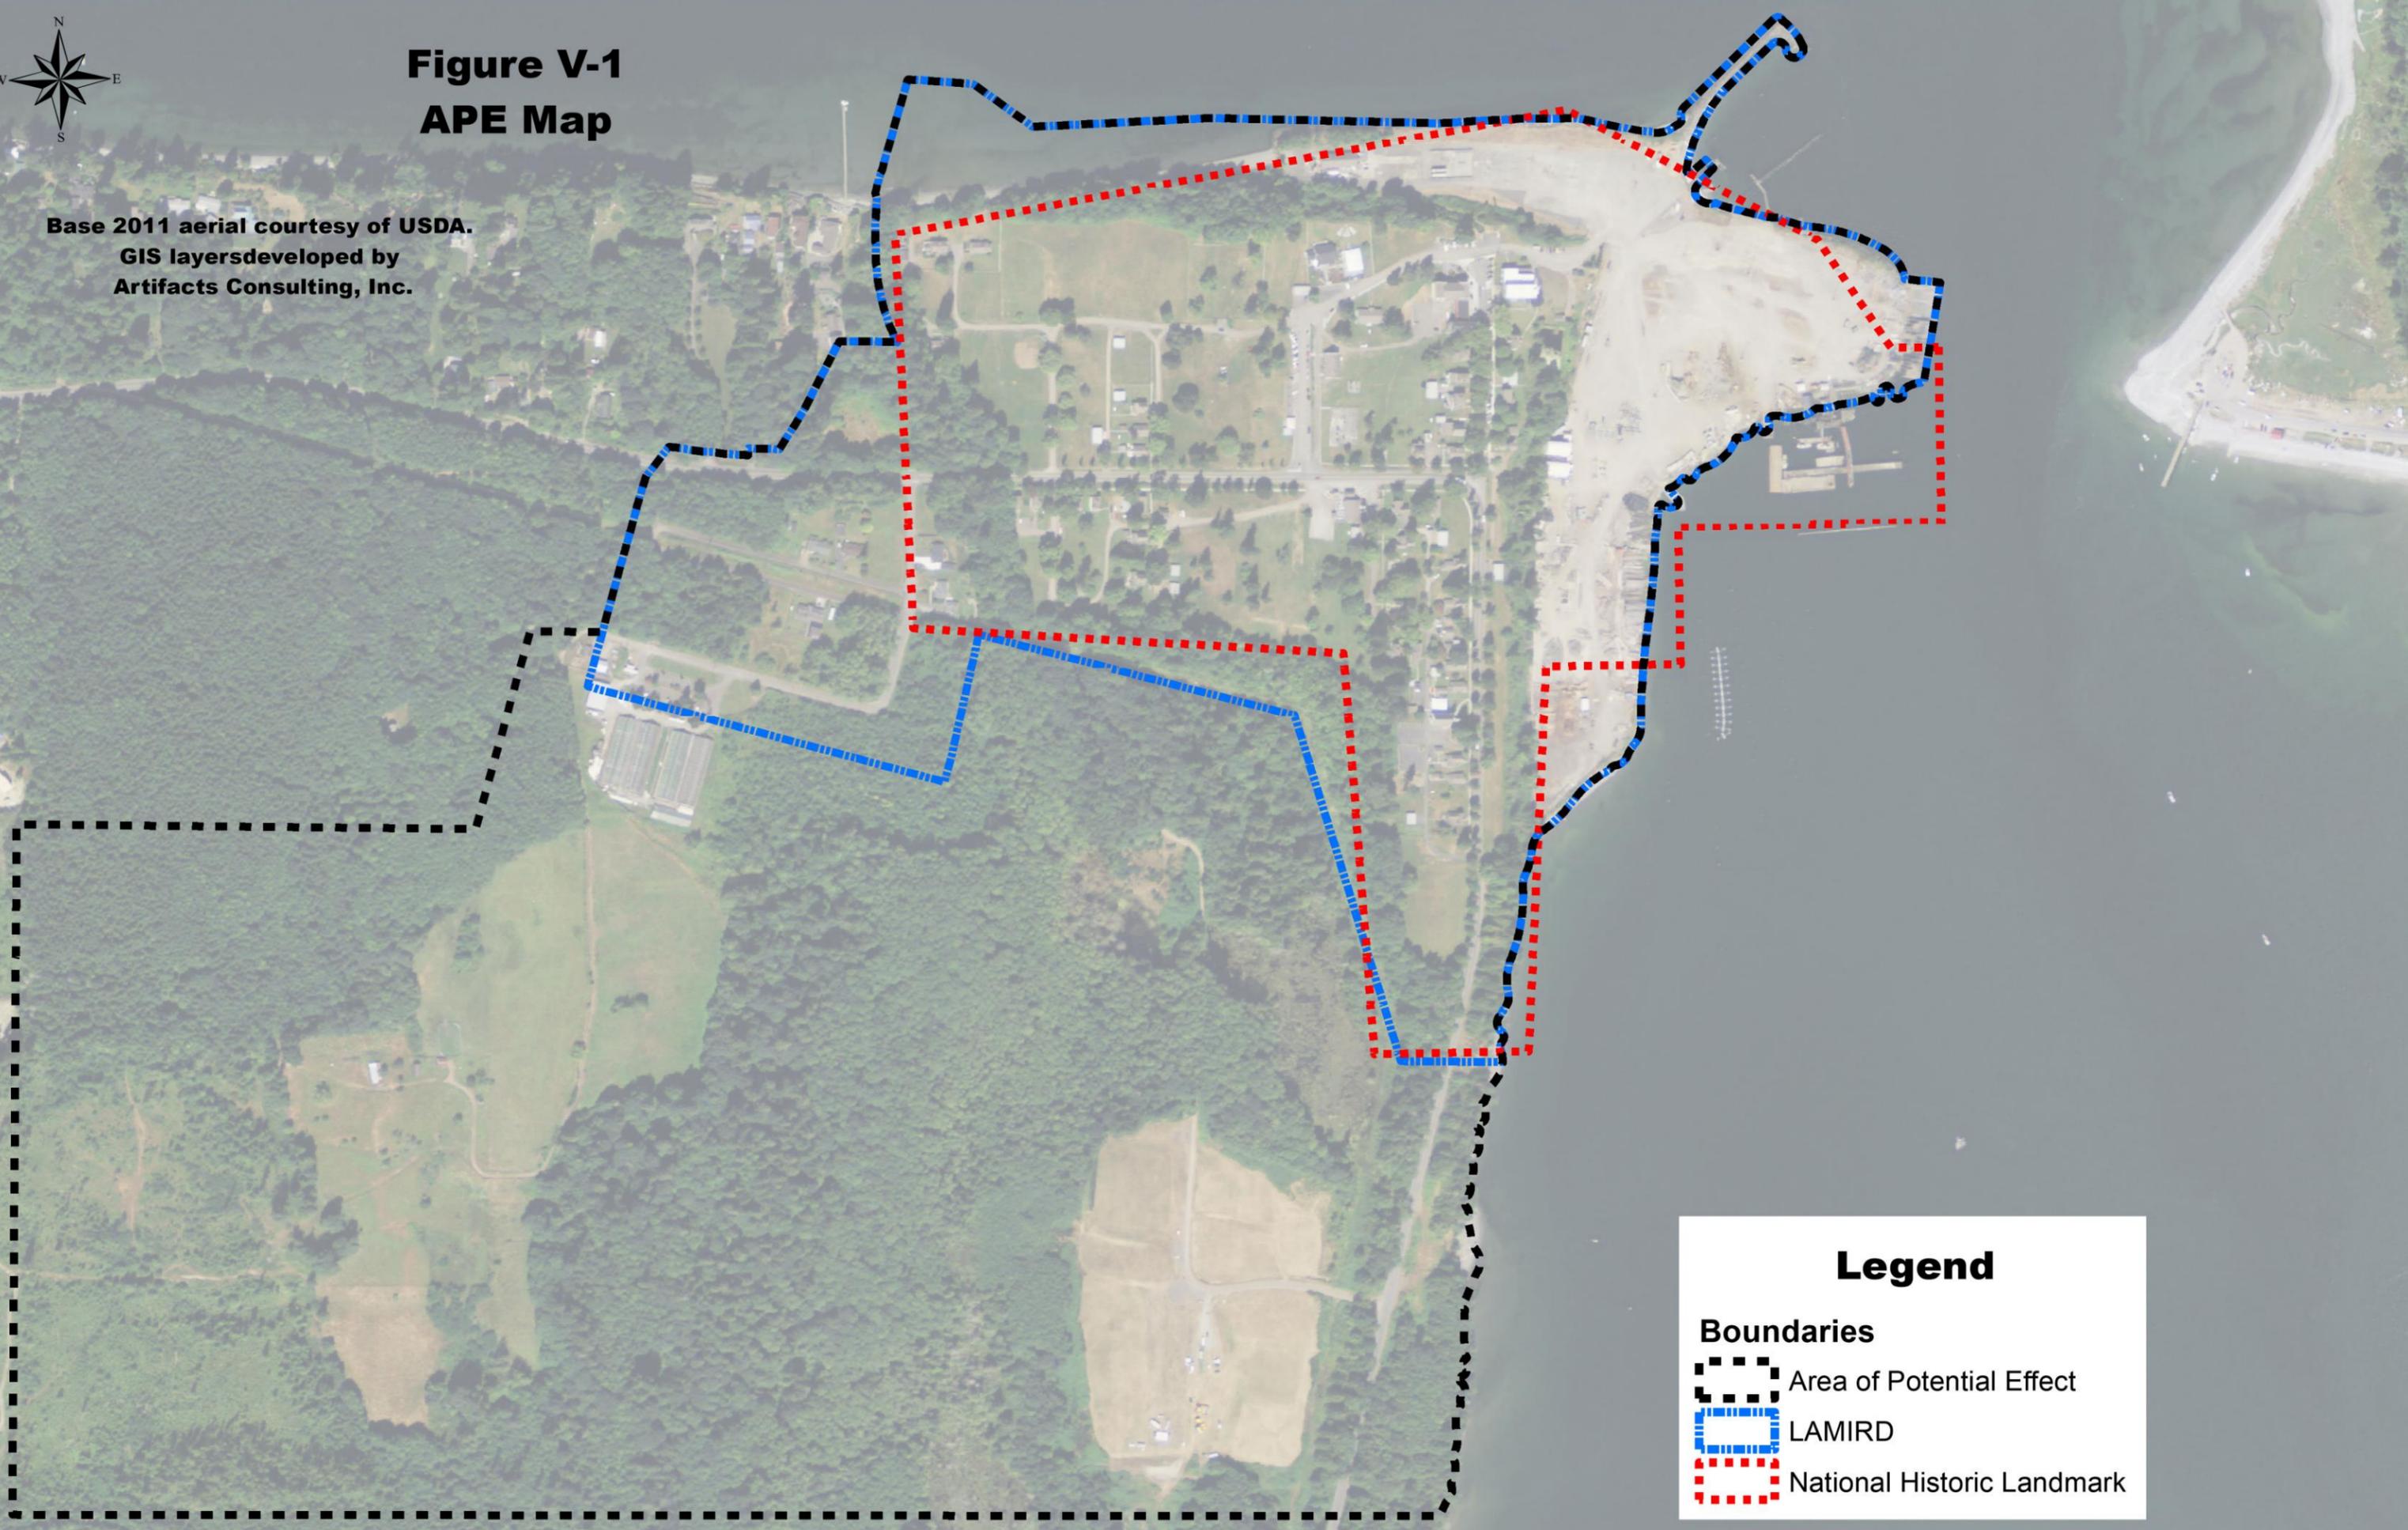
**Figure V-1  
APE Map**

Base 2011 aerial courtesy of USDA.  
GIS layers developed by  
Artifacts Consulting, Inc.

This survey identifies all known historic properties fifty years or older within the Area of Potential Effect (APE) (see **Figure V-1, APE Map**). The APE is the same as the Port Gamble Redevelopment Project site boundary. Artifacts Consulting, Inc. (Artifacts) completed Historic Property Inventory (HPI) forms for each listed and unlisted property over fifty years of age. (See **Section V, Maps, References, HPI Forms**, for PDF copies) On behalf of Kitsap County, Artifacts will submit these forms digitally to the Washington State Department of Archaeology and Historic Preservation (DAHP) for review.

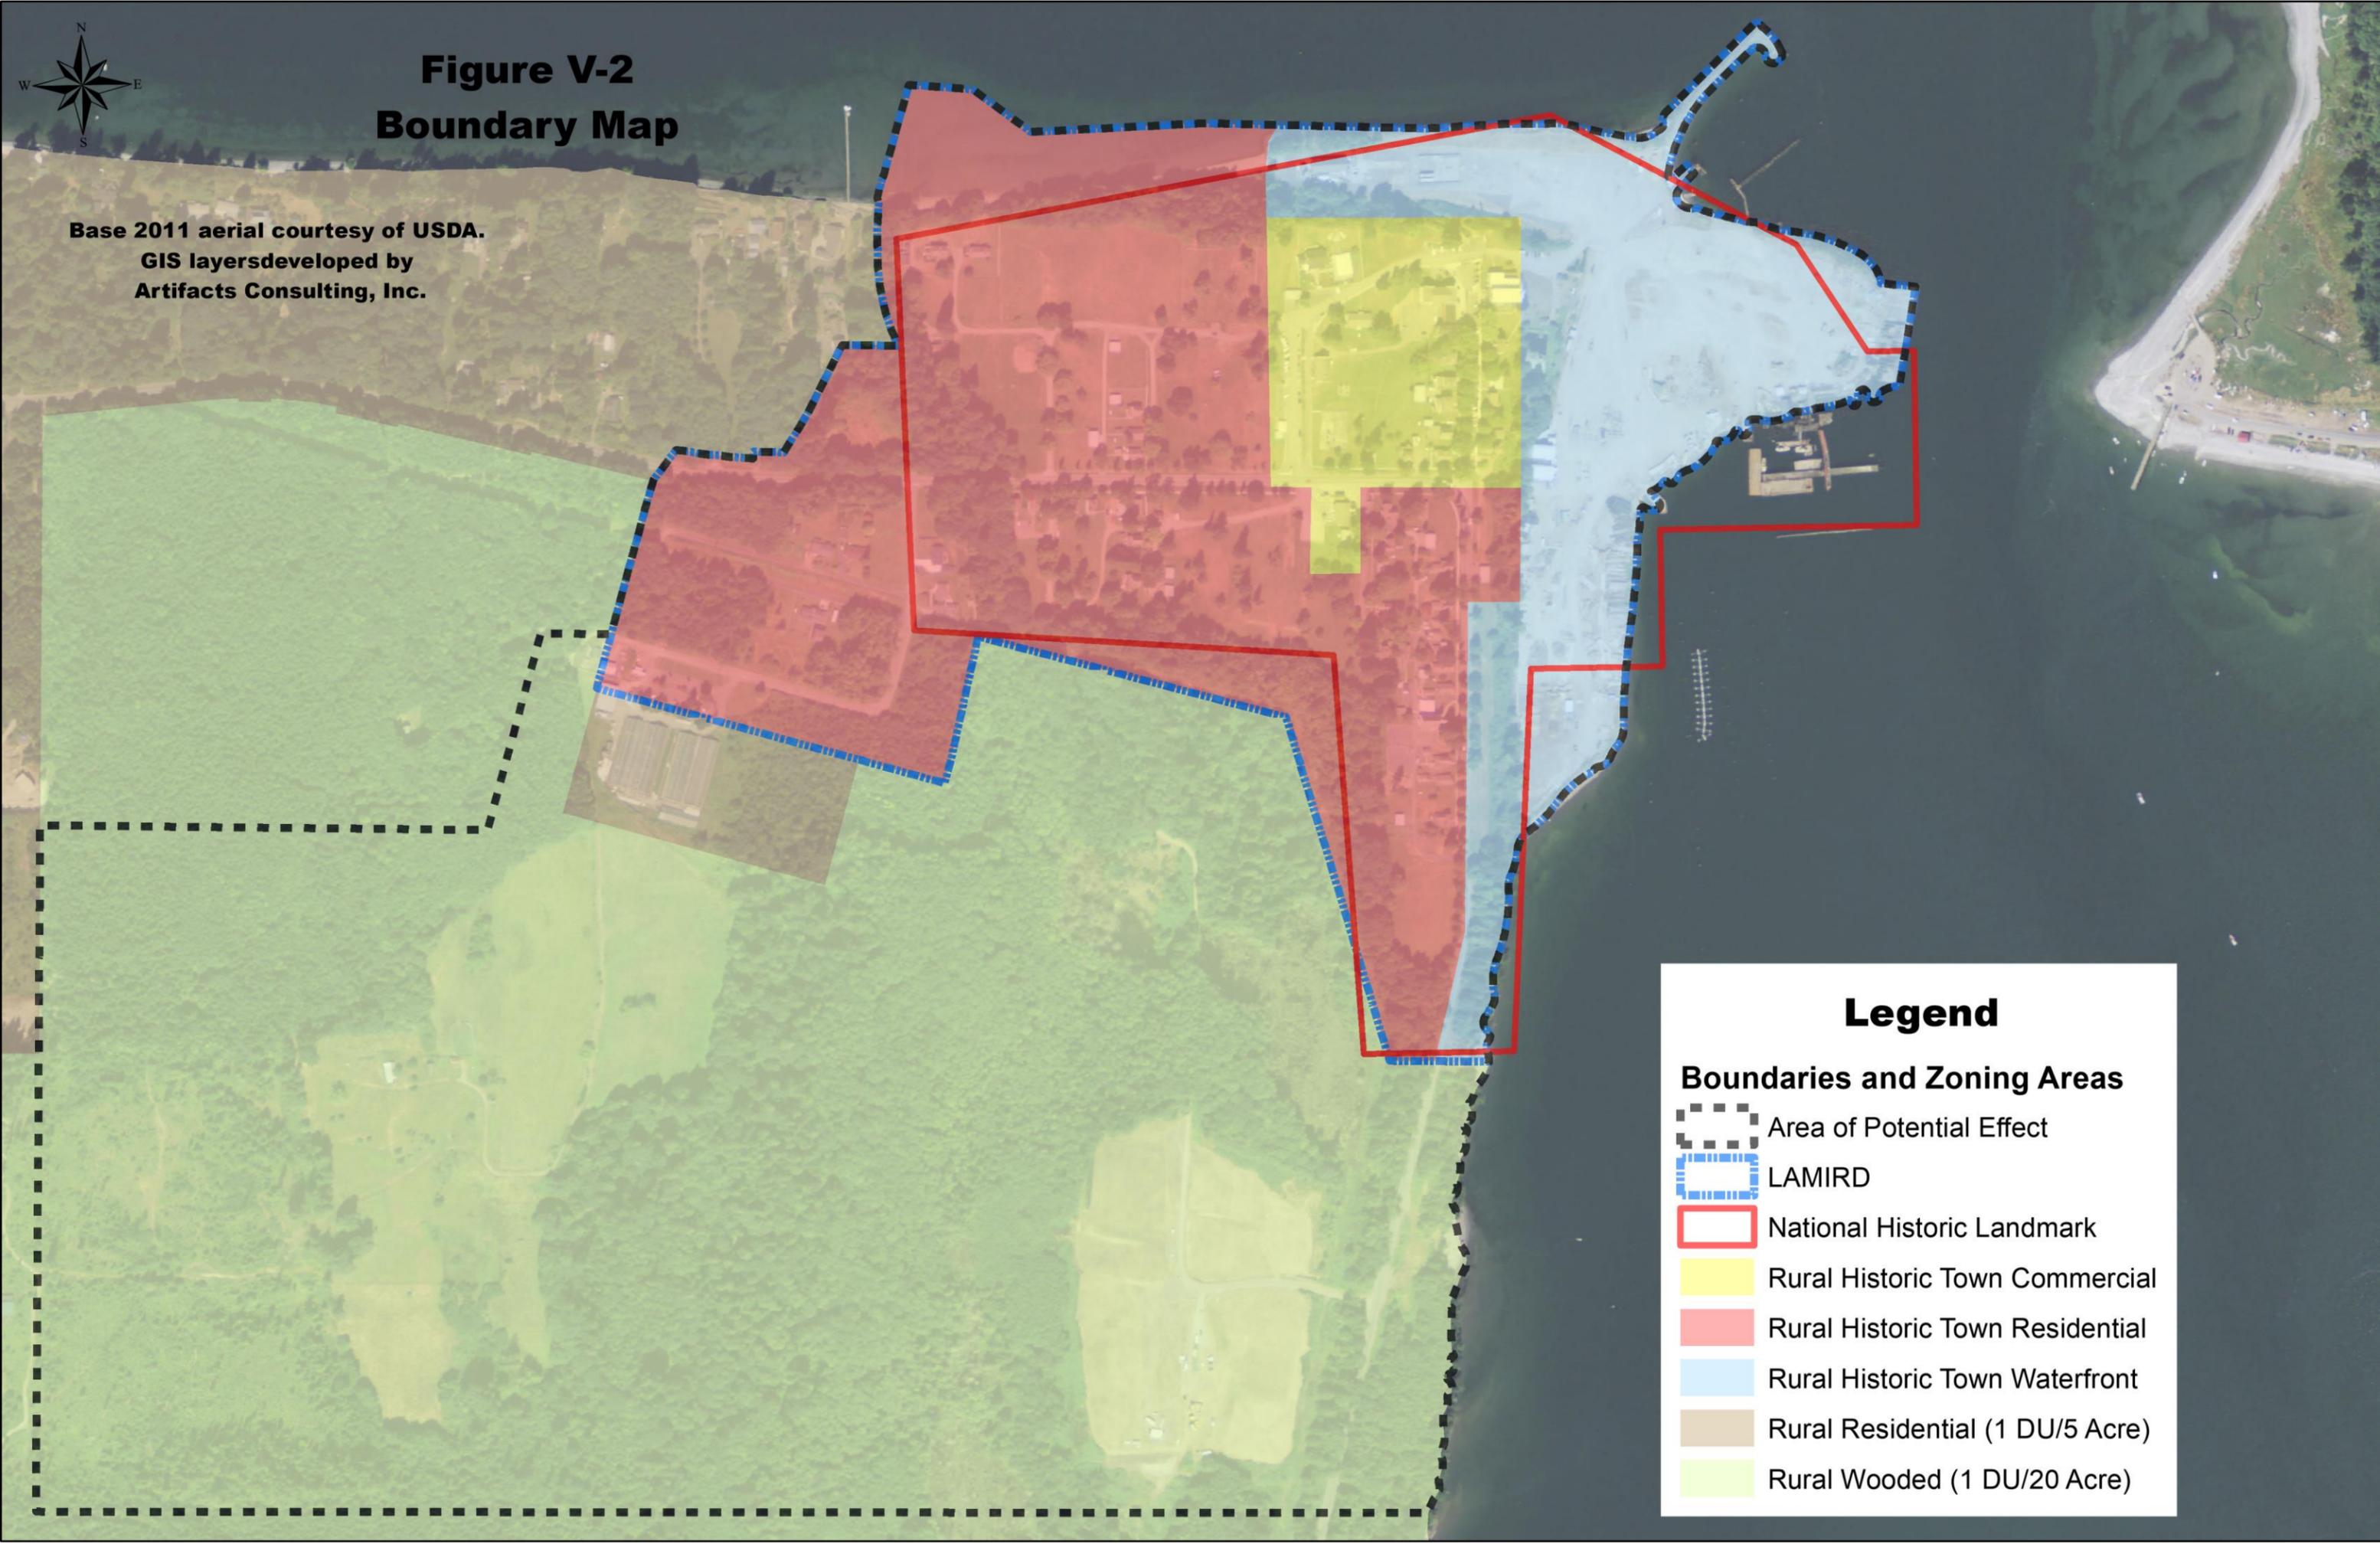
**Figure V-2  
Boundary Map**

Base 2011 aerial courtesy of USDA.  
GIS layers developed by  
Artifacts Consulting, Inc.

The study and organization of assessment data for the Port Gamble Redevelopment site is framed around properties within the Port Gamble National Historic Landmark district and those outside of the district. Underlying this are zoning designations defined by the Kitsap County Comprehensive Plan. In some cases, such as the Rural Historic Town Residential area, the zoning overlaps the Port Gamble National Historic Landmark district and areas outside the historic district. (See **Figure V-2, Boundary Map**, for additional detail).

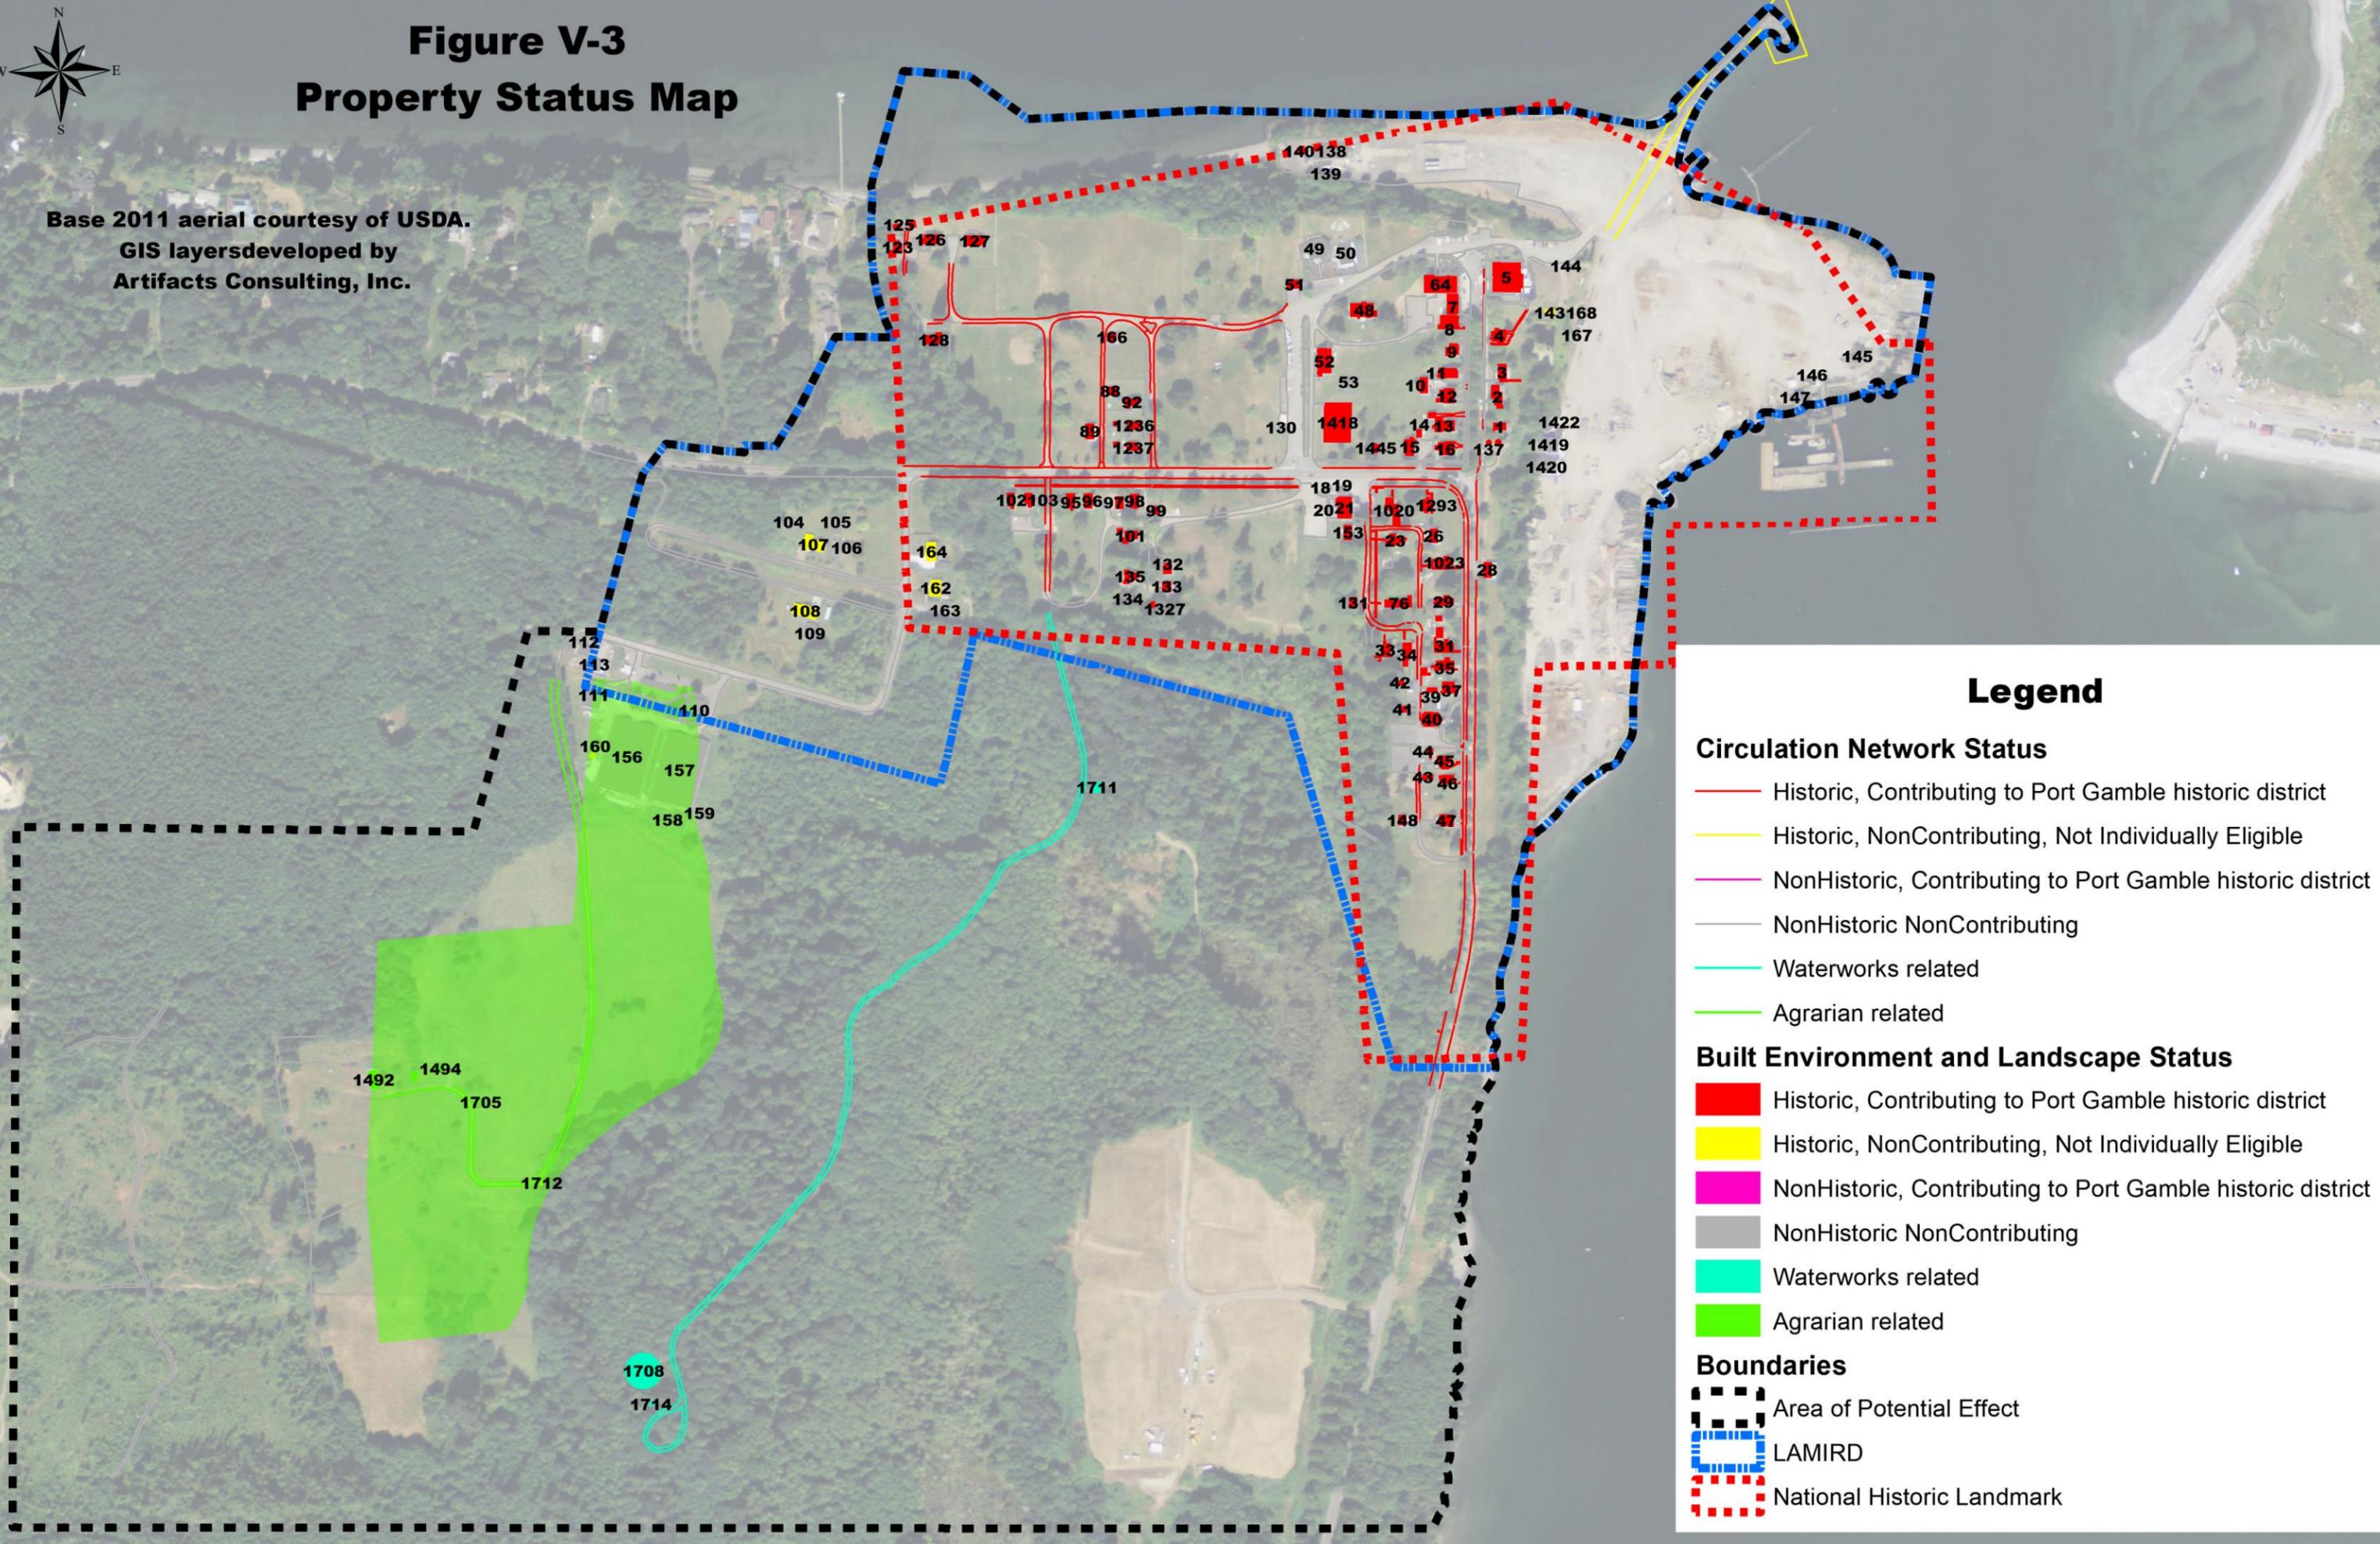
**Figure V-3  
Property Status Map**

Base 2011 aerial courtesy of USDA.  
GIS layers developed by  
Artifacts Consulting, Inc.

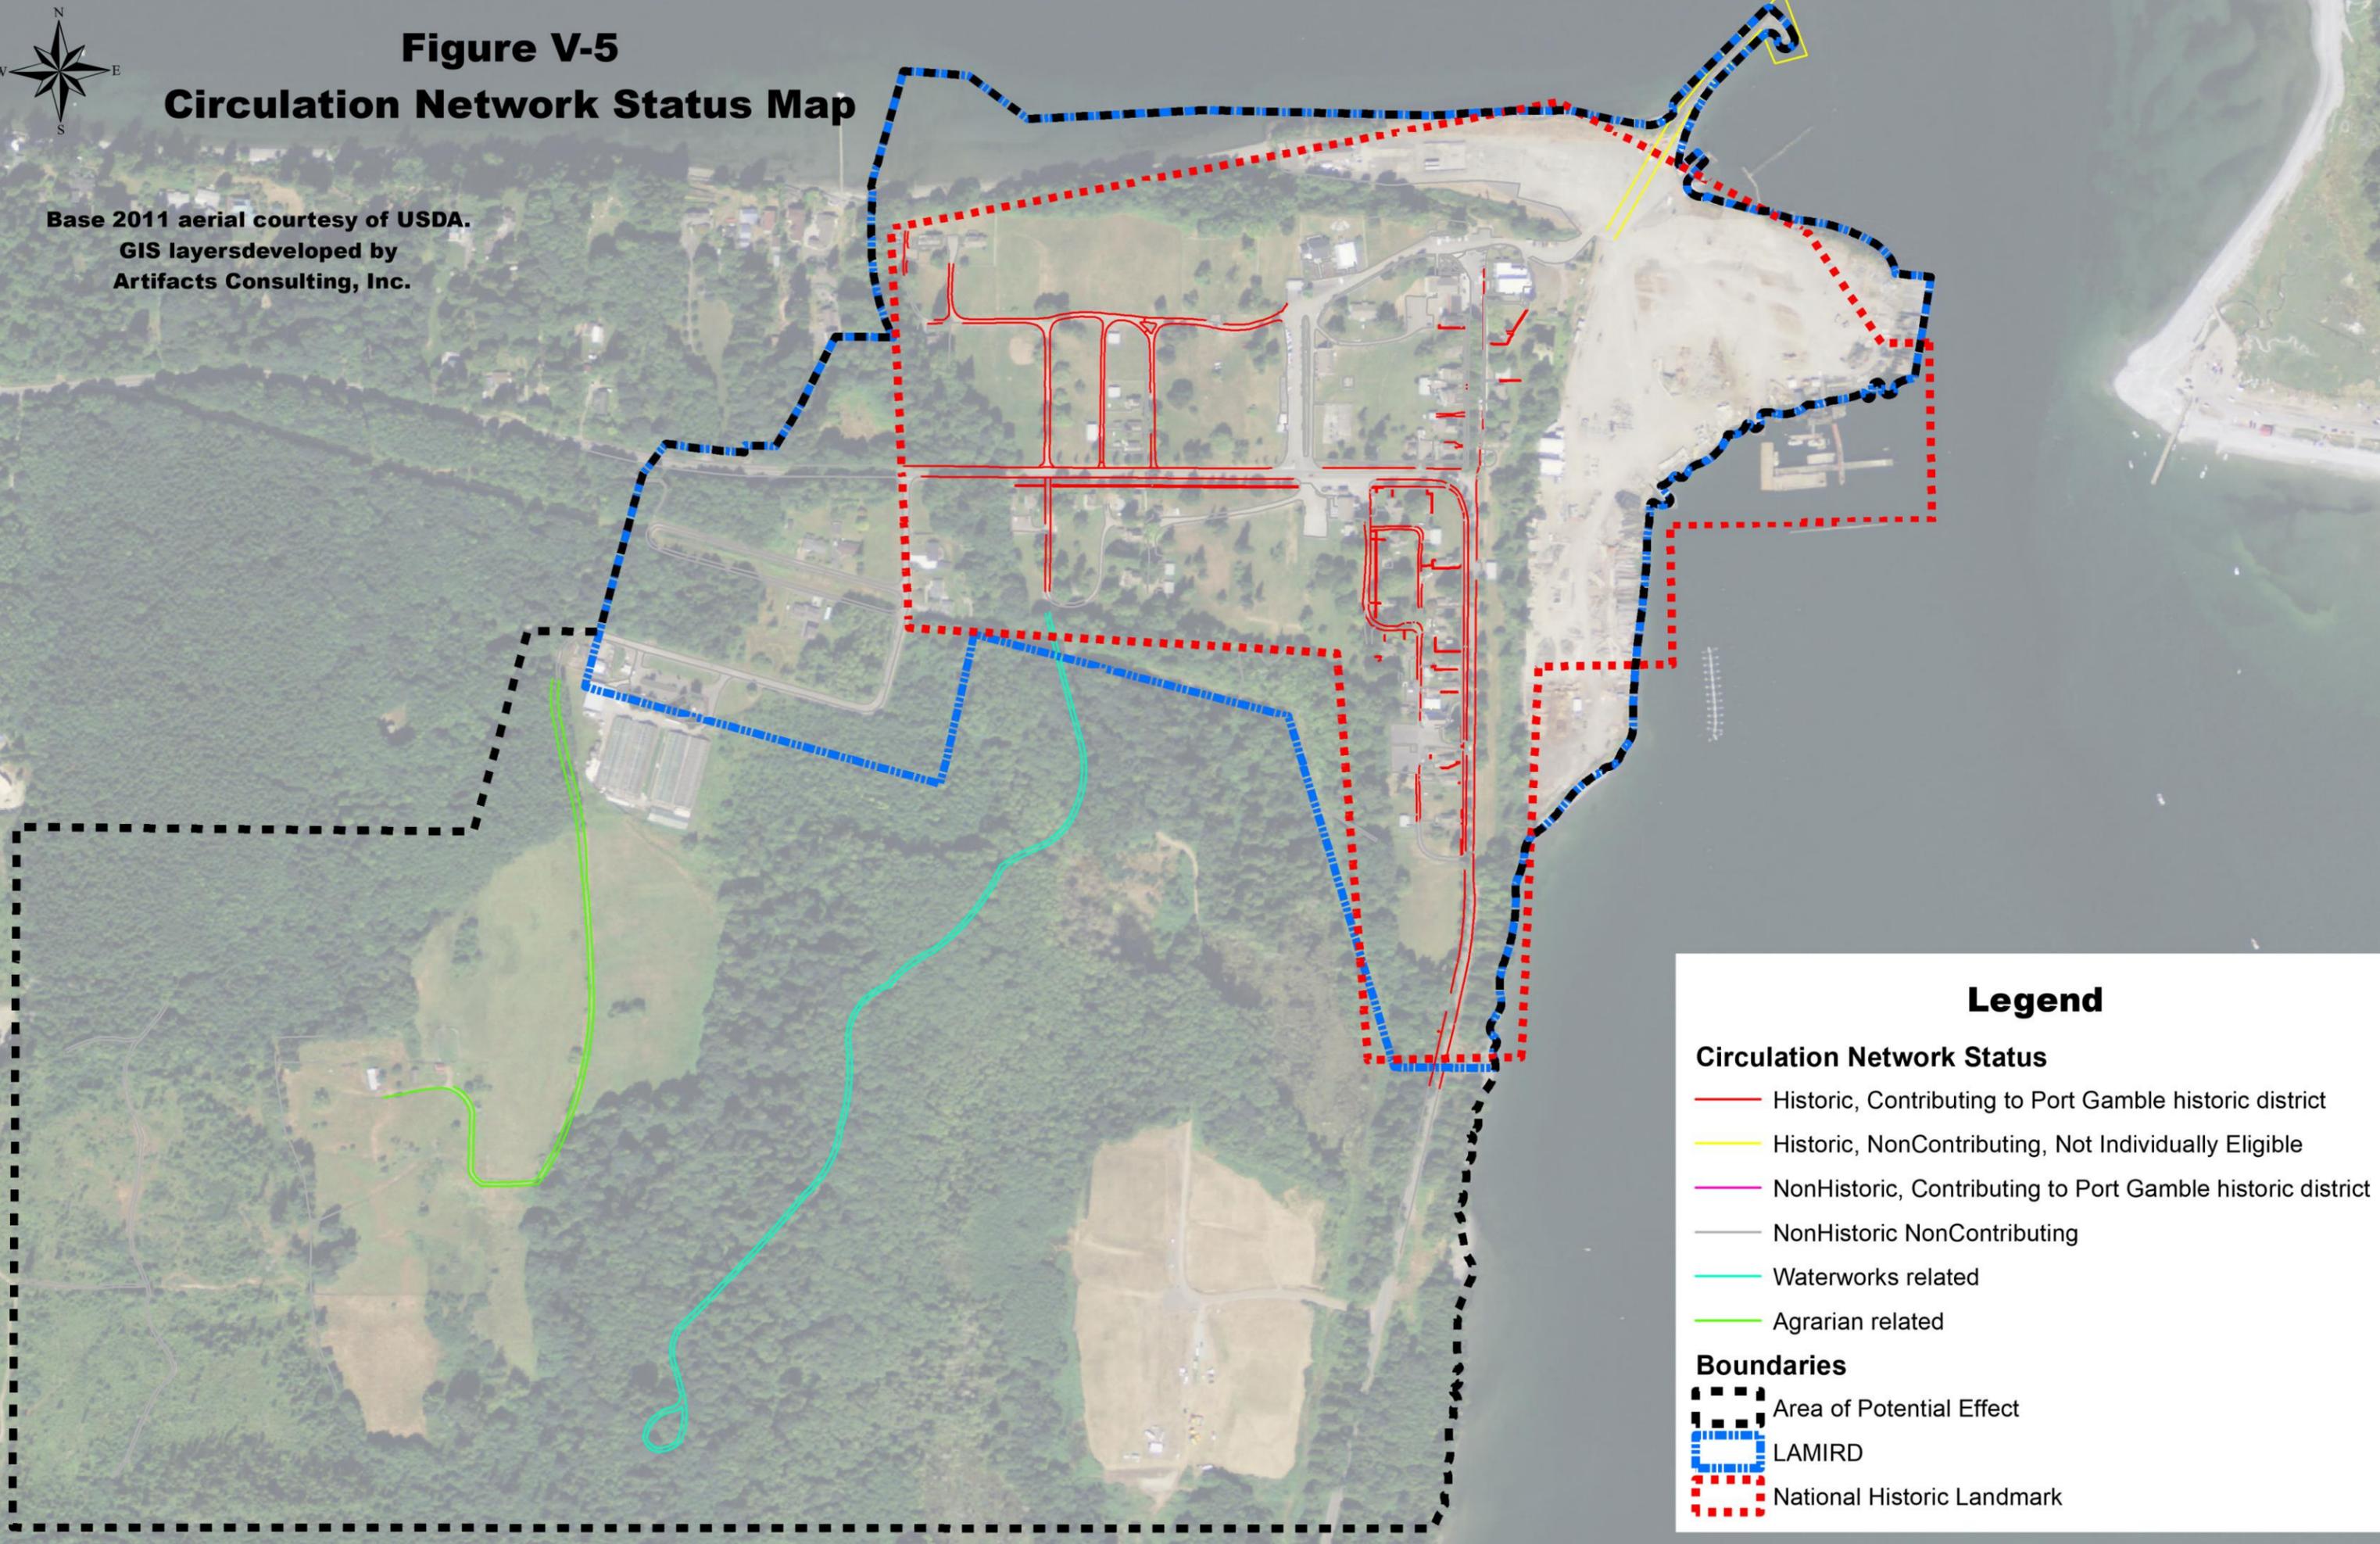
**Circulation Network Status Map**

Base 2011 aerial courtesy of USDA.  
GIS layers developed by  
Artifacts Consulting, Inc.

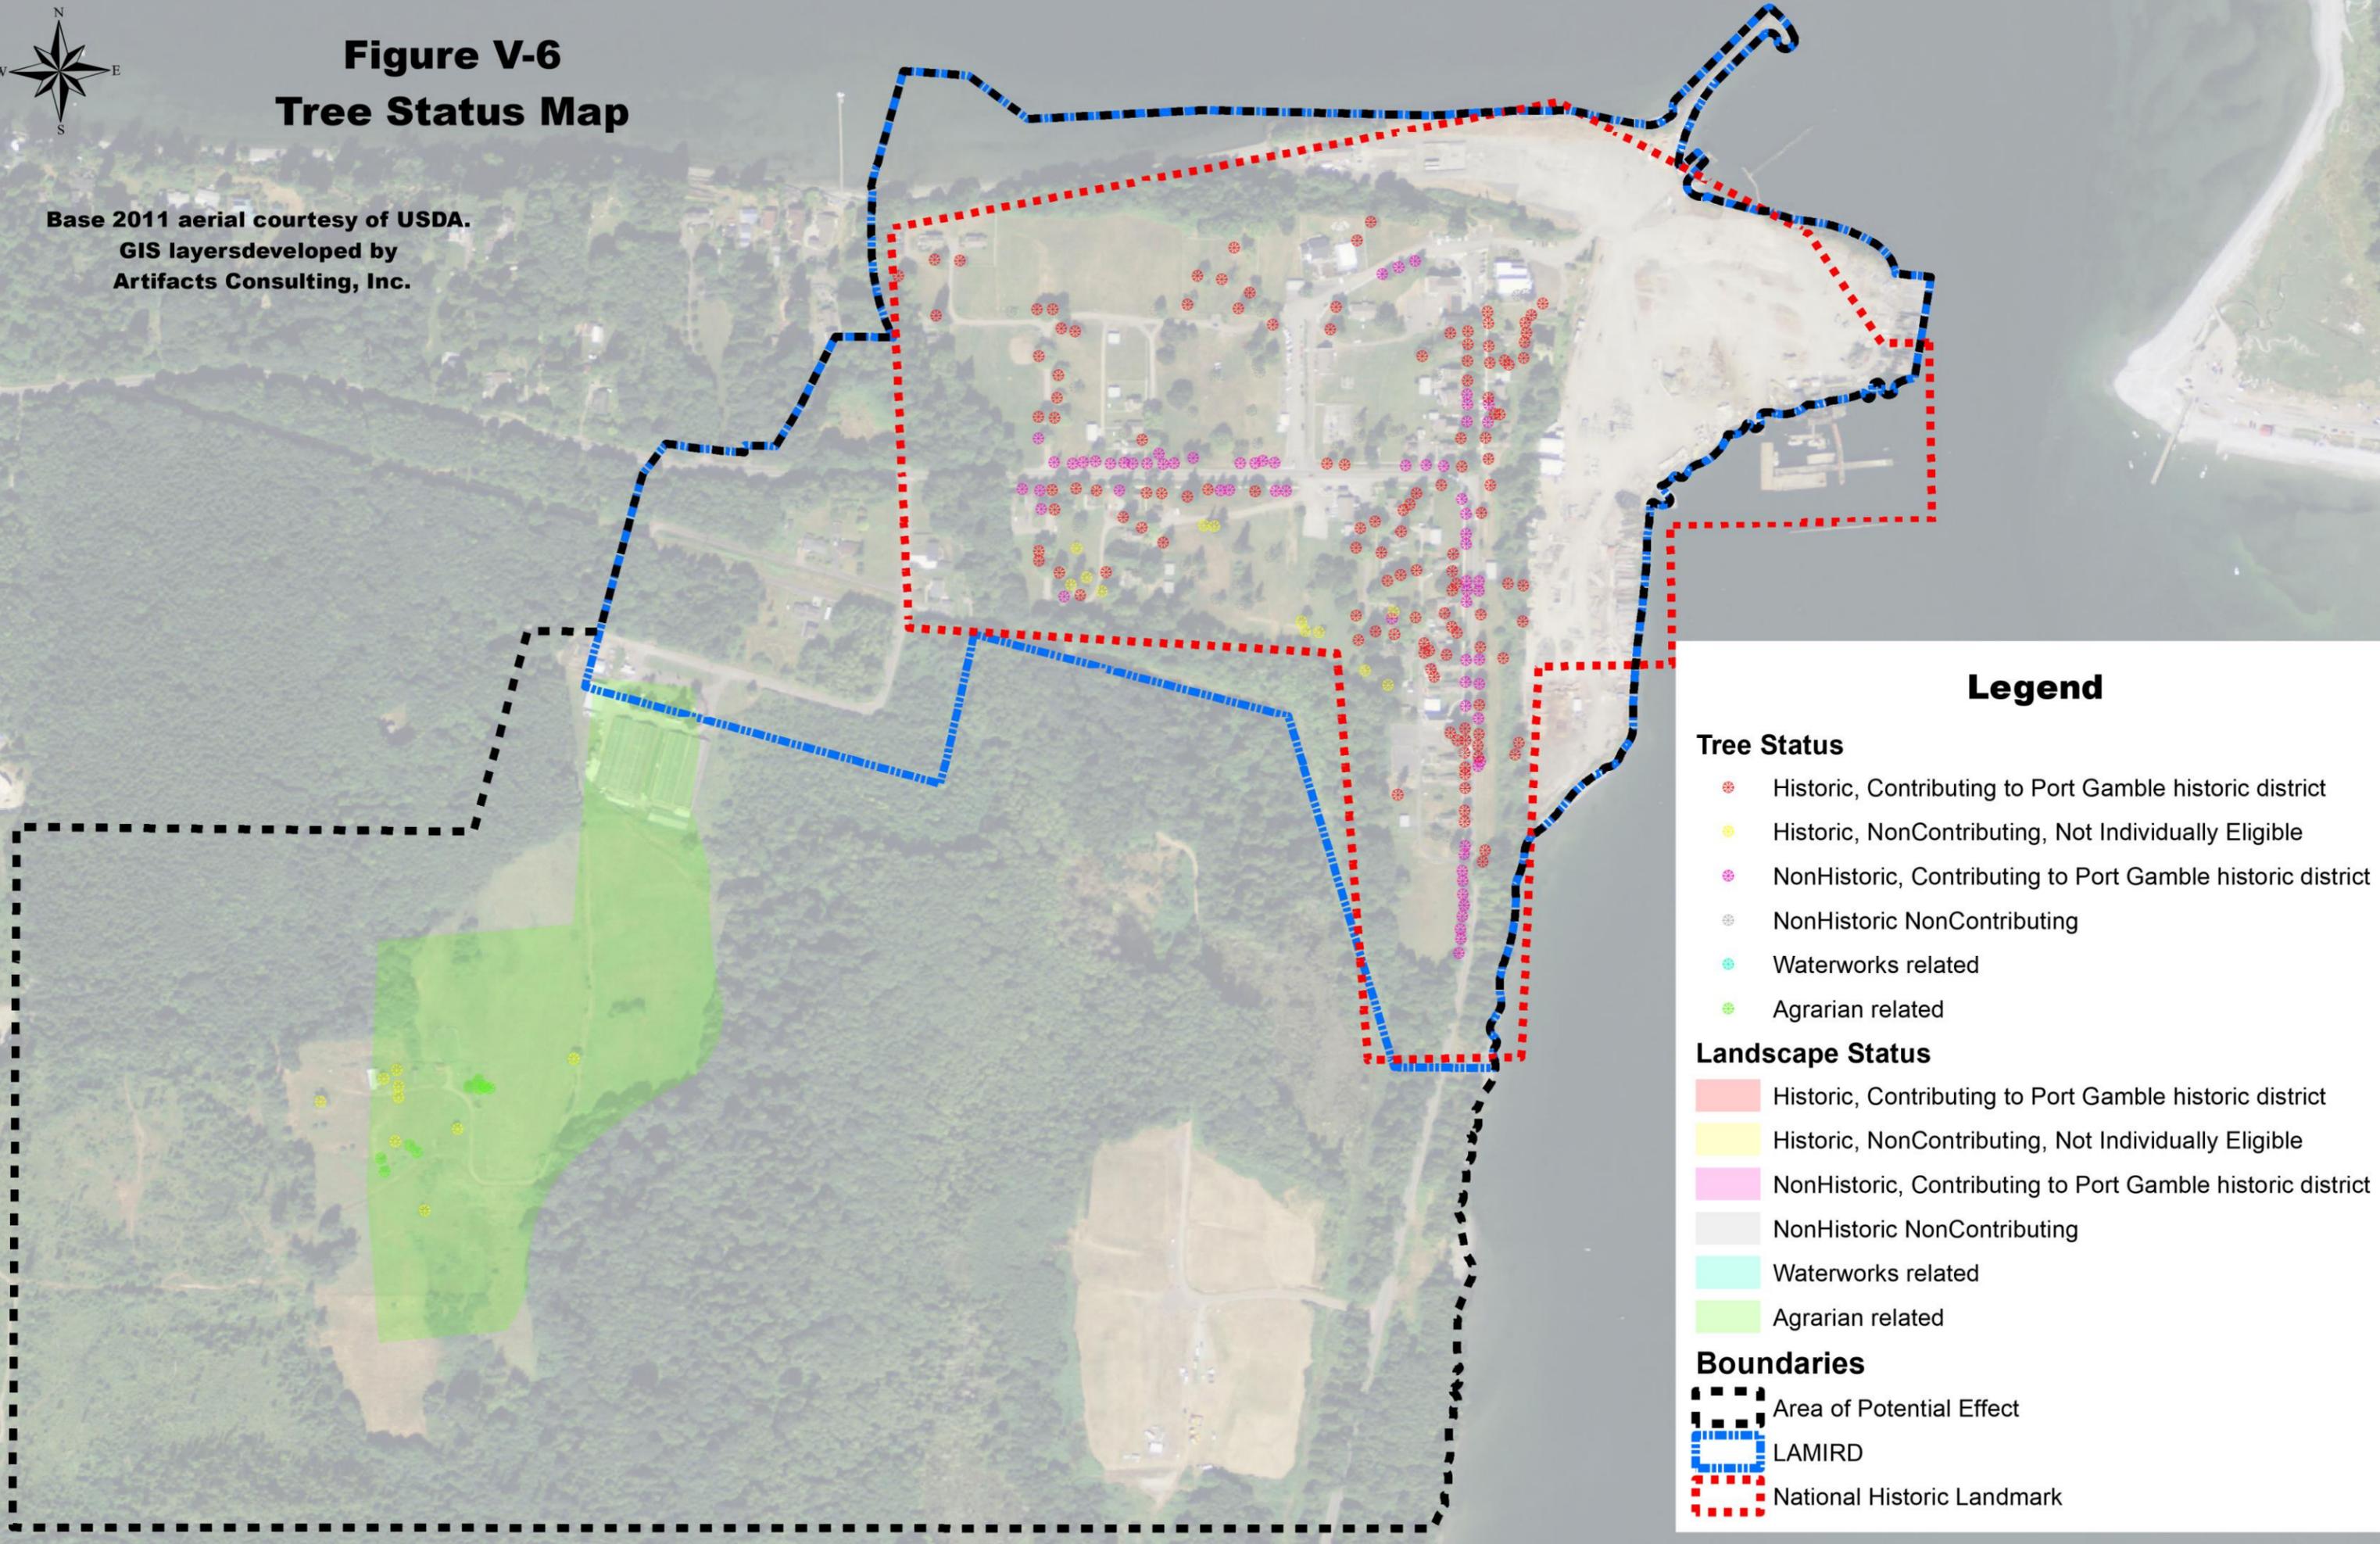
**Figure V-6  
Tree Status Map**

Base 2011 aerial courtesy of USDA.  
GIS layers developed by  
Artifacts Consulting, Inc.

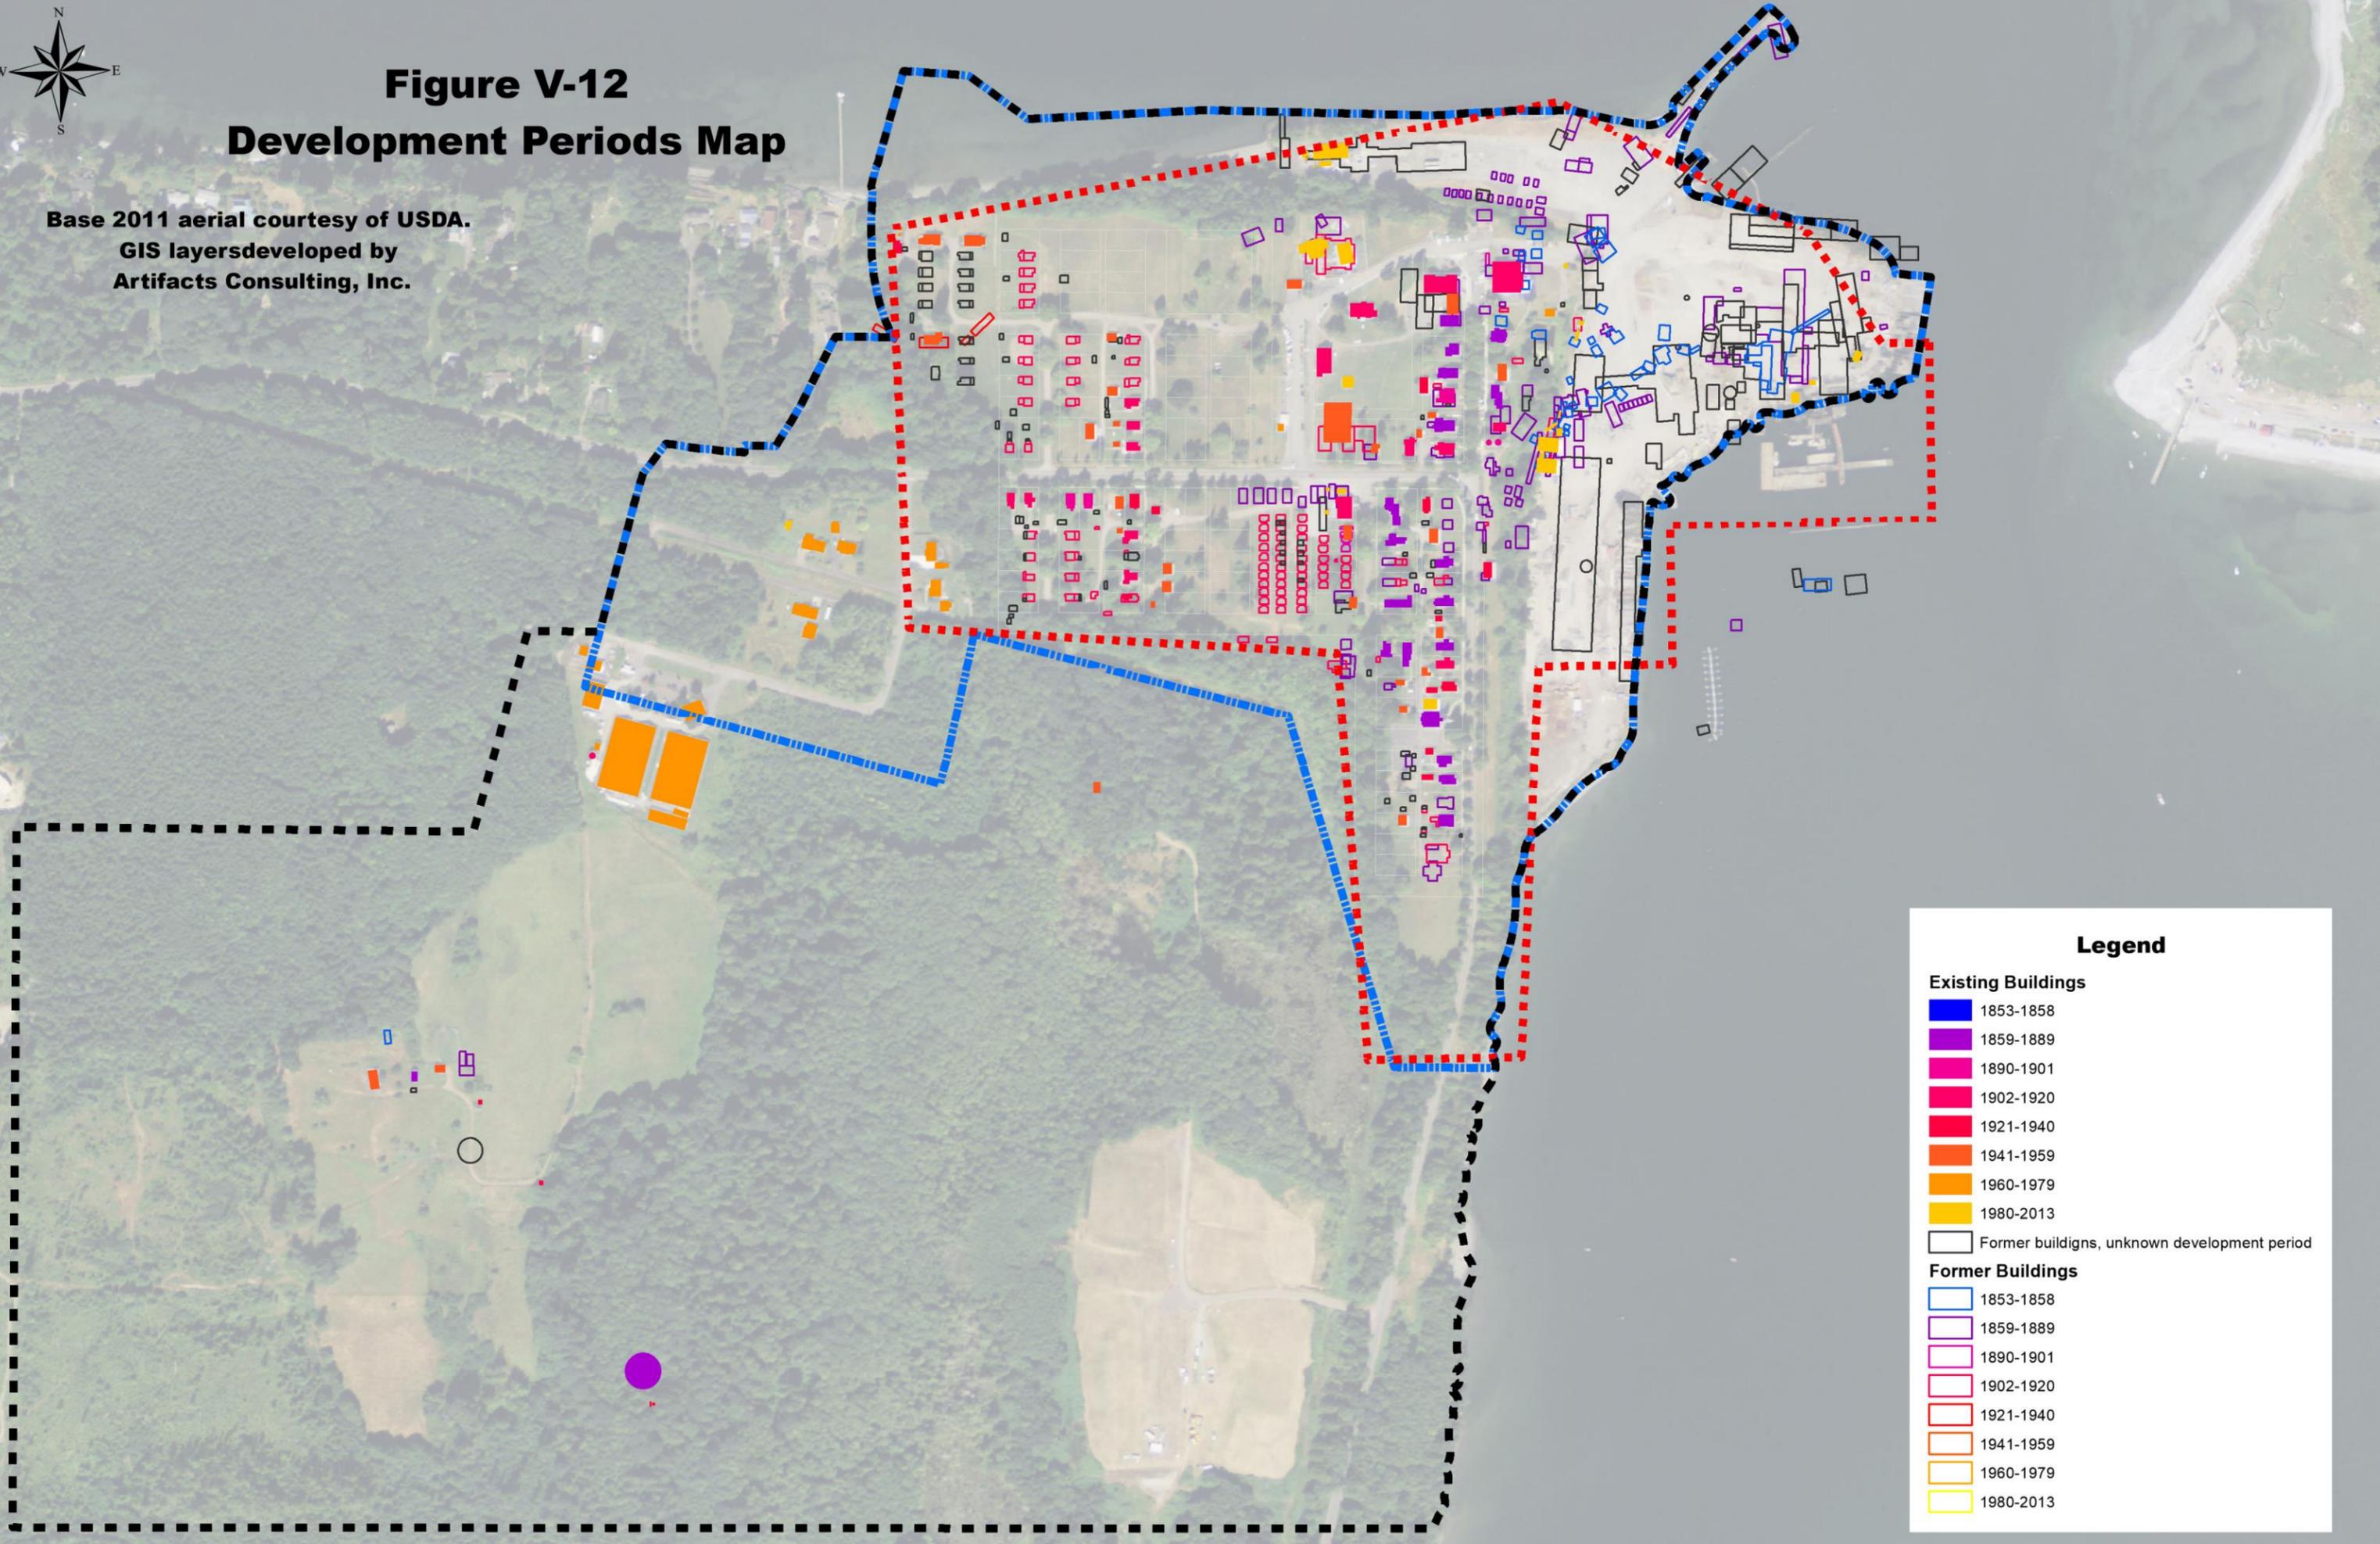
# Figure V-12 Development Periods Map

Base 2011 aerial courtesy of USDA.  
GIS layers developed by  
Artifacts Consulting, Inc.
