# **Historic Resources Report**

# **PORT GAMBLE REDEVELOPMENT PROJECT EIS**

*HISTORIC PROPERTIES*

*TECHNICAL REPORT*

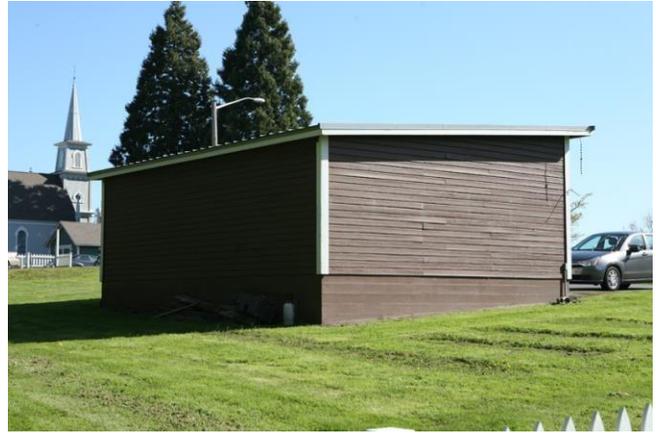
southeast corner  
2013

Built between 1947 and 1956, this two-bay garage is a utilitarian, vernacular style outbuilding. This single story, platform frame building occupies a rectangular footprint on a board formed concrete foundation. A shed roof clad with standing seam metal and having eave overhangs caps the building. Exterior walls are clad with wood drop siding and corner boards. The historic plan and cladding appear to be intact. The side hinged garage doors feature expressed wood frames. An added basketball hoop projects off the front facade.

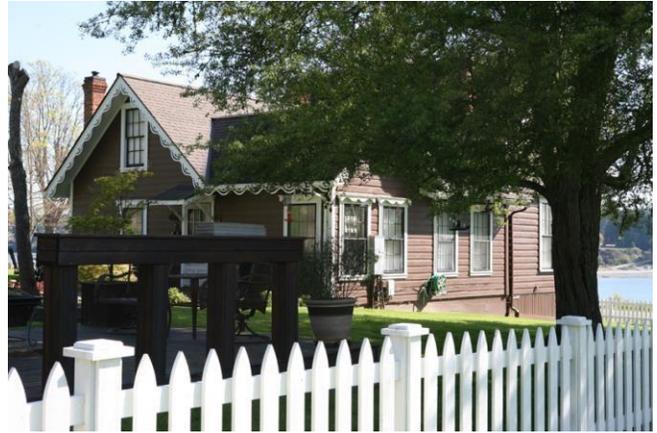
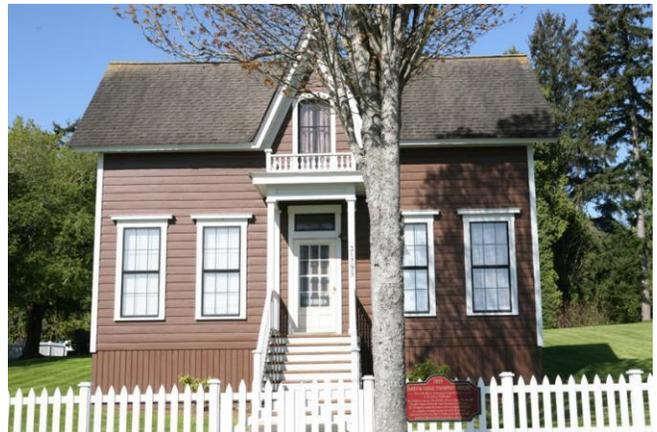
Northwest corner  
2013

Built in 1859, the James and Sarah Thompson House is located along Rainier Avenue. The house faces east, towards the water. This is an example of the employee built housing stock at Port Gamble, executed in the Gothic – Carpenter Gothic style. The one-and-a-half story massing occupies a rectangular footprint, supported by a poured concrete foundation. The house features a front gable roof with a central cross gable on the east slope. Historic additions to the rear (west) elevation are capped with lower gable roof segments. Corbelled brick chimneys perforate the roof slopes of the rear (west) gables. There is no water table on the Thompson House. The front (east) facade is symmetrically composed, with a projecting stoop at the first story; this also forms a small balcony at the second story. The front portion of the house is only one bay deep. Windows feature prominent surrounds with 6 over 6 sash. Shiplap siding clads the building. A multi lite front door with transom leads to the interior. A small balcony tops the front stoop roof. The historic plan, cladding, windows and front entry appear to be intact. There appear to have been slight alterations to the chimneys.

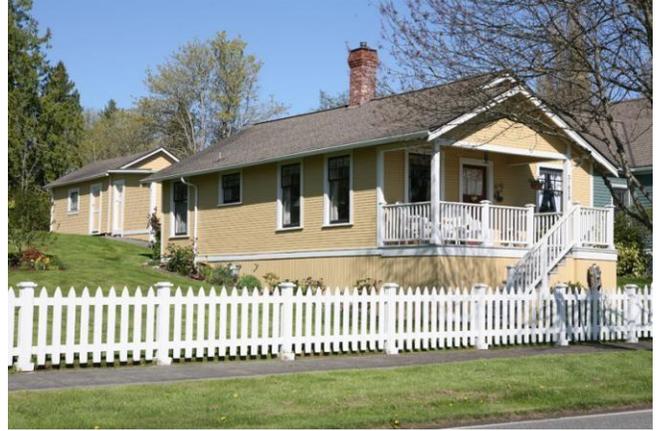
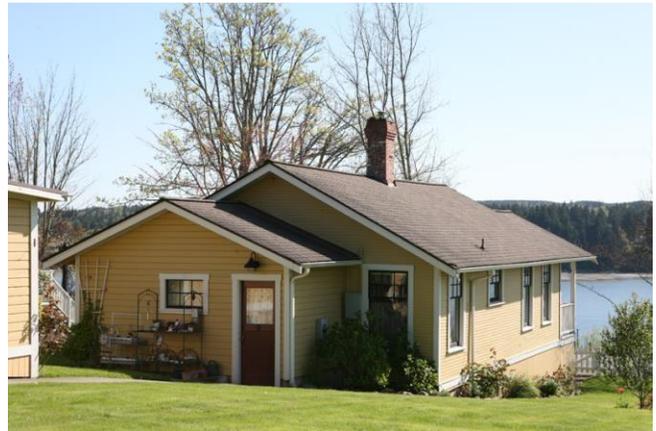
east front  
2013

Built between 1857 and 1878, this single story, single family residence exhibits the vernacular style. The platform framed, front gabled structure occupies a rectangular footprint. Skirting covers the post-and-pier foundation. Wood clapboard and drop siding clads the exterior walls. The historic plan, porch, windows and cladding appear to be intact. There appear to be slight alterations to the corbelled chimney. Windows feature 6 over 1 sash with casings. A flight of stairs leads up to the three-quarter width front porch. The front door features a single upper lite with a lower panel. Asphalt composition shingles clad the open eave roof.

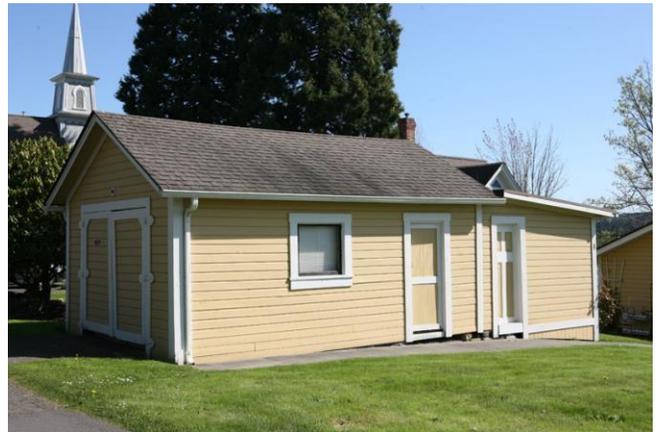
Northwest corner  
2013

Built between 1930 and 1946, this single bay garage is located west of Rainier Avenue and south of Pope Street in Port Gamble, Washington. The garage is a utilitarian, vernacular style outbuilding. This single story, platform frame building occupies a rectangular footprint on a post-and-pier foundation. A combination gable and shed roof, all covered with asphalt/composition shingles, caps the building. Exterior walls are clad with wood V-groove drop siding. Side hinged doors exhibit expressed framing. Vertical board forms the side personnel door. Windows consist of single lite wood sash with casings. The historic plan, cladding, windows and garage doors appear to be intact. A shed roof addition extends off the east side. Clad with V-groove horizontal siding and new skirting. The addition stands on a post and pier foundation. A four panel door provides access.

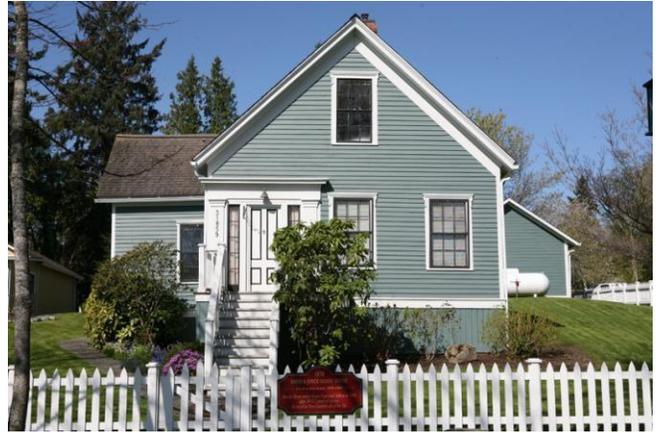
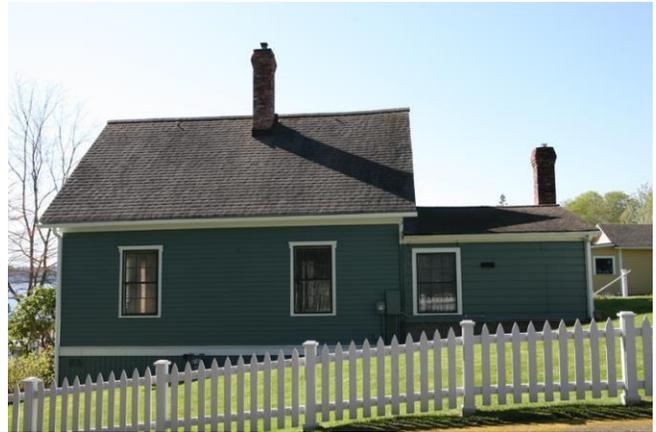
southeast corner  
2013

Built in 1870, the David and Joyce Olson House is in Port Gamble, Washington. This one-and-a-half story, single-family dwelling exhibits the Greek Revival style. A post-and-pier foundation supports the balloon framing system of the main house. A rear addition features a concrete block foundation. A front gable roof caps the house's primarily L-shaped footprint. Asphalt composition shingles clad the roof. Windows consist of 6 over 6 sash with casings. Painted wood lap siding with corner boards and a water table clad the building. Vertical wood skirting wraps the post and pier foundation. A direct flight of stairs leads to the front stoop. The multi panel front door features a prominent surround and multi-lite side lites. The historic plan, cladding, and front entry appear to be intact. There appear to be slight alterations to the windows and corbelled chimneys. There are new metal gutters.

This building features three rear additions. Additions feature concrete masonry unit foundations with wood drop siding. External brick chimney services the interior. The addition features a low pitch gable roof. Two new fixed lite windows on the rear facade. The rear corner addition features a shed roof with Vgroove siding, and 6-lite windows with casings providing day lighting. The entry door consists of four panels with a surround.

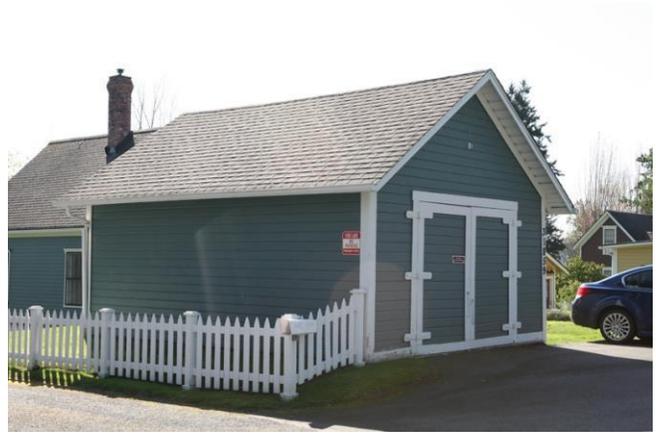
southwest corner  
2013

Built between 1921 and 1928, this single bay garage is located west of Rainier Avenue and south of Pope Street in Port Gamble, Washington. The garage is a utilitarian, vernacular style outbuilding. This single story, platform frame building occupies a rectangular footprint on a poured concrete foundation. A front gable roof covered with asphalt/composition shingles caps the building. Exterior walls are clad with wood V-groove drop siding. Wood blocking articulates the hinge mount locations on these side hinged doors. Windows feature 6 lites and wood casings. The historic plan, cladding, windows and garage doors appear to be intact.
