# POINT NO POINT PARK BEACH RESTORATION

ONSITE COMMUNITY MEETING

TUESDAY, JUNE 20, 2023, 4:30 PM - 6:00 PM

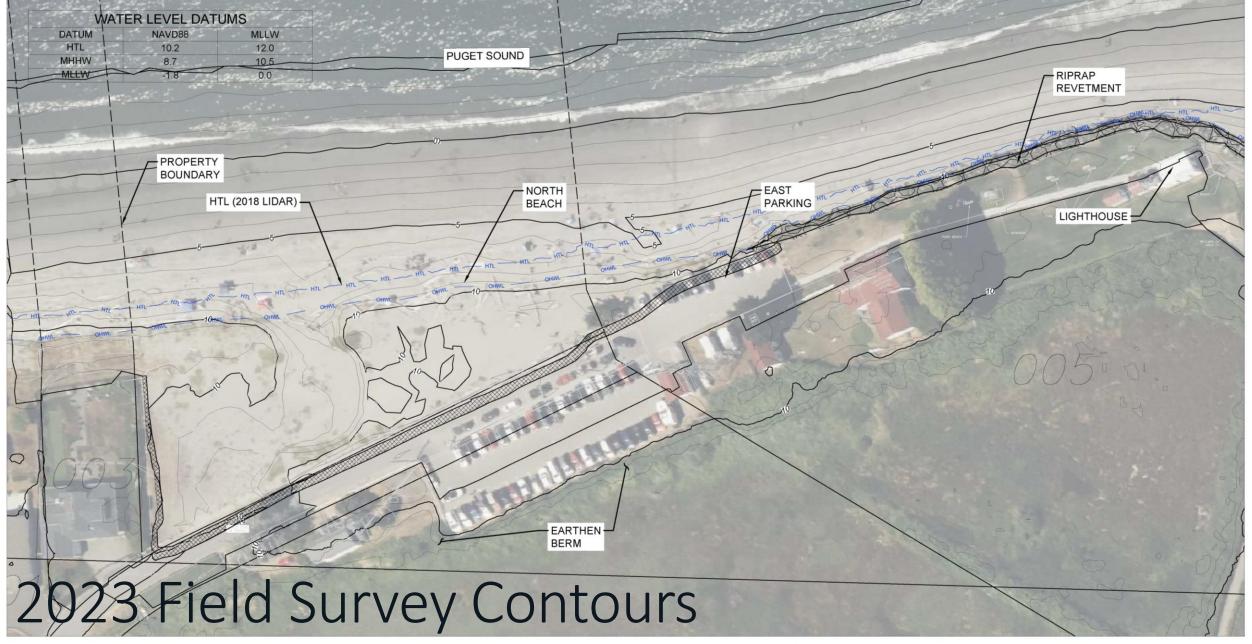
#### Elevation Change Map

- CONTOURS ARE DEVELOPED FROM KITSAP COUNTY PUBLIC WORKS SURVEY DEPARTMENT FIELD SURVEY COMPLETED JANUARY & FEBRUARY 2023.
- 2. ELEVATIONS SHOWN ARE IN U.S. FEET, NAVD88 VERTICAL DATUM (GEOID 12B).
- KTISAP COUNTY GIS DEPARTMENT PARCEL BOUNDARIES

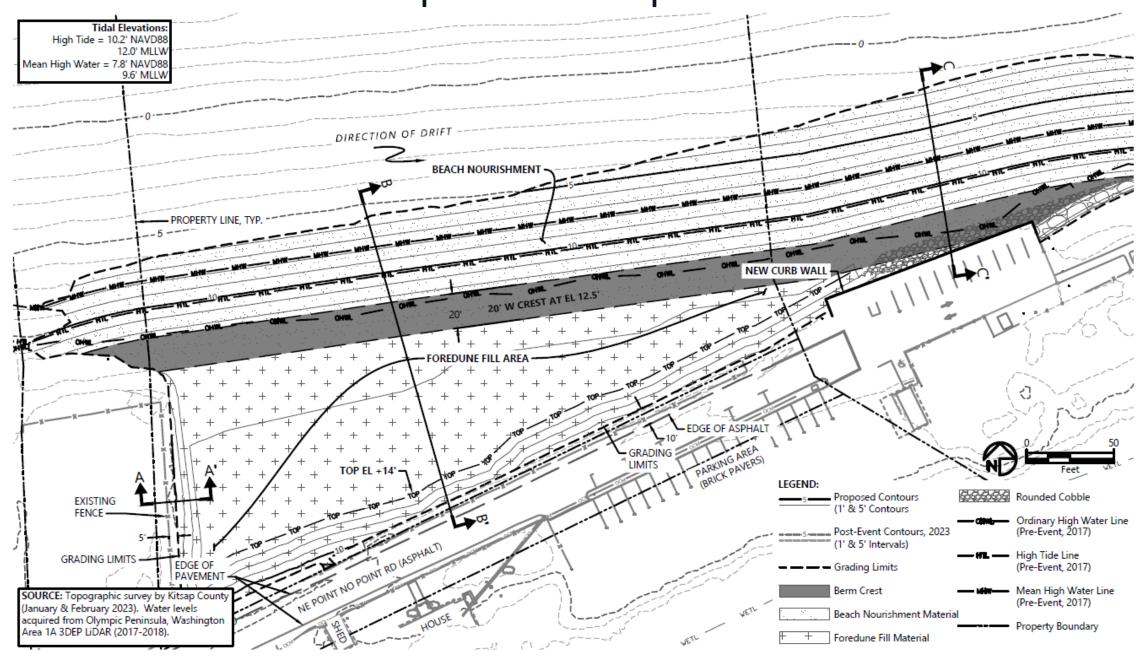
#### North Beach Repairs – Section Views

LEGEND: Armor Rock -...
Tide Line Existing Grade Filter Material (Post-Event, 2023) Mean High Water Line **Existing Grade** Post-Storm Channel (Pre-Event, 2017) Beach Nourishment Fill Material Material Proposed Grade **Tidal Elevations:** +++++++++++ Foredune Material High Tide = 10.2' NAVD88 Excavation Neatline 12.0' MLLW Rounded Cobble Mean High Water = 7.8' NAVD88 Ordinary High Water Line 9.6' MLLW

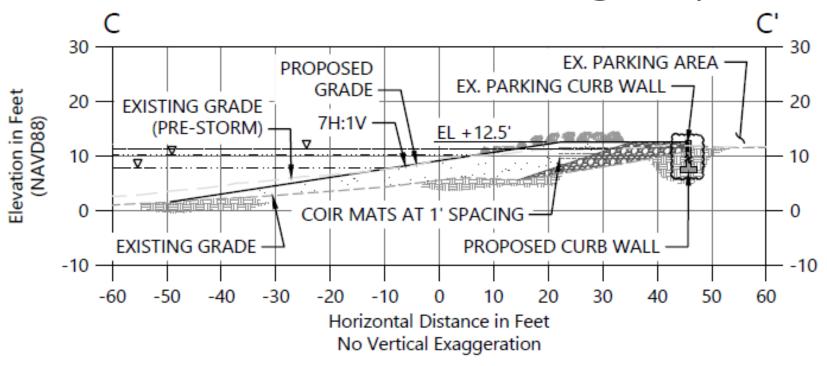
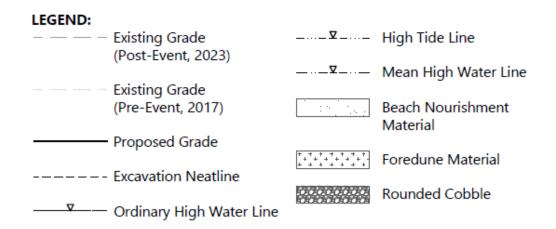
#### North Beach & Revetment Repairs

Armor Rock
Filter Material

Post-Storm Channel Fill Material

High Tide = 10.2' NAVD88 12.0' MLLW Mean High Water = 7.8' NAVD88 9.6' MLLW

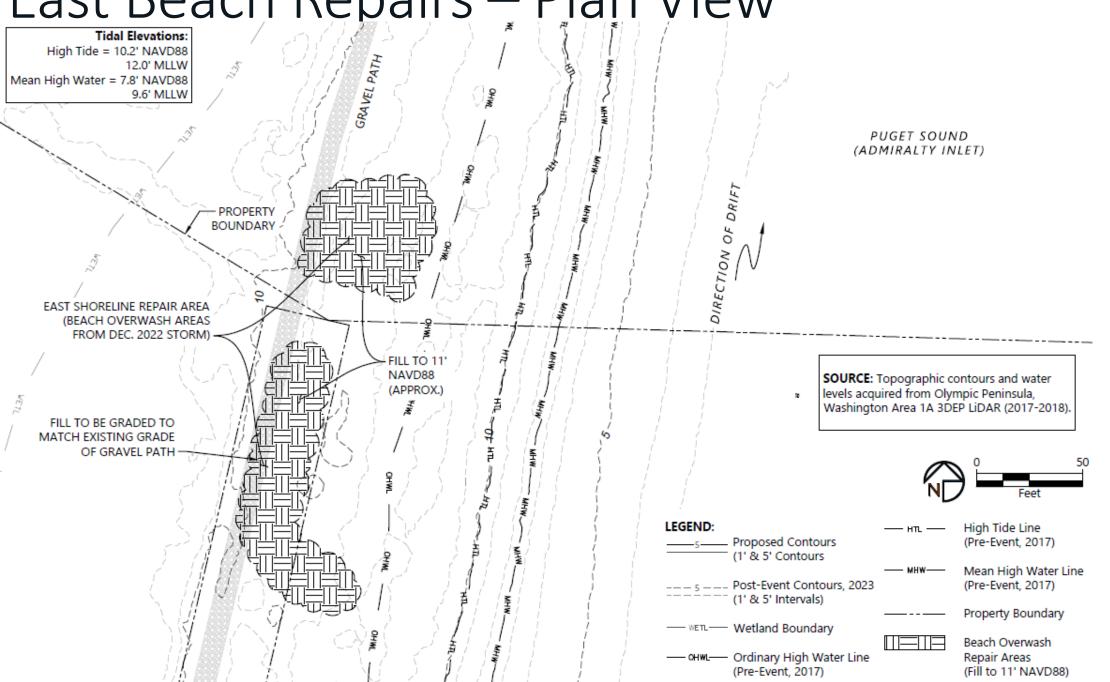
#### East Beach Repairs – Plan View

East Beach Area	<ul> <li>Beach nourishment with sand / wood</li> <li>Limit access to one to 2 points and fill others</li> </ul>	<ul><li>Elevation</li><li>Slope and footprint</li></ul>
