## Kitsap County

Americans with Disabilities Act (ADA)

Transportation Facilities
Transition Plan

Prepared by Transpo Group February 2025

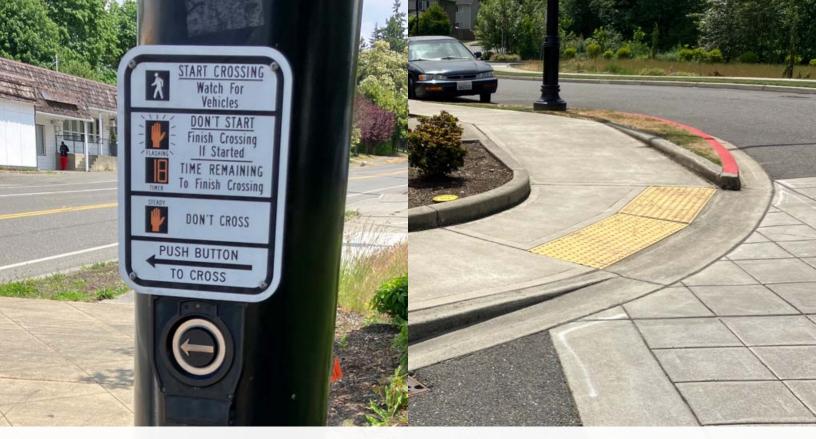
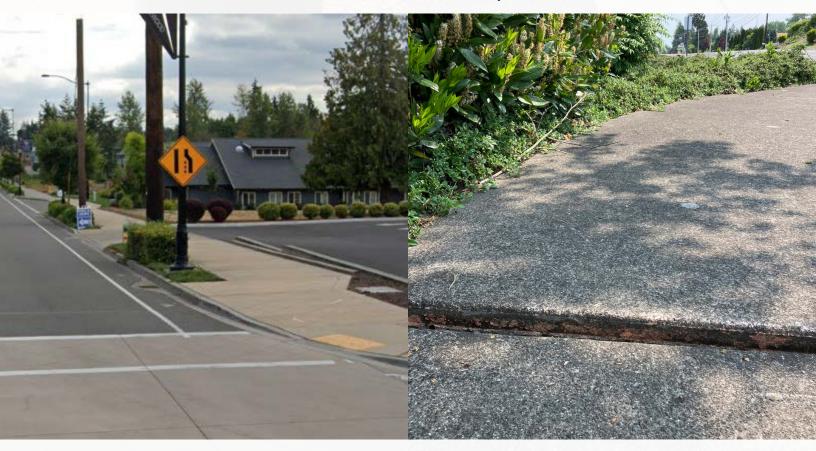
Figure 2.2 Examples of Inventoried Facilities

**Push Buttons**

**Curb Ramps**

Sidewalks Hazards

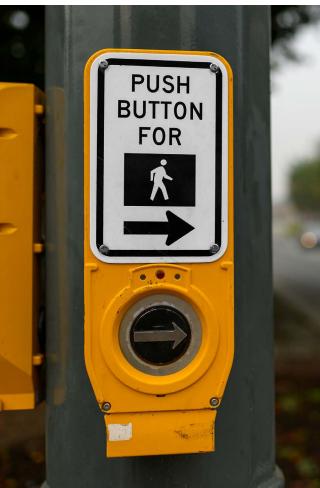
Figure 2.6 APS Pedestrian Push Button and Push Button Location Attributes

Data for pedestrian signal push buttons was collected by Transpo Group staff and Kitsap County. Accessible pedestrian signal push buttons (APS) provide integrated visual, audible, and vibrotactile information to help pedestrians cross signalized intersections. Some push buttons can be programmed to request an extended crossing time or to make the name of the street being crossed audible when pushed for a longer time.

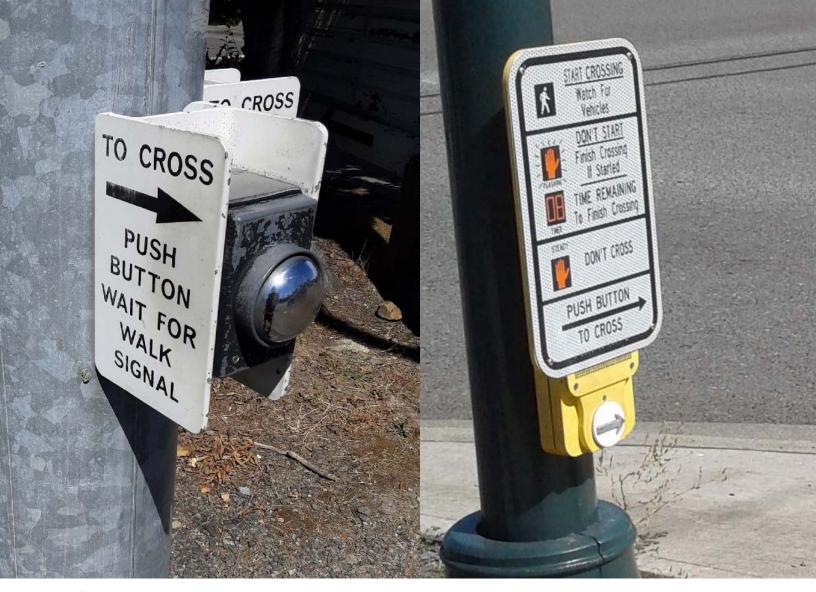
Figure 2.17 "H-style" And APS-style Pedestrian Push Button

Of the 334 inventoried pedestrian push buttons, 196 were non-APS style. Non-compliant pedestrian push buttons include non-APS style buttons to be replaced and APS-style buttons to be reprogrammed or relocated.

County. This style of push button can be upgraded to increase accessibility but must be fully replaced with an accessible pedestrian signal (APS)-style push button to achieve full ADA compliance (Figure 2.17).

The requirement to use APS-style push buttons is relatively new, and lack of compliance is typically due to a crossing not being upgraded prior to evolving requirements. Push buttons are most often upgraded to APS-style in groups rather than individually. As a result, APS-style additions and upgrades usually occur on an intersection-by-intersection basis.
