Regulated Building Material Inspection Report

Silverdale Recycling and Garbage Facility

April 10, 2023

Terracon Project No.81227638

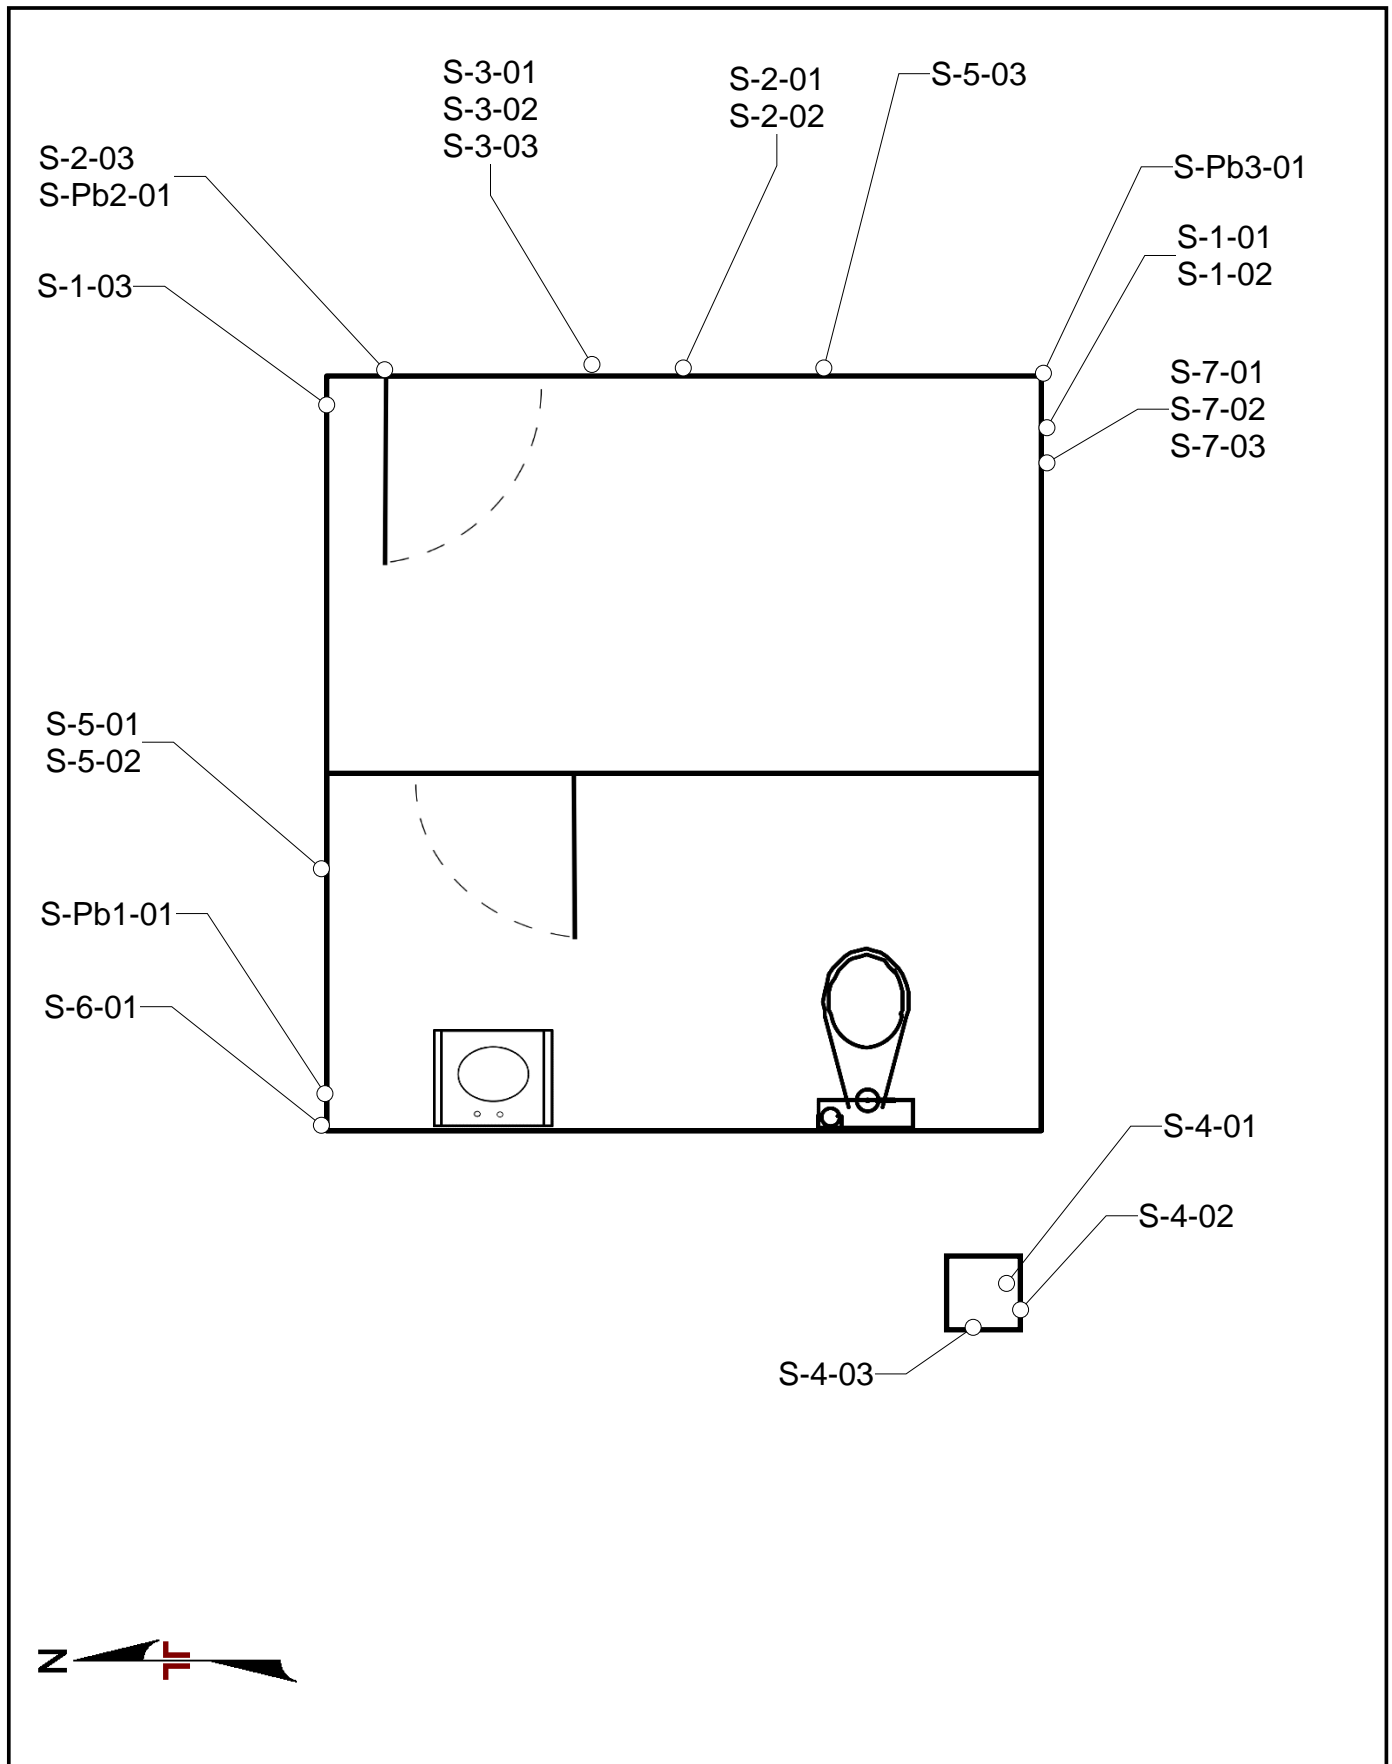
Material No.	Material Description	Material Location	Results
5 (M)	■ Brown Sealant	Associated with electrical box siding and exterior sheet metal seams on guard shack	5%-7% Chrysotile
6 (M)	■ Concrete slab	Foundation associated with the guard shack	ND (all layers)
7 (M)	■ Yellow insulation foam ■ Silver foil	Interior roof insulation within the guard shack	ND (all layers)
11 (M)	■ Grey sealant	Penetration sealant associated with walls of the three storage sheds	5%-7% Chrysotile
12 (M)	■ Assumed electrical panel components	Associated with guard shack	Assumed to contain asbestos
