### **INSPECTION REPORT**

This is a report from an inspection performed July 15, 2024, at the request of **Kitsap County Parks Department** of multiple buildings at 2485 McWilliams Road, Bremerton, WA. Known as Rolling Hills Golf Course.

The main structure, Restaurant and Pro Shop is a wood framed building built in the 1960's with a separate golf cart storage and 3 separate maintenance buildings.

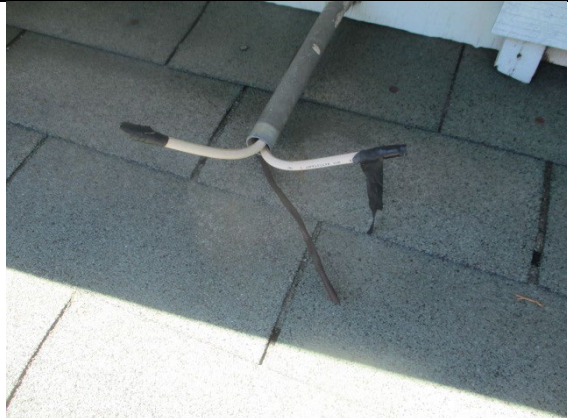
Typical exposed wires at Gable end that need to be capped off in a junction box

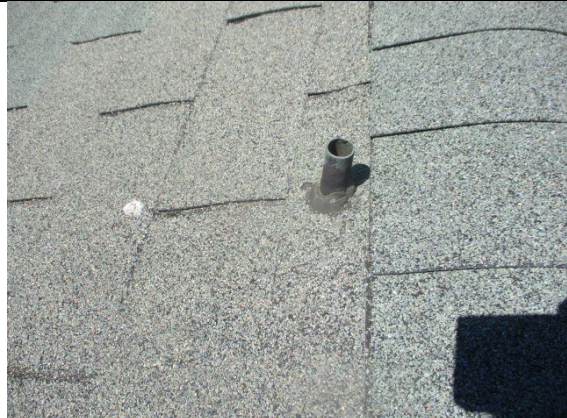
Plumbing vent at upper roof without a boot around it.

48. There is a plumbing vent pipe boot where the sloped roof meets the flat roof that is deteriorated and should be replaced.
49. There is an additional plumbing vent pipe where the sloped roof meets the flat roof that needs to have a boot installed around the pipe and set to drain the water above the roofing.

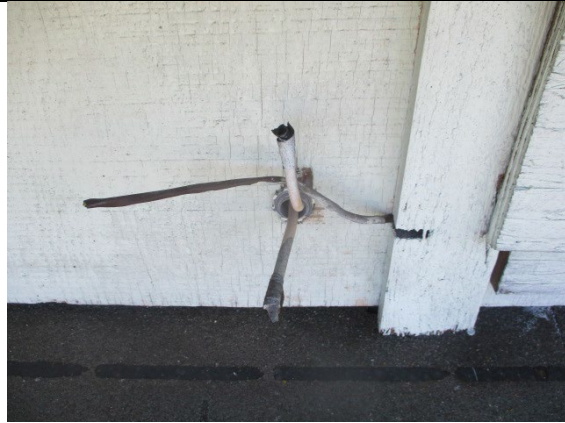
Exposed wires at gable end that should be placed inside of an approved junction box with a cover

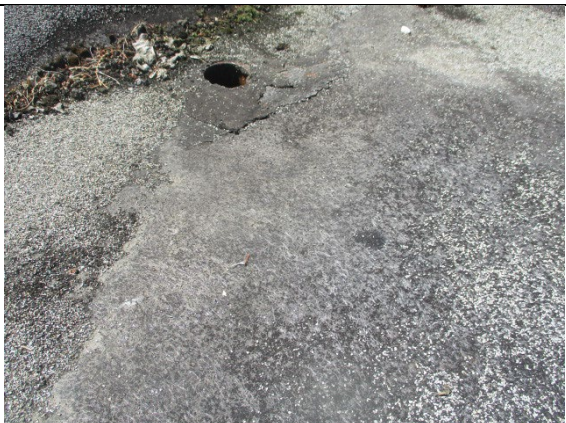
Drain in upper roof

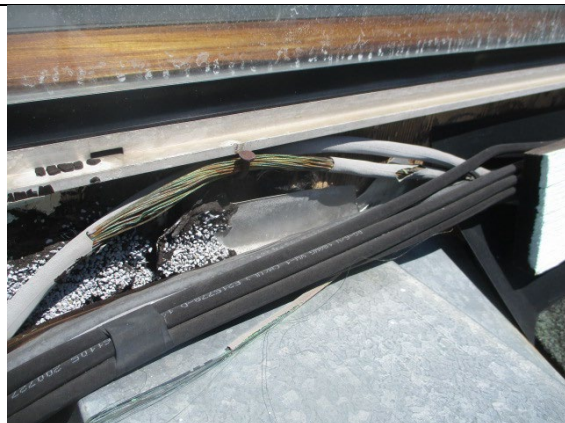
Exposed wires at parapet that need to be sealed/protected

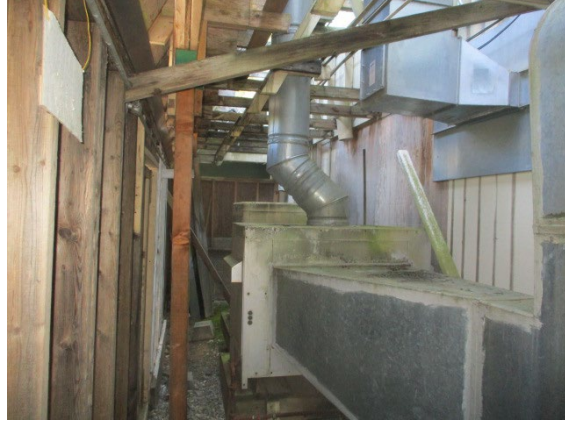
Area at north screen wall with HVAC equipment

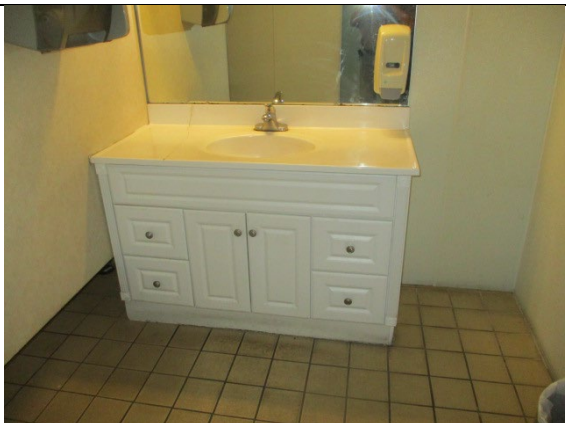
Typical the vanity that is not the compliant as it is closed on the area under the sink

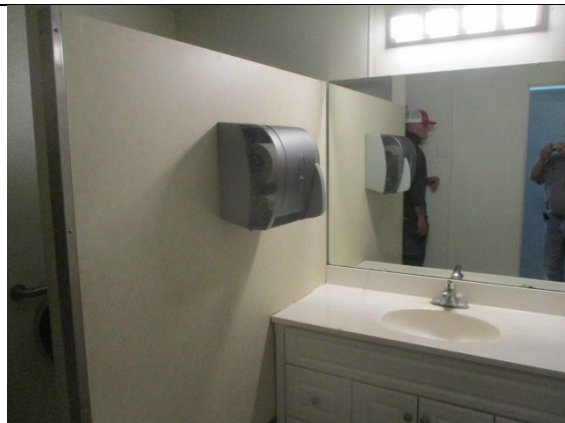
Typical restroom dispenser that is over 40 inches above the floor and is not ADA compliant

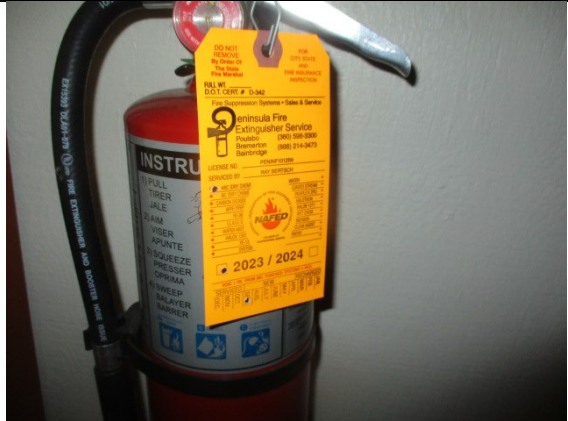
expired fire extinguisher service date

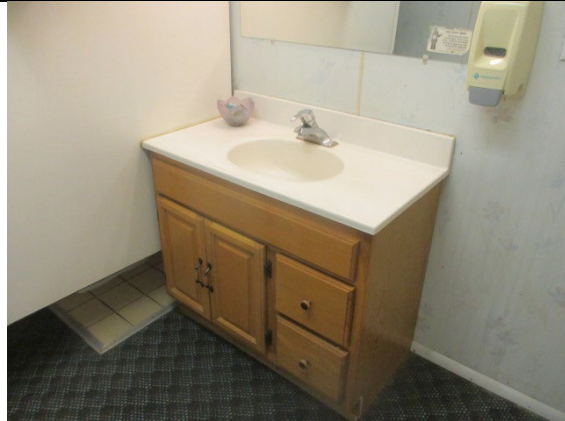
Typical vanity that is not ADA compliant
