2022 Annual Bridge Report

Prepared by Kitsap County Public Works
Engineering Division

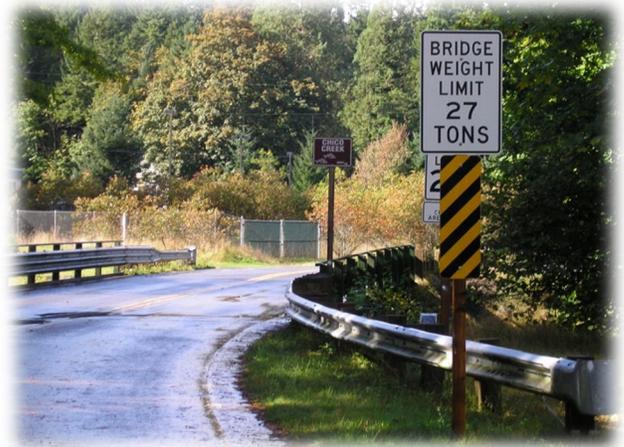
Taylor Road Bridge posted with weight restriction.

#	<i>Bridge Name</i>	<i>Posted</i>	<i>Operating Tons</i>	<i>Inventory Tons</i>
25	Taylor Road Bridge	Recommend Remove Current Weight Posting.	39.24	23.51
27	Lake Symington Bridge	Recommend Remove Current Weight Posting.	47.16	28.25

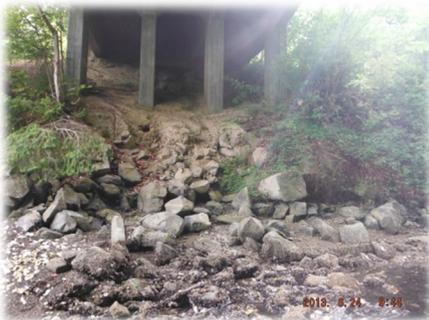
Little Beef Bridge BEFORE 2013

In the summer of 2013, the county hired a contractor to perform scour countermeasures on 2 scour critical bridges (Little Beef #19 & Sam Christopherson #17).

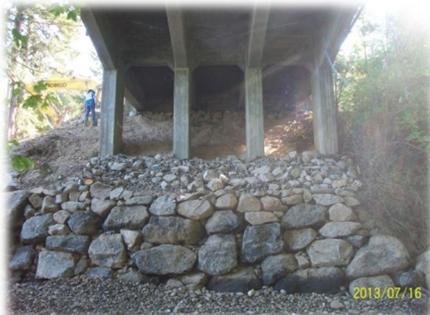
Little Beef Bridge AFTER 2013

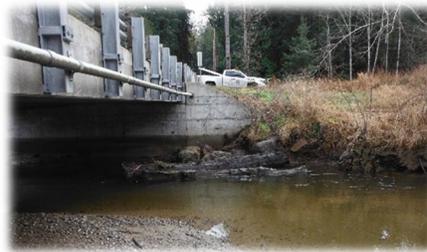
Stavis Bay Bridge BEFORE 2016

In February of 2016, county forces performed temporary scour countermeasure repairs on Stavis Bay Bridge #23. This was followed by permanent scour countermeasures installed in August of 2018.

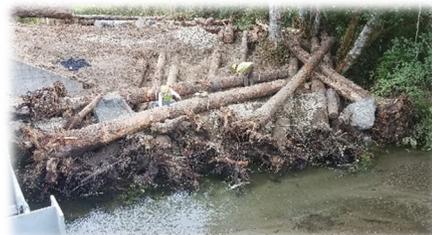
Stavis Bay Bridge AFTER 2018

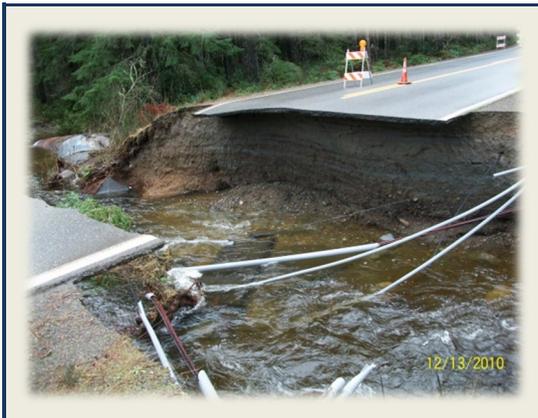
Storm washout of culvert on Lake Helena Dec. 2010

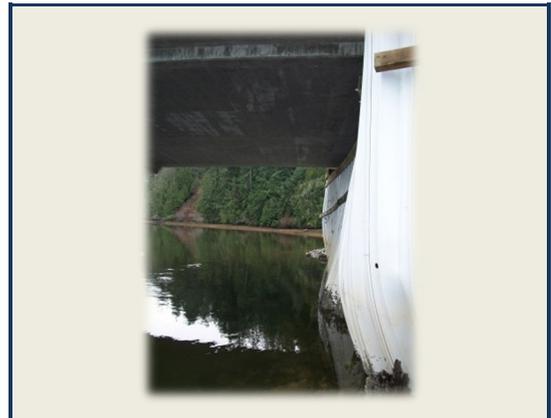
Bulging of vinyl sheeting at abutment from material migration Jan. 2010

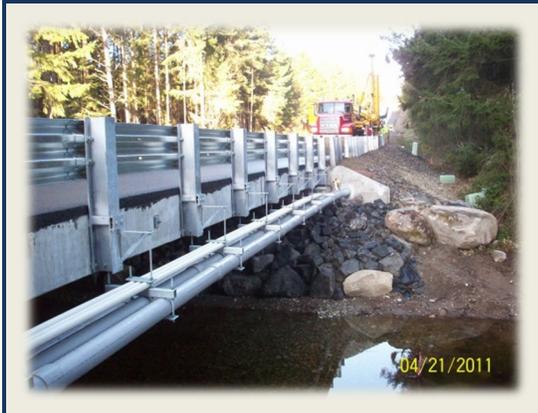
Lake Helena Bridge completed Apr. 2011

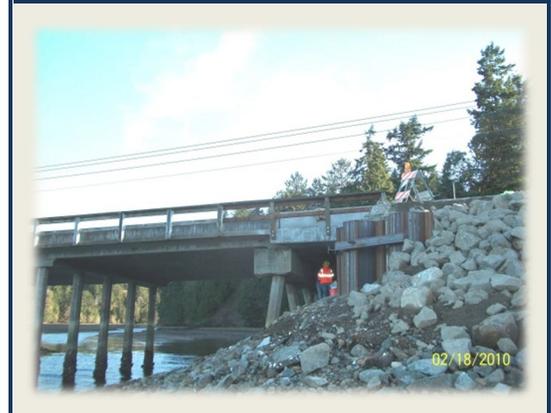
Big Beef Bridge repair completed Feb. 2010

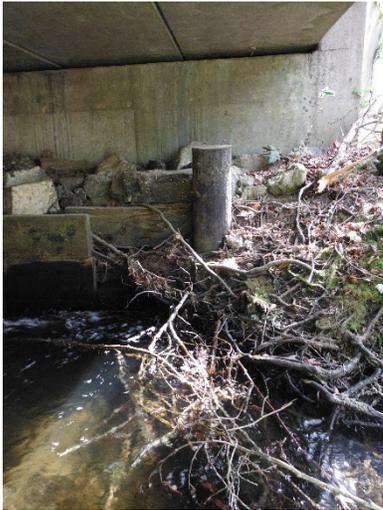
Vegetation undermining at SE corner

Monitor streambed movement at inlet end. Gravel aggregation underneath the bridge and at outlet. Monitor scour hole at NW corner especially during high flows. Temporary repairs warranted.

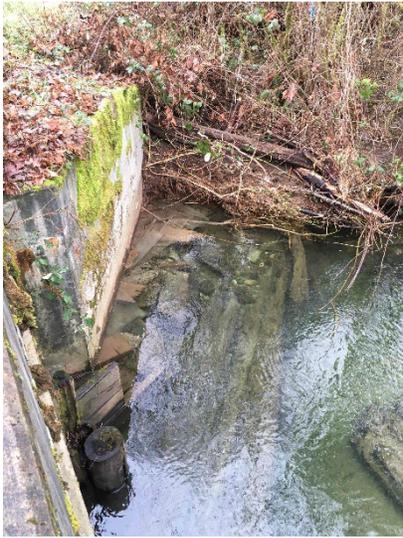
Scour and Load Rating	<p>Bridge has been load rated as per FHWA requirements by TranTech Engineering in 2018. Scour evaluation and analysis as well as hydraulic analysis was performed by Alpha Engineering in 1992.</p> <p>Scour hole developing at NW corner (P1 inlet). Approximately 4-6 feet below average water surface. Large woody debris trapped in the bottom. Roads is working on designing temporary repair. Silt deposit anabranch at NE corner forcing water to the West.</p> <p>This bridge is not scour critical. (No history of scour)</p>	
Photo

Scour hole at NW Corner

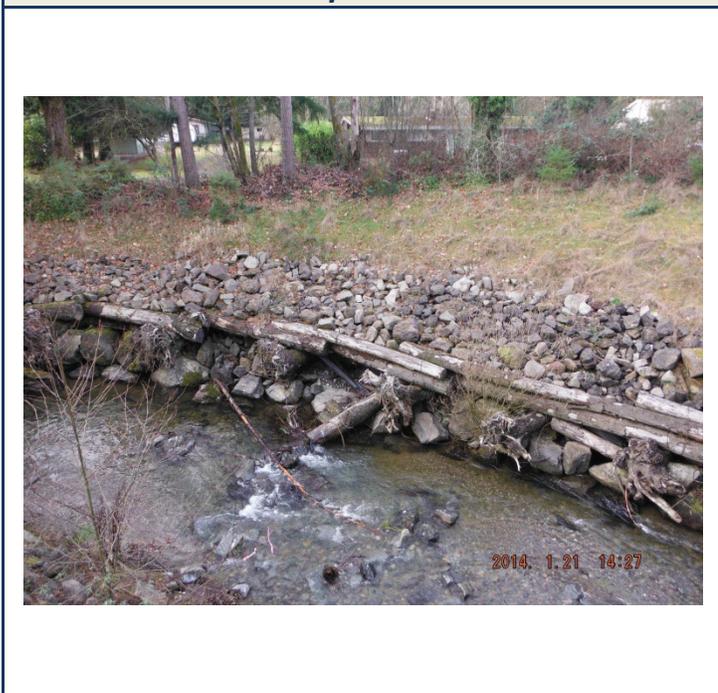
Hole in log weir 75' upstream from bridge in NW quadrant.

Recommendations	Monitor bank repair under the bridge. Monitor hole in log weir 35' & 75' upstream from bridge at NW quadrant. Broken locate wire for water line at splice point in the NE corner.
------------------------	---

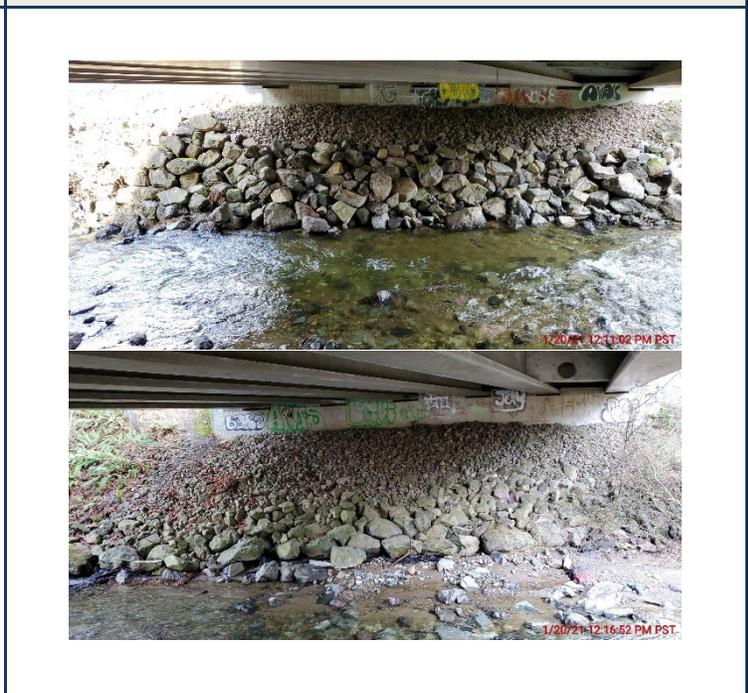
Bank Armor repair in 2020

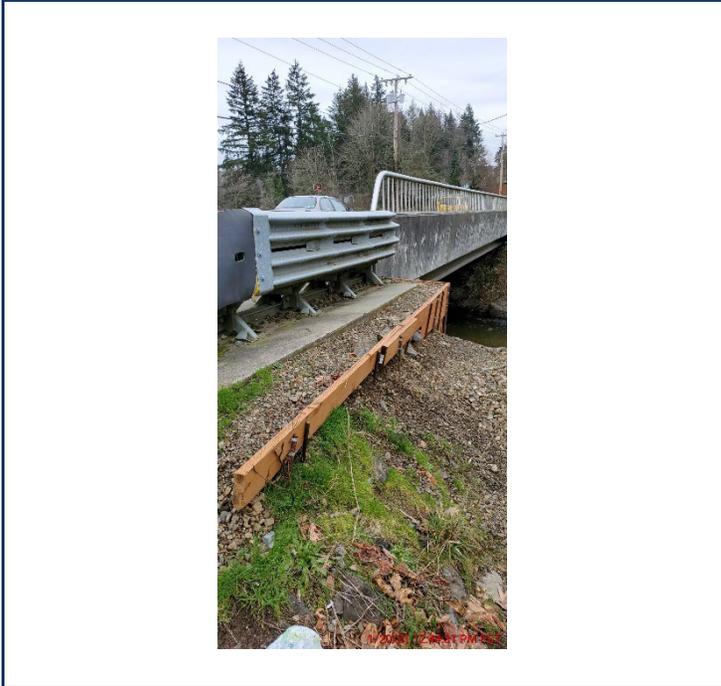
Repair of undermining of attenuator slab

Monitor slope armor at SE corner of bridge. The coating on the ductile iron pipe on the south side of the structure is beginning to rust. The ACP overlay is beginning to show perpendicular cracking at bridge joints due to continued settlement.

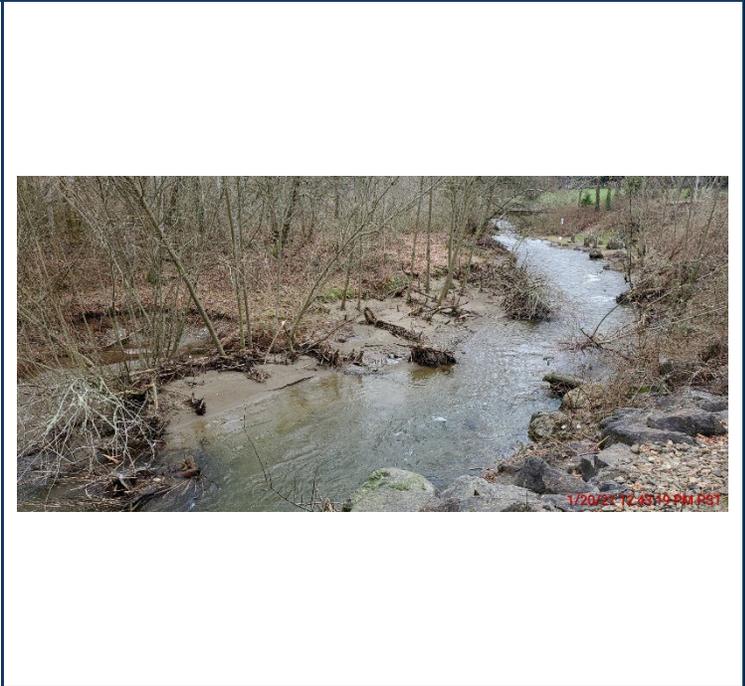
Upstream sediment and debris from broken beaver dam

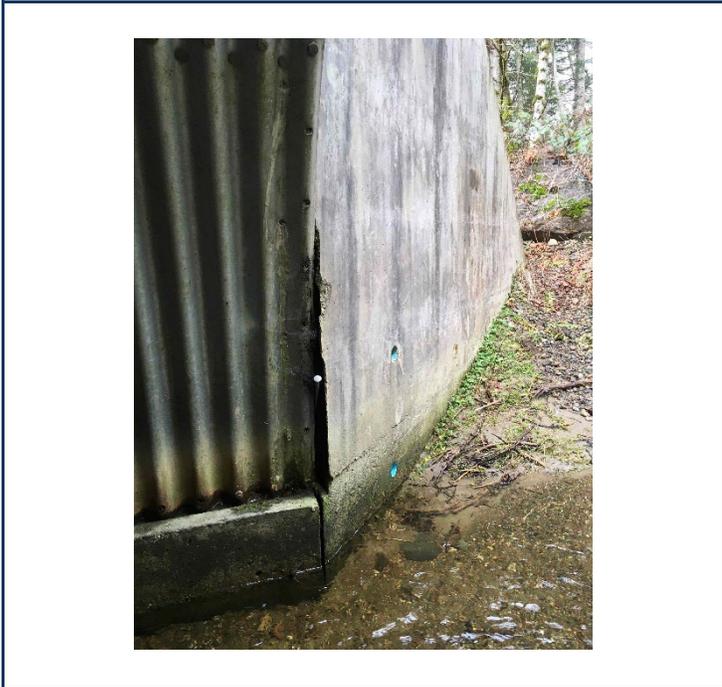
Nails found in wing wall attachments, for nets?

Recommendations	Monitor scour repair area for continued material loss at SW quadrant. Monitor wood debris upstream and bank sloughing at SW corner.
------------------------	---

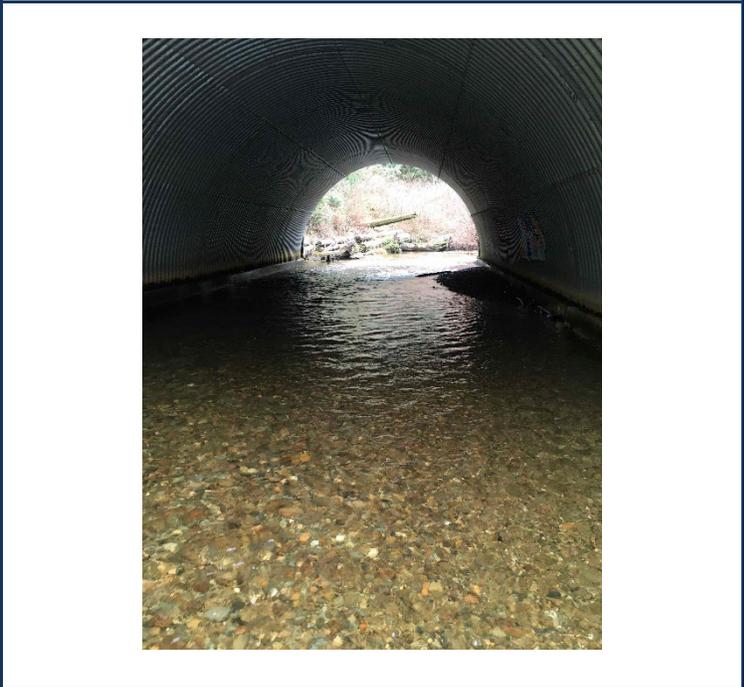
Downstream at outlet

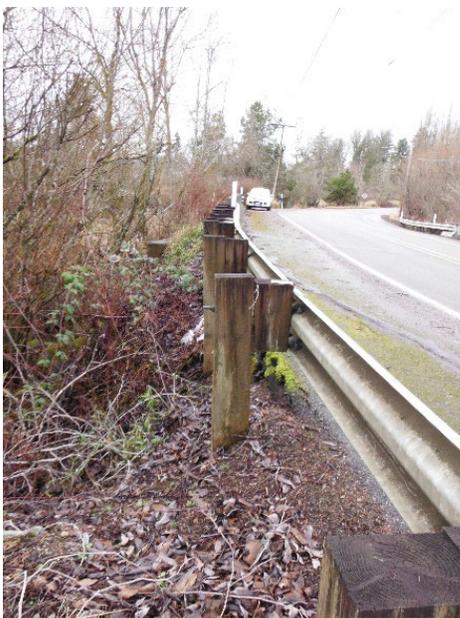
Sloughing rockery at NE quadrant

Repair ACP at both bridge joints and seal cracking in ACP Roadway. Monitor settlement and cracked ACP at the NE & SE corners at bridge ends in the embankment areas. Monitor void areas under both abutment walls. Monitor sloughed rockwall at NE embankment 15' to 20' of wall has toppled and recommend repair. Remove beaver dam under bridge adding to back water scour.

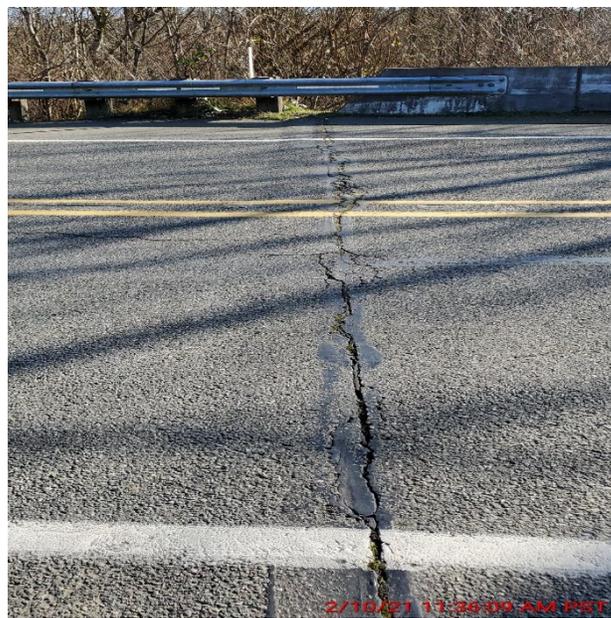
Cracking in ACP and at bridge joints

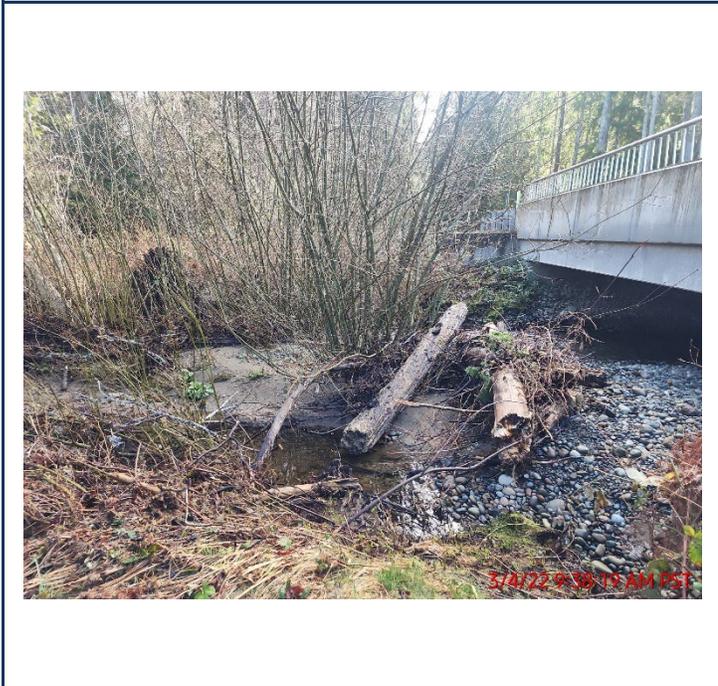
Debris getting caught on anabranch at downstream end of bridge

Recommendations	Bridge is in good condition. Monitor material moving from abutment embankments to stream bed during high flows. Monitor stream bank beginning to cut at the East side just downstream from the structure.
------------------------	---

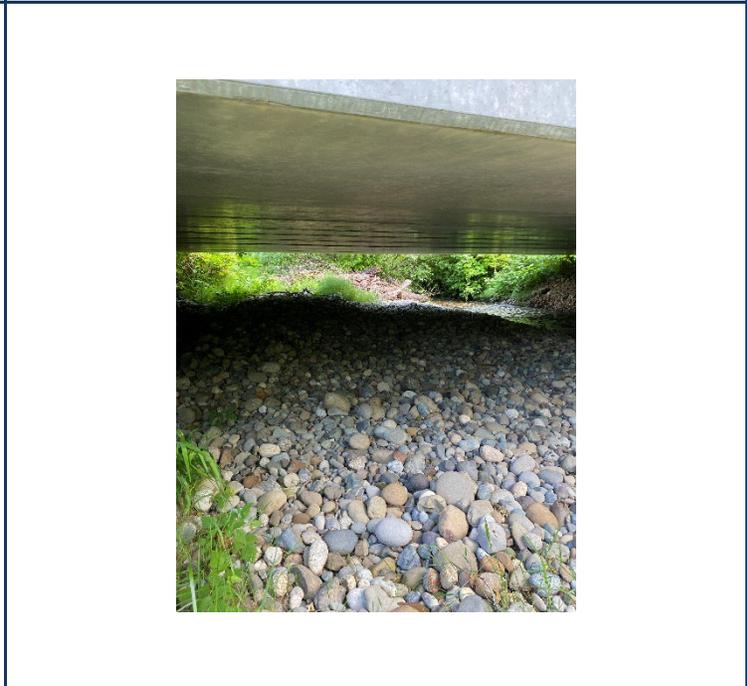
Looking downstream under bridge gravel buildup

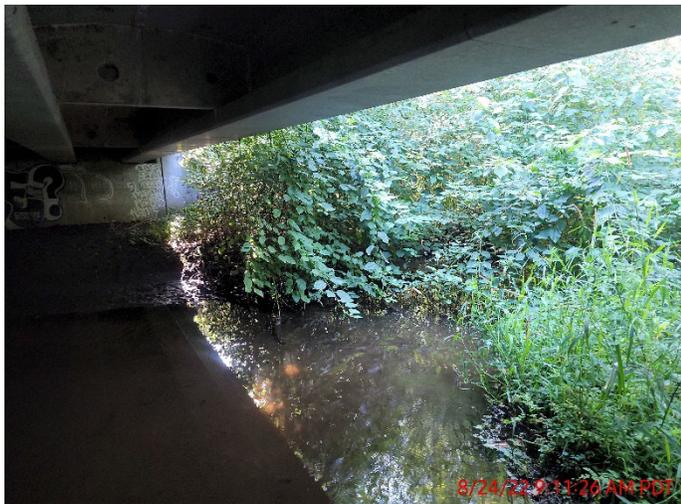
Inlet End siltation and vegetation

Heavy vegetation growing and siltation deposits at inlet & outlet ends and should be removed. Seal cracking in ACP at both bridge joints. NE & SW sidewalk panels settling up to 1/2". Monitor settlement along Pier 2 joint.

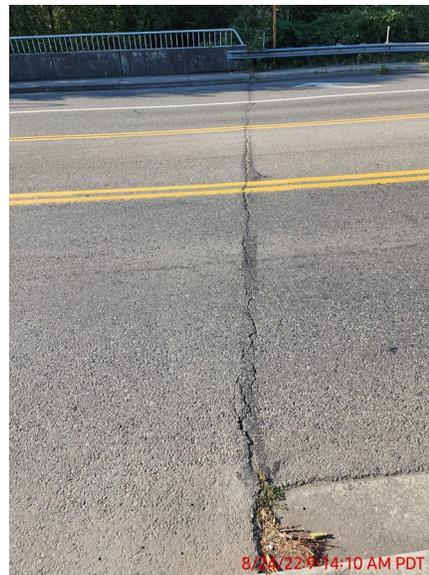
Seal Cracking in ACP at Bridge Joints

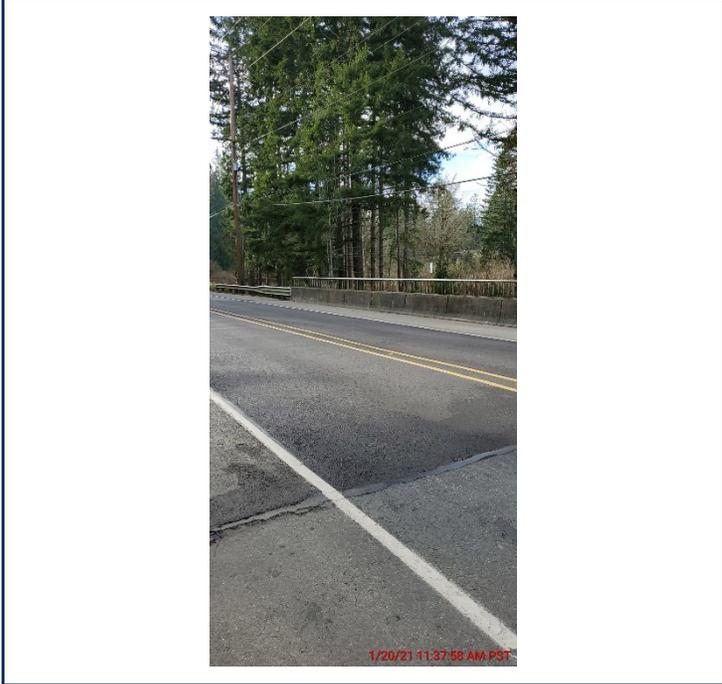
Travel lanes repaved in Summer 2020

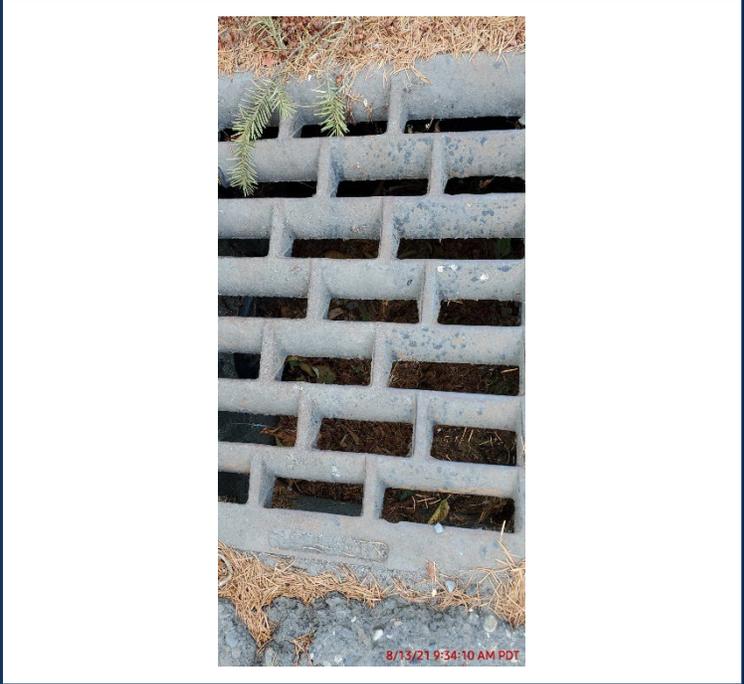
CB with some debris

Monitor bank armor at SW & NW corners.

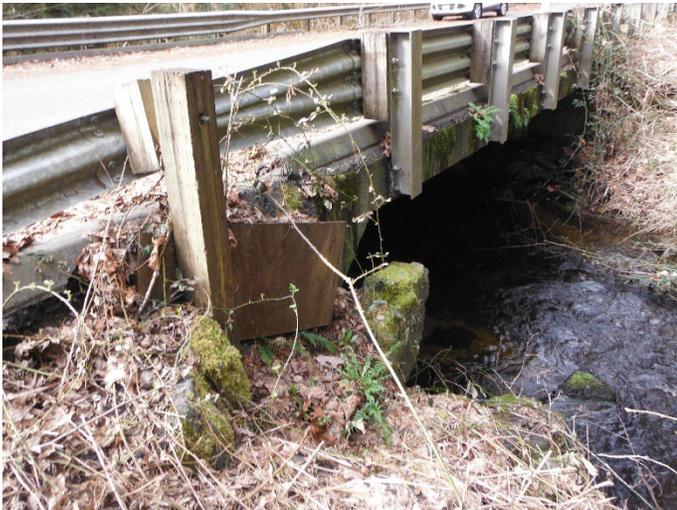
Failing ACP Curb

3 areas of failing ACP curb should be repaired: NE, NW, and SE corners. Monitor rip rap at NE & SW corners with evidence of bank loss at this time.

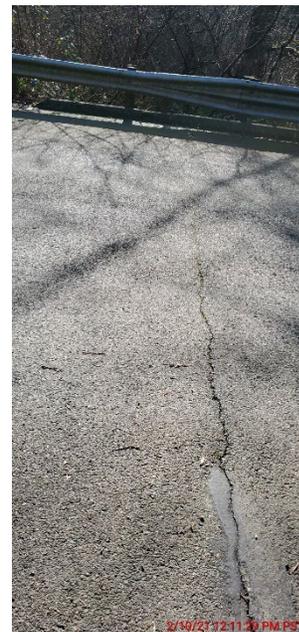
Cracking in ACP due to roadway settlement

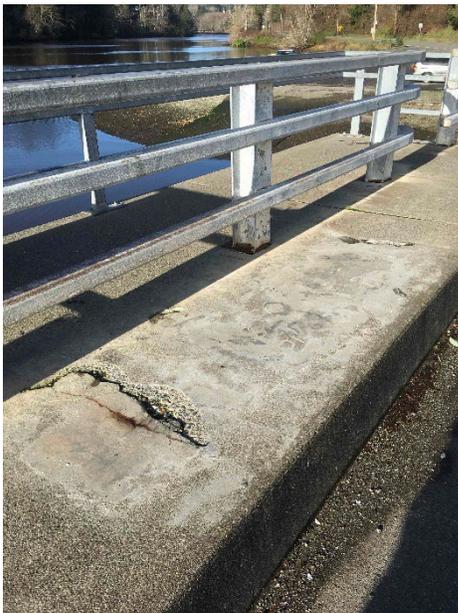
Sidewalk Spall

Current bridge rail and transitions do not meet current standards. Monitor settlement at bridge ends and approach roadways. Monitor scaling in wheel tracks of the concrete deck as well as 3/4" pipes appearing in deck 1-1.5' from curb in both lanes. Repair sidewalk spalls west side at observation area. Clean and reseal North (P2) bridge joint. Repair ACP at South (P1) Bridge Joint. Repair sidewalk panels at all four corners caused by settlement.

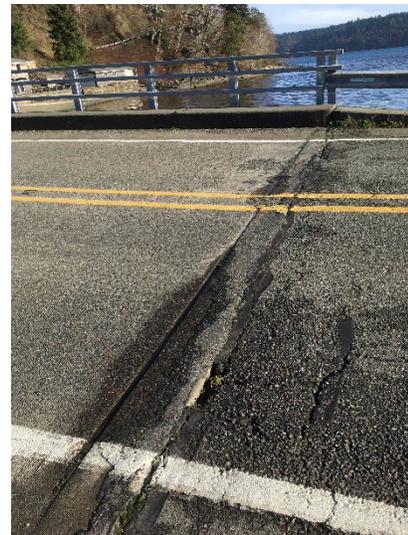
Repair ACP at South joint

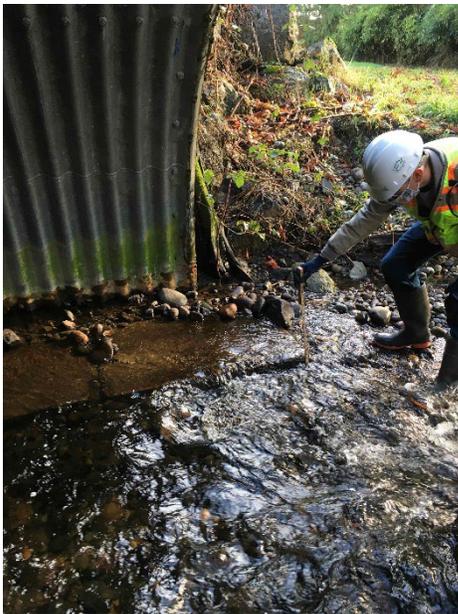
Monitor scour of east footing (Pier 2) during high flow events especially the exposed footing at inlet. East half of rock weir has been removed by flows.

SE Footing exposed 5" in winter inspection

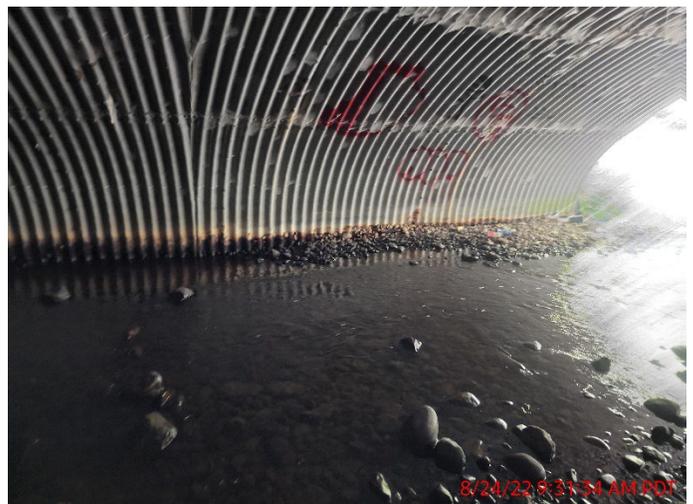
SE Footing only top exposure in summer inspection

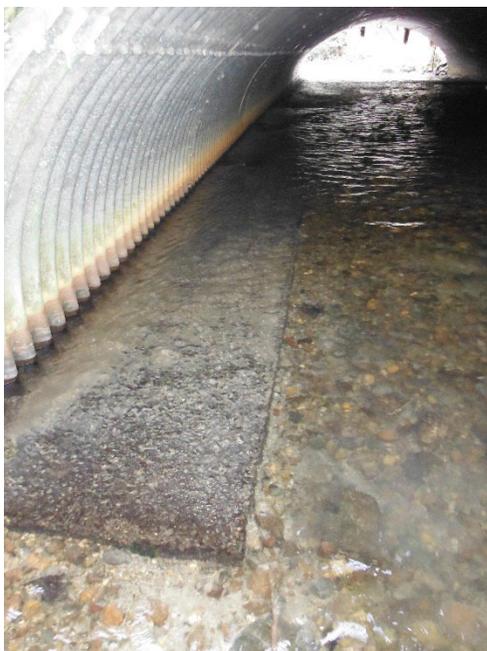
Monitor scour along the N & S footing areas at inlet ends. Top surface of Pier 1 (South) footing exposed in winter inspection. Top surface of Pier 2(North) footing exposed from inlet (East) back approx. 20 LF with 10" vertical at inlet. Monitor upstream debris. Monitor repair patching and cracking in ACP above culvert. South Pier (P1) wing wall at inlet end cracking at seam, approximately ¼".

Footing Exposed

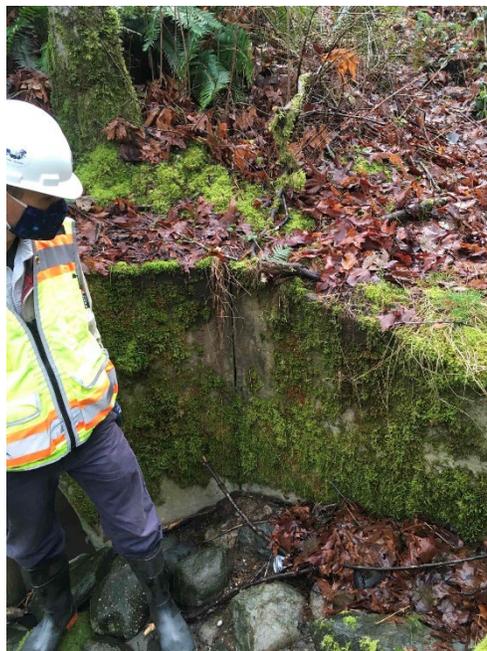
Pier 1 Inlet Wing Wall cracking

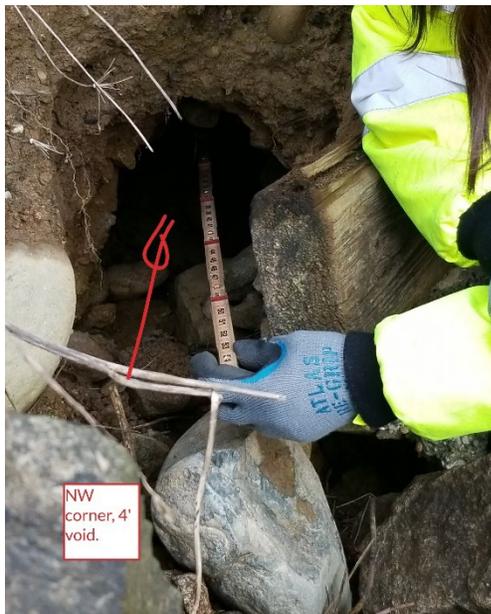
Abutment at Pier 4 with material loss at NW corner

Monitor steel sheet pile wall at west abutment and any movement of the beach armor rock. Existing piles at west abutment are now exposed 5' below pile cap and should be monitored closely during high water events and tides. Monitor settlement of native material under sidewalk panels at all four corners. Recommend packing in quarry spalls at NE corner abutment due to undermining from tidal action. Timber pedestrian rail is rotting and should be replaced. Cathodic protection is recommended for steel sheet pile abutment. Reseal Southwest joint.

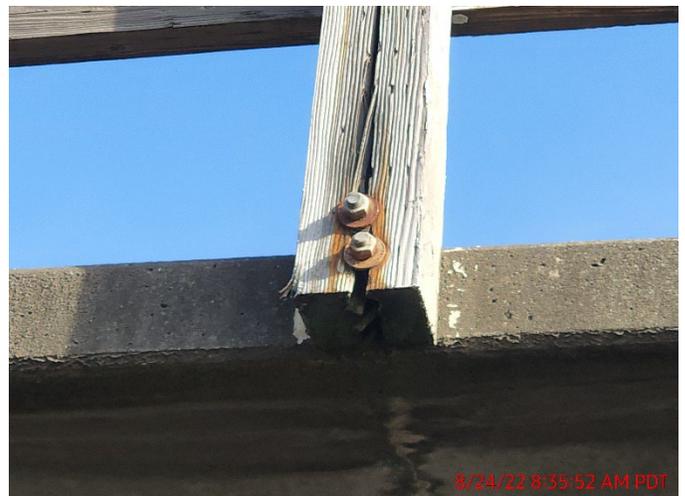
Timber Ped Rail in need of replacement

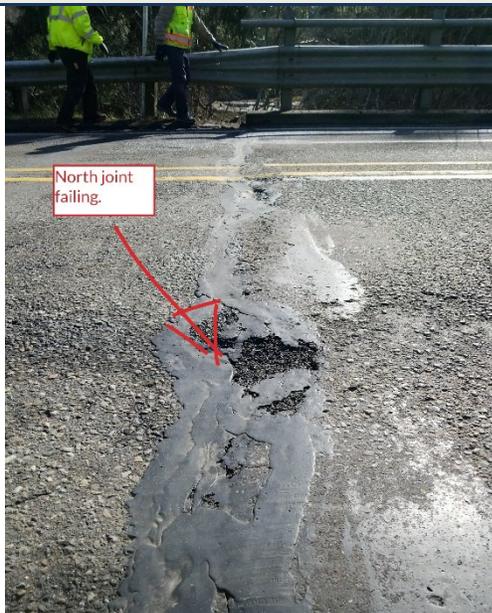
North bridge joint in need of repair

Repair Northeast bridge joint and resal the Southwest bridge joint. Monitor material loss and settlement at cantilevered spans. Repair ACP curb at NW corner to prevent surface runoff and slope surface erosion.

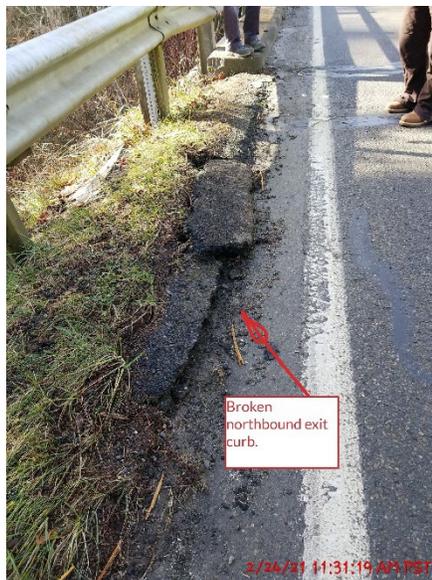
Broken ACP curb at NW corner of bridge

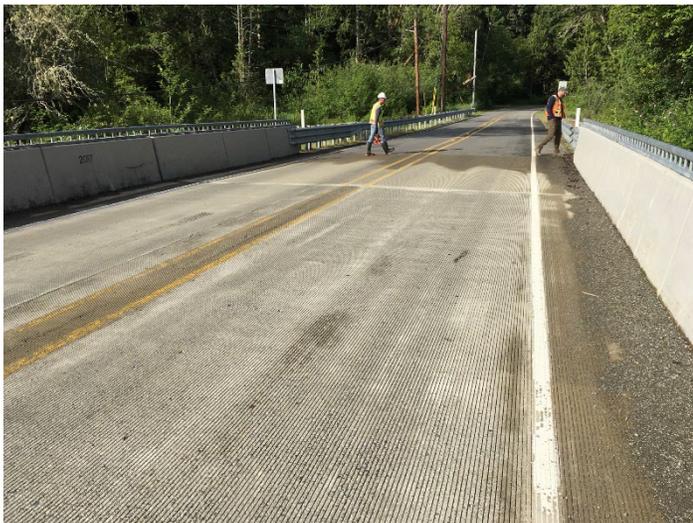
Sand buildup at shoulder

Monitor scaling of Southbound bridge deck. May warrant surface treatment if continues to deteriorate. Monitor settlement at approach slabs approximately $\frac{1}{4}$ ". Deck shoulders have sand buildup from wintertime maintenance. Reseal asphalt joint at approach slabs.

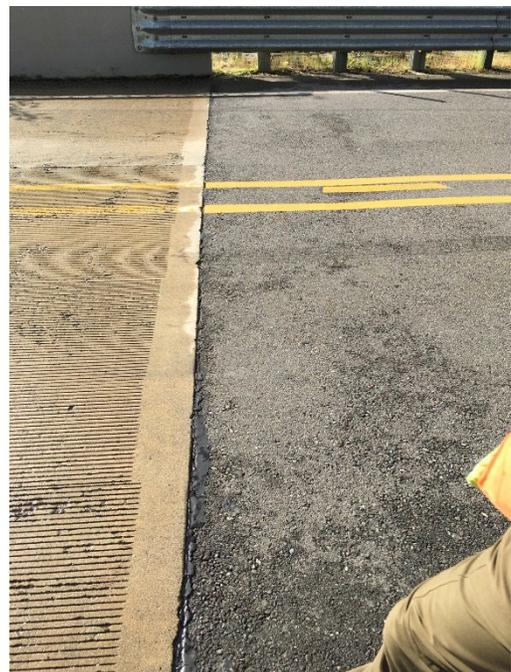
Reseal asphalt joint at approach slabs

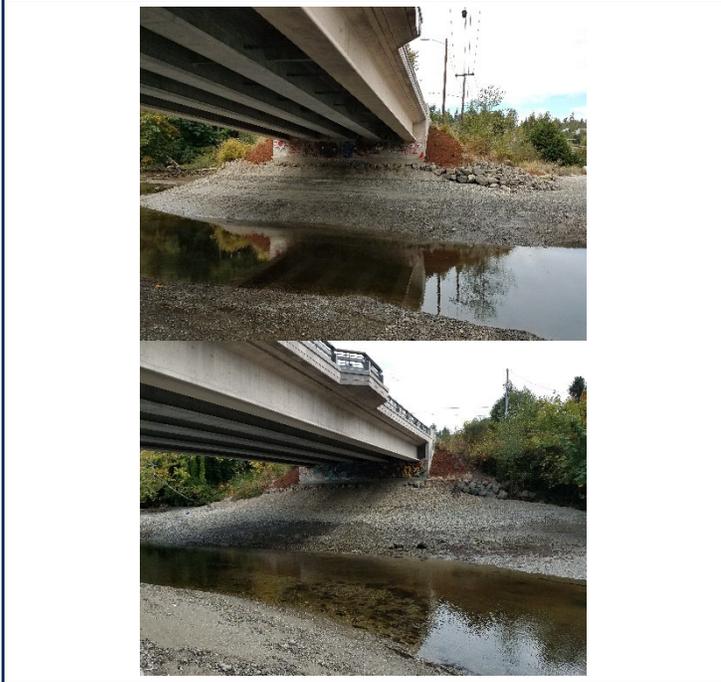
Summer 2018 Abutment Scour Repair

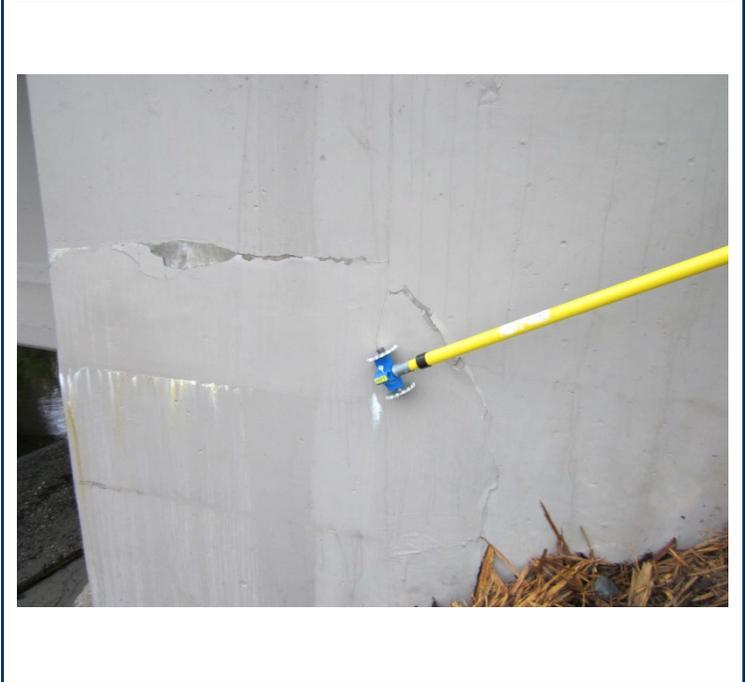
NW Corner Surface Spall

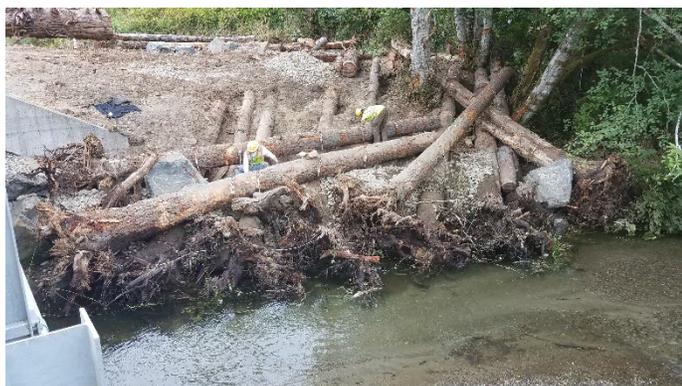
Pier 2 scour repair summer 2018

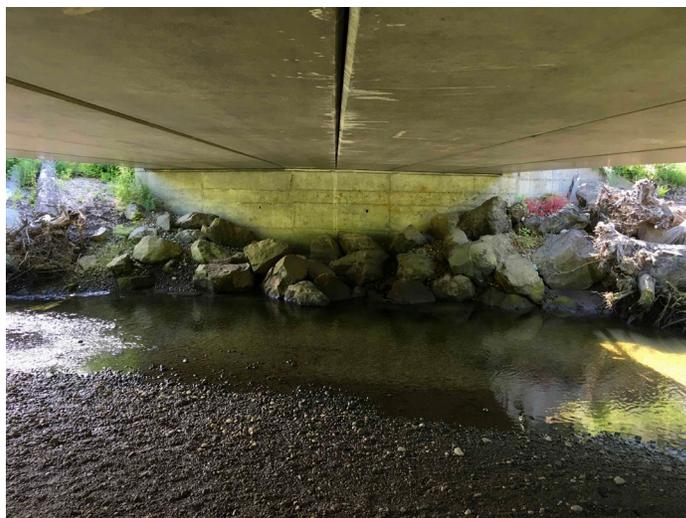
Monitor scour countermeasures and abutments for scour during high tides and high-water events. Pier 2 abutment has some erosion of the armament mainly in the center of the abutment and large riprap has begun to topple into the creek.

Pier 2 Armament Sloughing

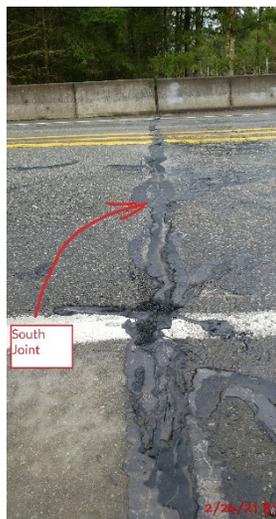
South joint

Grout conduit void at North abutment between girders A & B. Deteriorating joint allowing soils to migrate to the abutments underneath bridge, recommend repairing north ACP bridge joint. Recommend recoating exposed rebar on girder undersides with galvanizing spray. Recommend placing grout in gap between concrete slope protection and abutment at east end on north pier.

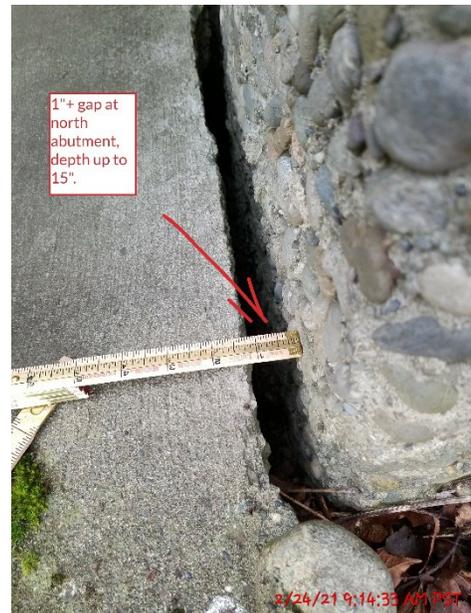
Gap in concrete slope protection with void at NE corner

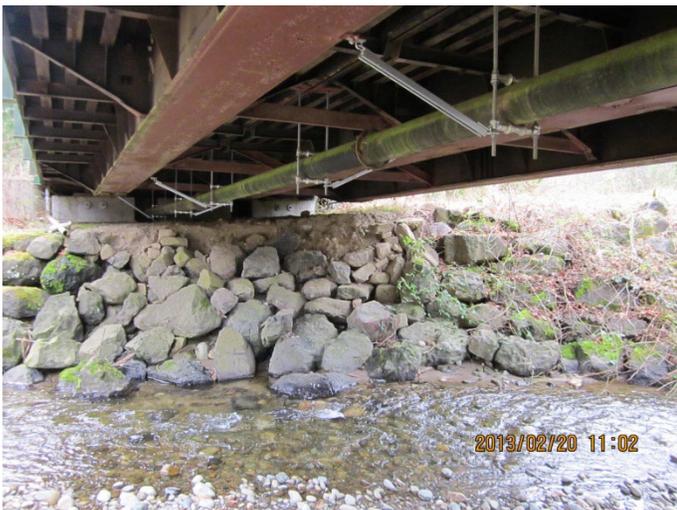
Sloughing of Rock Armor on East Abutment

Monitor sloughing rock slope armor at east abutment. Clean drain at NE corner of the bridge. Guardrail Terminal at the NW corner was missing hardware to secure to the wooden post. This has already been fixed by Roads Maintenance.

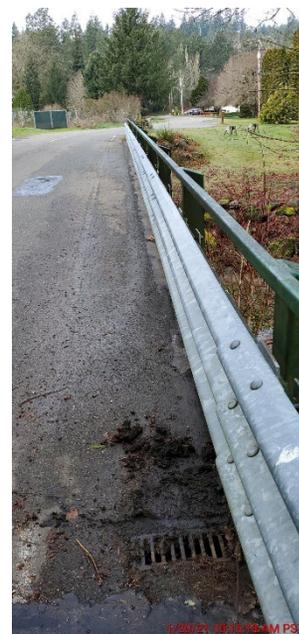
NE Corner Drain to clean

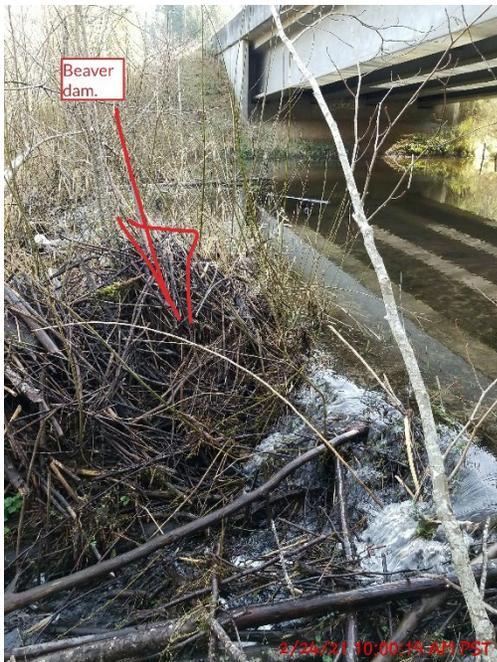
Beaver dam at north side of structure. Heavy sediment build-up under bridge.

Reseal both bridge joints at approach slabs. Monitor transverse cracking and scaling in deck. Monitor stream flow path and large sediment deposits and heavy vegetation growth under the bridge. Beaver intrusion/activity spotted at location recently.

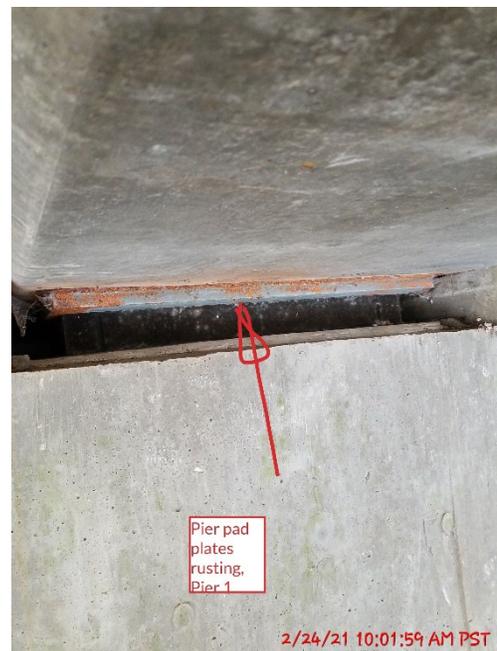
Superstructure	Girder	Precast prestressed concrete (W83G) bulb-tee girders, approx. length of 127'. 6" spall with exposed rebar on exterior flange at the SE corner between wing wall & barrier. Plates between girders and elastomeric pads beginning to rust, more predominantly at Pier 1.
	Deck	9" cast-in-place concrete deck and epoxy coated reinforcement. Numerous transverse cracks across deck full width across deck area – 6' to 8' spacing. Crack lengths and widths appear to be increasing. Silica sealer applied to entire deck area in Summer 2014. The majority of the sealed is worn off in the travel lanes. Minor flexure cracks evident between all girders with efflorescence showing in deck underside. Deck surface is starting to scale in the wheel tracks. 2 small deck spalls at expansion joints SE & NW corners in the driving lane. West expansion joint starting to crack and separate.
	Other	Cast-in-place concrete bridge railing. Minor scraps along the north barrier as well as the nw corner spalled off from a vehicular accident. Barrier joint filler between sections is worn/missing allowing moisture/sediment to travel from the roadway to abutment. Guardrail transitions and terminals were replace in 2020 under CRP 5032.

Girder plates beginning to rust. More predominantly at West Pier 1

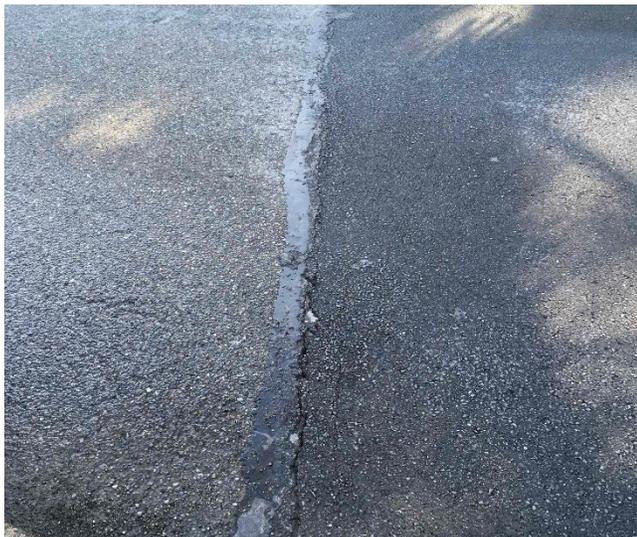
Reseal Bridge Joints

Monitor cracking in pier walls and deck underside. Monitor roadway settlement at both ends. Clean debris from fish ladder gate at lake side. Remove logs hung up on inlet end of spillway. Reseal bridge ACP at bridge joints.

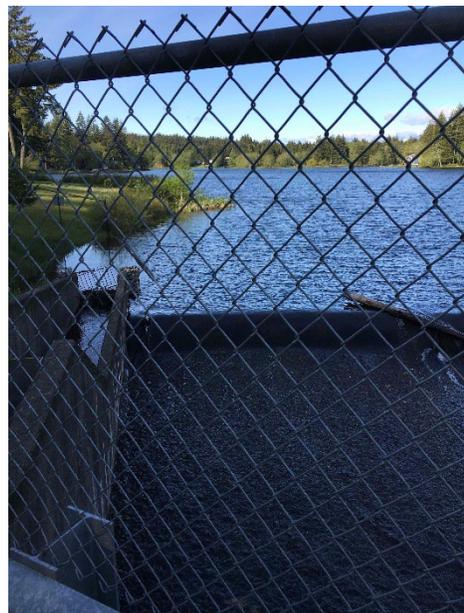
Clean debris from fish ladder gate & logs at inlet

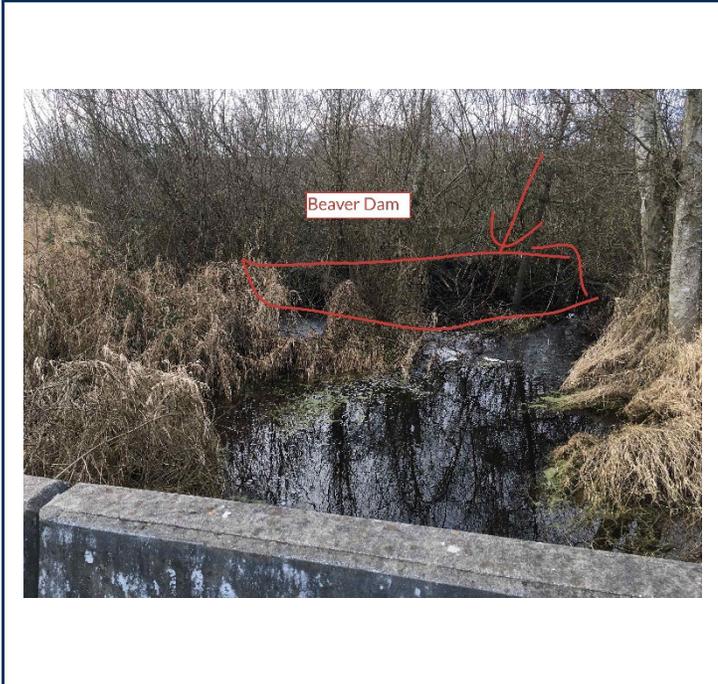
Upstream beaver dam

All components are in good condition. Large vegetation mass should be removed from inlet end as well as silt deposited at outlet end. Upstream beaver dam has been rebuilt (since removal in 2016) with approximately 5-6' height/elevation. Monitor large woody debris lodged in SW quad at inlet.

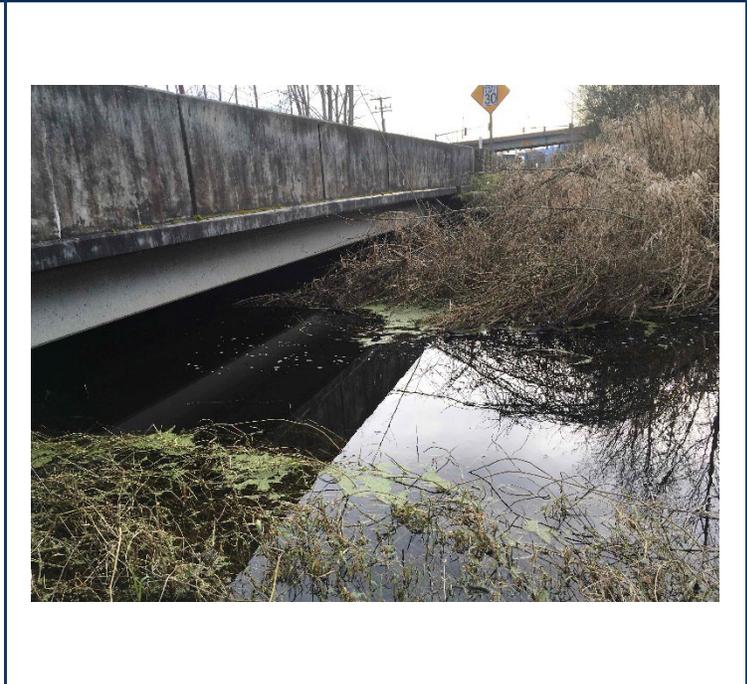
Debris buildup in SW quadrant at inlet end.

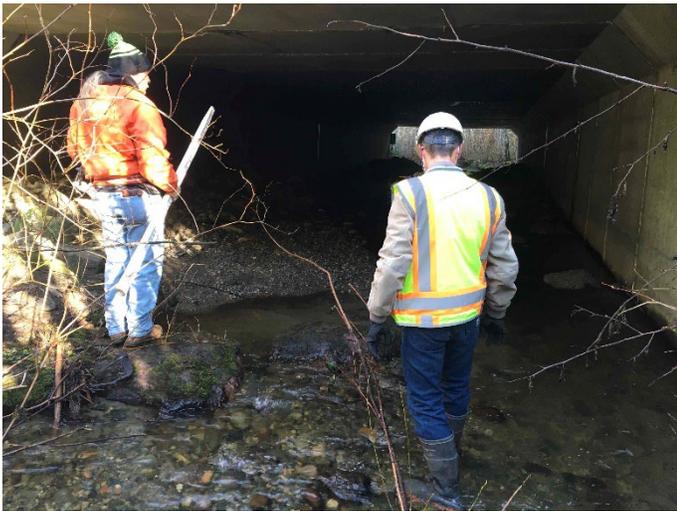
Heavy growth and sedimentation at Inlet end looking east.

Monitor streambed movement at the SE corner at inlet end. Heavy growth and sediment deposits at inlet end should be monitored or removed.

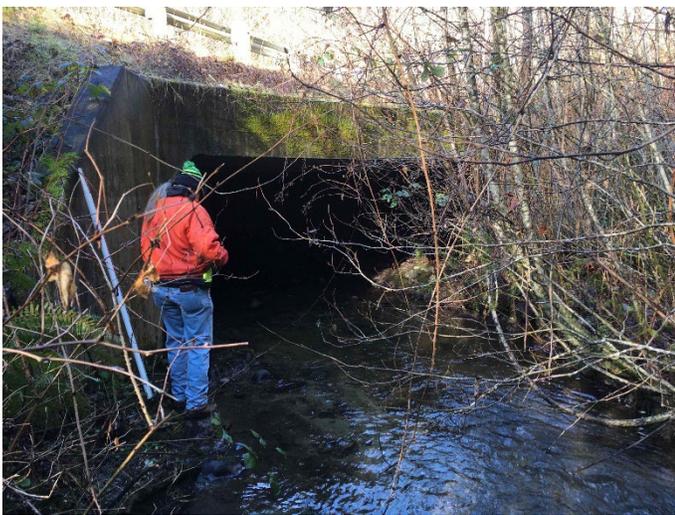
Inlet end vegetation/sediment build-up

Monitor spalling in ceiling areas. Heavy growth and sediment deposits at inlet and outlet ends should be monitored or removed. There is also sediment and streambed gravel aggregation underneath the length of the structure on Pier 2 side. Monitor flows at NW corner as material continues to be removed by flows.

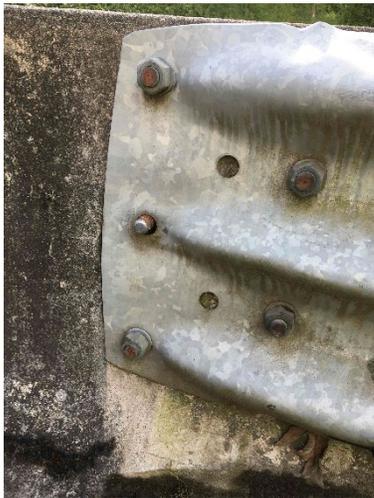
Replace missing nut at SE transition

Replace missing nut at guardrail transition section connection to concrete barrier at SE quadrant. Replace missing screw on utility conduit cover/access. Reseal ACP at Bridge Joints

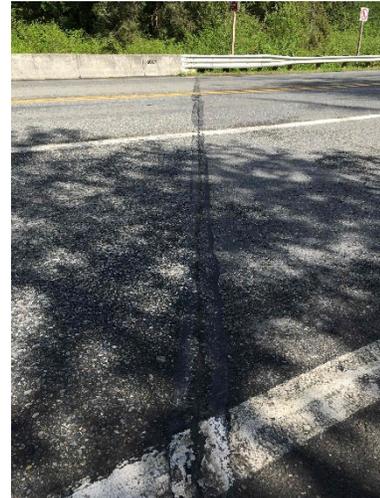
Reseal ACP at Bridge Joints

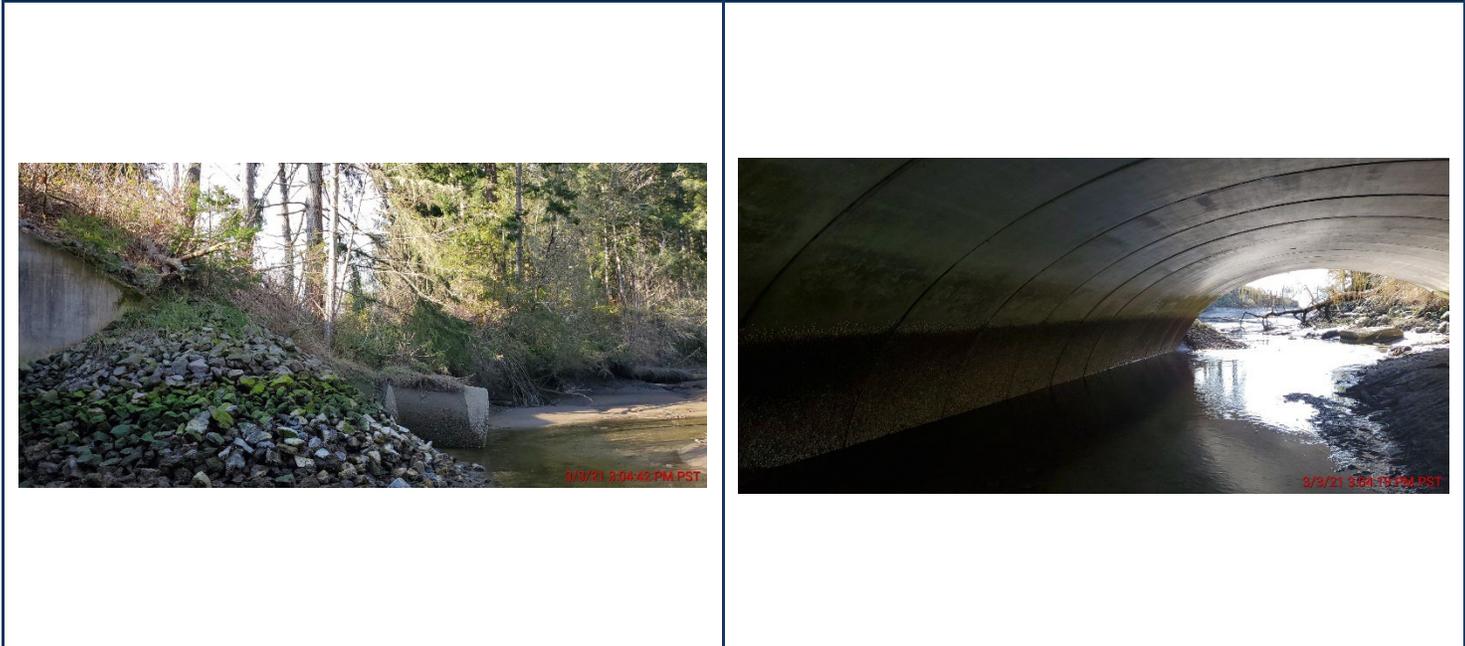
Upstream concrete storm pipe, last section disconnected	Flows along southern pier and sediment buildup along north pier
--	--

Recommendations	Monitor rotational movement and or settlement at wing wall connections. Monitor flows through structure concentrated in the south side, no exposure of the footing at this time.
------------------------	--

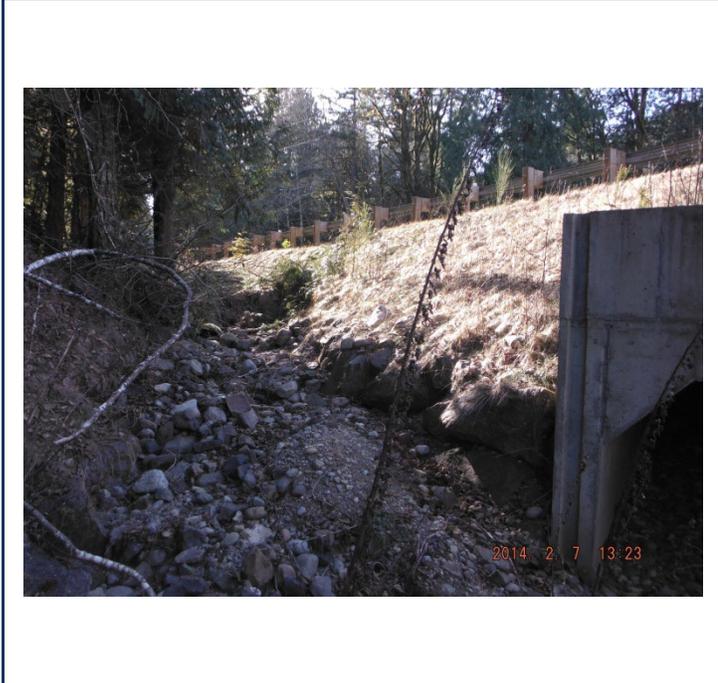
Embankment sloughing at SE Corner

Recommendations Monitor off site flows near wing wall at SE corner. Seasonal flows only.
