2022 Annual Bridge Report

Prepared by Kitsap County Public Works
Engineering Division

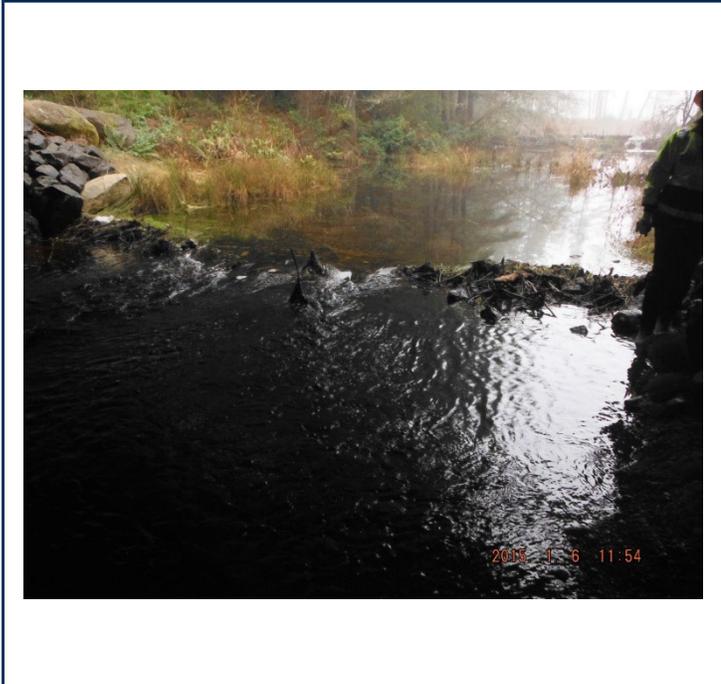
Rock & Wood Dam at inlet end.

Seal longitudinal cracking in wheel tracks of ACP which has been accelerating. Remove rock & wood dam being built at inlet end. Monitor the ponding water at the North side of the bridge and at NW corner due to settlement.

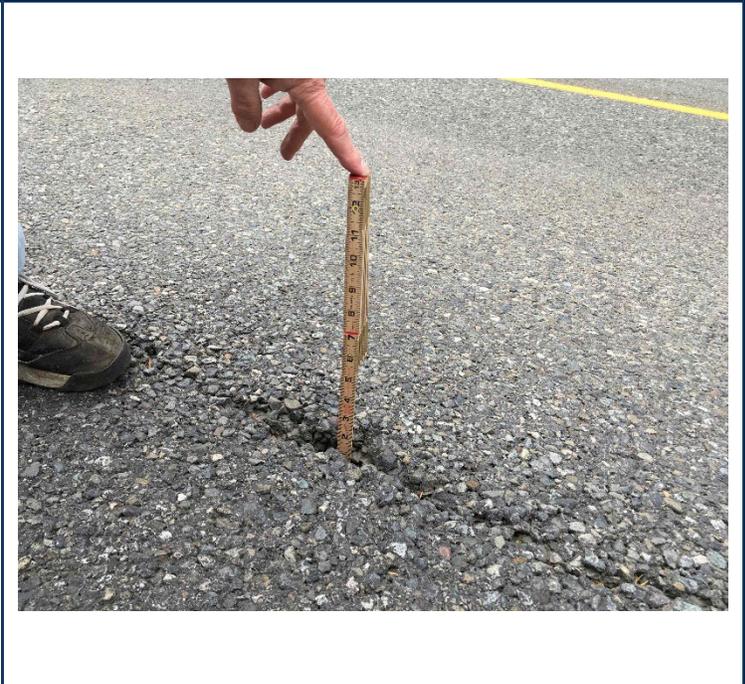
**ACP wearing down in wheel tracks.
Alligatoring in some spots.**

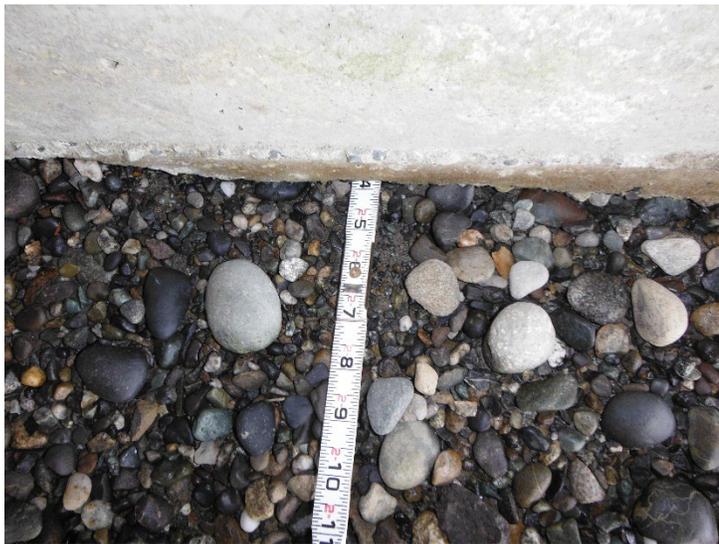
Pier 1 scour under abutment

Monitor abutment slopes during higher tides. Monitor material loss at all four corners. Monitor material loss at center of Pier 1 abutment which is approximately 12 LF across the bottom face of the abutment and as much as 2.45' in depth back from face. Between the continuous tidal action and mobile streambed material, this bridge may need future shotcrete protection of abutment and piles similar to Southworth Bridge (#21). Reseal ACP at Pier 2 joint.

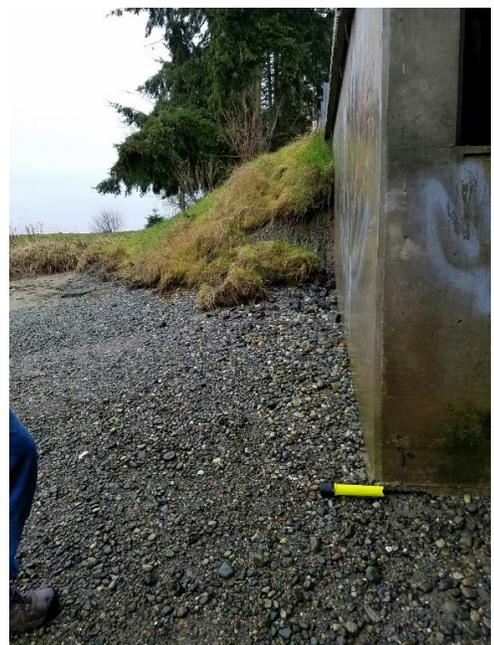
Material sloughing & loss at NE corner

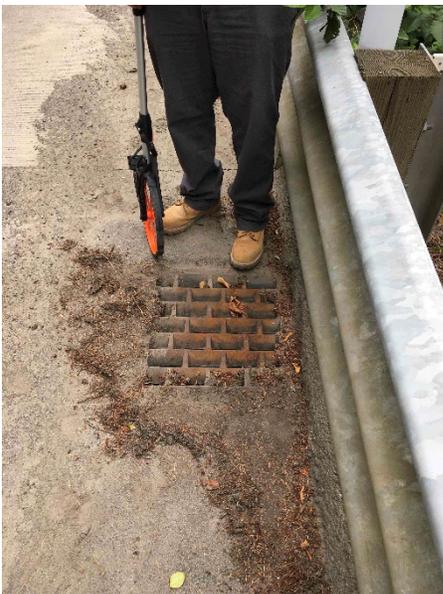
Clean debris build-up at CB

Monitor CB at SW corner for plugging. Monitor erosion area at SE quadrant over embankment slope. Clean and place hot poured joint to seal water out at both bridge joints. Clean debris build-up at CB at SW corner.

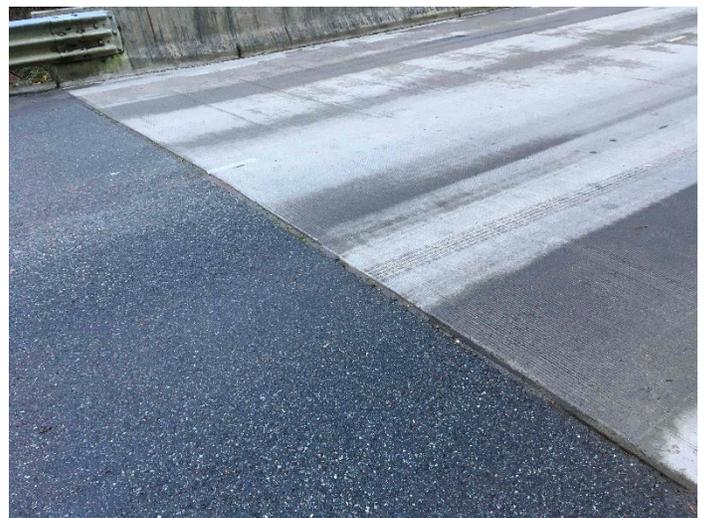
Clean and seal bridge joints

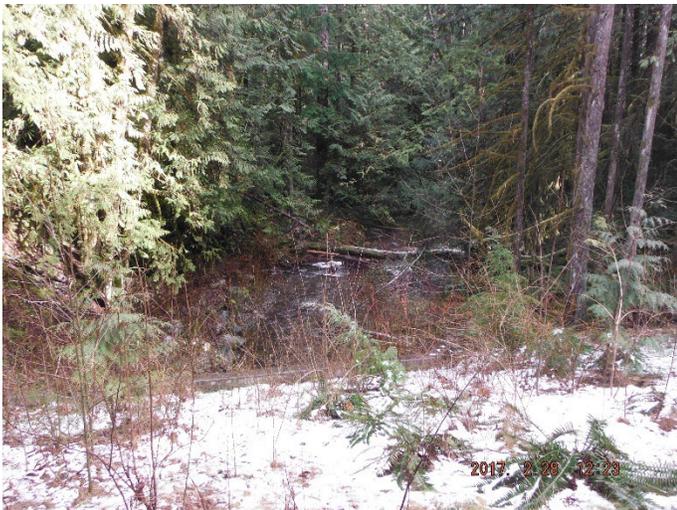
Downstream debris

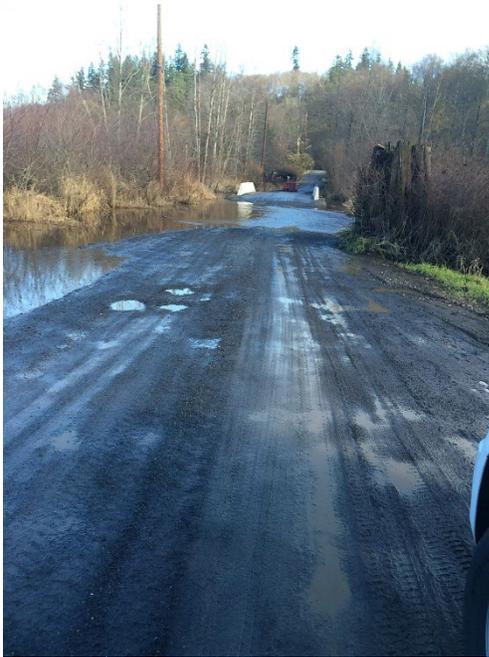
Water over approach roadway on West end.

Monitor roadway settlement on both sides of deck. Monitor settlement and separation of barrier terminals at all 4 corners. Monitor water over roadway in high flows. Replace broken/missing reflective tape on South barrier. Seal cracking in ACP at bridge joints resulting from settlement.

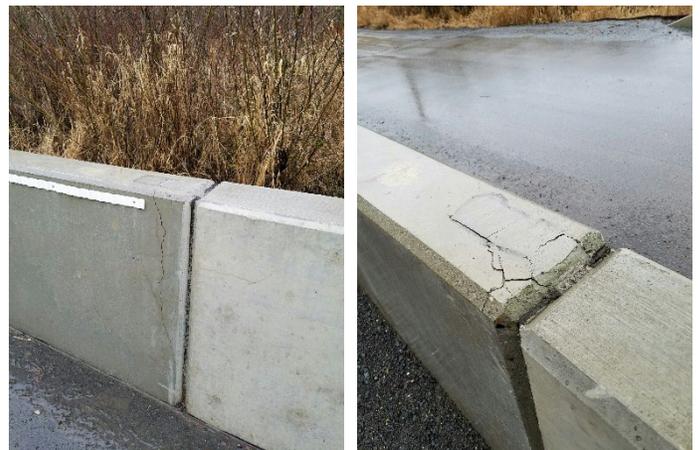
Superstructure	Girder	Precast concrete slabs 14" x 48" x 23' in length.
	Deck	3" HMA over Waterproof Membrane.
	Other	Cast-in-place concrete bridge barrier has cracking at all 4 corner terminal connections to bridge barrier due to settlement on both ends behind abutment. On the south barrier, the reflective tape has been damaged and needs replacing.
Substructure	Foundation	Driven 9½" steel pile foundation approximately 35'-40' in length.
	Abutments	Cast-in-place concrete abutment with elastomeric bearing pads and sheet pile protection. Beam seat 21".
Scour and Load Rating	<p>Bridge has been load rated as per FHWA requirements by Sargent Engineering in 2015. Load Rating updated by TranTech Engineering in 2019 for SU and EV ratings.</p> <p>Scour analysis has not yet been performed for this structure.</p>	
Photo

Cracking & separation of Barrier terminals

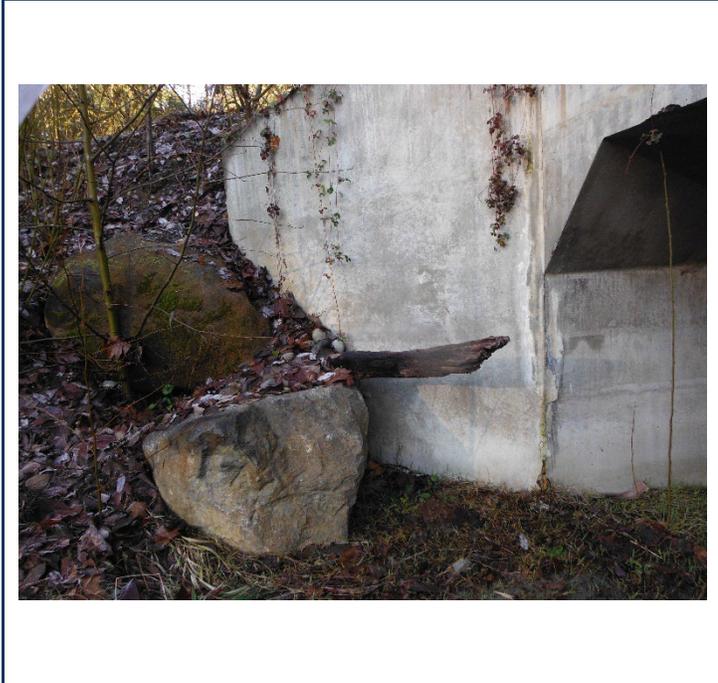
Inlet Pier 1 SW corner

Recommendations	Monitor moisture at joints. Monitor bank at SW corner wing wall. No notable changes since last inspections. Beaver sticks present but no beaver dam at this time.
------------------------	---

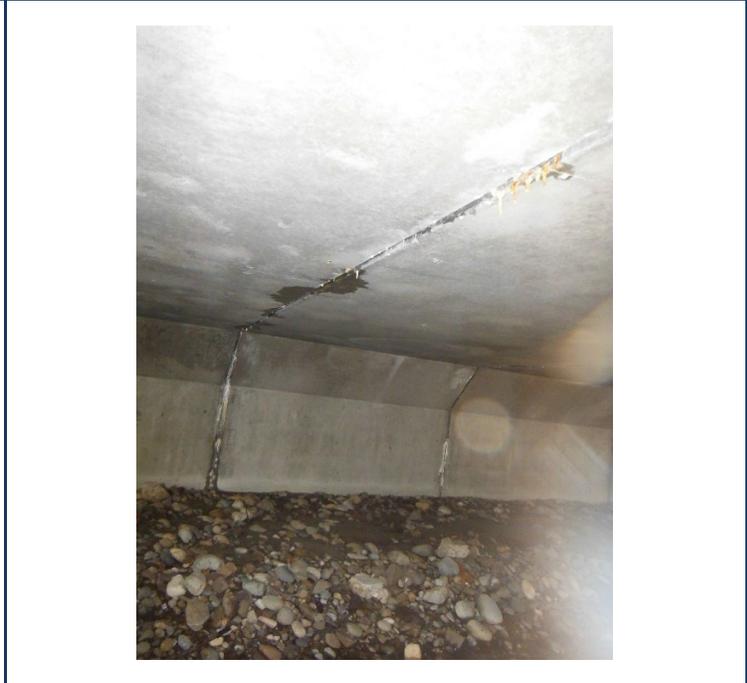
<i>Superstructure</i>	<i>Culvert</i>	3-side precast concrete culvert 35' length with a 23' span x 9'-10" rise. Components are all in good condition. Minor moisture present at joints including leaking in spots with efflorescence.
<i>Substructure</i>	<i>Foundation</i>	Precast footings and wing walls with rebar reinforcement.
<i>Scour and Load Rating</i>	Bridge has been load rated as per FHWA requirements by TranTech Engineering in 2019. Scour analysis has not yet been performed for this structure.

Wall & ceiling seams with moisture & efflorescence

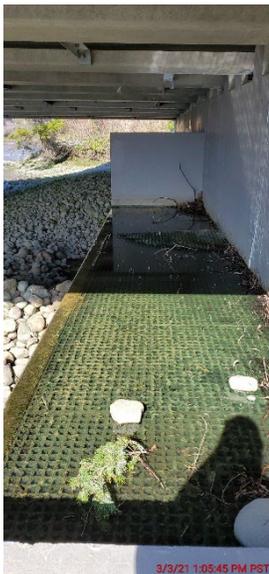
Stormwater diffuser grating needs maintenance

Clean vegetation from south side sidewalk. Address flow issues at stormwater diffuser causing erosion on southern half. Need to backfill overflow pipe from diffuser with cobbles as now is completely exposed to the elements.

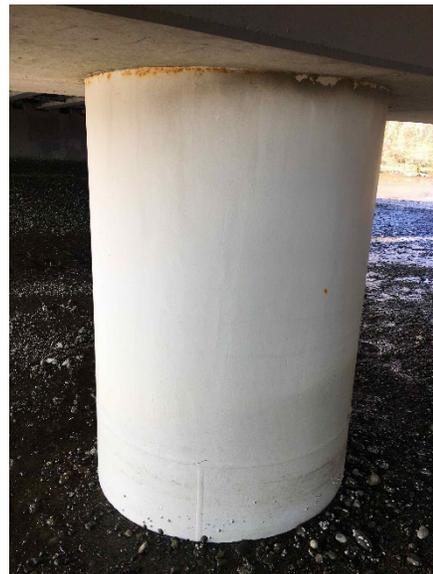
Pier 2 & 3 columns with rusting appearing at top of column

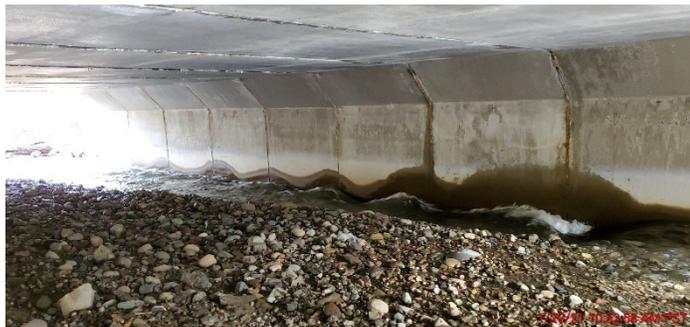
<i>Superstructure</i>	<i>Culvert</i>	3-side precast concrete culvert 50’ length with a 25’ span x 9’-10” rise. Components are all in new condition. Some moisture dripping between sections 4 & 5 on Pier 2 side.
<i>Substructure</i>	<i>Foundation</i>	Precast footings and wing walls with rebar reinforcement.
<i>Scour and Load Rating</i>	<p>Bridge has been load rated as per FHWA requirements by TranTech Engineering in 2019. Scour analysis has not yet been performed for this structure.</p> <p>Heavy beaver activity at inlet of this structure with dam full span across inlet. Water is flowing slight trickle on East end of structure. Only 3-4 feet of freeboard in culvert underside.</p>	
<i>Photo</i>

Flows concentrated at Pier 2

Monitor moisture in joint on Pier 2. Monitor beaver activity seen at upstream side of structure.

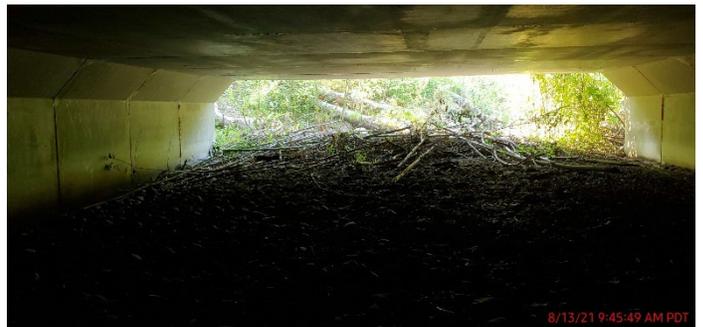
Beaver dam at inlet end

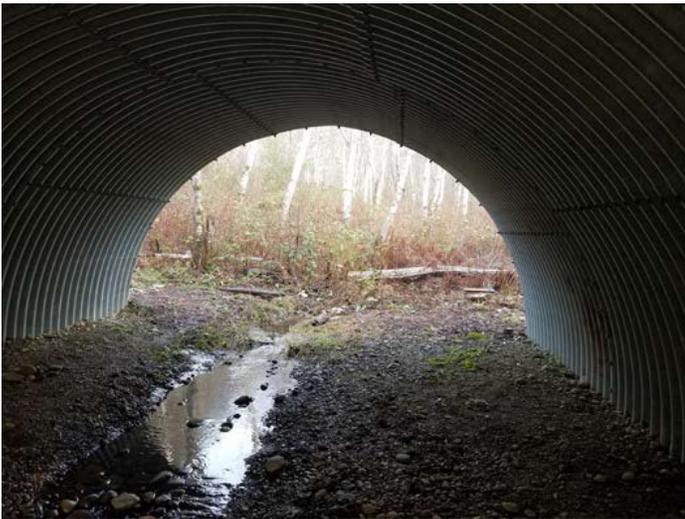
Low flow due to wetland drainage

No recommendations at this time. Monitor footing at Pier 1 for exposure. Currently approximately 6 feet of top of footing is now exposed.

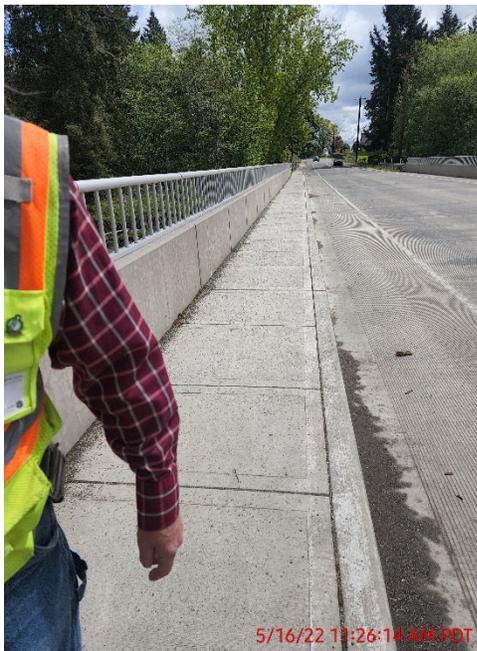
Sand Buildup

Clean sidewalks from sand buildup. Monitor settlement at asphalt joint with approach slabs.

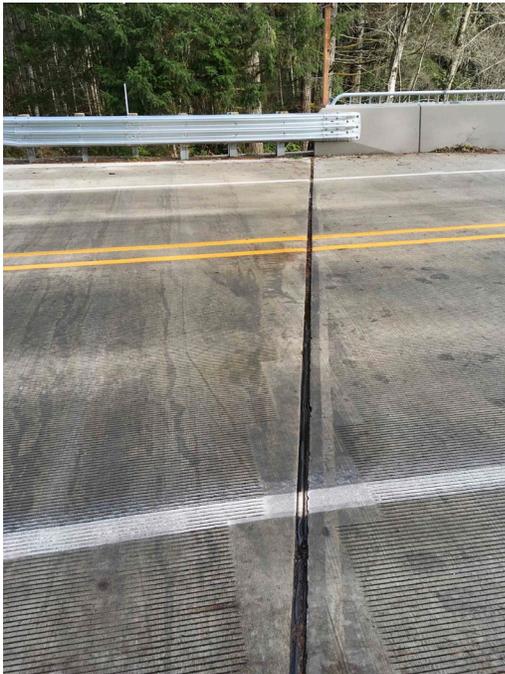
Compression Joint between deck and approach slab

Clean sand from compression joint seal between bridge and approach slabs. Apply hot poured joint sealer between ACP and Concrete approach slabs.

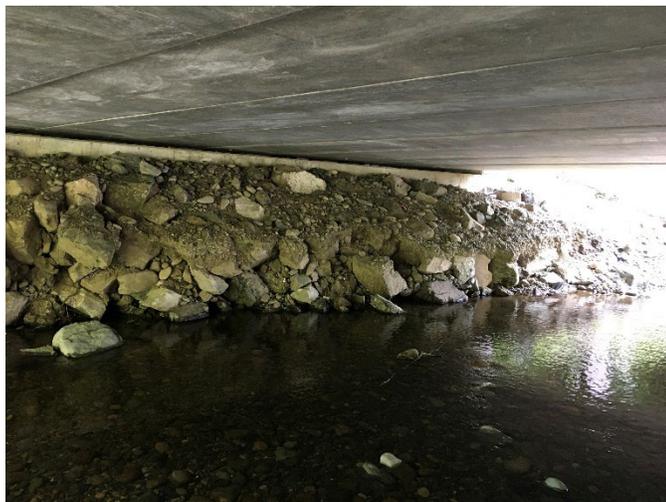
Monitor high flows for bank erosion. Some loss of lower rock armament on P2 side with potential for more in high flows.

Rock Armament @ P2

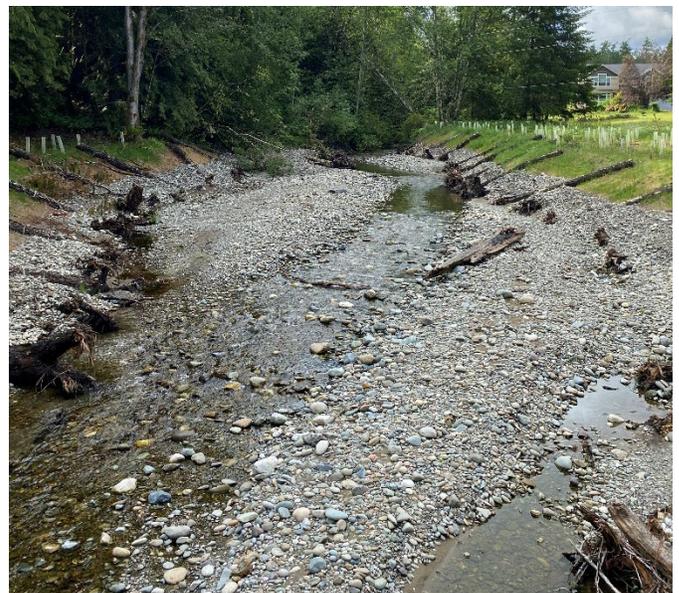
Upstream Bank Repairs
