2023 Annual Bridge Report

Prepared by Kitsap County Public Works Engineering Division This sheet intentionally left blank.

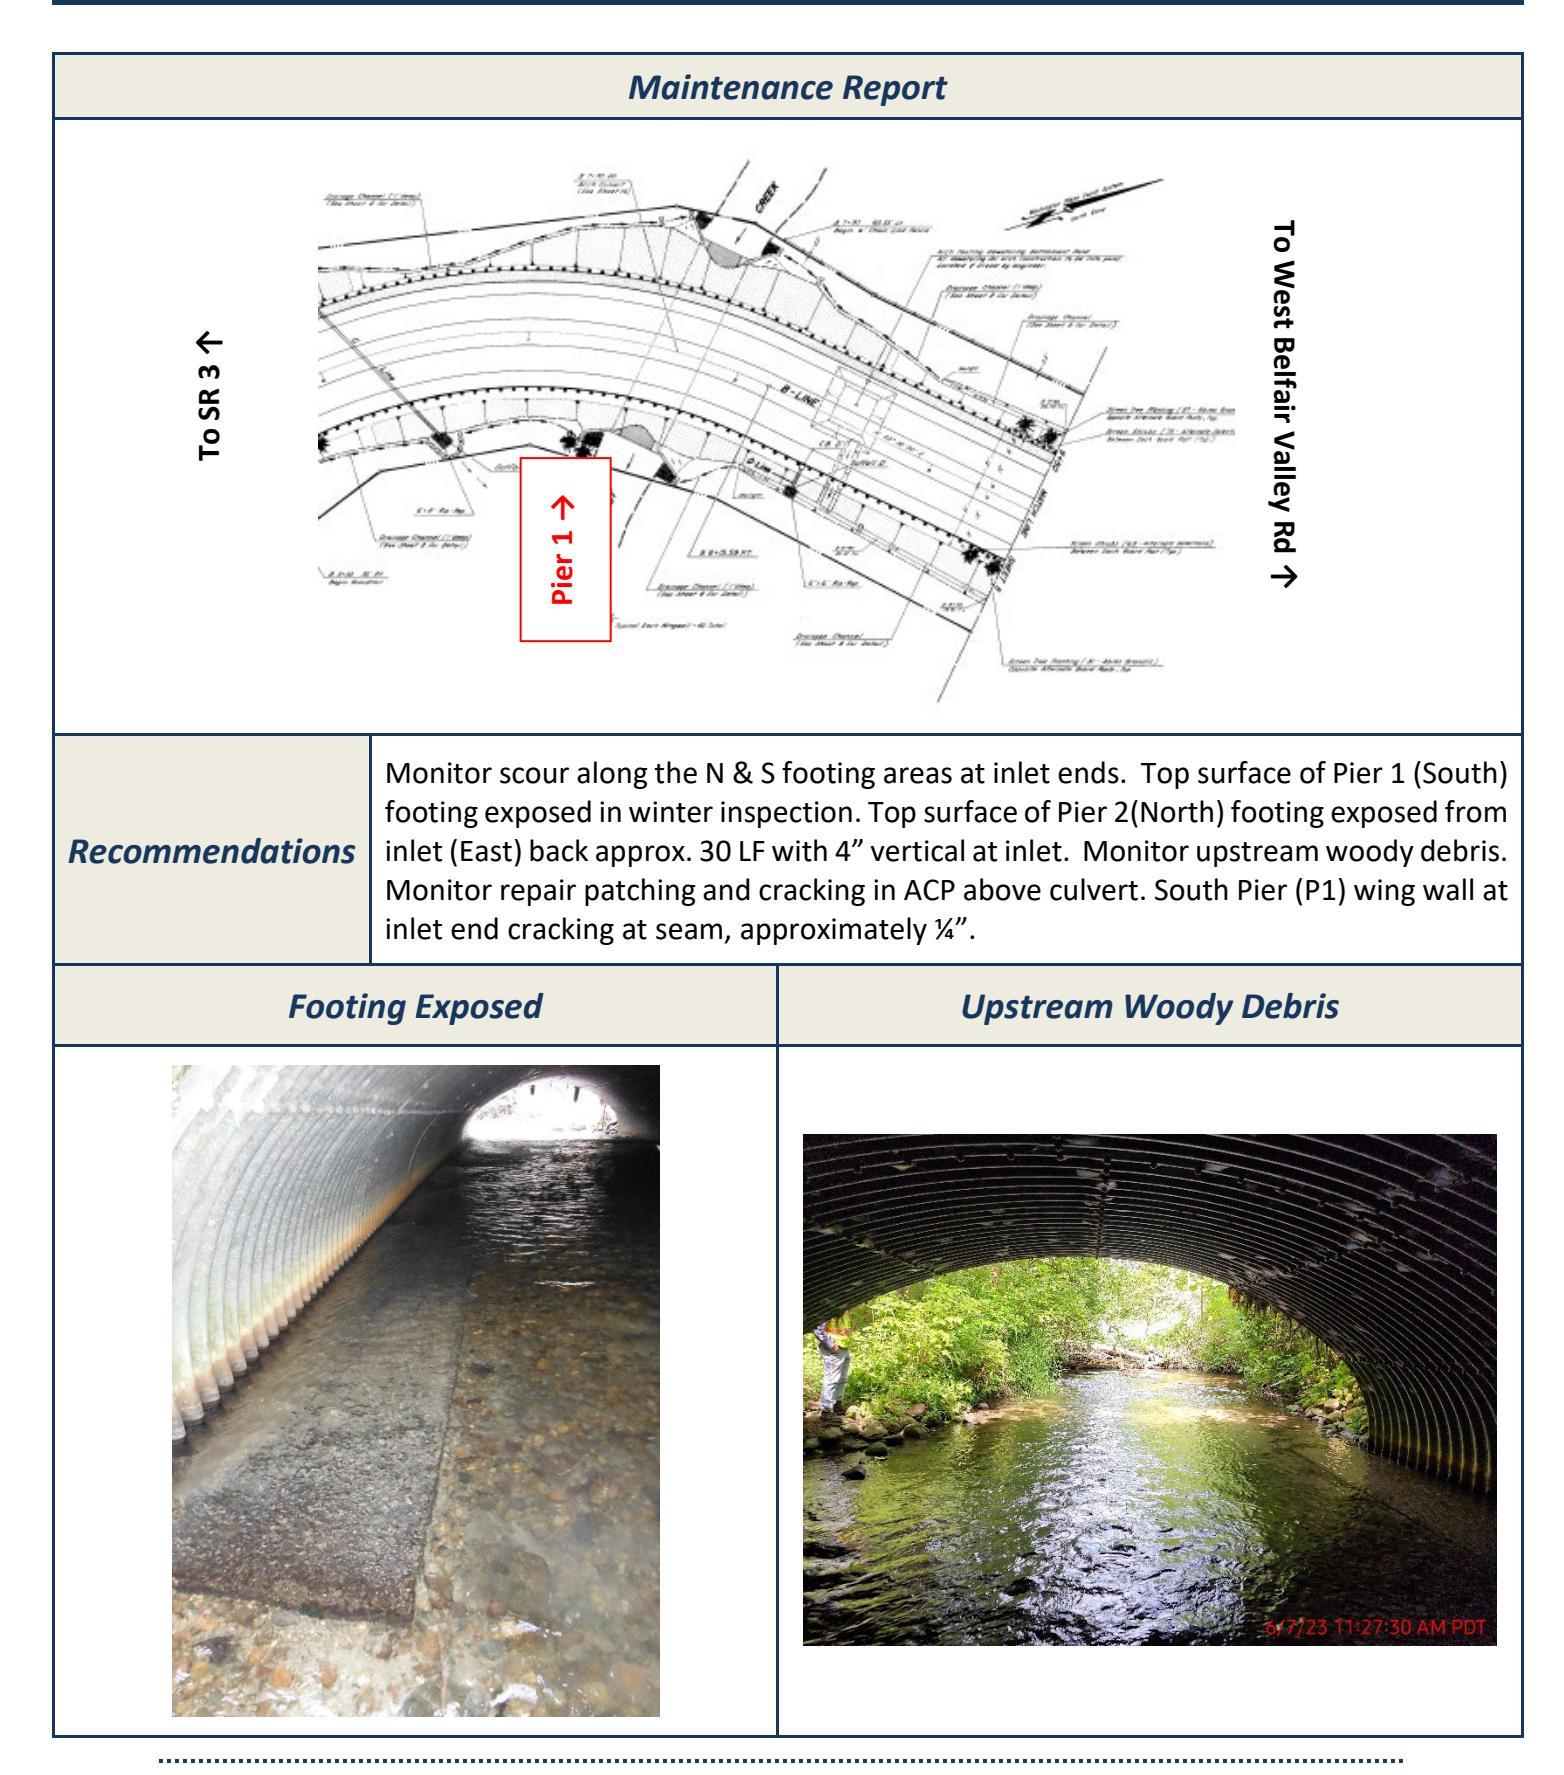
Bridge 17 – Sam Christopherson Arch Culvert					
Sam Christopherson Boulevard	Gorst Creek	1987	Good (G)	Jun. 7, 2023	
Route Name	Feature Intersected	Year Built	Overall Condition	Last Inspection

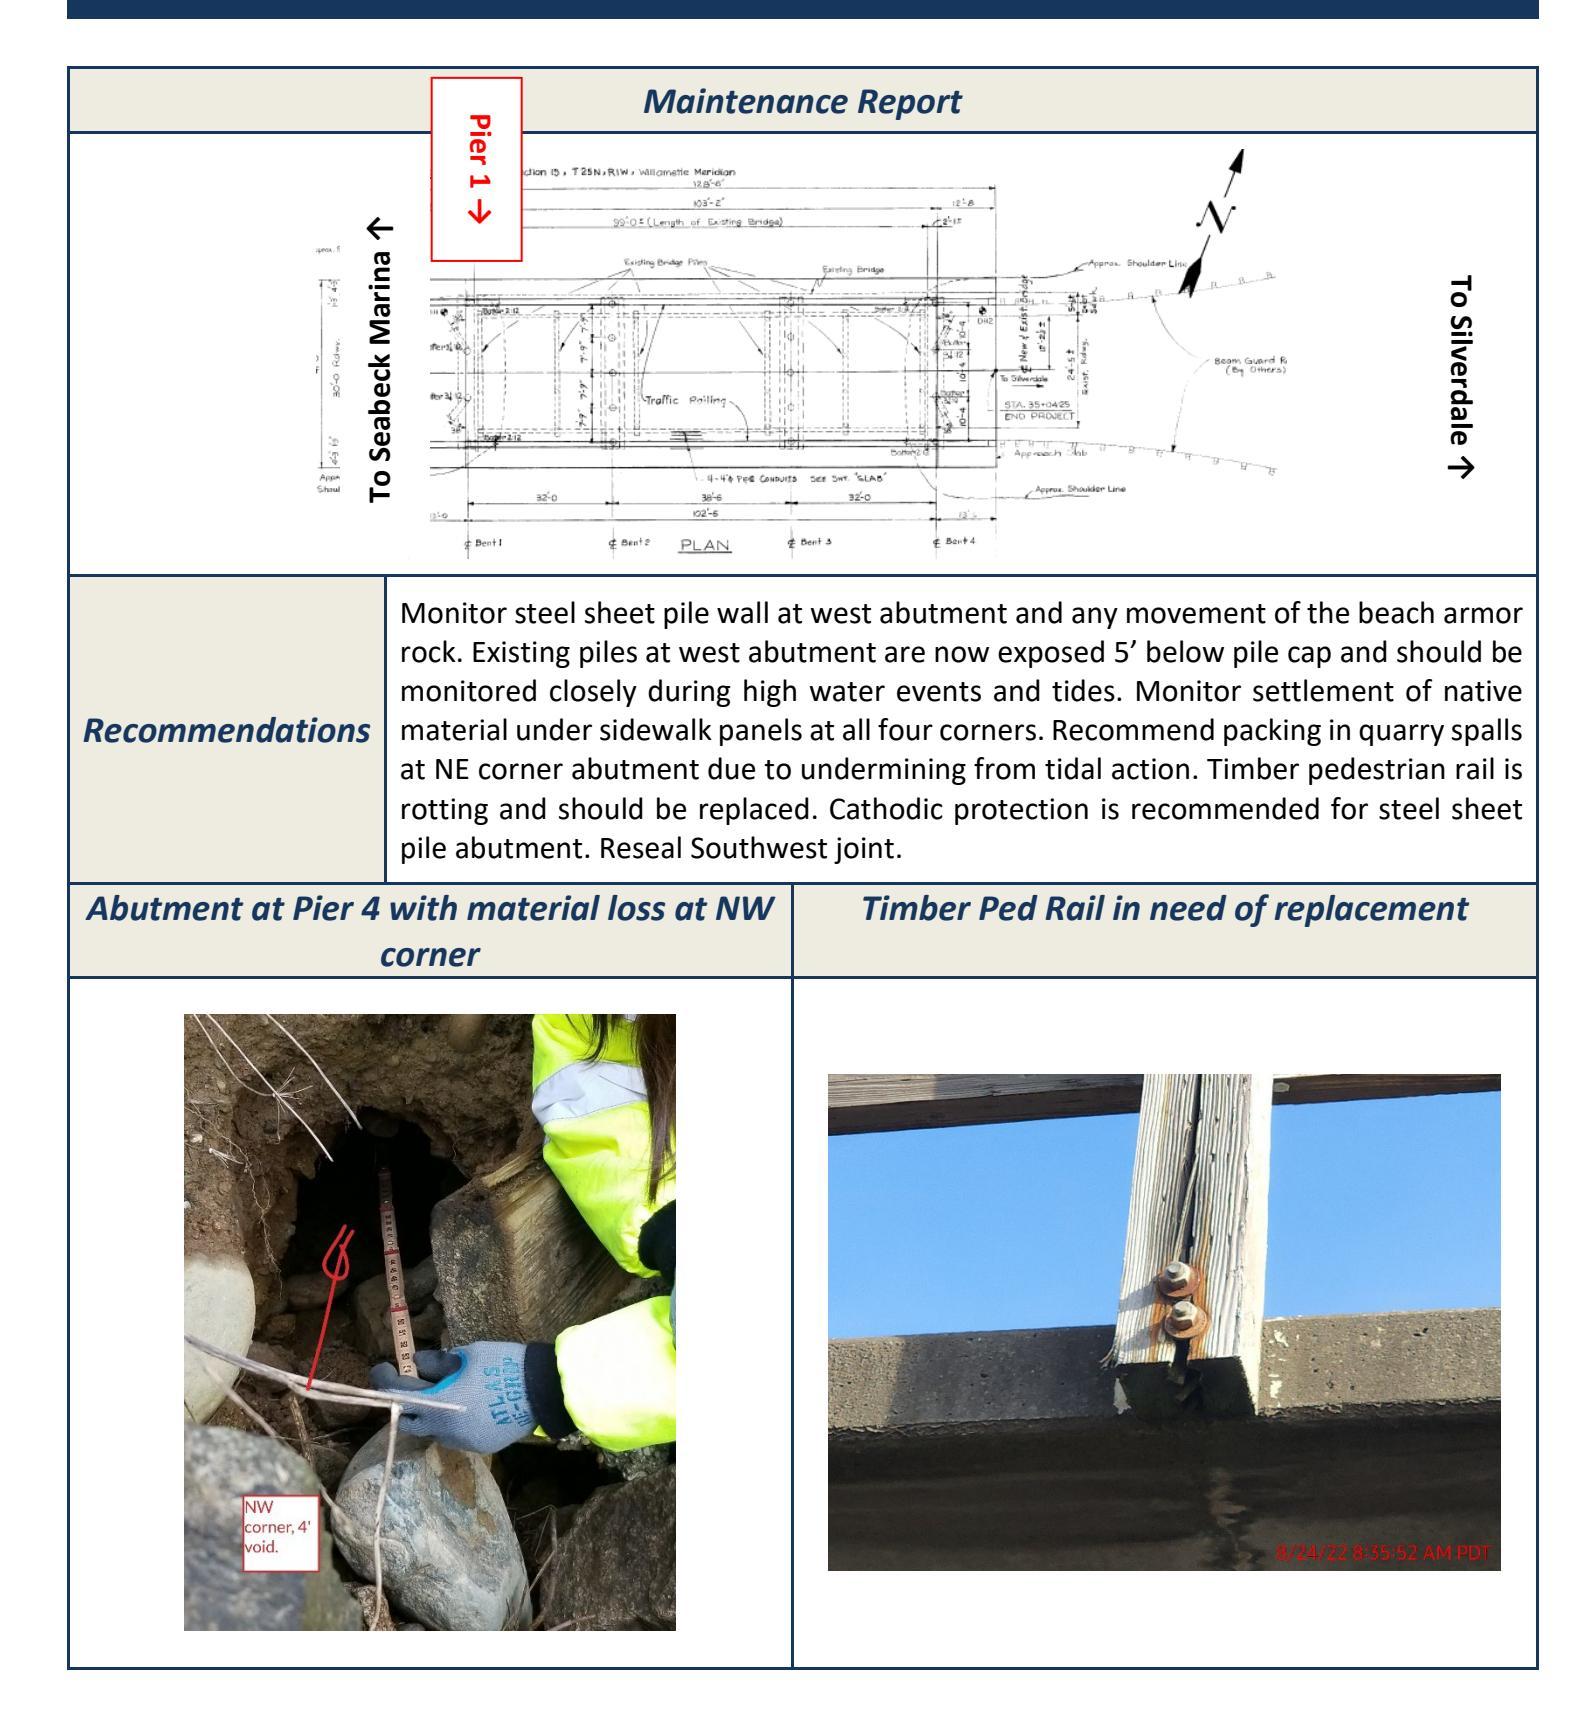
Bridge 18 – Big Beef Bridge								
Seabeck Highway Big Beef Creek 1974 Fair (F) Aug. 24, 202								
Route Name	Feature Intersected	Year Built	Overall Condition	Last Inspection

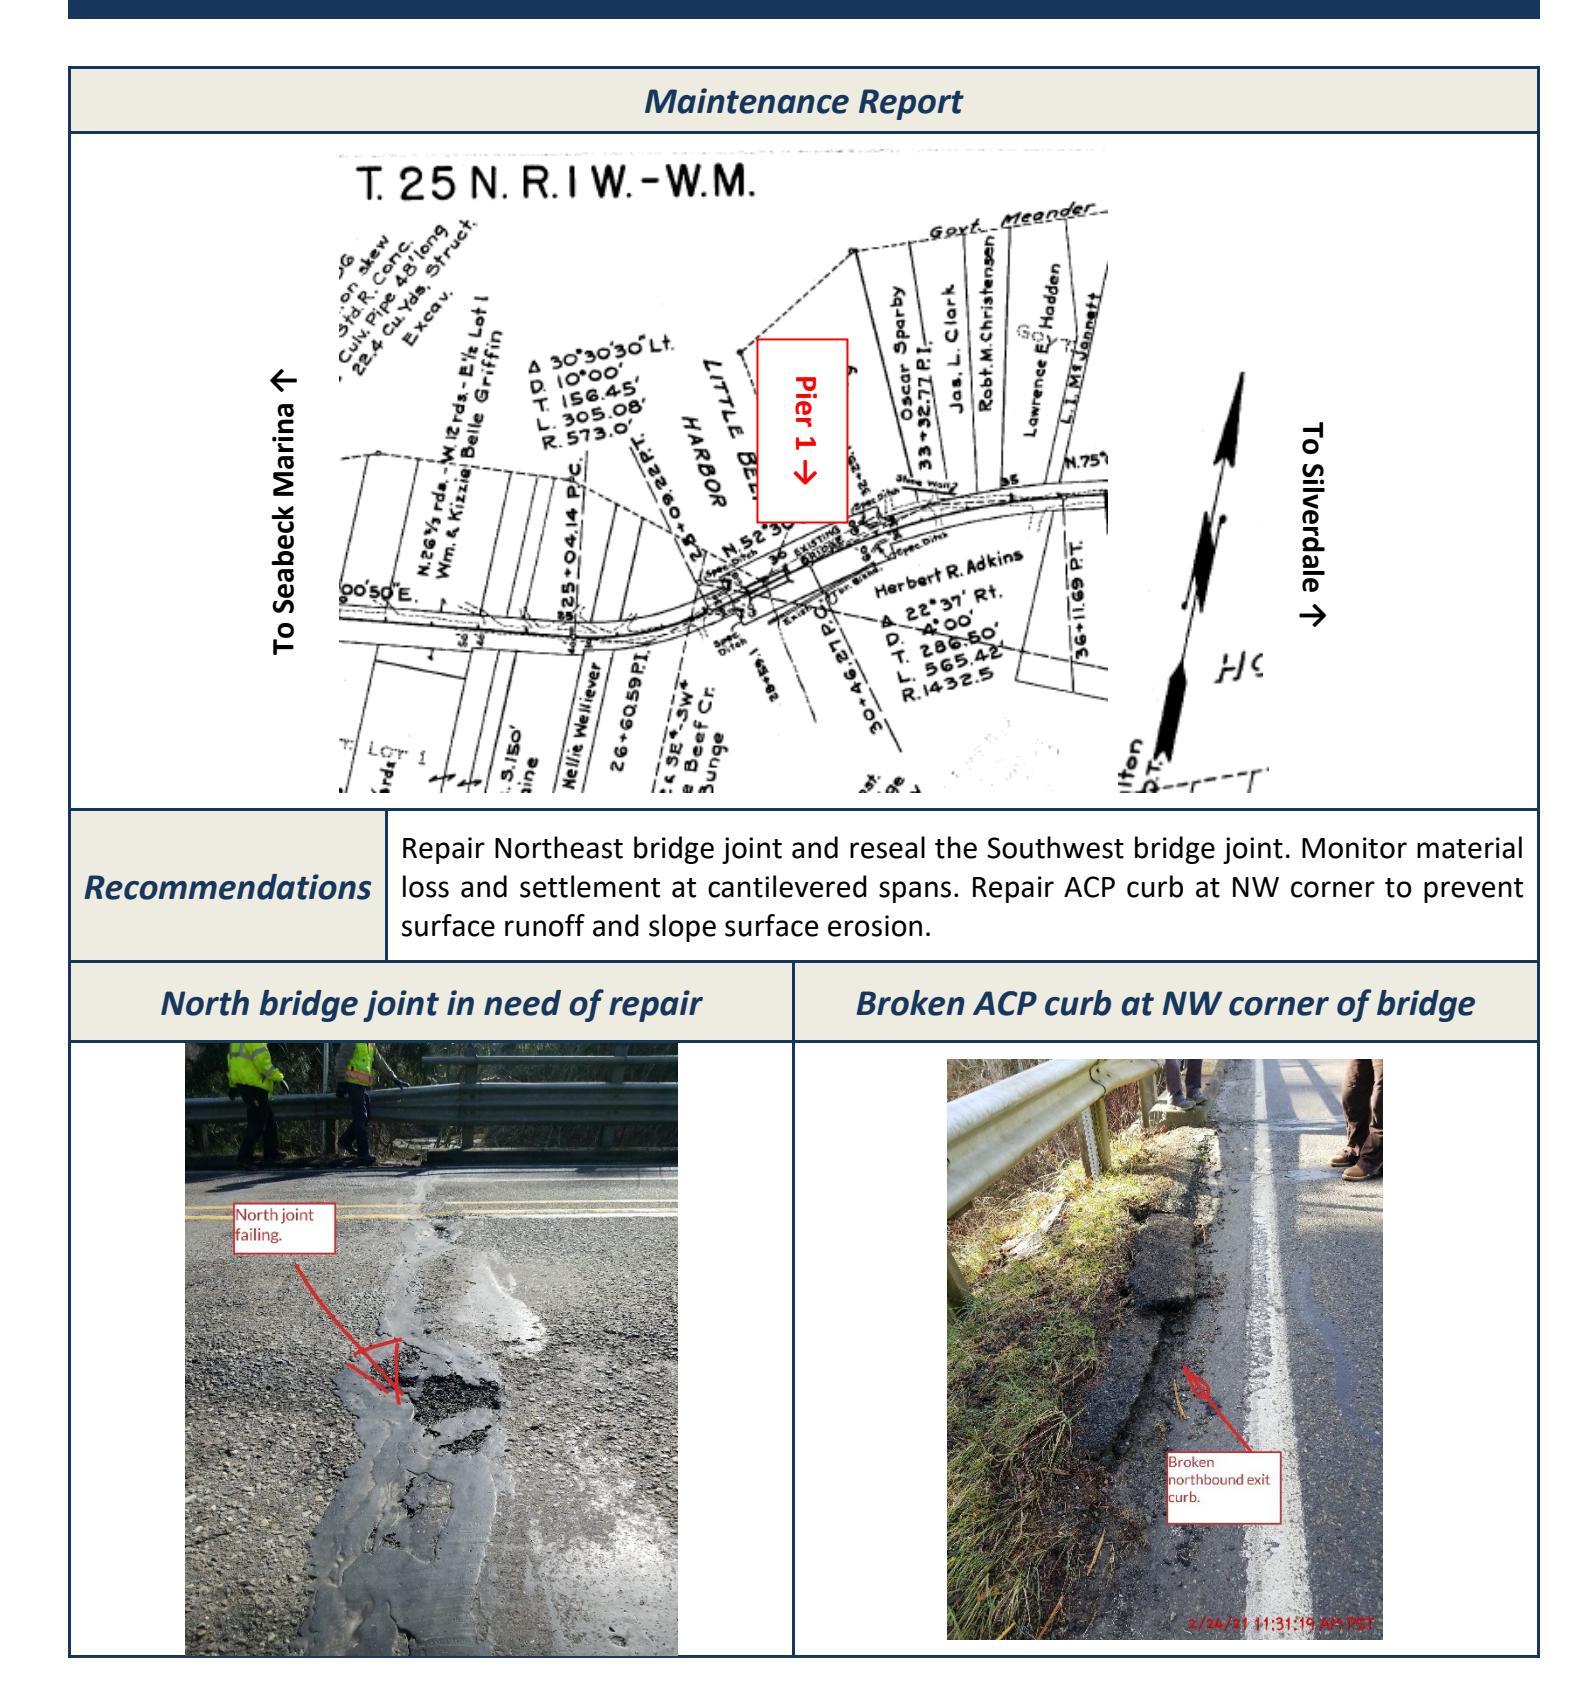
Bridge 19 – Little Beef Bridge

Scour and Load Rating	Bridge has Recommer was perfor Scour coun	beo ndeo rme nter	en load rated as per FHWA requirements by TranTech Engineering in 2019. d posting for SU5, SU6, & SU7 trucks. Scour evaluation and analysis phase 1 d by Entranco Engineering in 1997, followed by Phase 2 analysis in 1997. measures installed Summer 2013.			
Photo		Scour countermeasures installed Summer 2013. This bridge is scour critical.

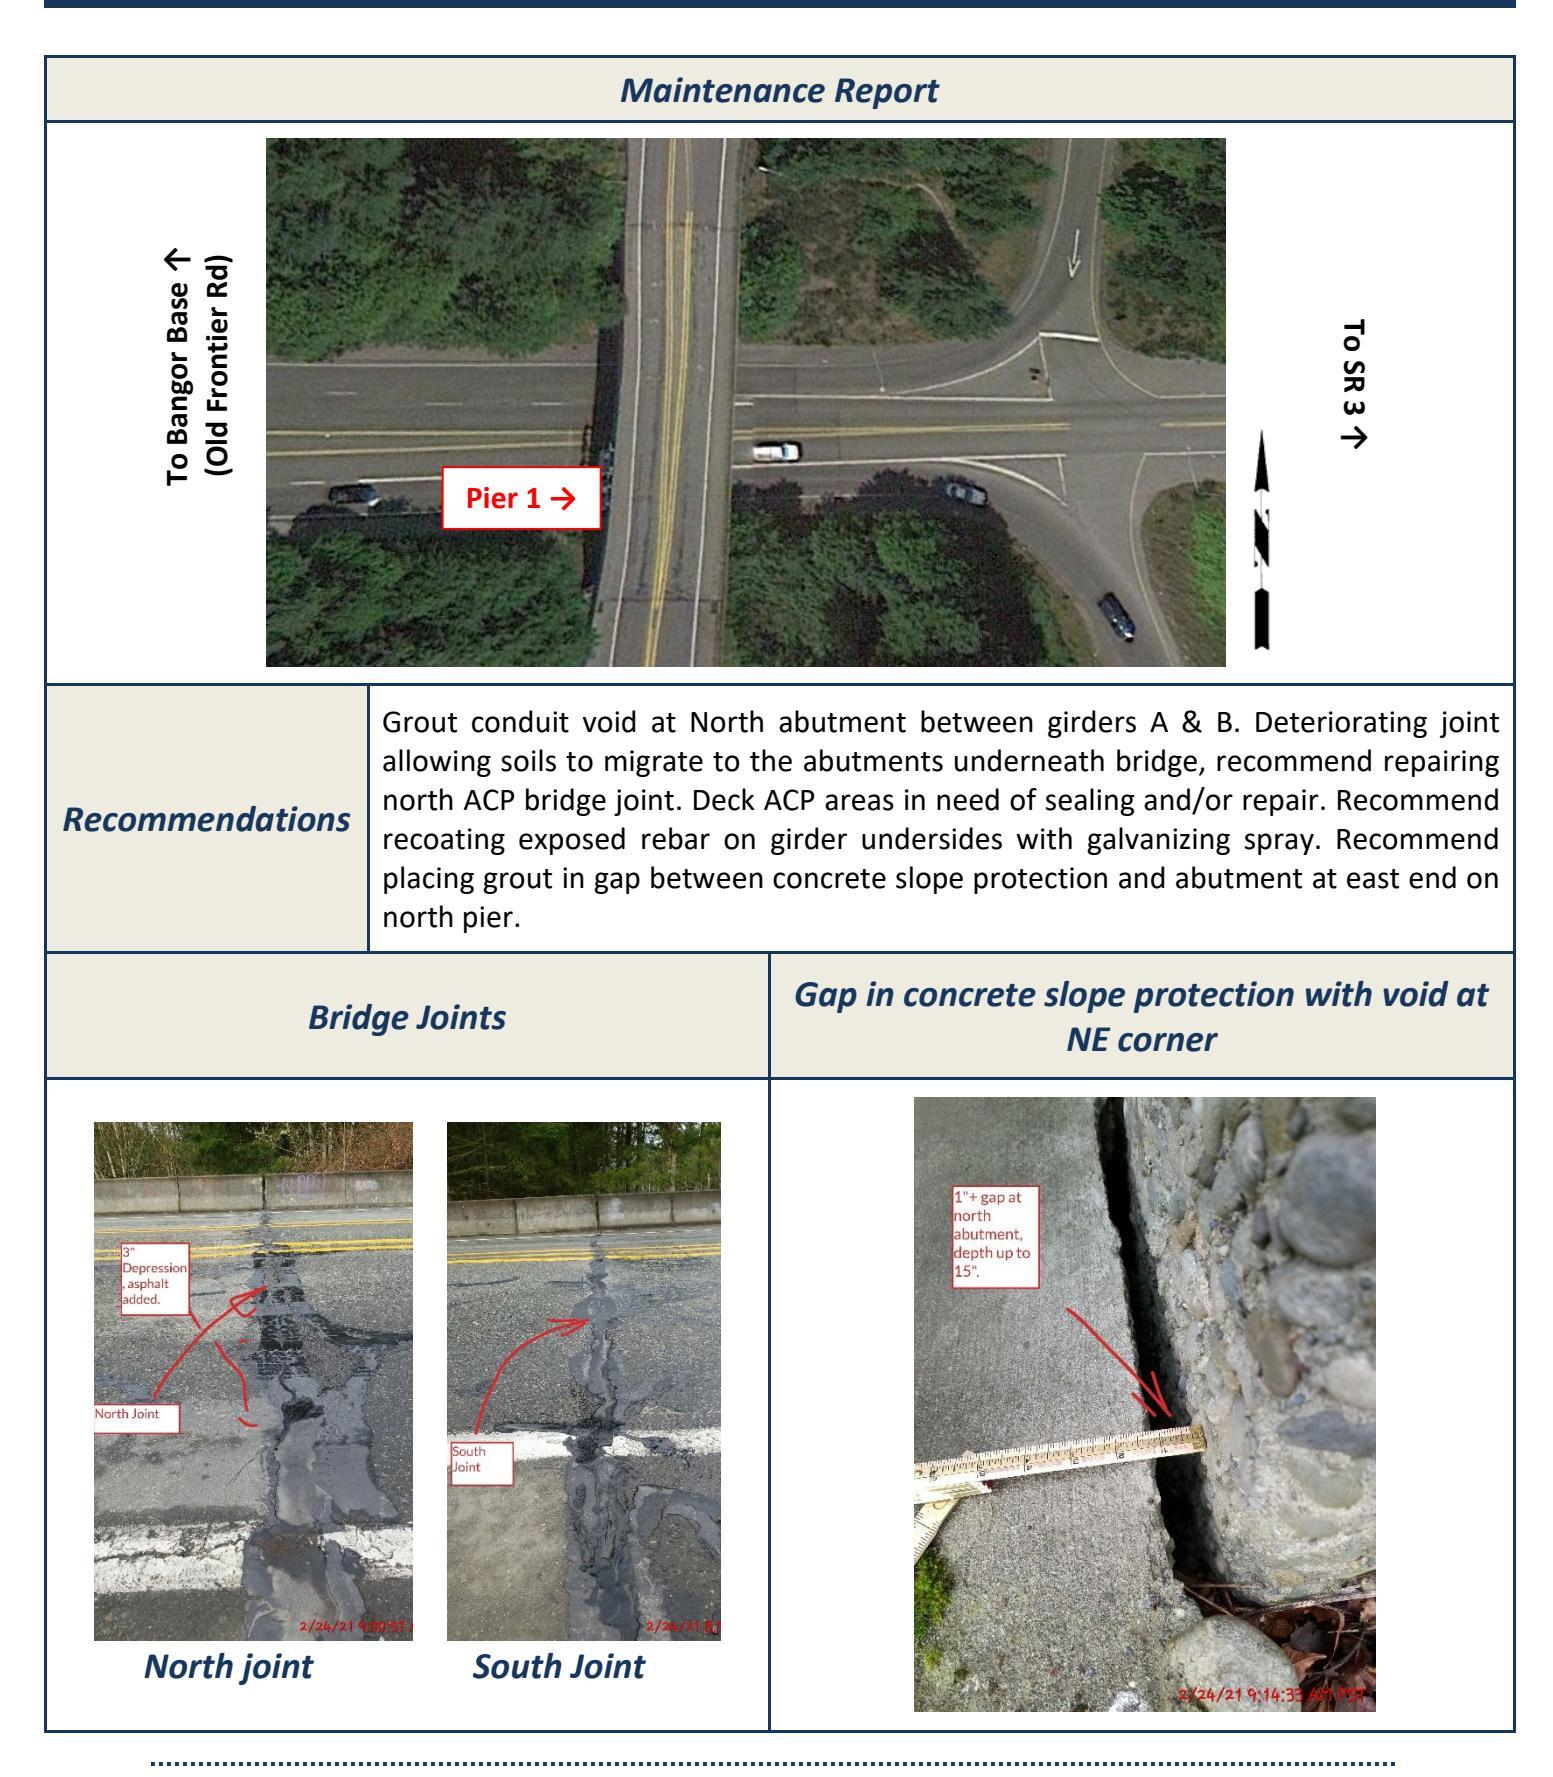
Bridge 24 – Trigger Ave Bridge

Scour and Load	Bridge has	beei	n load rated as per FHWA requirements by TranTech Engineering in 2017.		
Nating	This bridge	e is n	ot scour critical. (Bridge not over water, therefore, not scour critical.)		
Photo		1	North Poulsbo Hood canal or Ju = u = u u = u U = u

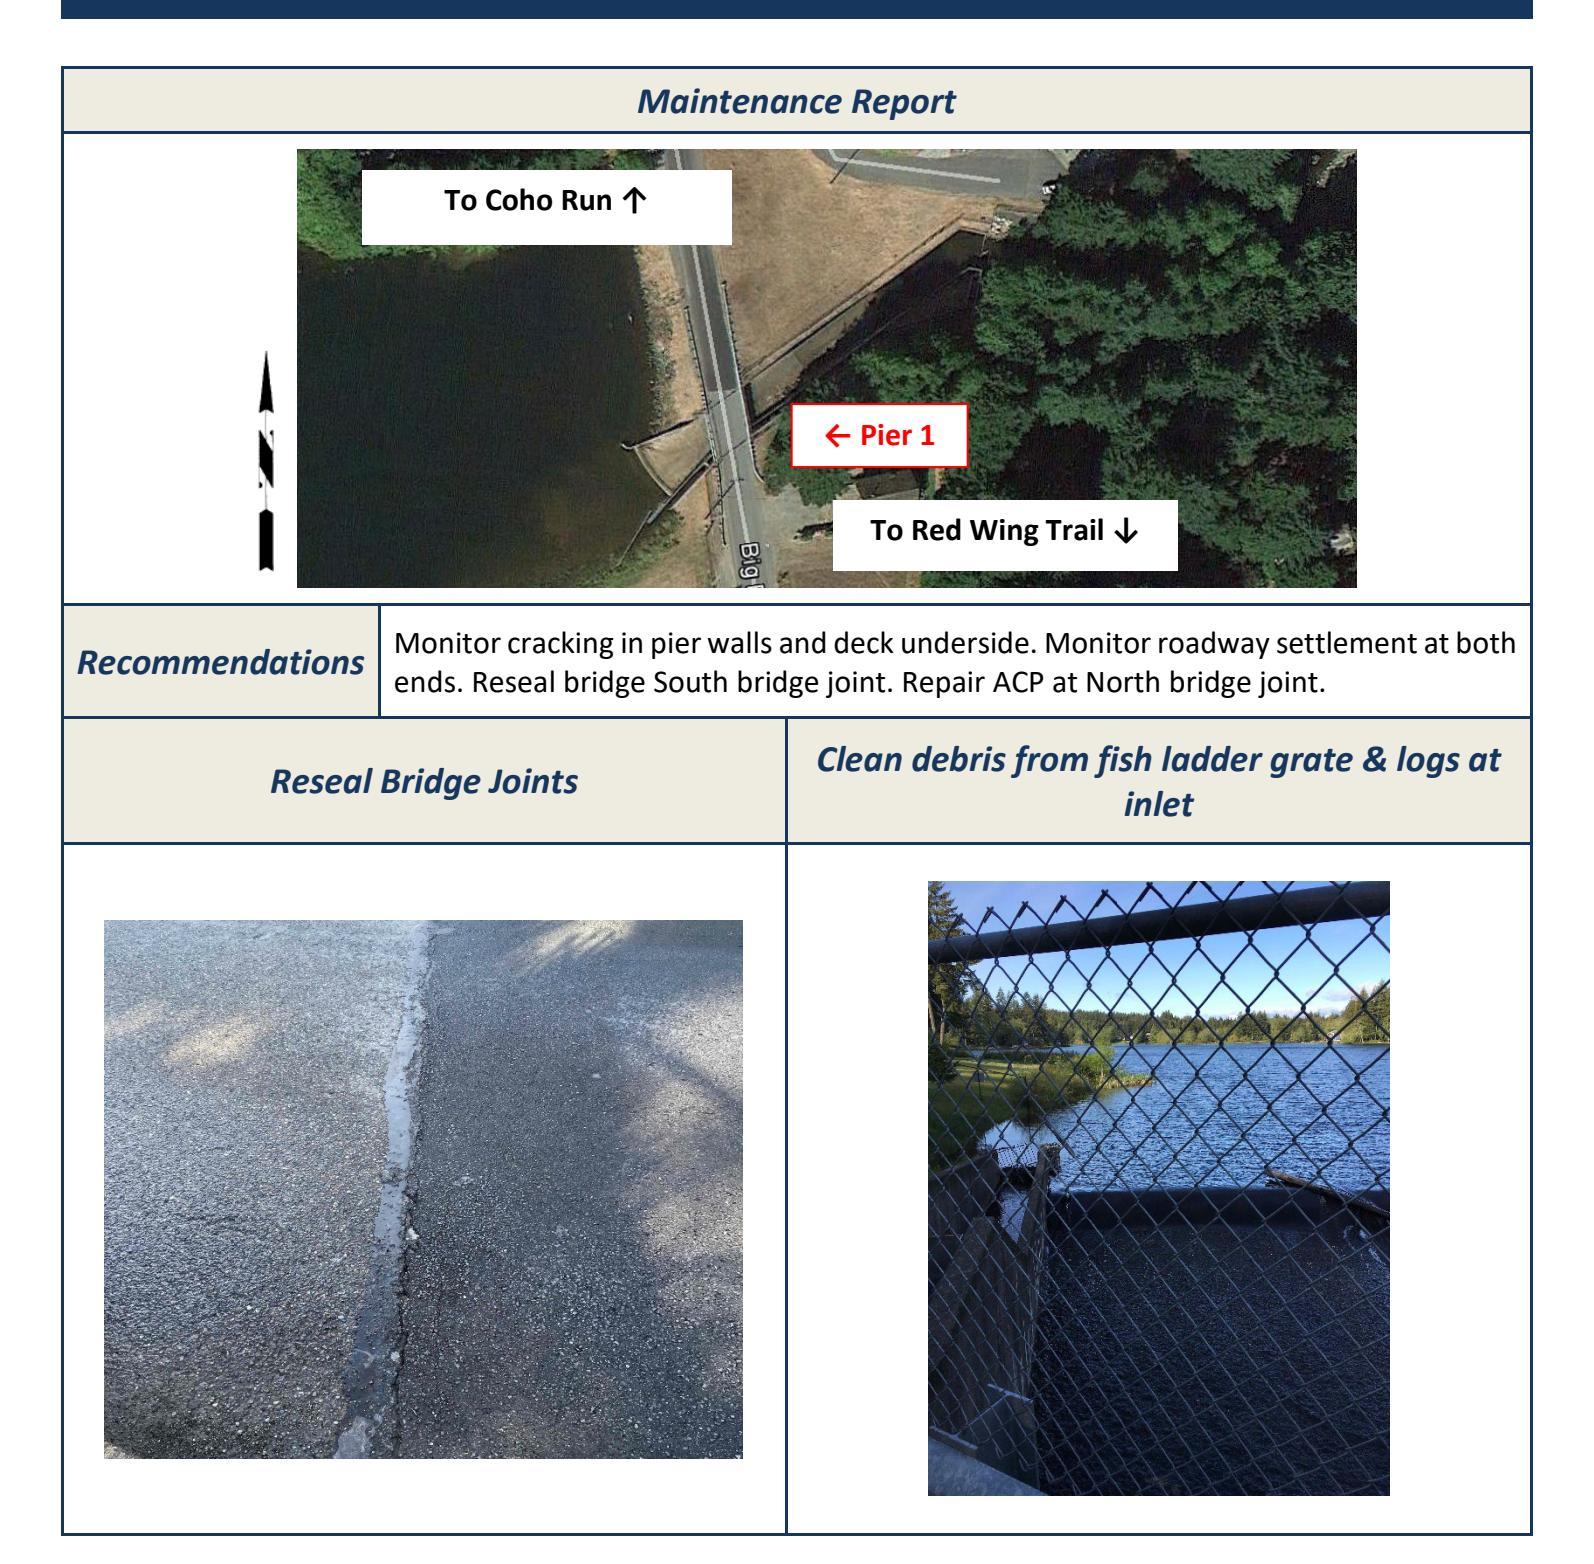
Bridge 27 – Lake Symington Bridge								
Big Beef Crossing NWLake Symington Spillway1964Fair (F)Ma								
Route Name	Feature Intersected	Year Built	Overall Condition	Last Inspection

Scour and Load Rating	Bridge has Scour analy 14 tons. This bridge	Bridge has been load rated as per FHWA requirements by TranTech Engineering in 2017. Scour analysis has not yet been performed for this structure. Recommended posting is at 14 tons. This bridge is pet scour critical. (Structure footings are protected by concrete crillway.)					
Photo	This bridge is not scour critical. (Structure footings are protected by concrete spillway.)

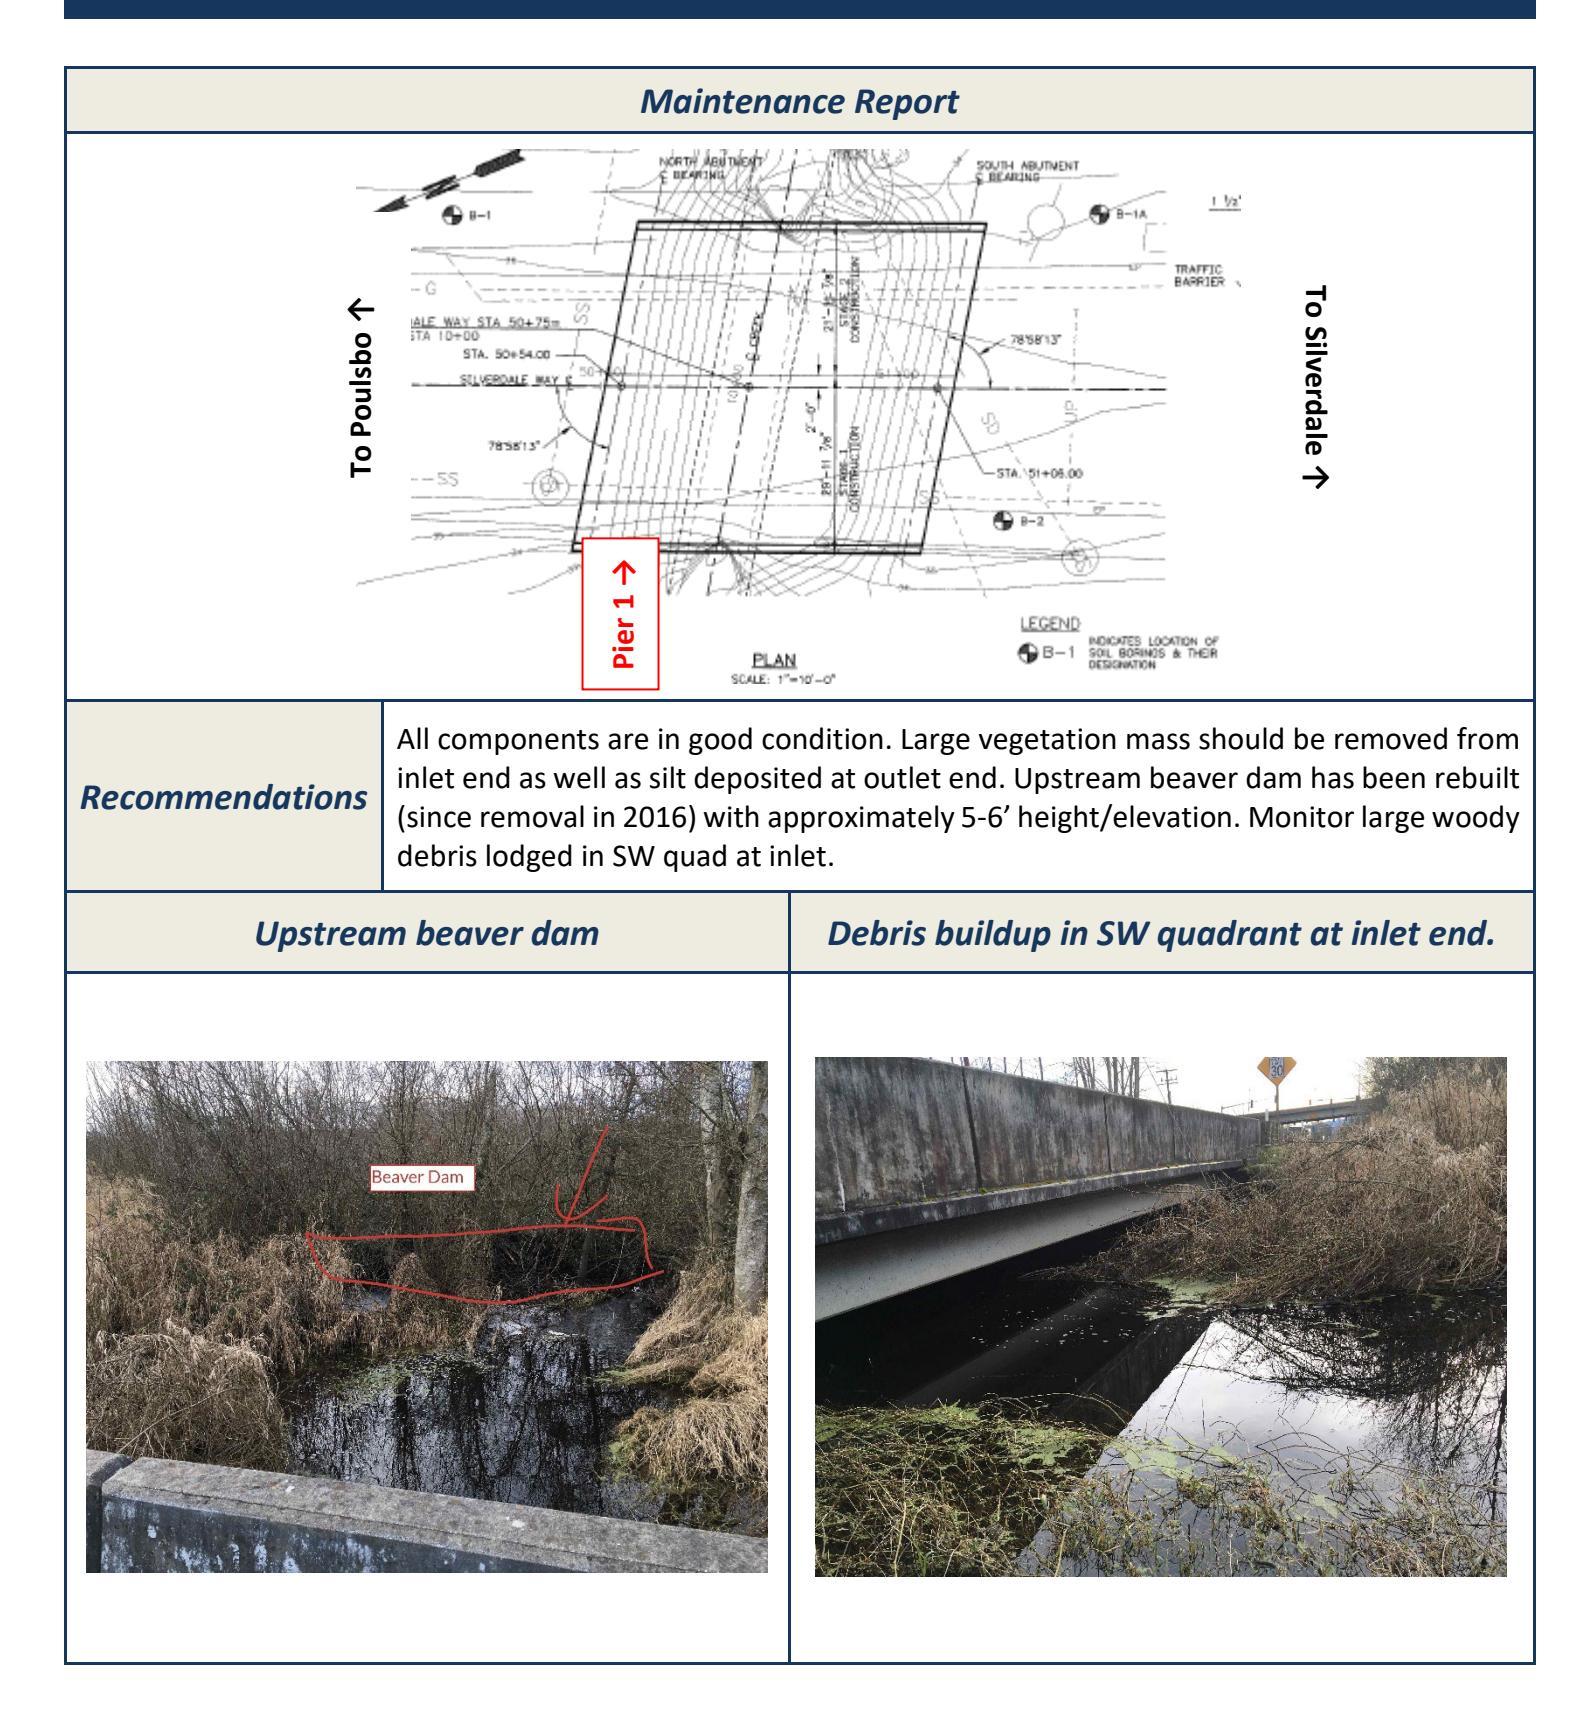
Bridge 28 – Clear Creek Bridge								
Silverdale Way Clear Creek 2006 Good (G) Jul. 24, 2023								
Route Name	Feature Intersected	Year Built	Overall Condition	Last Inspection

Girder	Pr fo	ecast prestressed concrete Channel Beams 48″x28″x52′ in length. No defects und in good condition. Minor moisture present between girders throughout.				
Superstructure	Deck	3″	ACP Overlay.				
	Other	Cast-in-place concrete bridge barrier in good condition. Hairline cracking evenly spaced approximately 4'. NW corner approach hairline installed bioretention ditch for water quality.					
Substructure	Foundatio	on	Driven HP12x53 steel pile foundation with vertical and battered pile configuration.				
Substructure	Abutmen	ts	Cast-in-place concrete abutment with elastomeric bearing pads. Beam seat –24". SW corner small area of moisture present at bearing pad.				
Scour and Load Rating	Bridge has I Scour analy	bee vsis	n load rated as per FHWA requirements by TranTech in 2019. has not yet been performed for this structure.				
Photo

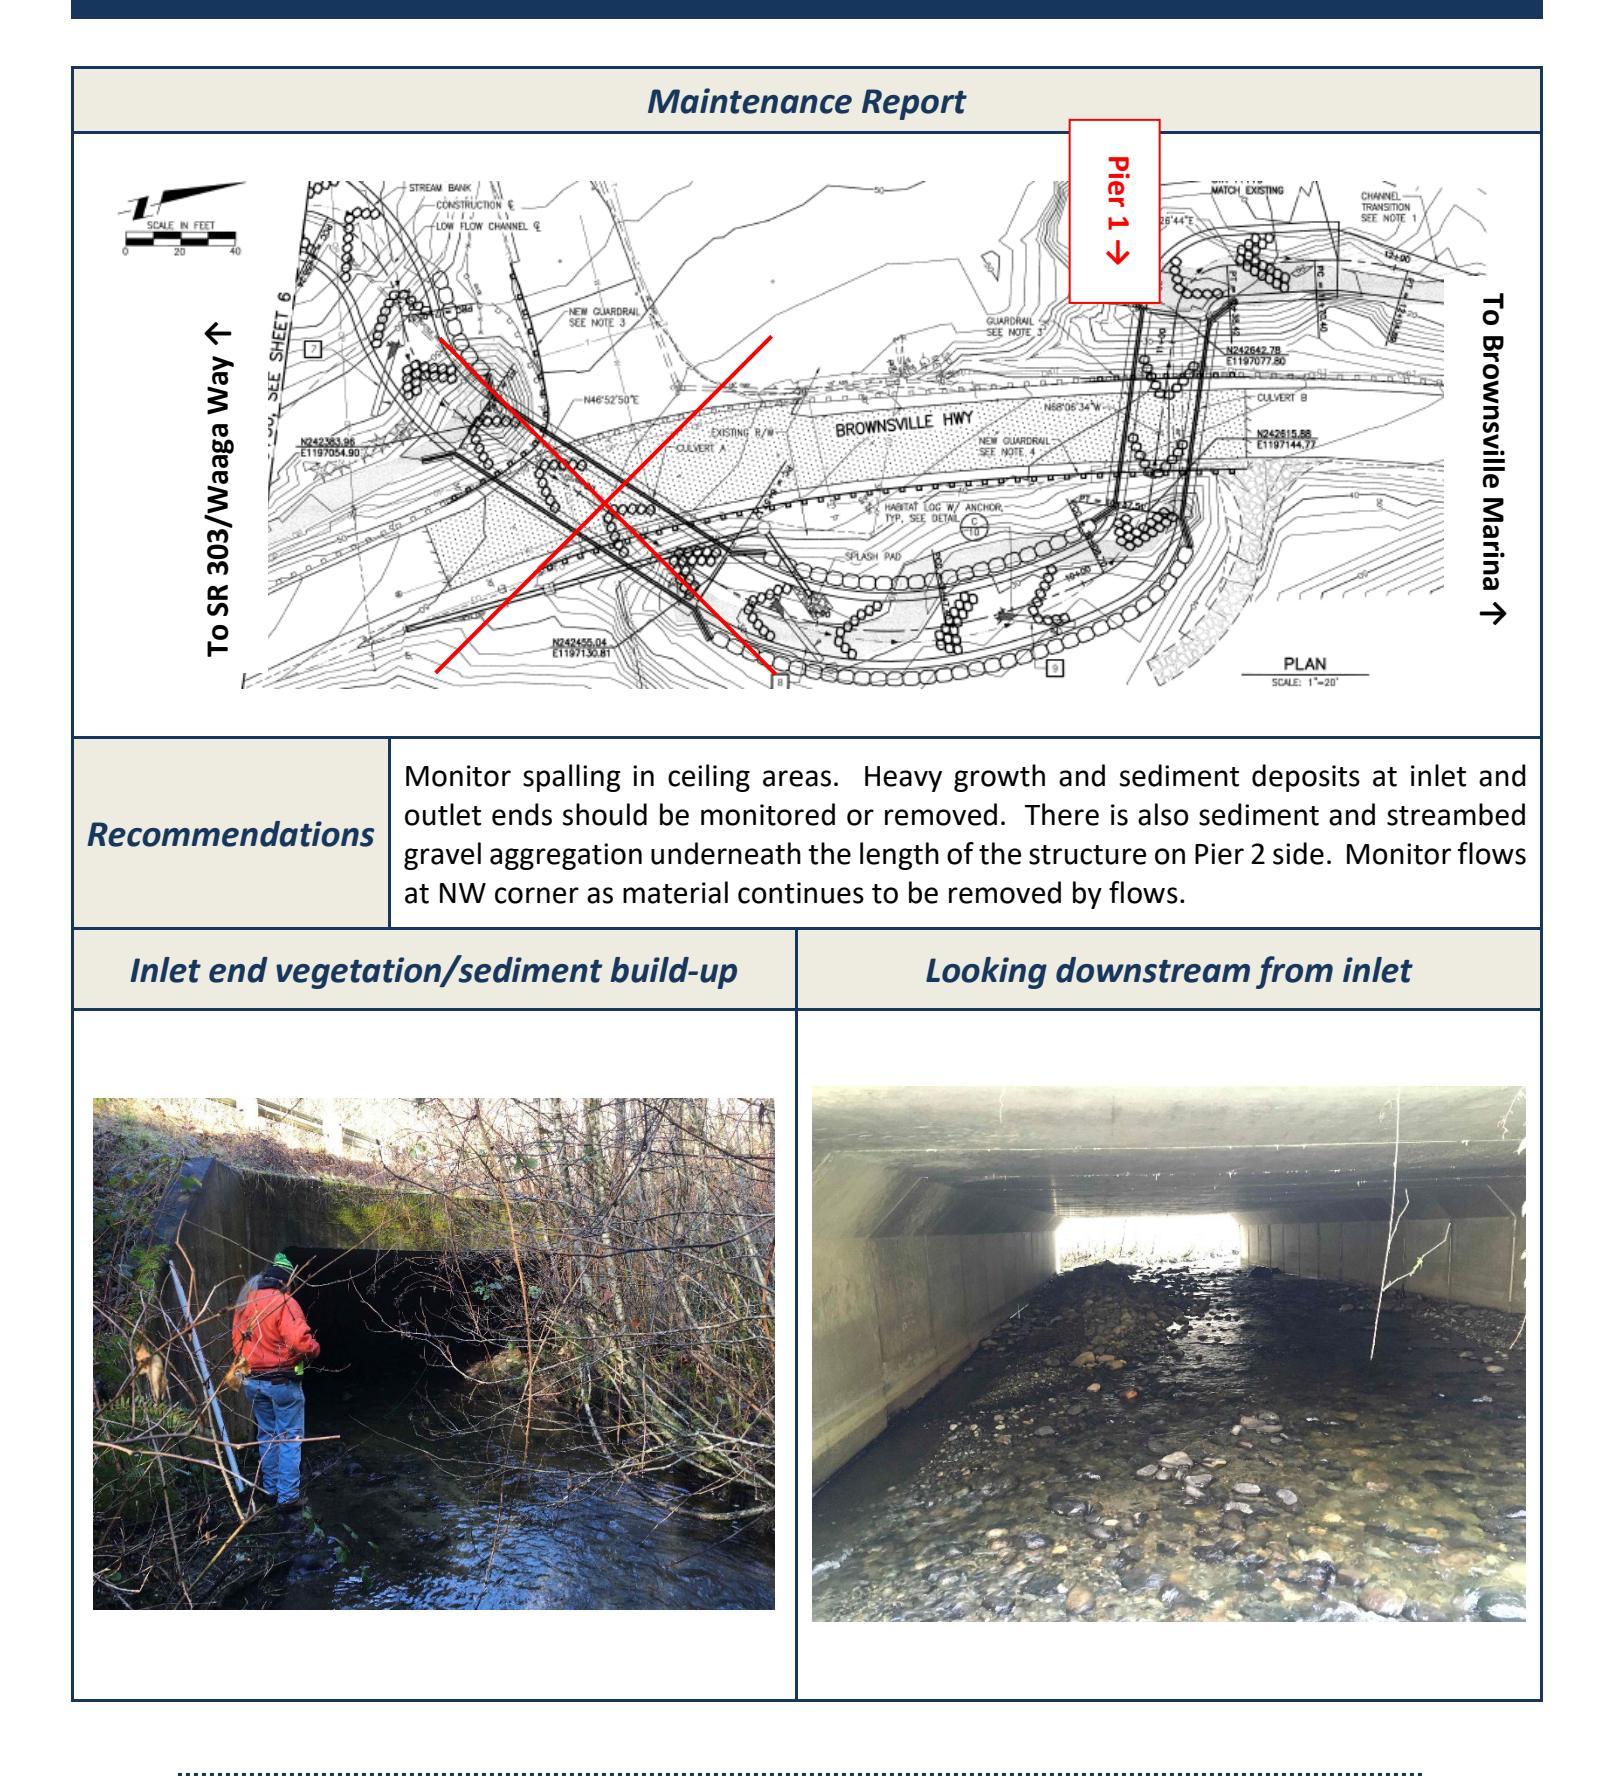
Photo								
Bridge 30 – Gluds Pond North Culvert

Bridge 30 – Gluds Pond North Culvert								
Brownsville Highway		Steele Creek	2007	Good (G)	Jul. 14, 2022			
Route Name		Feature Intersected	Year Built	Overall Condition	Last Inspection			
Superstructure	Culvert	3-sided Precast Correfflorescence present a 1" vertical difference 8th panel joints all ha uniformly 1.5' long x now there is a spall. F	unit in good condit om inlet end the first banels. From outfall e delamination in ceilin ep. 9 th panel delamin or differential settlem	tion. Moisture and 5 ceiling joints have end the 4 th , 5th, 6th, g area that measure nation has fallen and nent occurred.				
Substructure	Foundatio	Precast Concrete grout seam 3' up 1	Spread Footing from channel ele	s. SE wing wall con evation.	nection has broken			
Scour and Load Rating	In 2018 it w excess of 8' for this stru This bridge	In 2018 it was determined by TranTech Engineering that this structure has sufficient fill, in excess of 8' and does not require a load rating. Scour analysis has not yet been performed for this structure. This bridge is not scour critical.

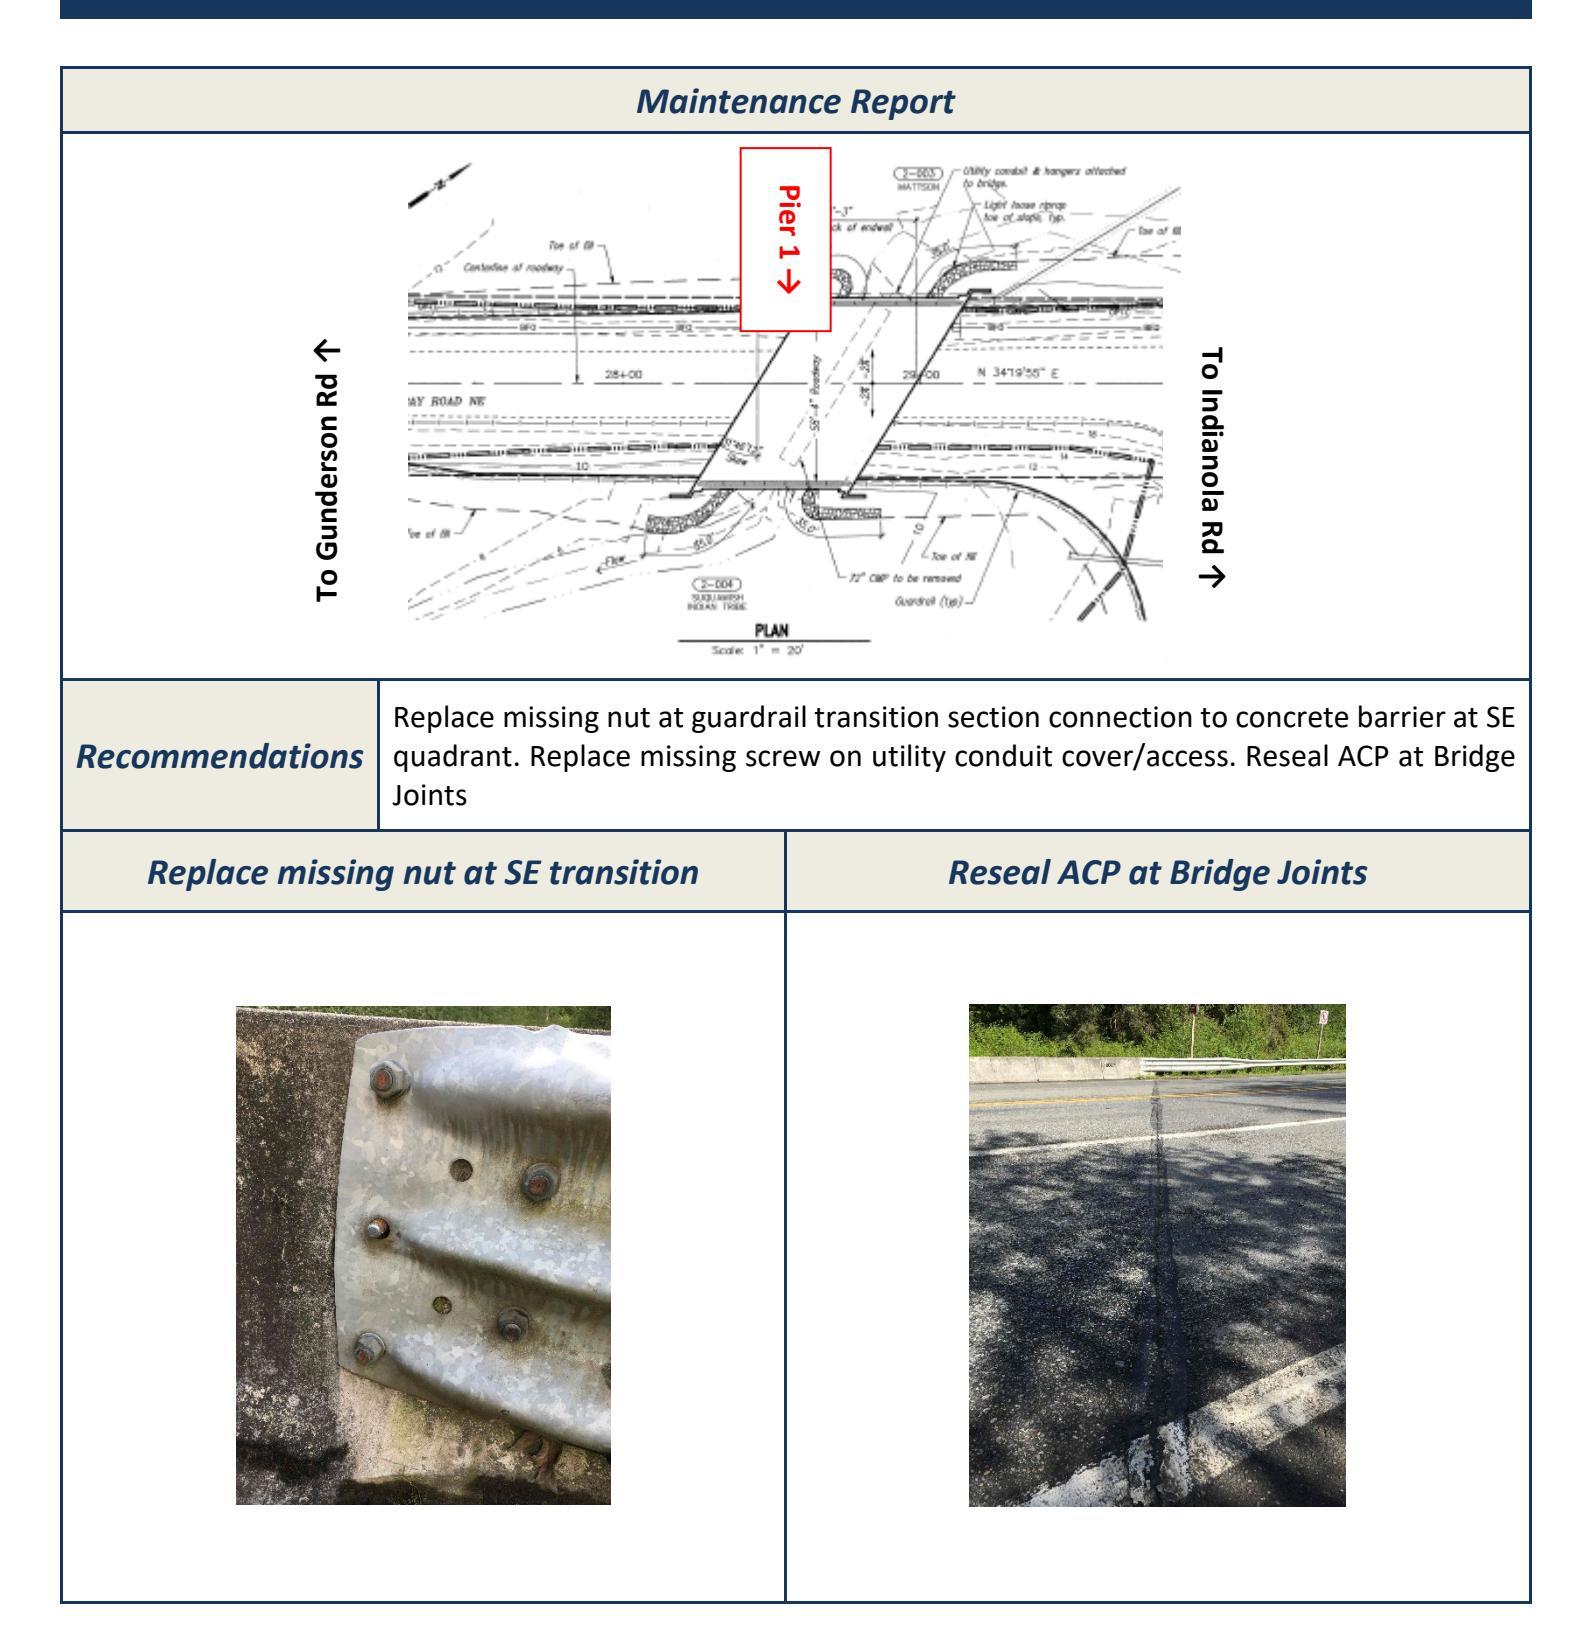
Bridge 31 – Miller Bay Bridge								
Miller Bay Road Grover Creek 2007 Good (G) Jun								
Route Name	Feature Intersected	Year Built	Overall Condition	Last Inspection

Scour and Load Rating	Bridge has been load rated as per FHWA requirements by TranTech Engineering in 2019. Scour analysis has not yet been performed for this structure.			
Photo	This bridge is not scour critical.
