2023 Annual Bridge Report

Prepared by Kitsap County Public Works Engineering Division This sheet intentionally left blank.

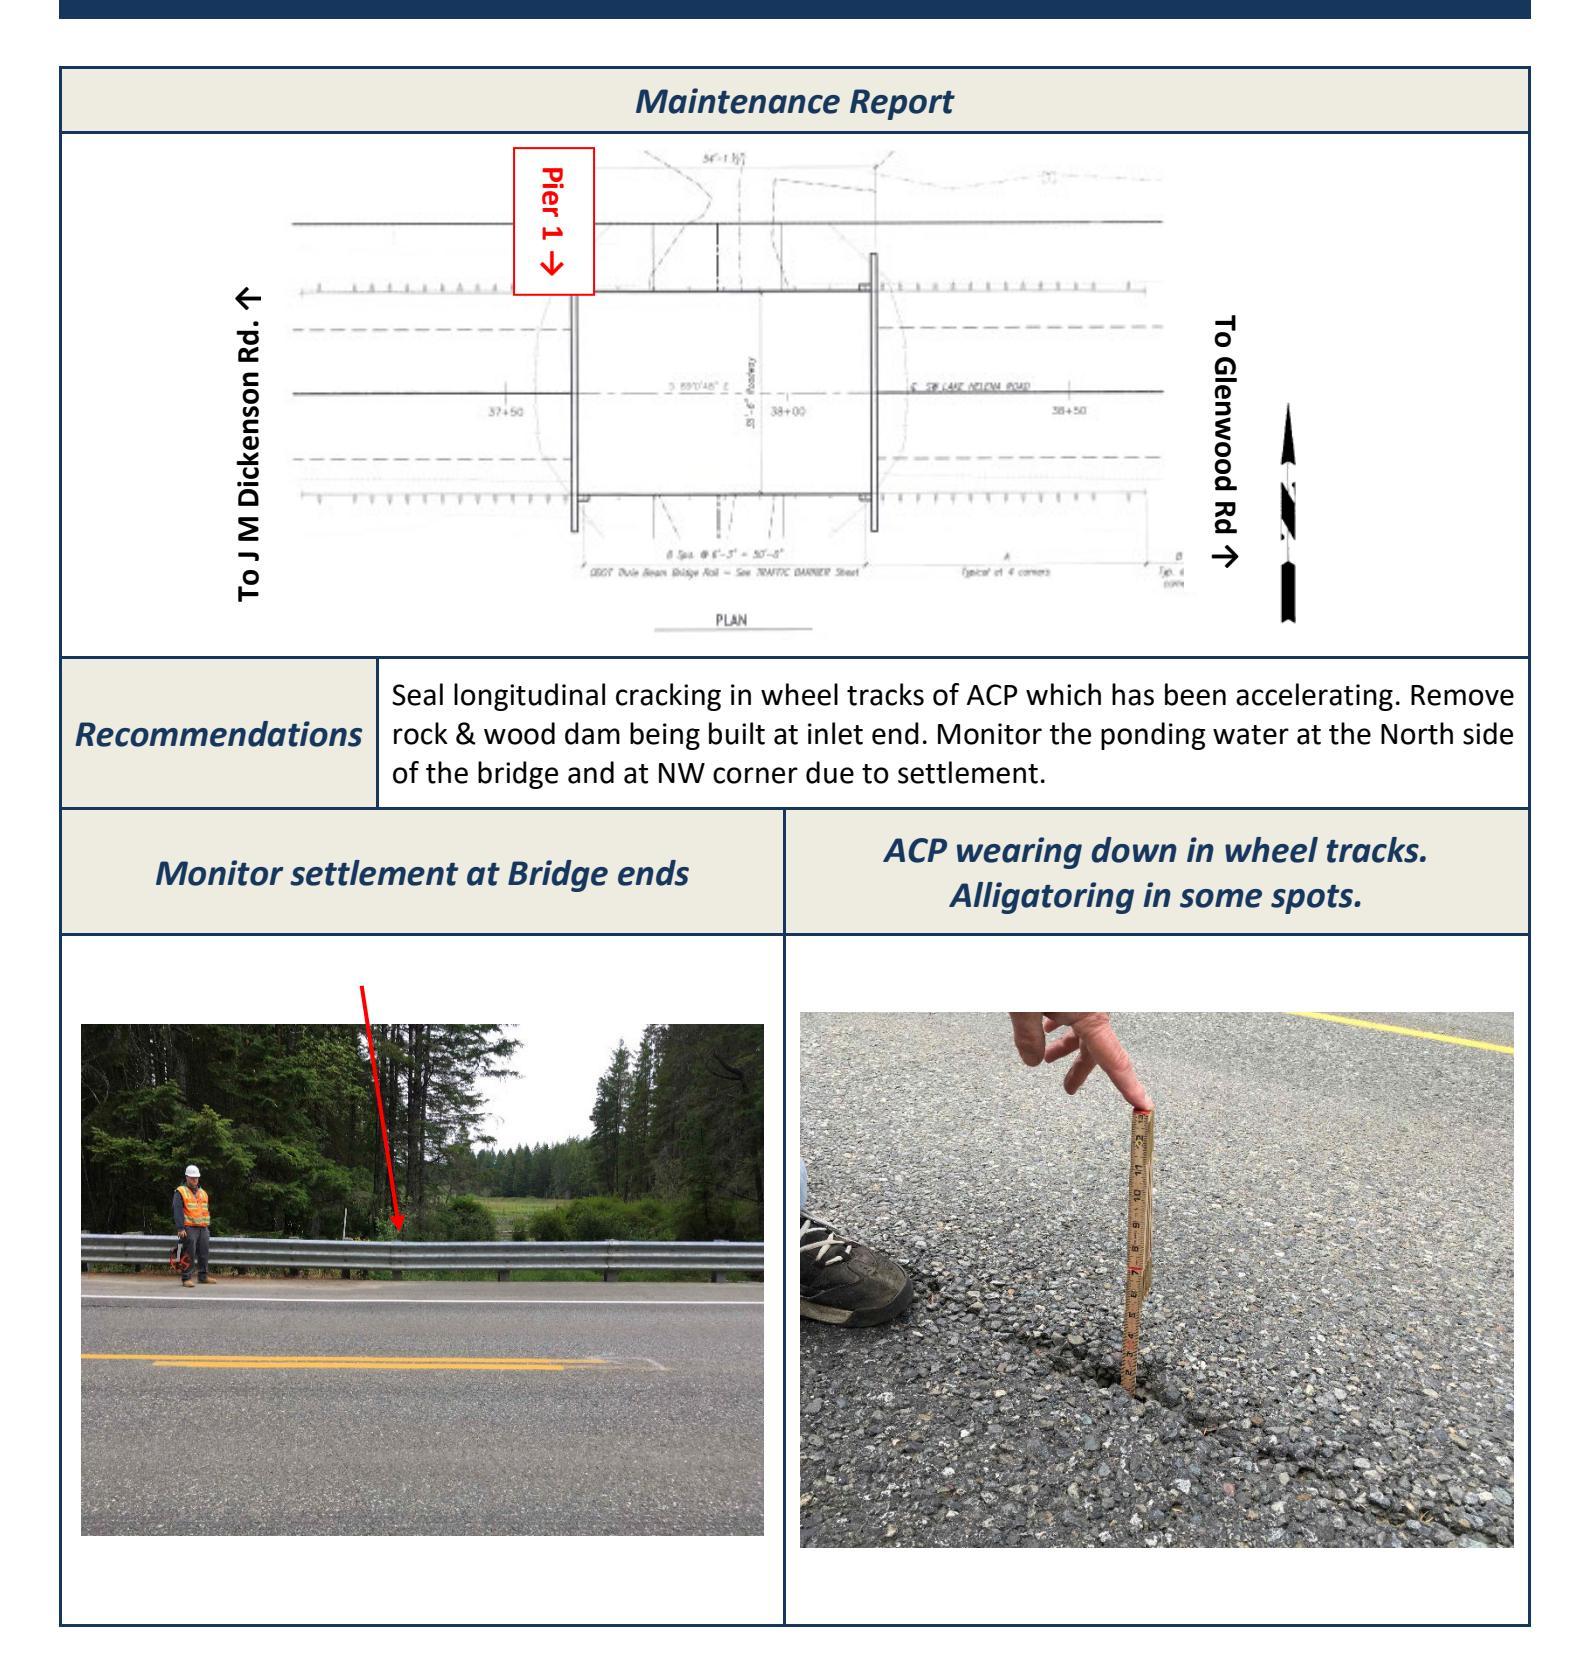
Bridge 34 – Lake Helena Bridge								
Lake Helena Road	Muck Fork Creek	2011	Good (G)	Jul. 14, 2023				
Route Name	Feature Intersected	Year Built	Overall Condition	Last Inspection

Girder	Pr ba Ea	Precast prestressed concrete voided slab 21"x48"x52' in length. Section of backer rod hanging from underside of girders at 2 nd seam from South side on East abutment and 5 th seam from south side at midspan and pier 1.				
Superstructure	Deck	3″ tra wł	ACP overlay with waterproof membrane. Longitudinal cracking in wheel acks is accelerating some areas have 2" deep crack/void longitudinally in neel track.				
	Other	М	etal nested Thrie Beam bridge railing attached to exterior slabs.				
	Foundatio	on	Driven W12x74 steel H-pile foundation approx. 50' in length.				
Substructure	Abutmen	 Cast-in-place concrete abutment with elastomeric bearing pads and rip rapprotection. Beam seat -24". Small beaver dam at inlet end across channed 3' wide x 1' high. Rock armor is being moved by foot traffic. Settlement visually noticeable on both piers as seen in guardrail dip at bridge joint Settlement measured along southern side with 1.5" at Pier 1 and 1" at Pier 2 compared to midspan.

Scour and Load Rating	Bridge has been load rated as per FHWA requirements by Sargent Engineering in 2011. Load Rating updated by TranTech Engineering in 2019 for SU and EV ratings. Scour analysis has not yet been performed for this structure.						
Photo

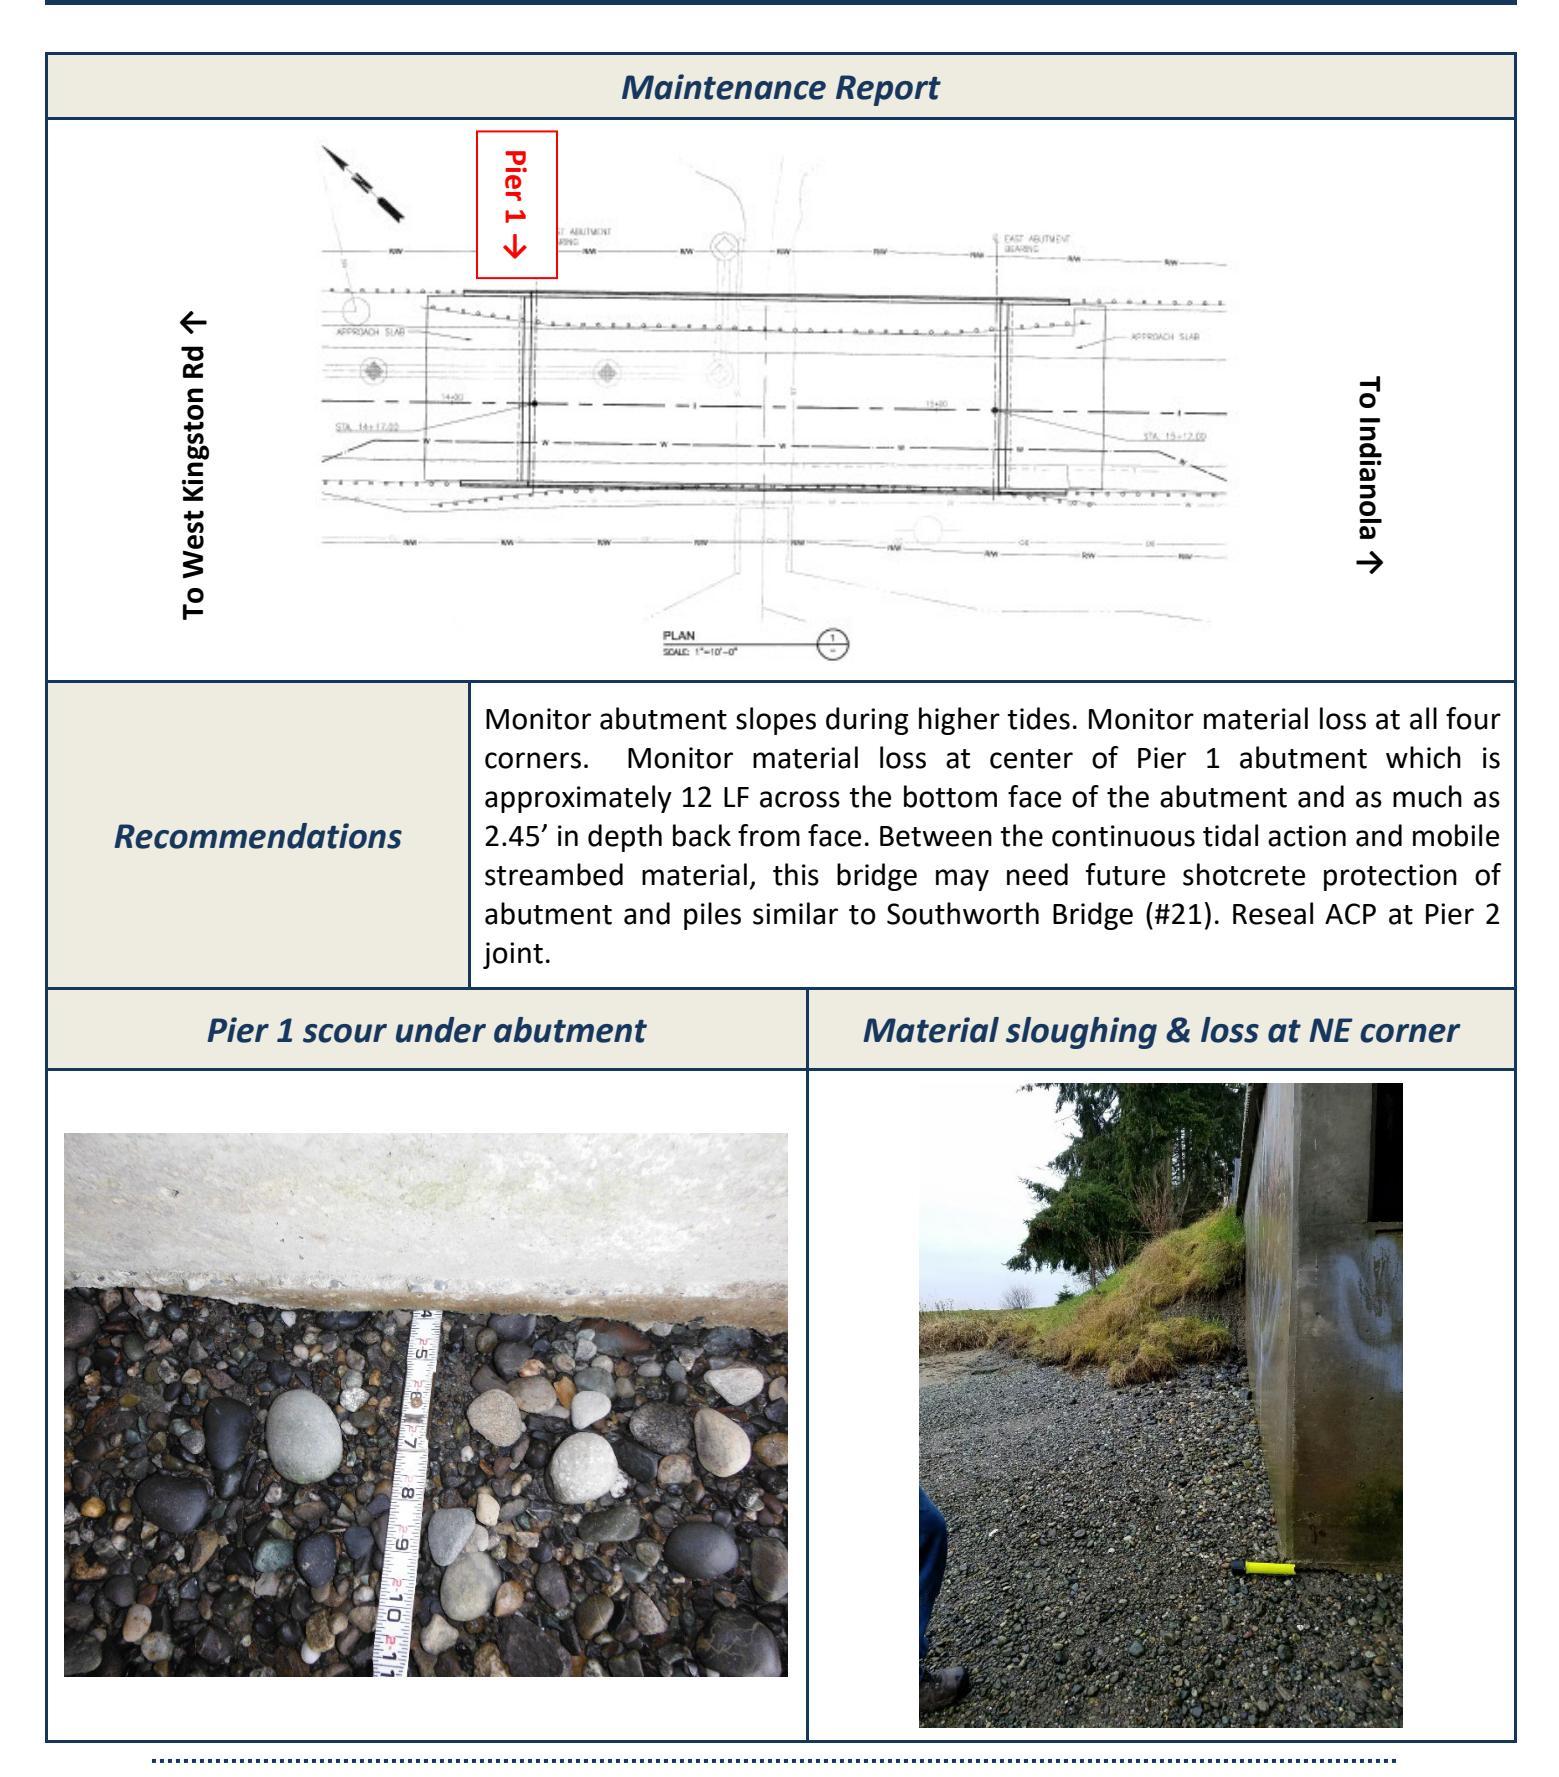
Bridge 35 – Carpenter Creek Bridge							
South Kingston Road	Carpenter Creek	2011	Good (G)	Jun. 21, 2023			
Route Name	Feature Intersected	Year Built	Overall Condition	Last Inspection

Girder	Precast prestressed concrete W41DG bulb-tee girders.					
Superstructure	Deck	3" ACP overlay with waterproof membrane.					
	Other	Ca 4"	st-in-place concrete bridge barrier in good condition. SE Sidewalk panel x5" surface spall. Sidewalk has superficial crack on 3 rd panel from North.				
	Foundatio	on	Driven HP14x89 steel H-pile foundation approximately 55' in length.				
Substructure	Abutmen	ments Cast-in-place concrete abutment with elastomeric bearing pads. Beam –54". Material loss and sloughing at all 4 corners of the abutments. Bor of the pile cap/abutment is beginning to be exposed at the center of P approximately 12 feet with a 1" void underneath with a depth of 30" from face of abutment. Both corners of Pier 2 have loss of abutr armament and beginning to see small void under corner only a few in deep by ¼" in height. Evidence of moisture at utility conduits and paver seat at exterior of abutment.

Scour and Load Rating	Bridge has Scour analy	bee vsis	Deen load rated as per FHWA requirements by TranTech Engineering in 2019. Sis has not yet been performed for this structure.				
Photo

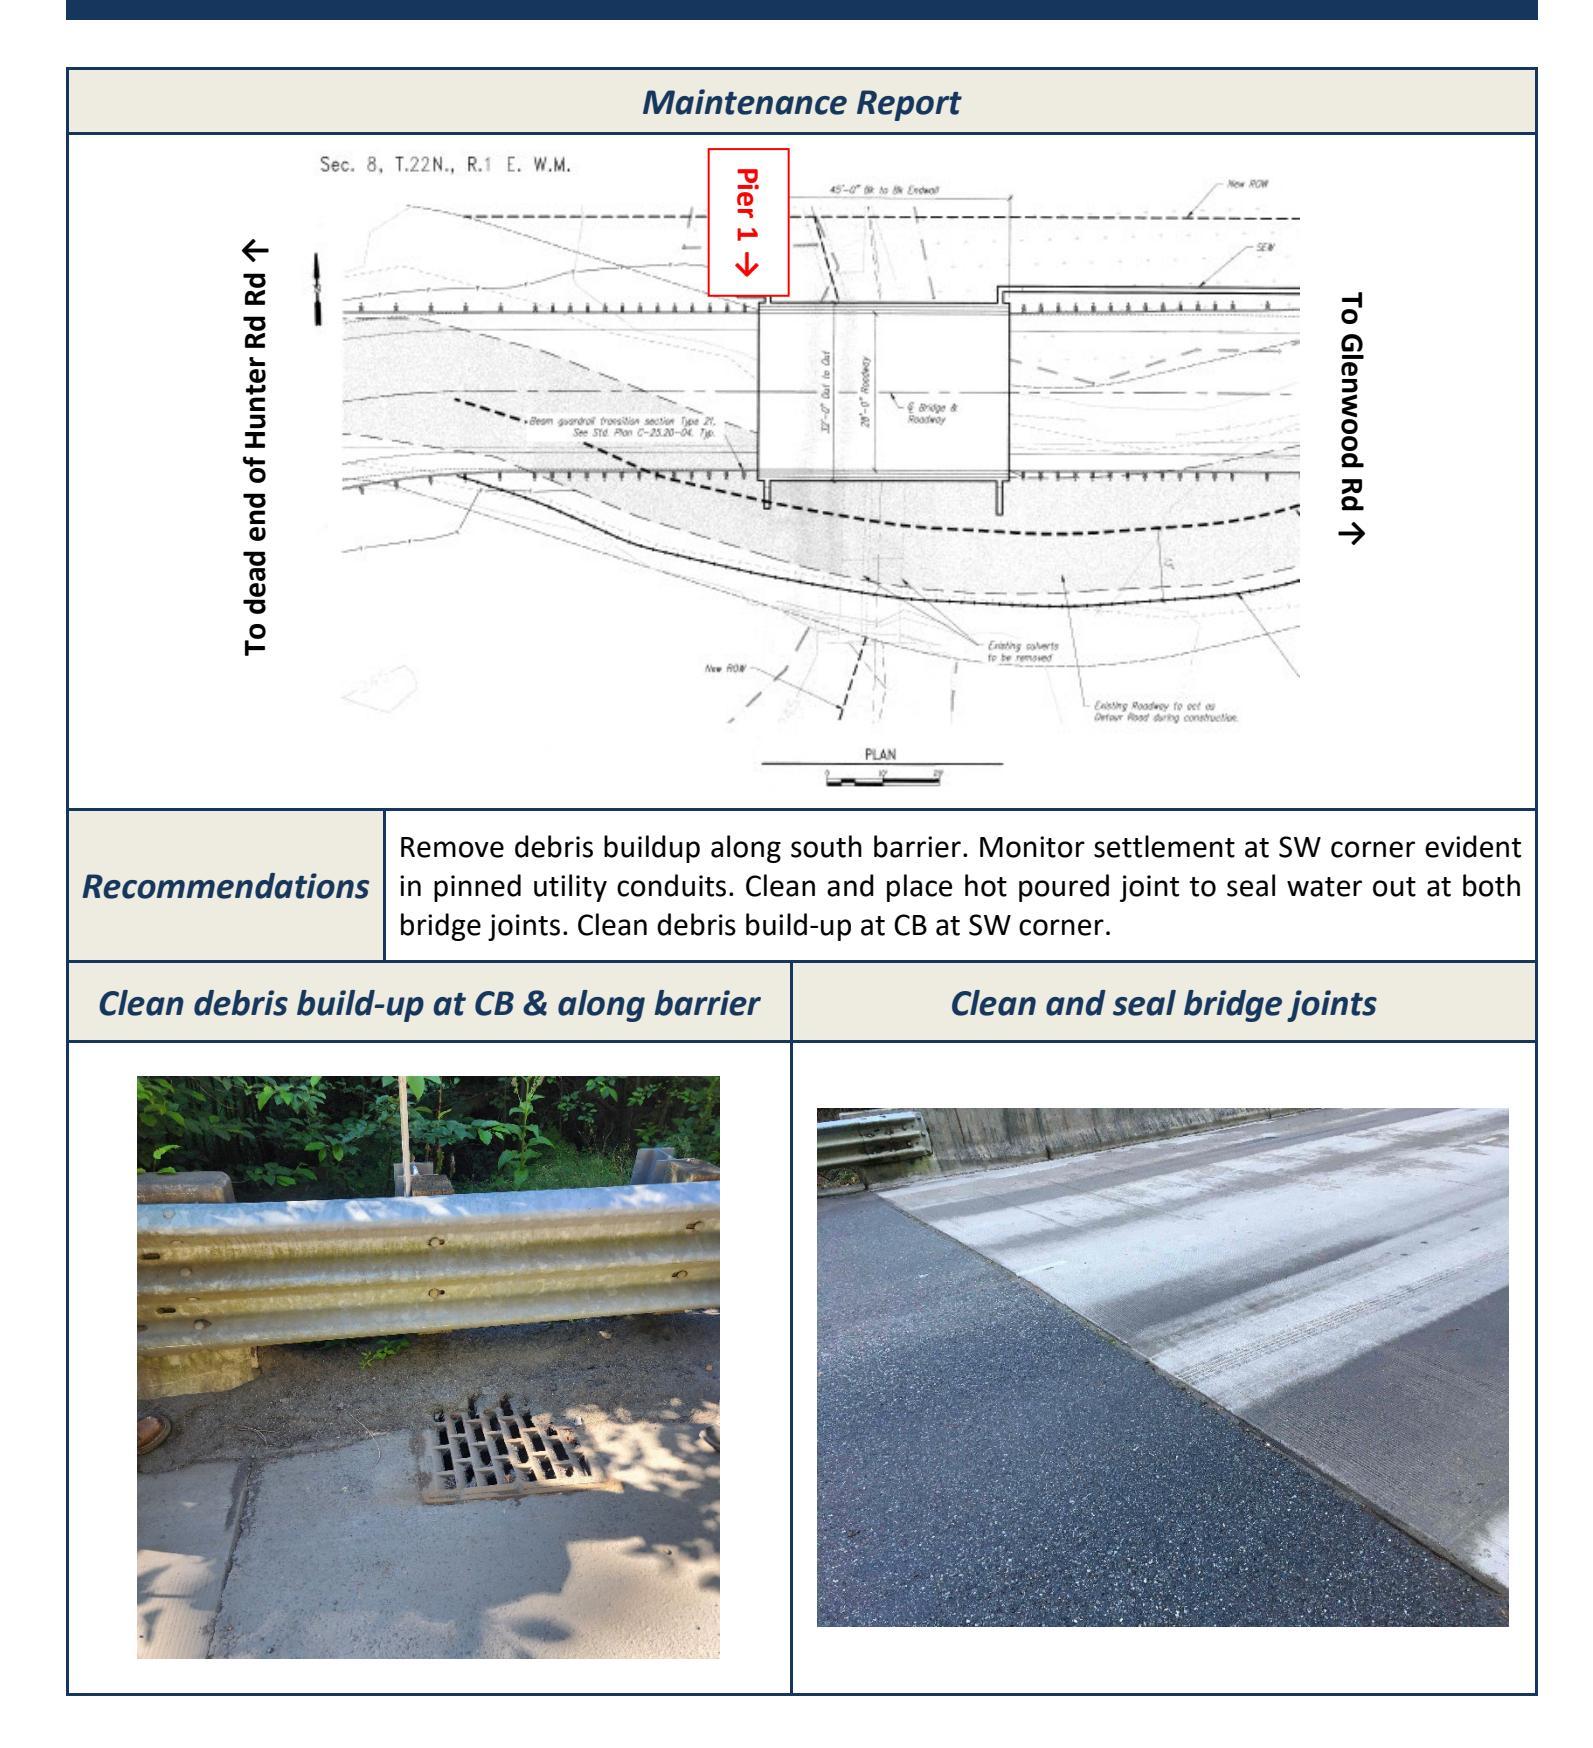
Bridge 36 – Hunter Bridge							
Hunter Road	Huge Creek	2012	Good (G)	Jul. 14, 2023			
Route Name	Feature Intersected	Year Built	Overall Condition	Last Inspection

Girder	<i>Girder</i> Precast prestressed concrete voided slabs 24"x48"x45' in length.				
Superstructure	Deck	5" cast-in-place concrete deck with epoxy reinforcing steel. Scaling in deck beginning to show.				
	Other	Cast-in-place concrete bridge barrier in good condition. Hairline vertical cracking noticeable on both sides.				
	Foundatio	Driven 12¾" steel pile foundation approximately 28'-35' in length with reinforcing steel and concrete.				
Substructure	Abutmen	Cast-in-place concrete abutment with elastomeric bearing pads and large rip rap protection. Minor loss of rock armor at SE, SW, and NW corners. Beam seat –36".				
Scour and Load Rating	Bridge has been load rated as per FHWA requirements by TranTech Engineering in 2019. Scour analysis has not yet been performed for this structure. This bridge is not scour critical.					
Photo	Sour analysis has not yet been performed for this structure. This bridge is not scour critical.

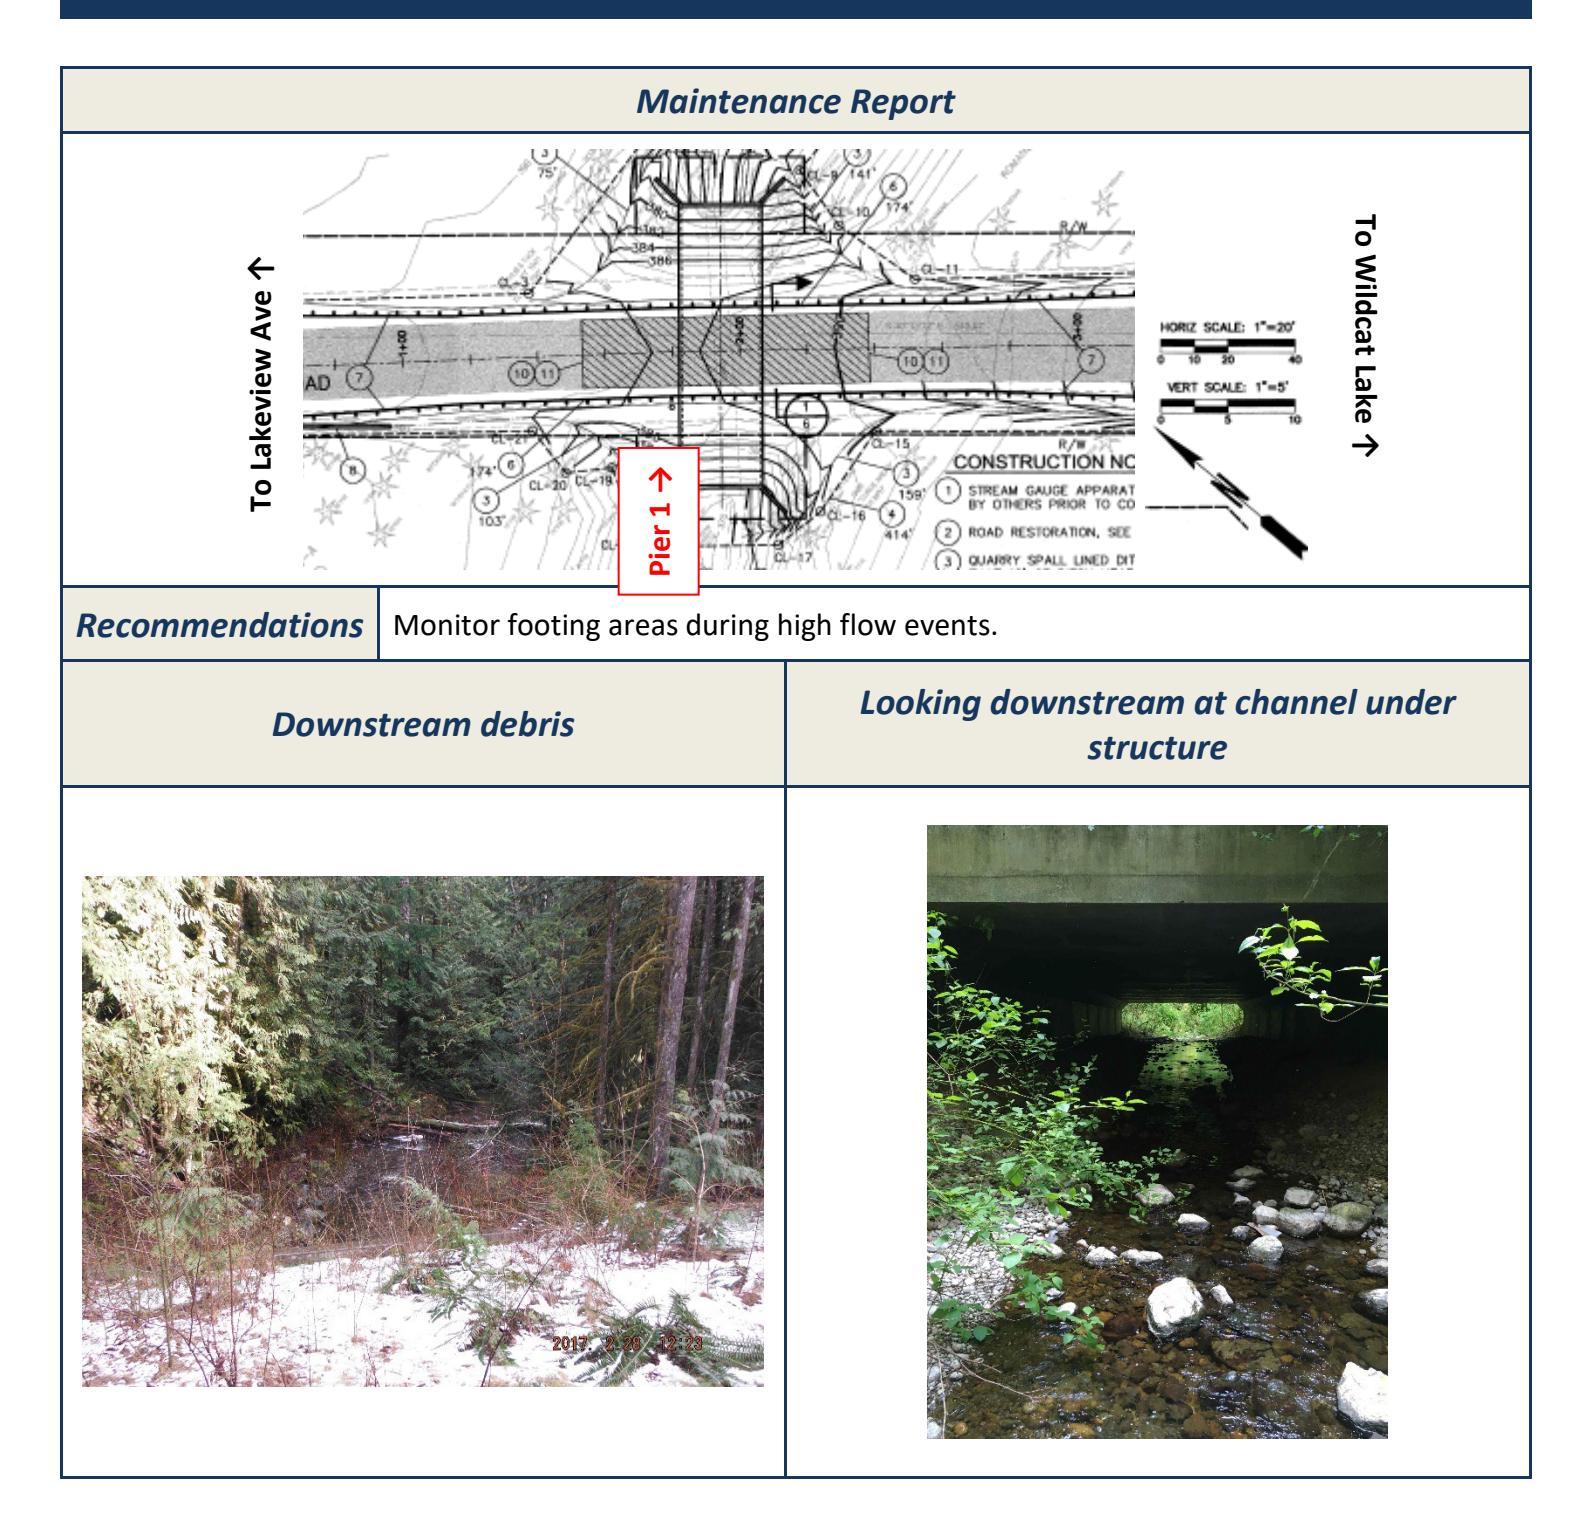
Bridge 37 – Wildcat Lake Culvert						
Wildcat Lake F	Road	Wildcat Creek	2012	Good (G)	May. 9, 2023	
Route Name		Feature Intersected	Year Built	Overall Condition	Last Inspection	
Superstructure	Culvert 3-side precast concrete culvert 85' length with a 23' span x 9'-1 Components are all in new condition. There is evidence of repair ceil from construction at the first seem from the inlet, center span. N between seams starting to increase and weep in areas show with efflor mineral deposits present, 2 nd thru 6 th seams from inlet.				span x 9'-10" rise. If repair ceiling spall Inter span. Moisture Inter with efflorescent	
Substructure	Foundatio	Foundation Precast footings and wing walls with rebar reinforcement.				
Scour and Load Rating	Bridge has been load rated as per FHWA requirements by Tetra Tech Engineering in 20 In 2018 the structure was determined by TranTech Engineering to have sufficient fi excess of 10' therefore not needing to be load rated for EV or SU4-SU7. Scour analysis not yet been performed for this structure.				Engineering in 2012. have sufficient fill in 7. Scour analysis has

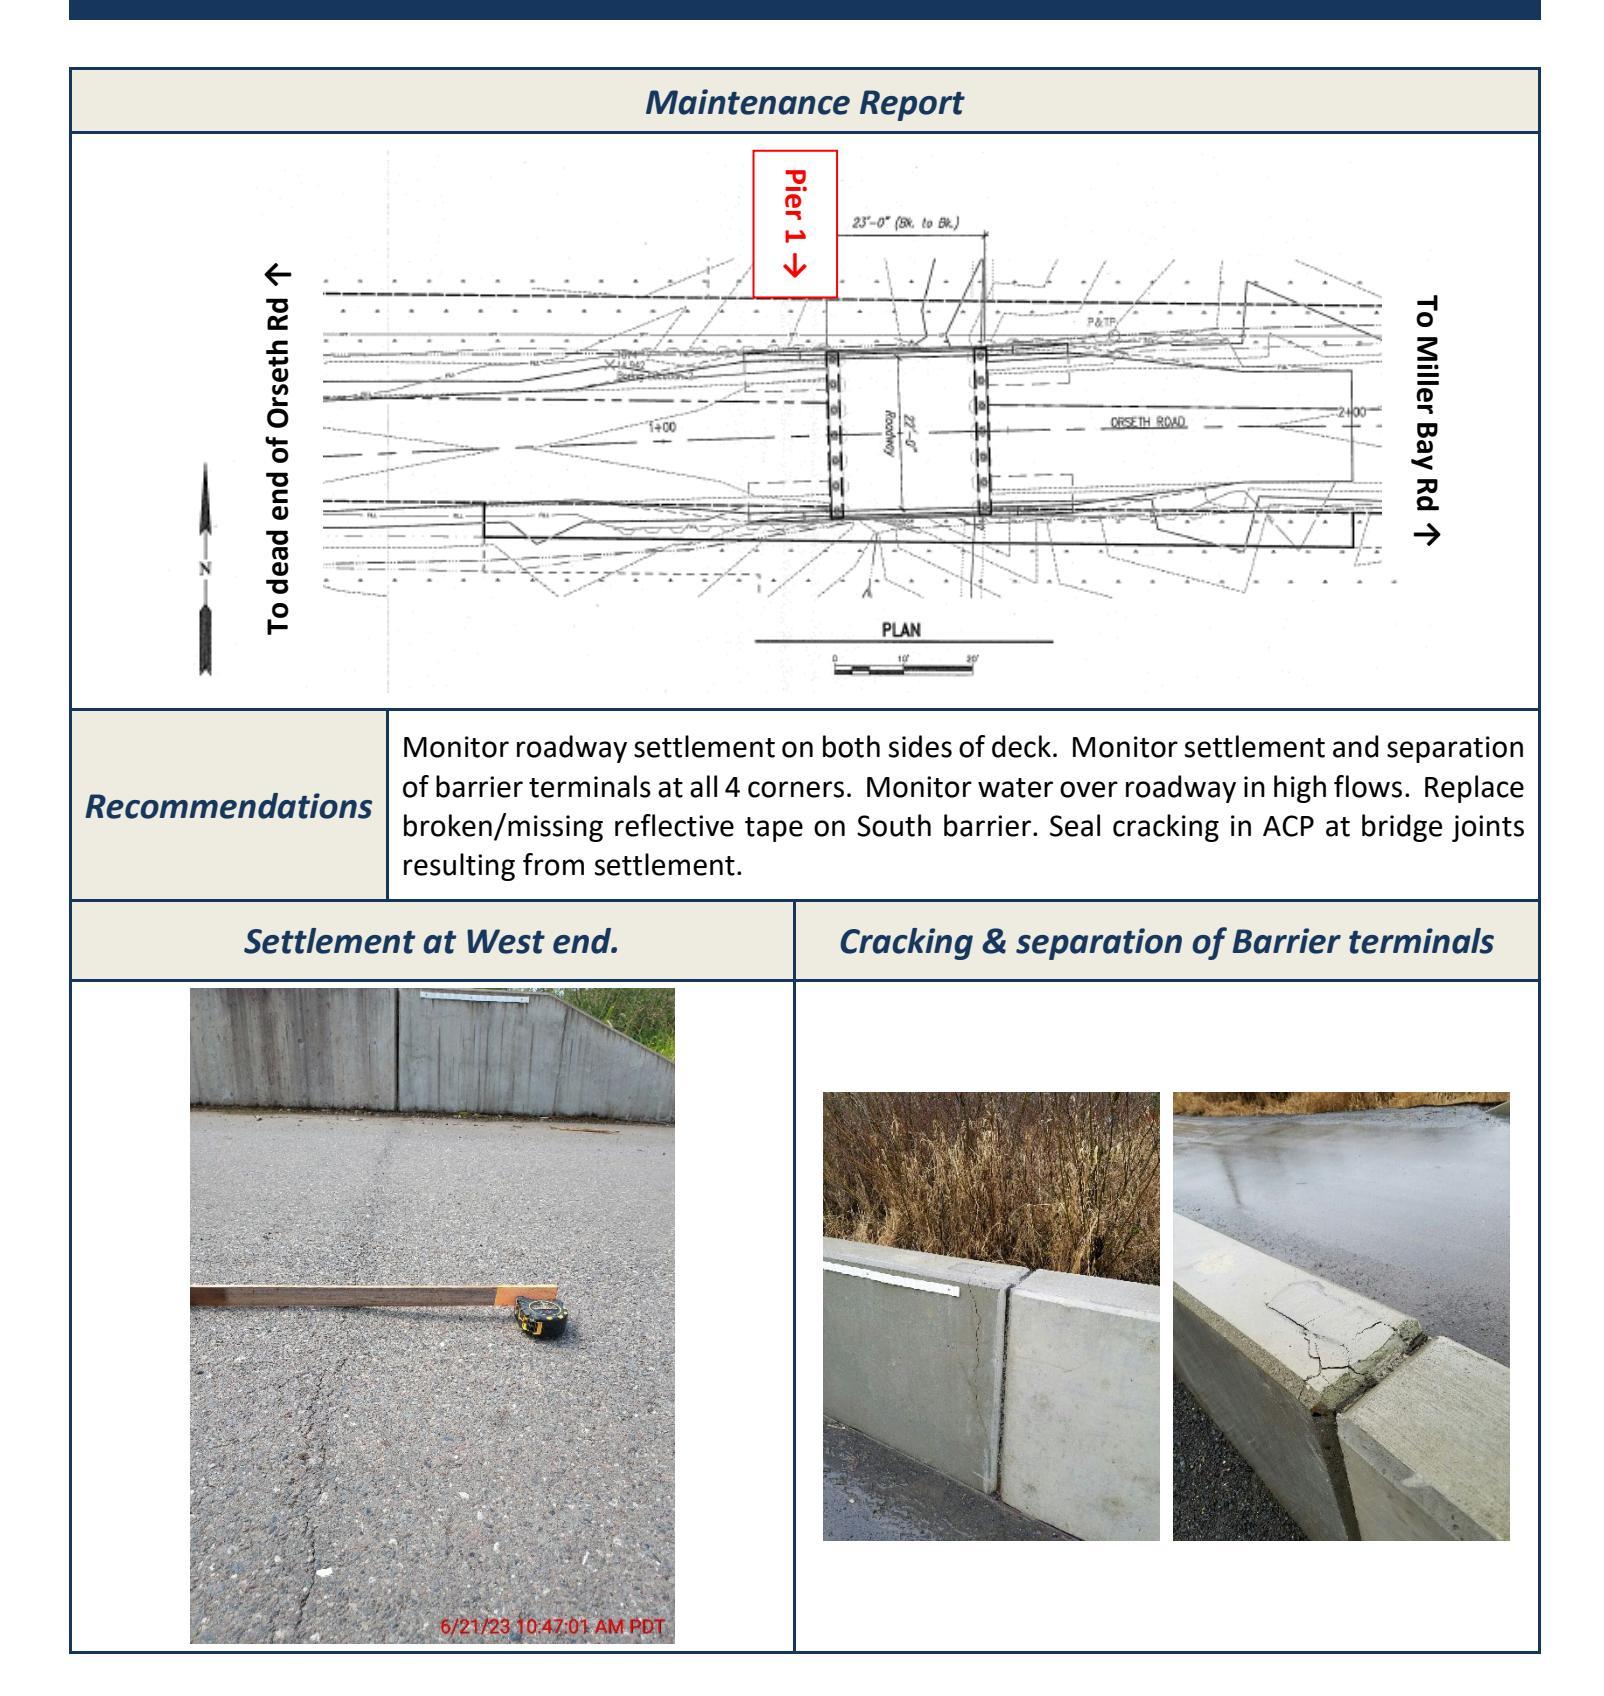
Bridge 38 – Orseth Road Bridge							
Orseth Road	Grovers Creek	2015	Good (G)	Jun. 28, 2023			
Route Name	Feature Intersected	Year Built	Overall Condition	Last Inspection

Girder	Pr	ecast concrete slabs 14"x 48"x 23' in length.		
	Deck	3″	HMA over Waterproof Membrane.		
Superstructure	Other	Ca co ab ne	est-in-place concrete bridge barrier has cracking at all 4 corner terminal onnections to bridge barrier due to settlement on both ends behind outment. On the south barrier, the reflective tape has been damaged and eeds replacing.		
	Foundatio	on	Driven 9½" steel pile foundation approximately 35'-40' in length.		
Substructure	Abutments		Cast-in-place concrete abutment with elastomeric bearing pads and sheet pile protection. Beam seat 21". Settlement on West Joint (Pier 1) is measured at 1".		
Scour and Load Rating	Bridge has l Rating upda Scour analy	Bridge has been load rated as per FHWA requirements by Sargent Engineering in 2015. Load Rating updated by TranTech Engineering in 2019 for SU and EV ratings. Scour analysis has not yet been performed for this structure.

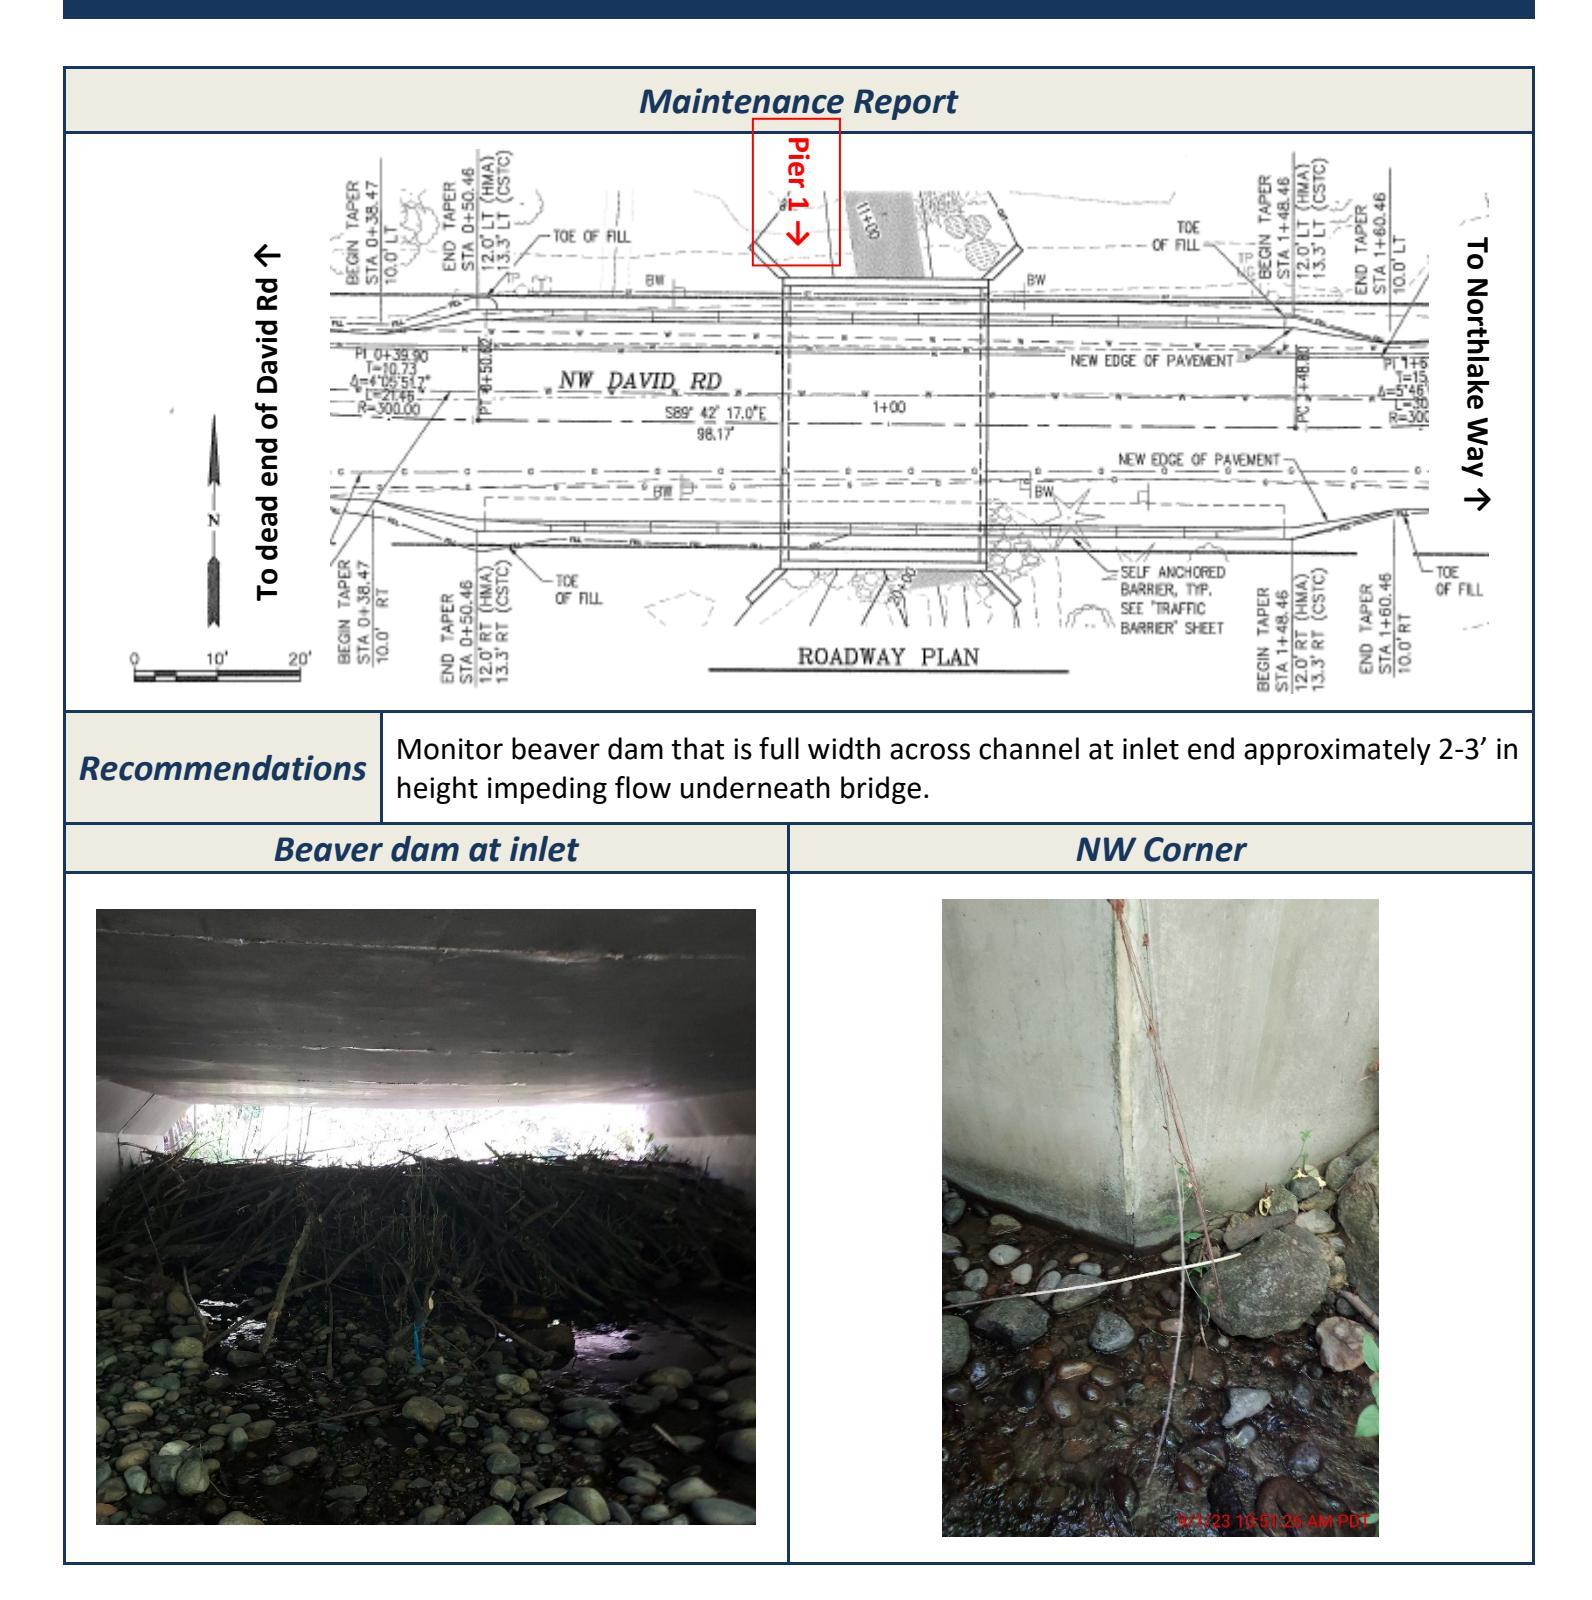
Bridge 39 – David Road Culvert							
David Road	Dickerson Creek	2015	Good (G)	Sep. 1, 2023			
Route Name	Feature Intersected	Year Built	Overall Condition	Last Inspection

Superstructure	Culvert	3-: Co ind	side precast concrete culvert 35' length with a 23' span x 9'-10" rise. Imponents are all in good condition. Minor moisture present at joints cluding leaking in spots with efflorescence.
Substructure	Foundatio	on	Precast footings and wing walls with rebar reinforcement.
Scour and Load Rating	Bridge has bee Scour analysis		en load rated as per FHWA requirements by TranTech Engineering in 2019. has not yet been performed for this structure.
Photo

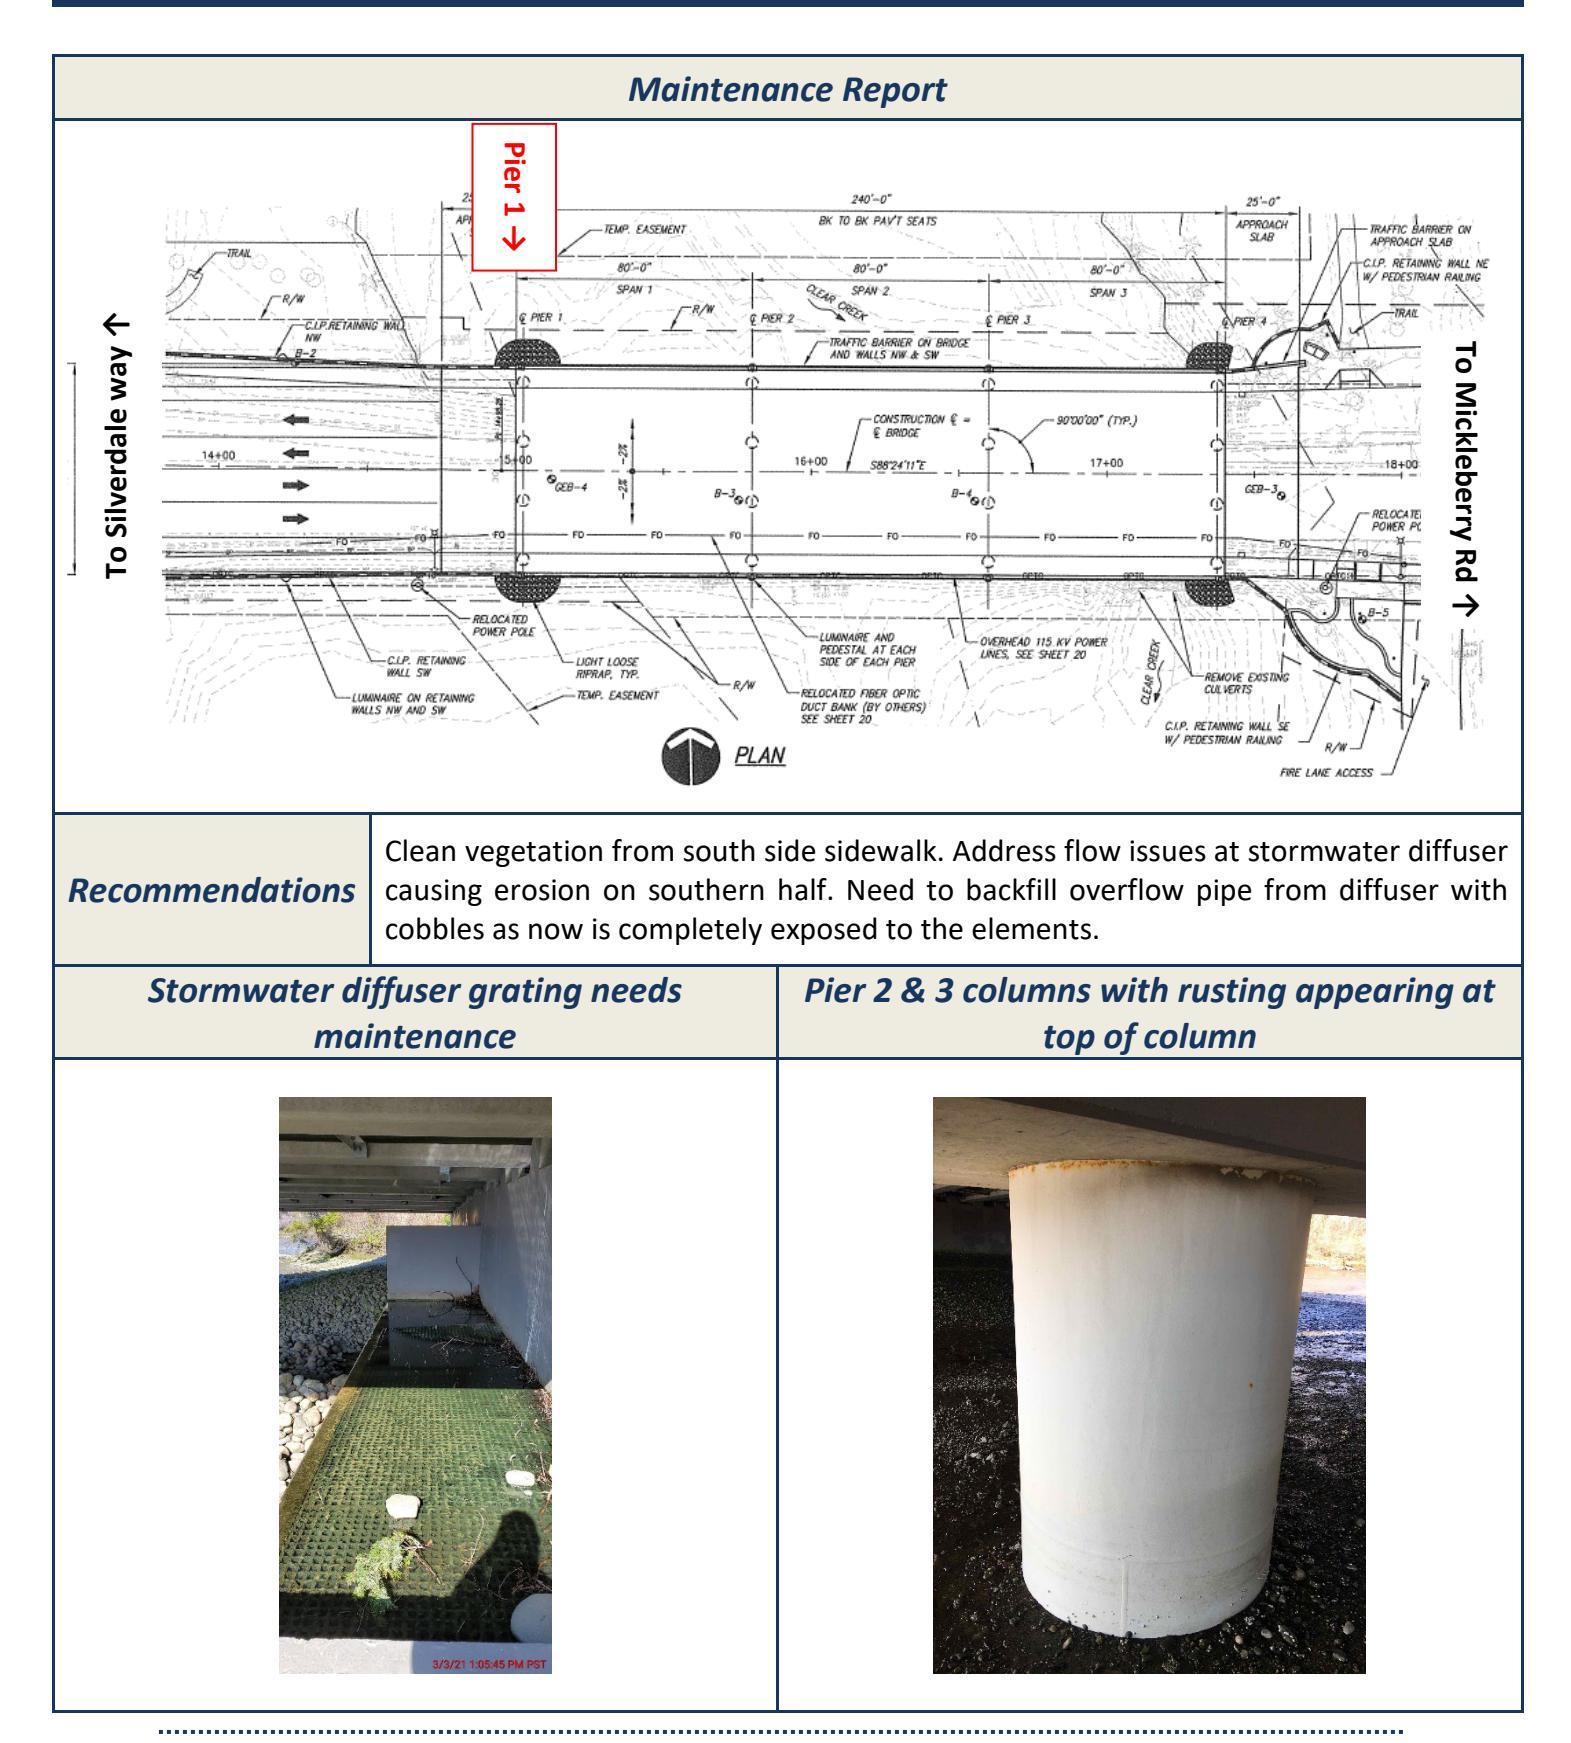
Bridge 40 – Bucklin Hill Bridge

Scour and Load Rating	Bridge has been load rated as per FHWA requirements by Exeltech in 2016. Load Rating updated by TranTech Engineering in 2019 for SU and EV ratings.				
Photo		Scour analysis has not yet been performed for this structure.
