2023 Annual Bridge Report

Prepared by Kitsap County Public Works Engineering Division This sheet intentionally left blank.

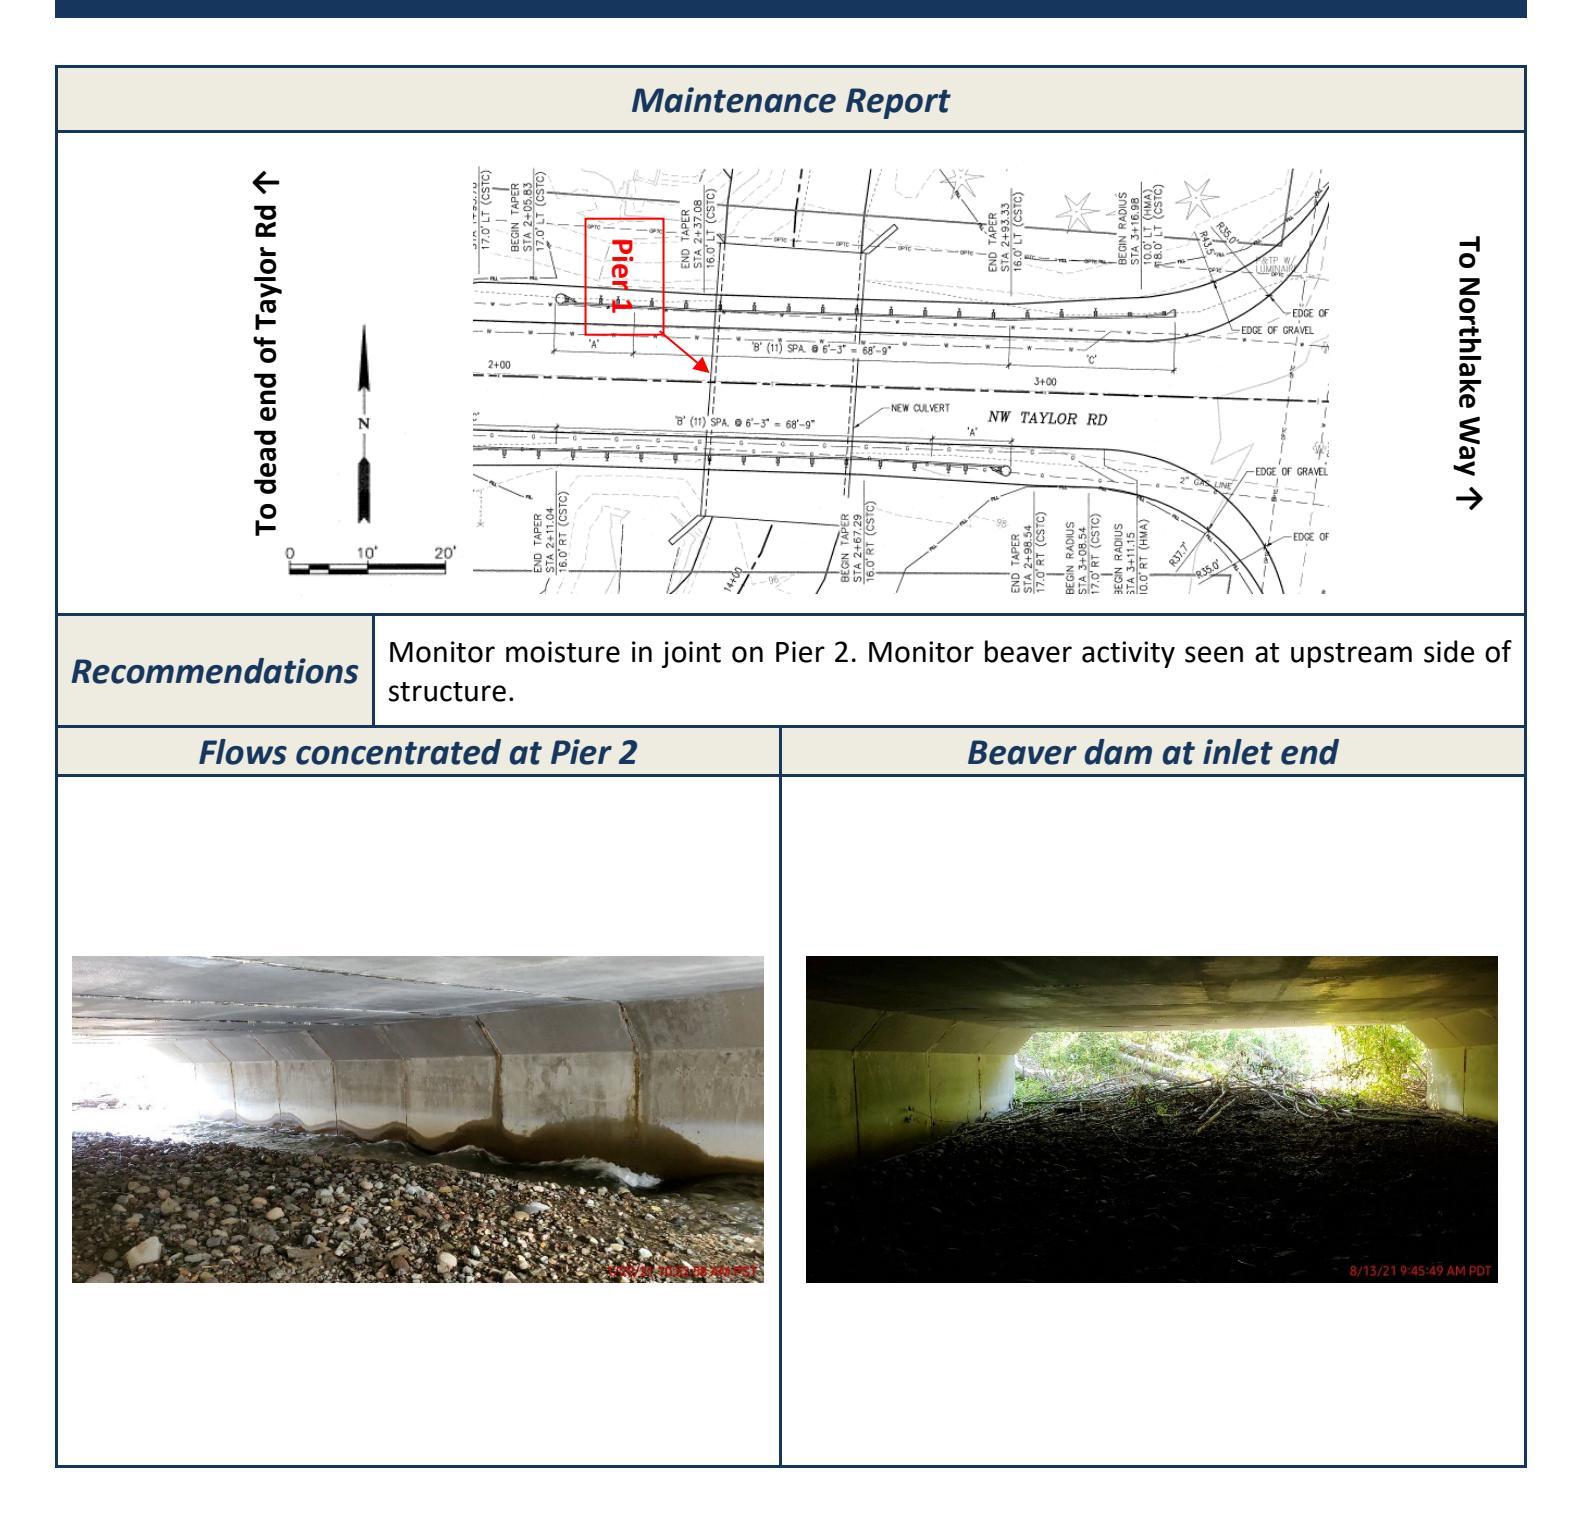
Bridge 41 – Taylor Road Culvert							
Taylor Roa	d	Dic	kerson Creek	2016	Good (G)	Aug. 31, 2023		
Route Name	ľ	Fec	iture Intersected	Year Built	Overall Condition	Last Inspection		
Superstructure	Culvert 3 Solution		-side precast concrete culvert 50' length with a 25' span x 9'-10" rise. Components are all in new condition. Some moisture dripping between ections 4 & 5 on Pier 2 side.					
Substructure	Foundati	on	Precast footings a	nd wing walls wi	ith rebar reinforceme	nt.		
Scour and Load Rating	Bridge has been load rated as per FHWA requirements by TranTech Engineering in 2019 Scour analysis has not yet been performed for this structure. Heavy beaver activity at inlet of this structure with dam full span across inlet. Water i flowing slight trickle on East end of structure. Only 3-4 feet of freeboard in culver underside.					ingineering in 2019. cross inlet. Water is reeboard in culvert		
Photo

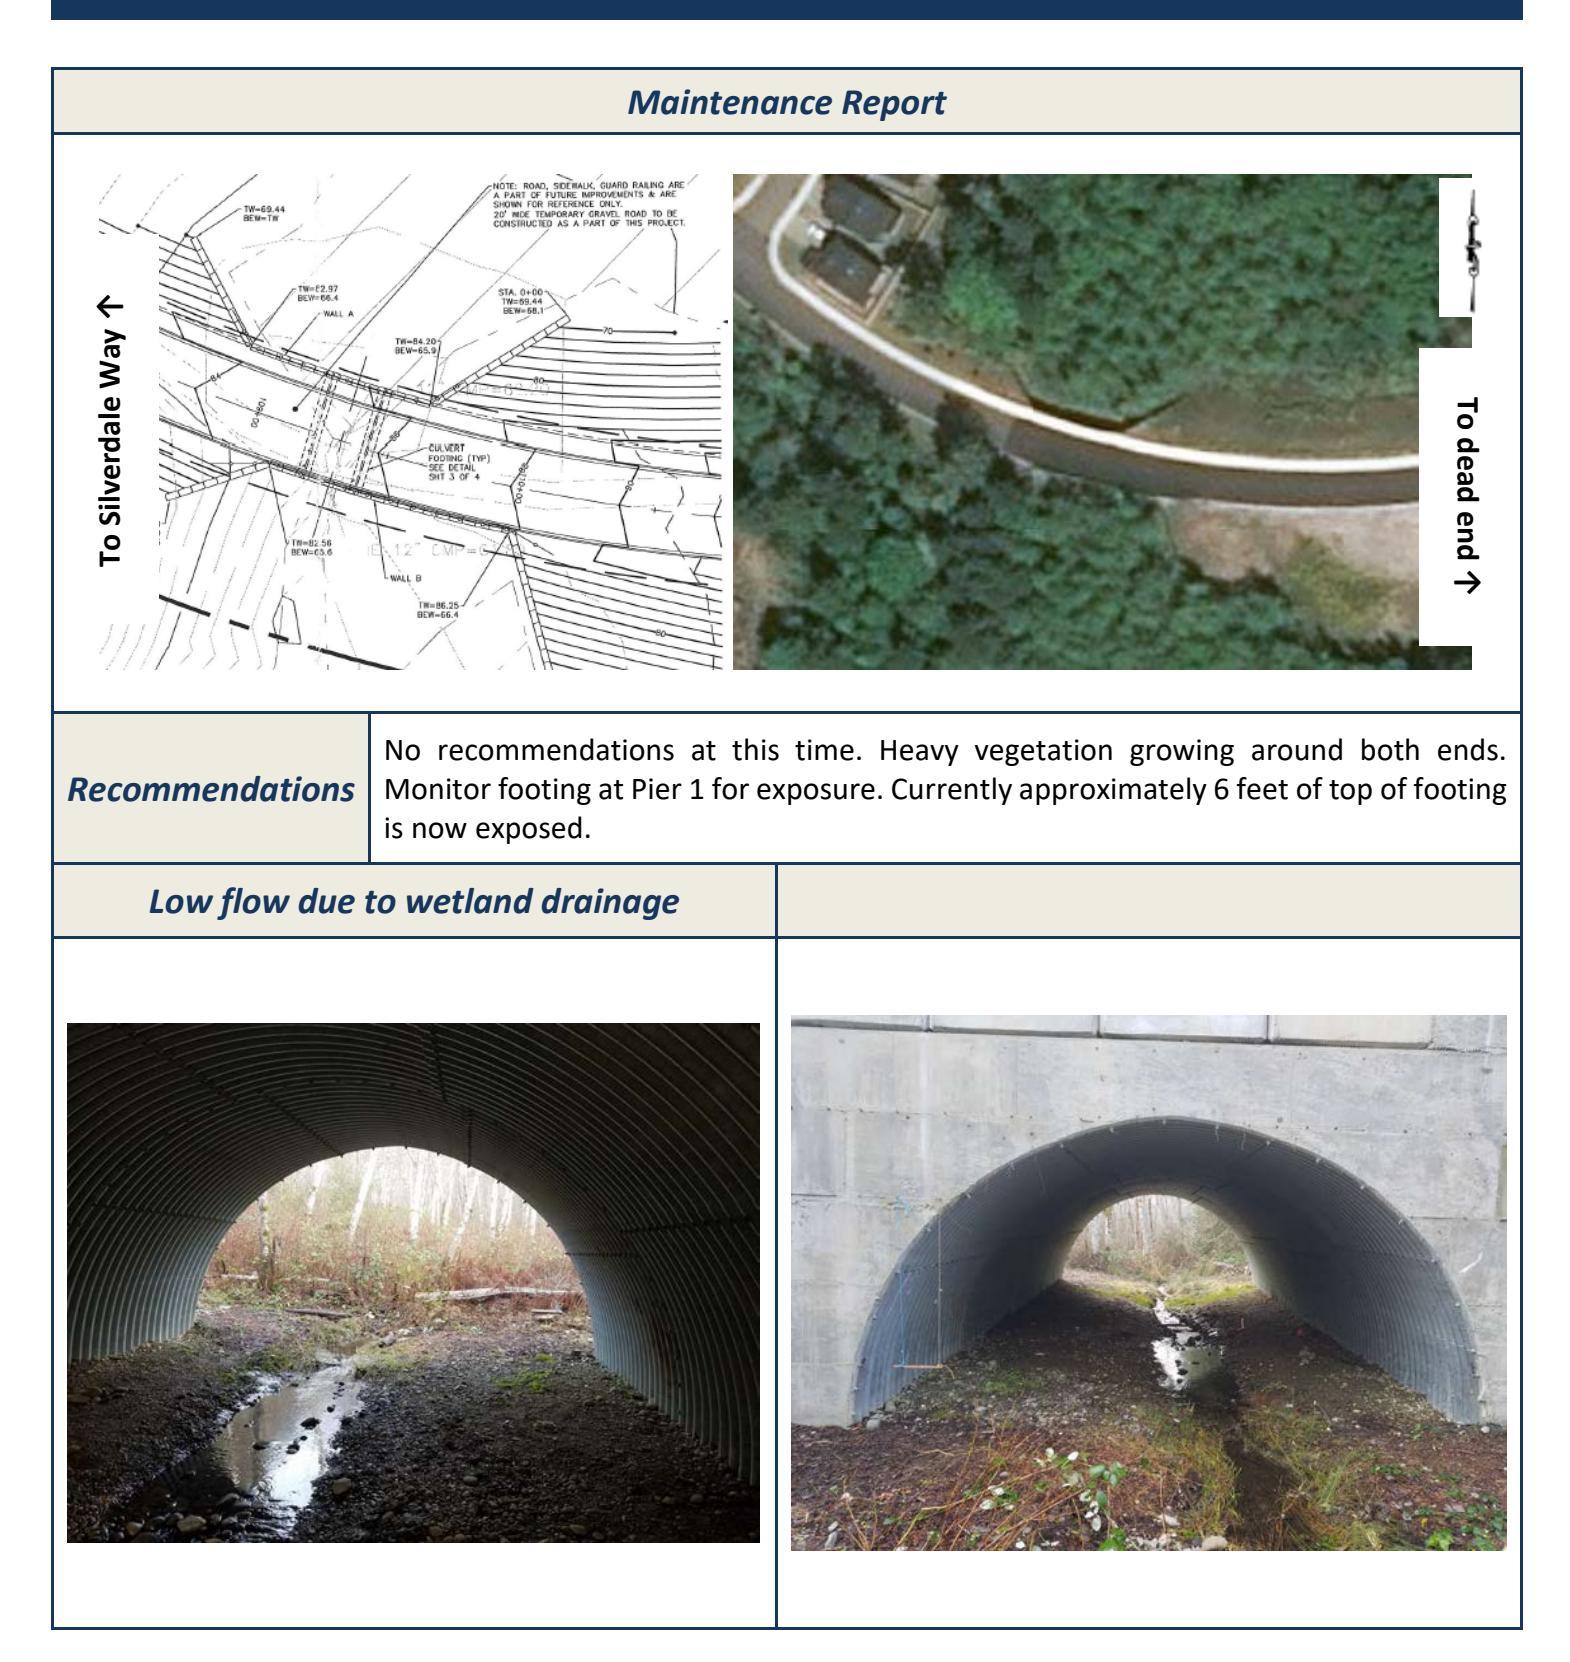
Bridge 42 – Woodbridge Culvert

Superstructure	Culvert	Low profile steel multi-plate arch culvert in new condition. Slight deflection the top of the culvert.				
Substructure	Foundatio	on	Concrete footing is 4.5' in depth and 2' in height with 4"x8" keyway filled with grout.			
Other	Concrete s culvert wi Ultrablock	ide th reta	walk is built on fill over the culvert structure. ACP installed on fill over the concrete bridge railing and metal pedestrian railing in new condition. aining walls on both faces of the culvert.			
Scour and Load Rating	Bridge has Scour eval yet been p This bridge	Bridge has been load rated as per FHWA requirements by Pacific Affiliates Inc., in 2017. Scour evaluation was performed by TranTech Engineering in 2018. Scour analysis has not yet been performed for this structure.				
Photo			<image/>

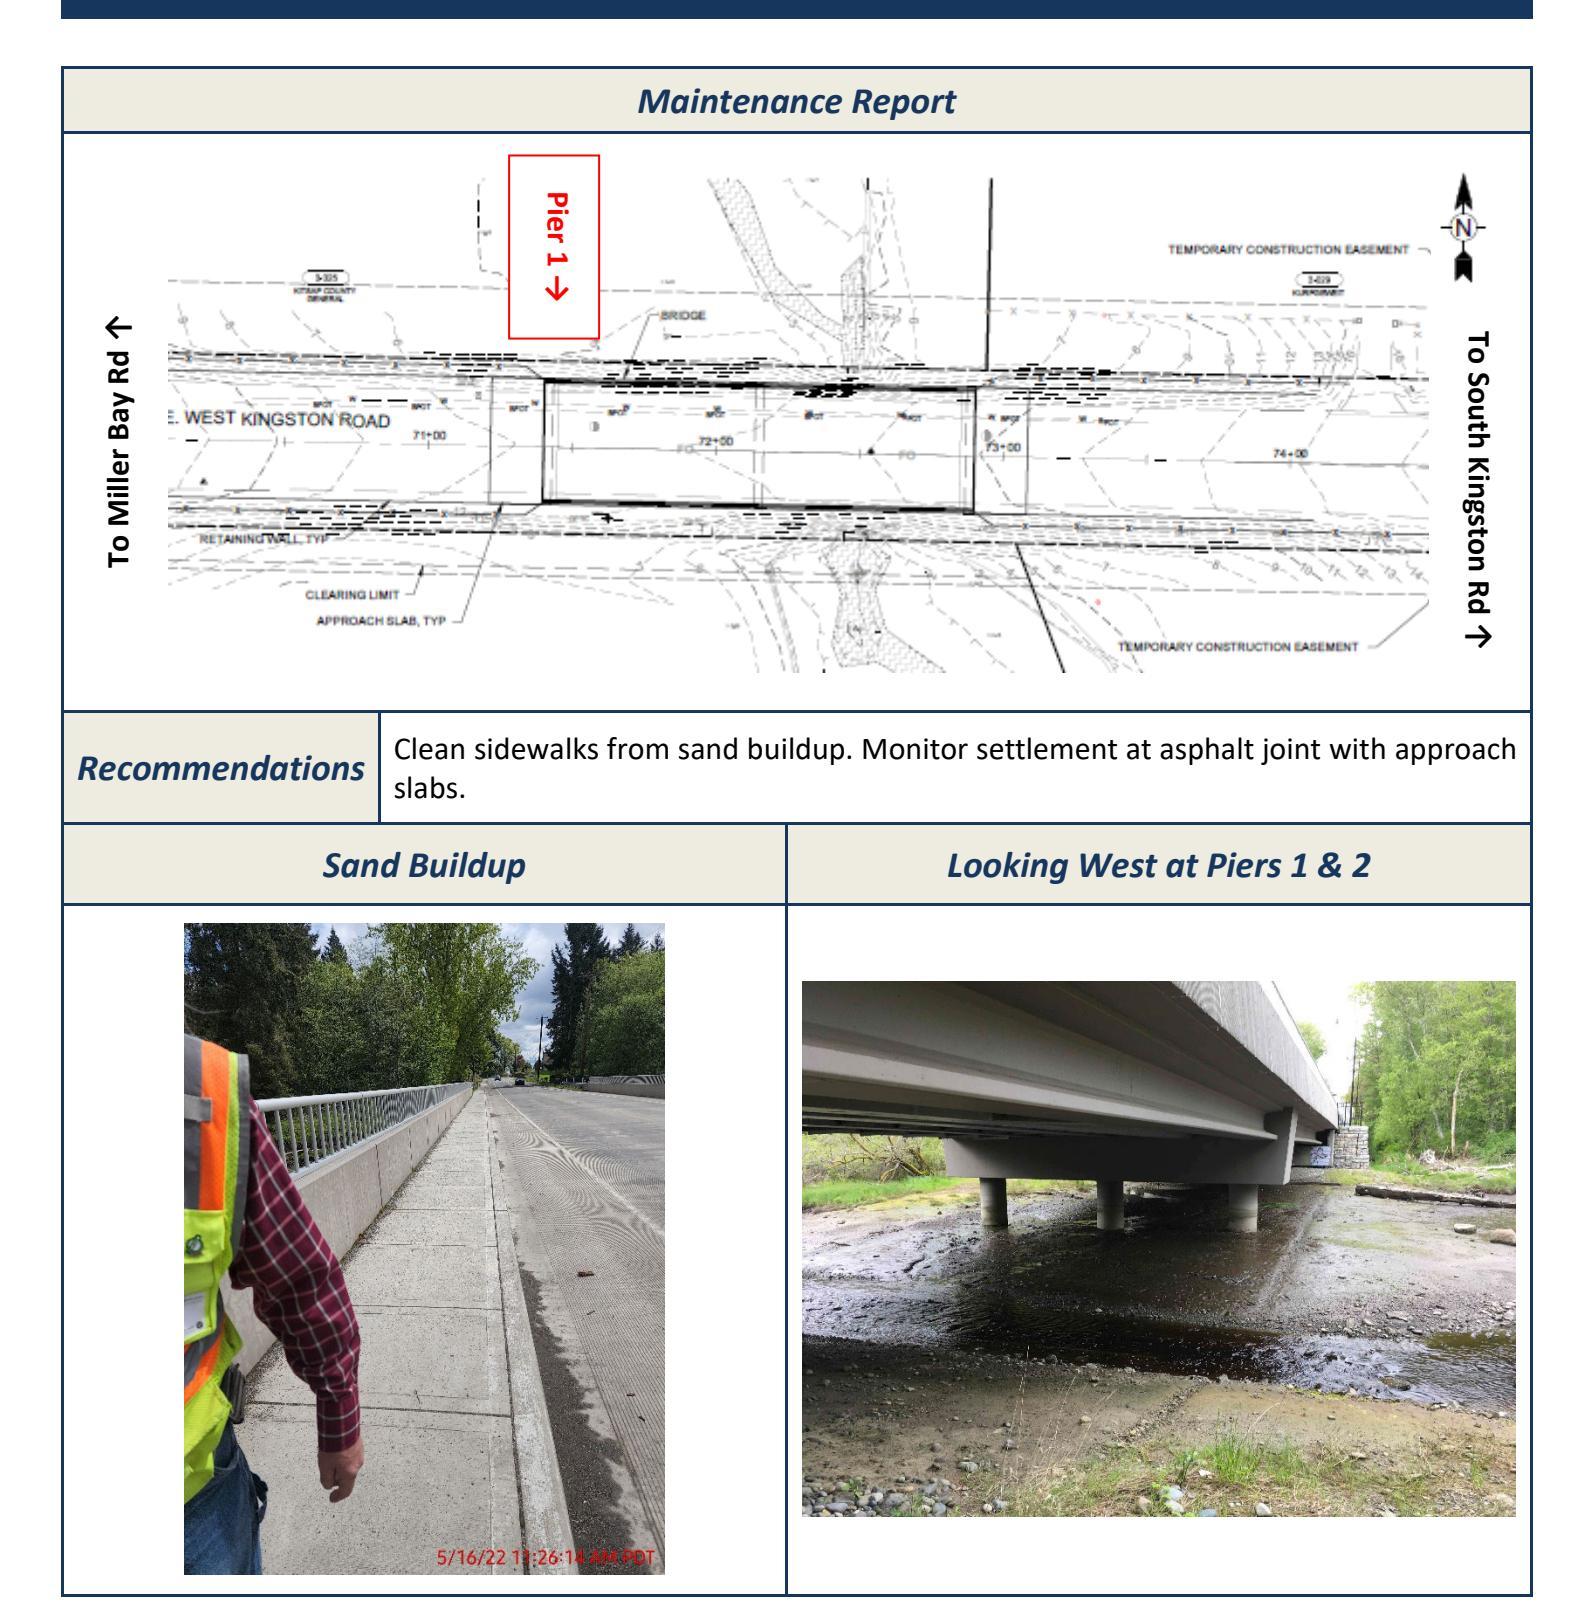
Bridge 43 – West Kingston Bridge

Girder	Pr Sp ca	estressed precast (WF36G) concrete wide flange girders in good condition. ots of exposed steel visible on the bottom flanges of the girder likely from sting aids.			
C	Deck	Ca	st-in-place 7.5" concrete deck with epoxy coated rebar in good condition.			
Superstructure	Other	Cc ra Cc bc co	ncrete bridge railing with hairline cracking throughout. Metal pedestrian ling in new condition. Elastomeric bearing pads at each end of the 5 girders. Impression Seal between bridge and approach slabs. Concrete sidewalks on oth sides of the bridge in good condition. Guardrail on all 4 quadrants in new ndition.			
Foundatio		on	Abutments 1 & 2 have $3 - 4'$ diameter drilled shaft and the intermediate pier has $3 - 5'$ diameter drilled shafts have rebar and concrete encased in steel casing; length 40-50 feet.			
Substructure	Abutments		Each cast-in-place concrete abutment is 5' wide. The intermediate pier consists of a 3' diameter column on top of the drilled shaft foundation with a 5' wide pile cap.

Bridge has	Bridge has been load rated as per FHWA requirements by Tetra Tech, Inc. in 2018.				
Scour and	Scour evaluation was performed by TranTech Engineering in 2018.					
Load Rating	Scour analy	Scour analysis has not yet been performed for this structure.				
	This bridge is not scour critical.					
Photo

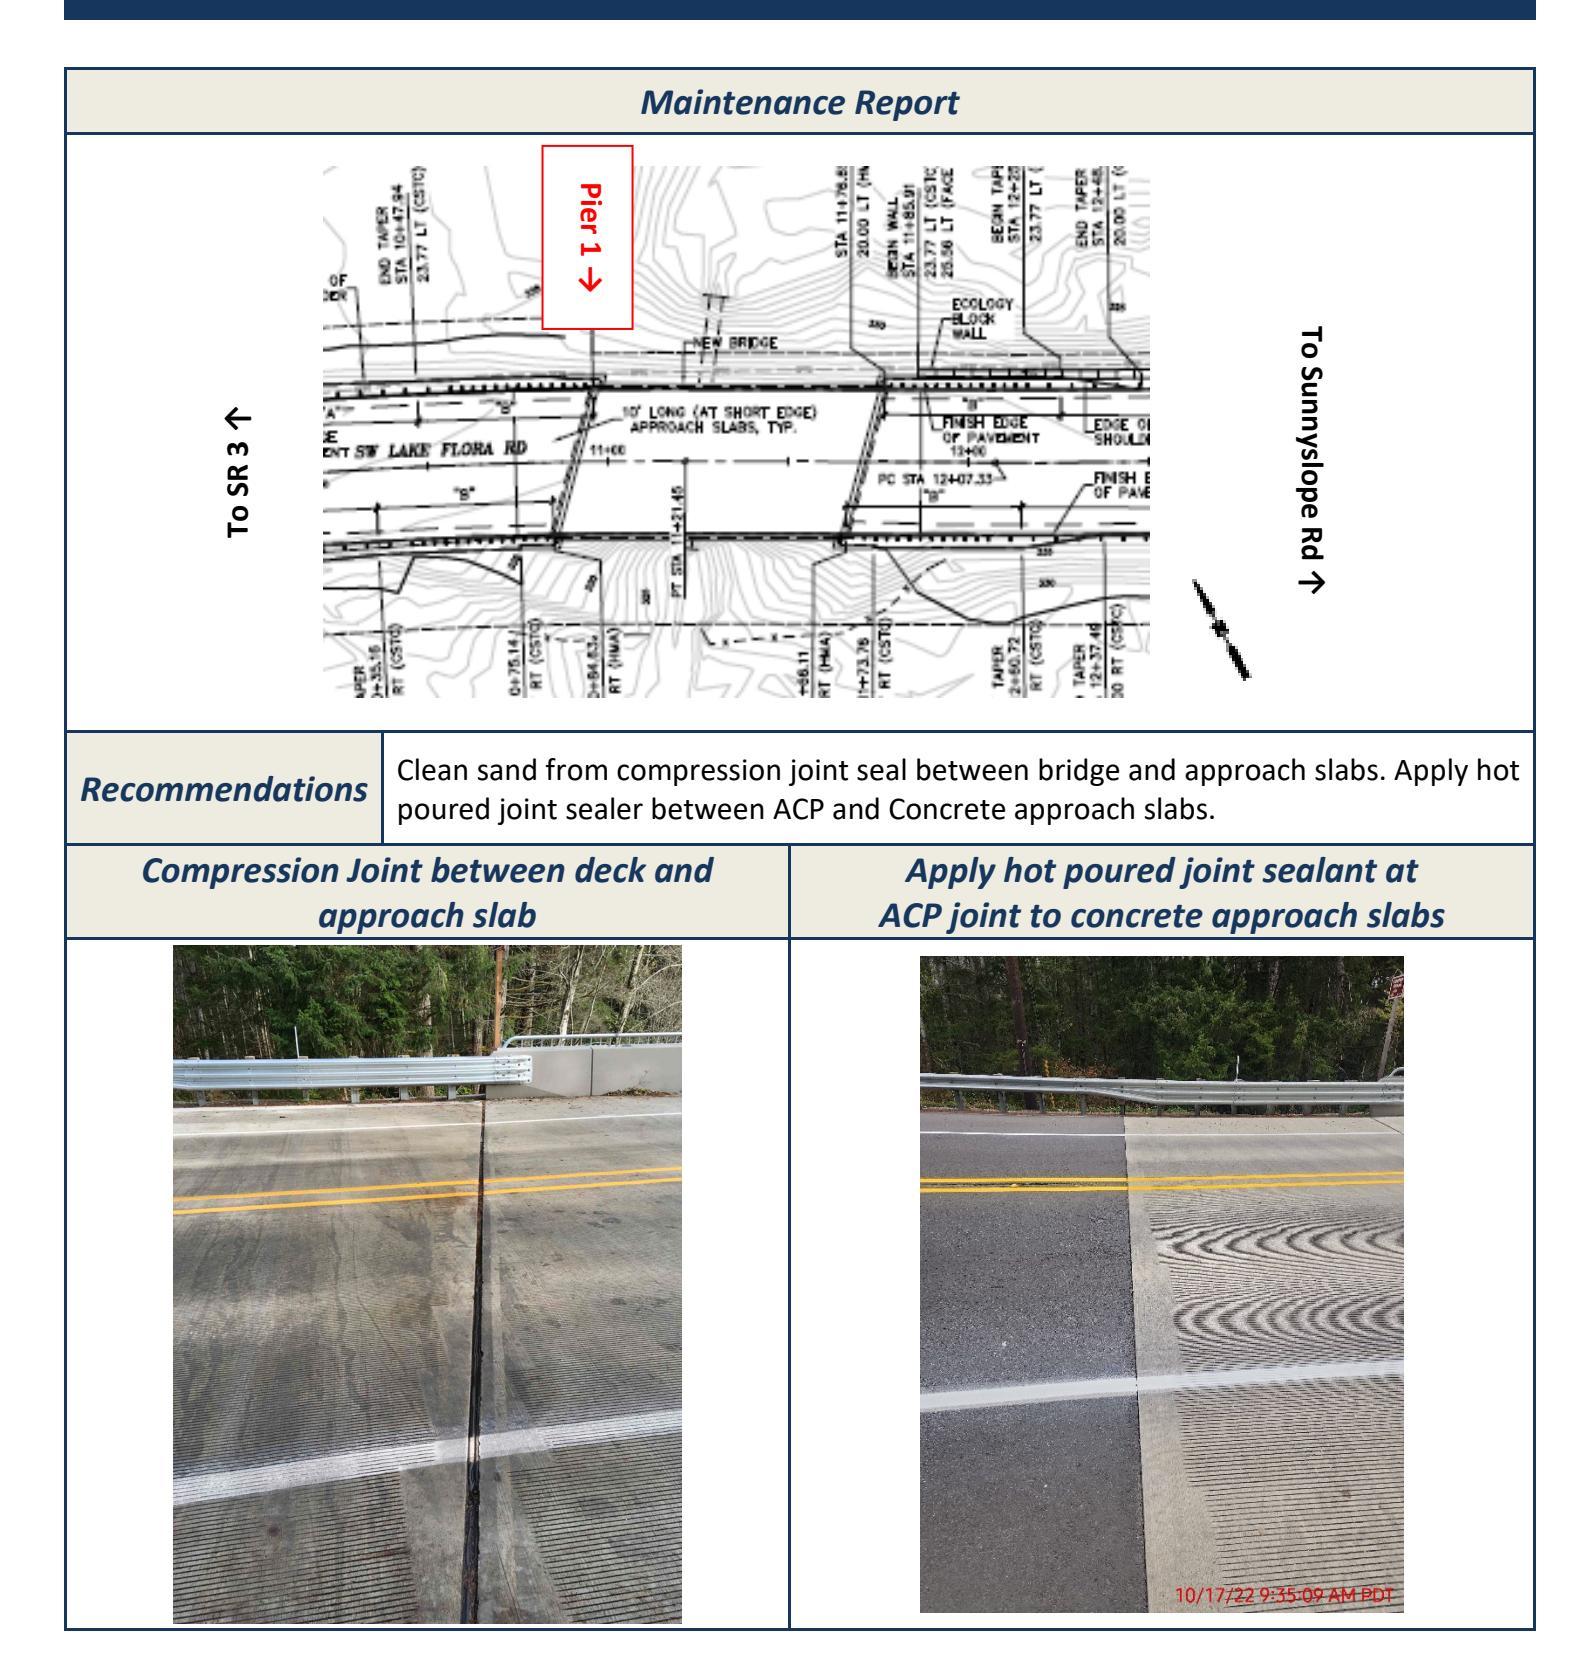
Bridge 44 – Lake Flora Road Bridge

Girder	Pr Sp ca	estressed precast (WF36G) concrete wide flange girders in new condition. ots of exposed steel visible on the bottom flanges of the girder likely from sting aids.		
Superstructure	Deck	Ca	st-in-place 7.5" concrete deck with epoxy coated rebar in good condition.		
Superstructure	Other	Cc co Se co	oncrete bridge railing in new condition. Metal pedestrian railing in new ndition. Elastomeric bearing pads at each end of the 7 girders. Compression al between bridge and approach slabs. Guardrail on all 4 quadrants in new ndition.		
Substructure	Foundation		Each concrete abutment is supported with 10 Steel H14x73 piles approximately 60-65 feet in length driven to elevations ranging from 293- 297.		
	Abutments		Each cast-in-place concrete abutment is 3' wide.		
	Bridge has been load rated as per FHWA requirements by Sargent Engineers in 2020.				
Scour and	Scour evaluation was performed by Sargent Engineers in 2020.

Load Rating	Scour analysis has not yet been performed for this structure.				
	This bridge is not scour critical.				
Photo

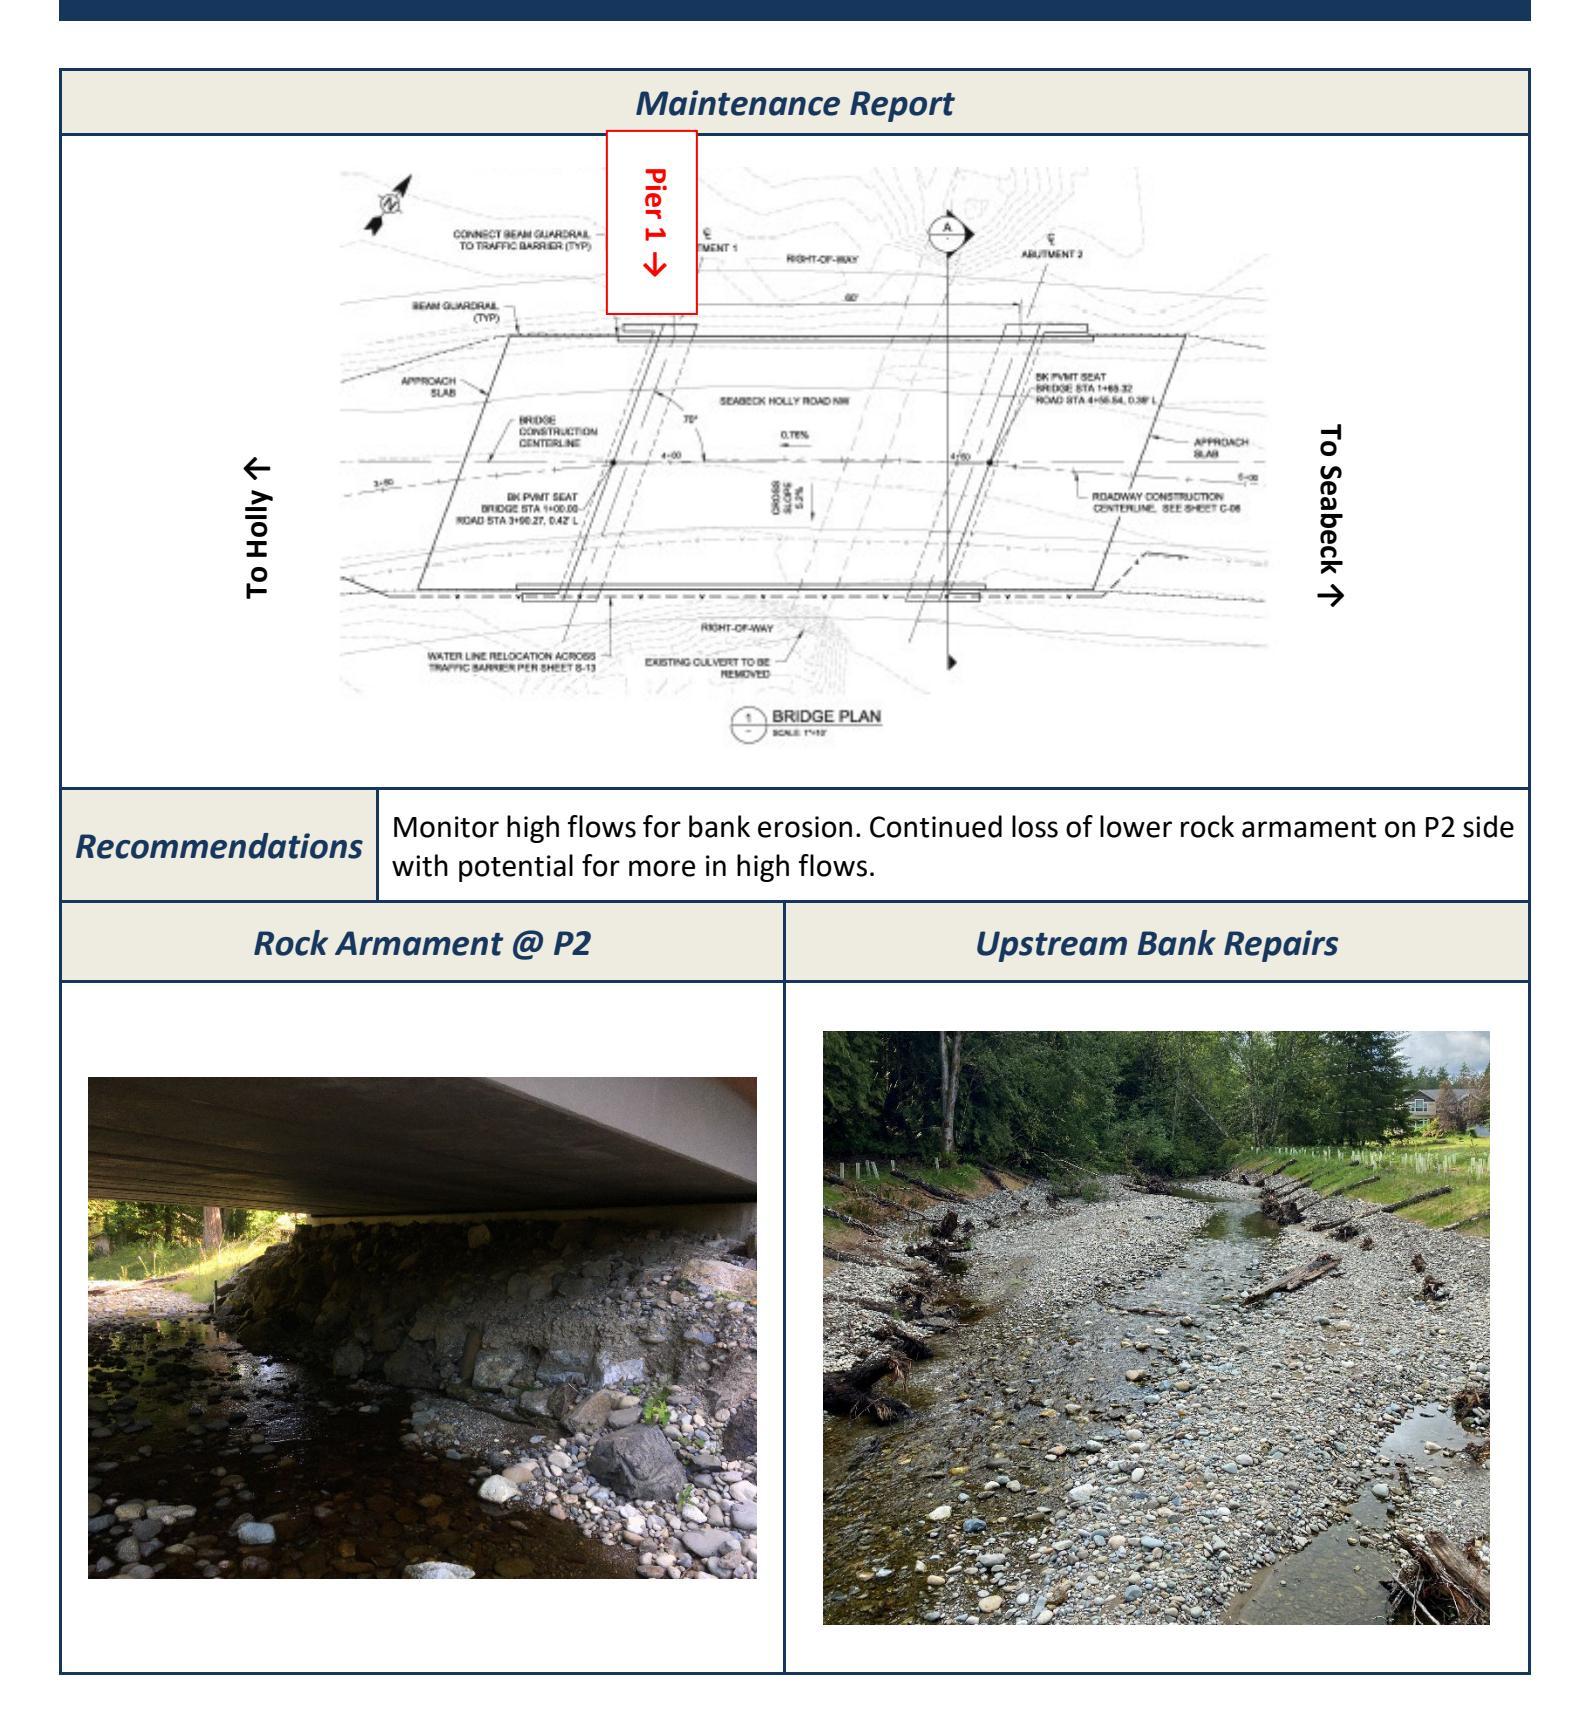
Bridge 45 – Seabeck Hwy @ Larson Lane Bridge

Superstructure	Girder	Prestressed concrete voided slab girder 2' x 4' x 62.5' in new condition.			
	Deck	Cast-in-place concrete deck with epoxy coated reinforcing steel. Deck thicknes varies from 8.5" at high (north) side to 4.5" at the lower (south) side. Sligh scaling in starting to show in wheel tracks.			
		Ca M	st-in-place single slope concrete bridge railing (42" tall) in good condition. etal pedestrian railing (12" tall) Type S-BP-12 in new condition.		
	Other	1'-1" in thickness) in good condition. 2.5" Elastomeric compression seal placed in 1.5" width joint between concrete deck and concrete approach slabs.			
		2' x 6" x 1" Elastomeric Bearing pads with 14-gauge shims under each end slab girders in new condition.			
Substructure	Foundation		Driven steel pile casings filled with concrete foundation. 2 rows of 8 piles per abutment for 32 total piles. Average pile tip elevation on Abutment 1 is 40.65' and average for Abutment 2 is 41.7'.

Abutments		Cast-in-place concrete abutment in new condition.		
Scour and Load Rating	Bridge has been load rated as per FHWA requirements by Tetra Tech in 2021.				
	Scour evaluation and analysis was performed by Tetra Tech in 2021.				
	Bank stabilization repair completed in 2021 by Hood Canal Salmon Enhancement Group.				
	This bridge is not scour critical.				
Photo
