POINT NO POINT PHASE 2 RESTORATION AND REPAIR PROJECT

EXISTING CONDITIONS PLAN (1 OF 3)

POINT NO POINT PHASE 2 RESTORATION AND REPAIR PROJECT
GRADING AND MATERIALS PLAN (2 OF 3)

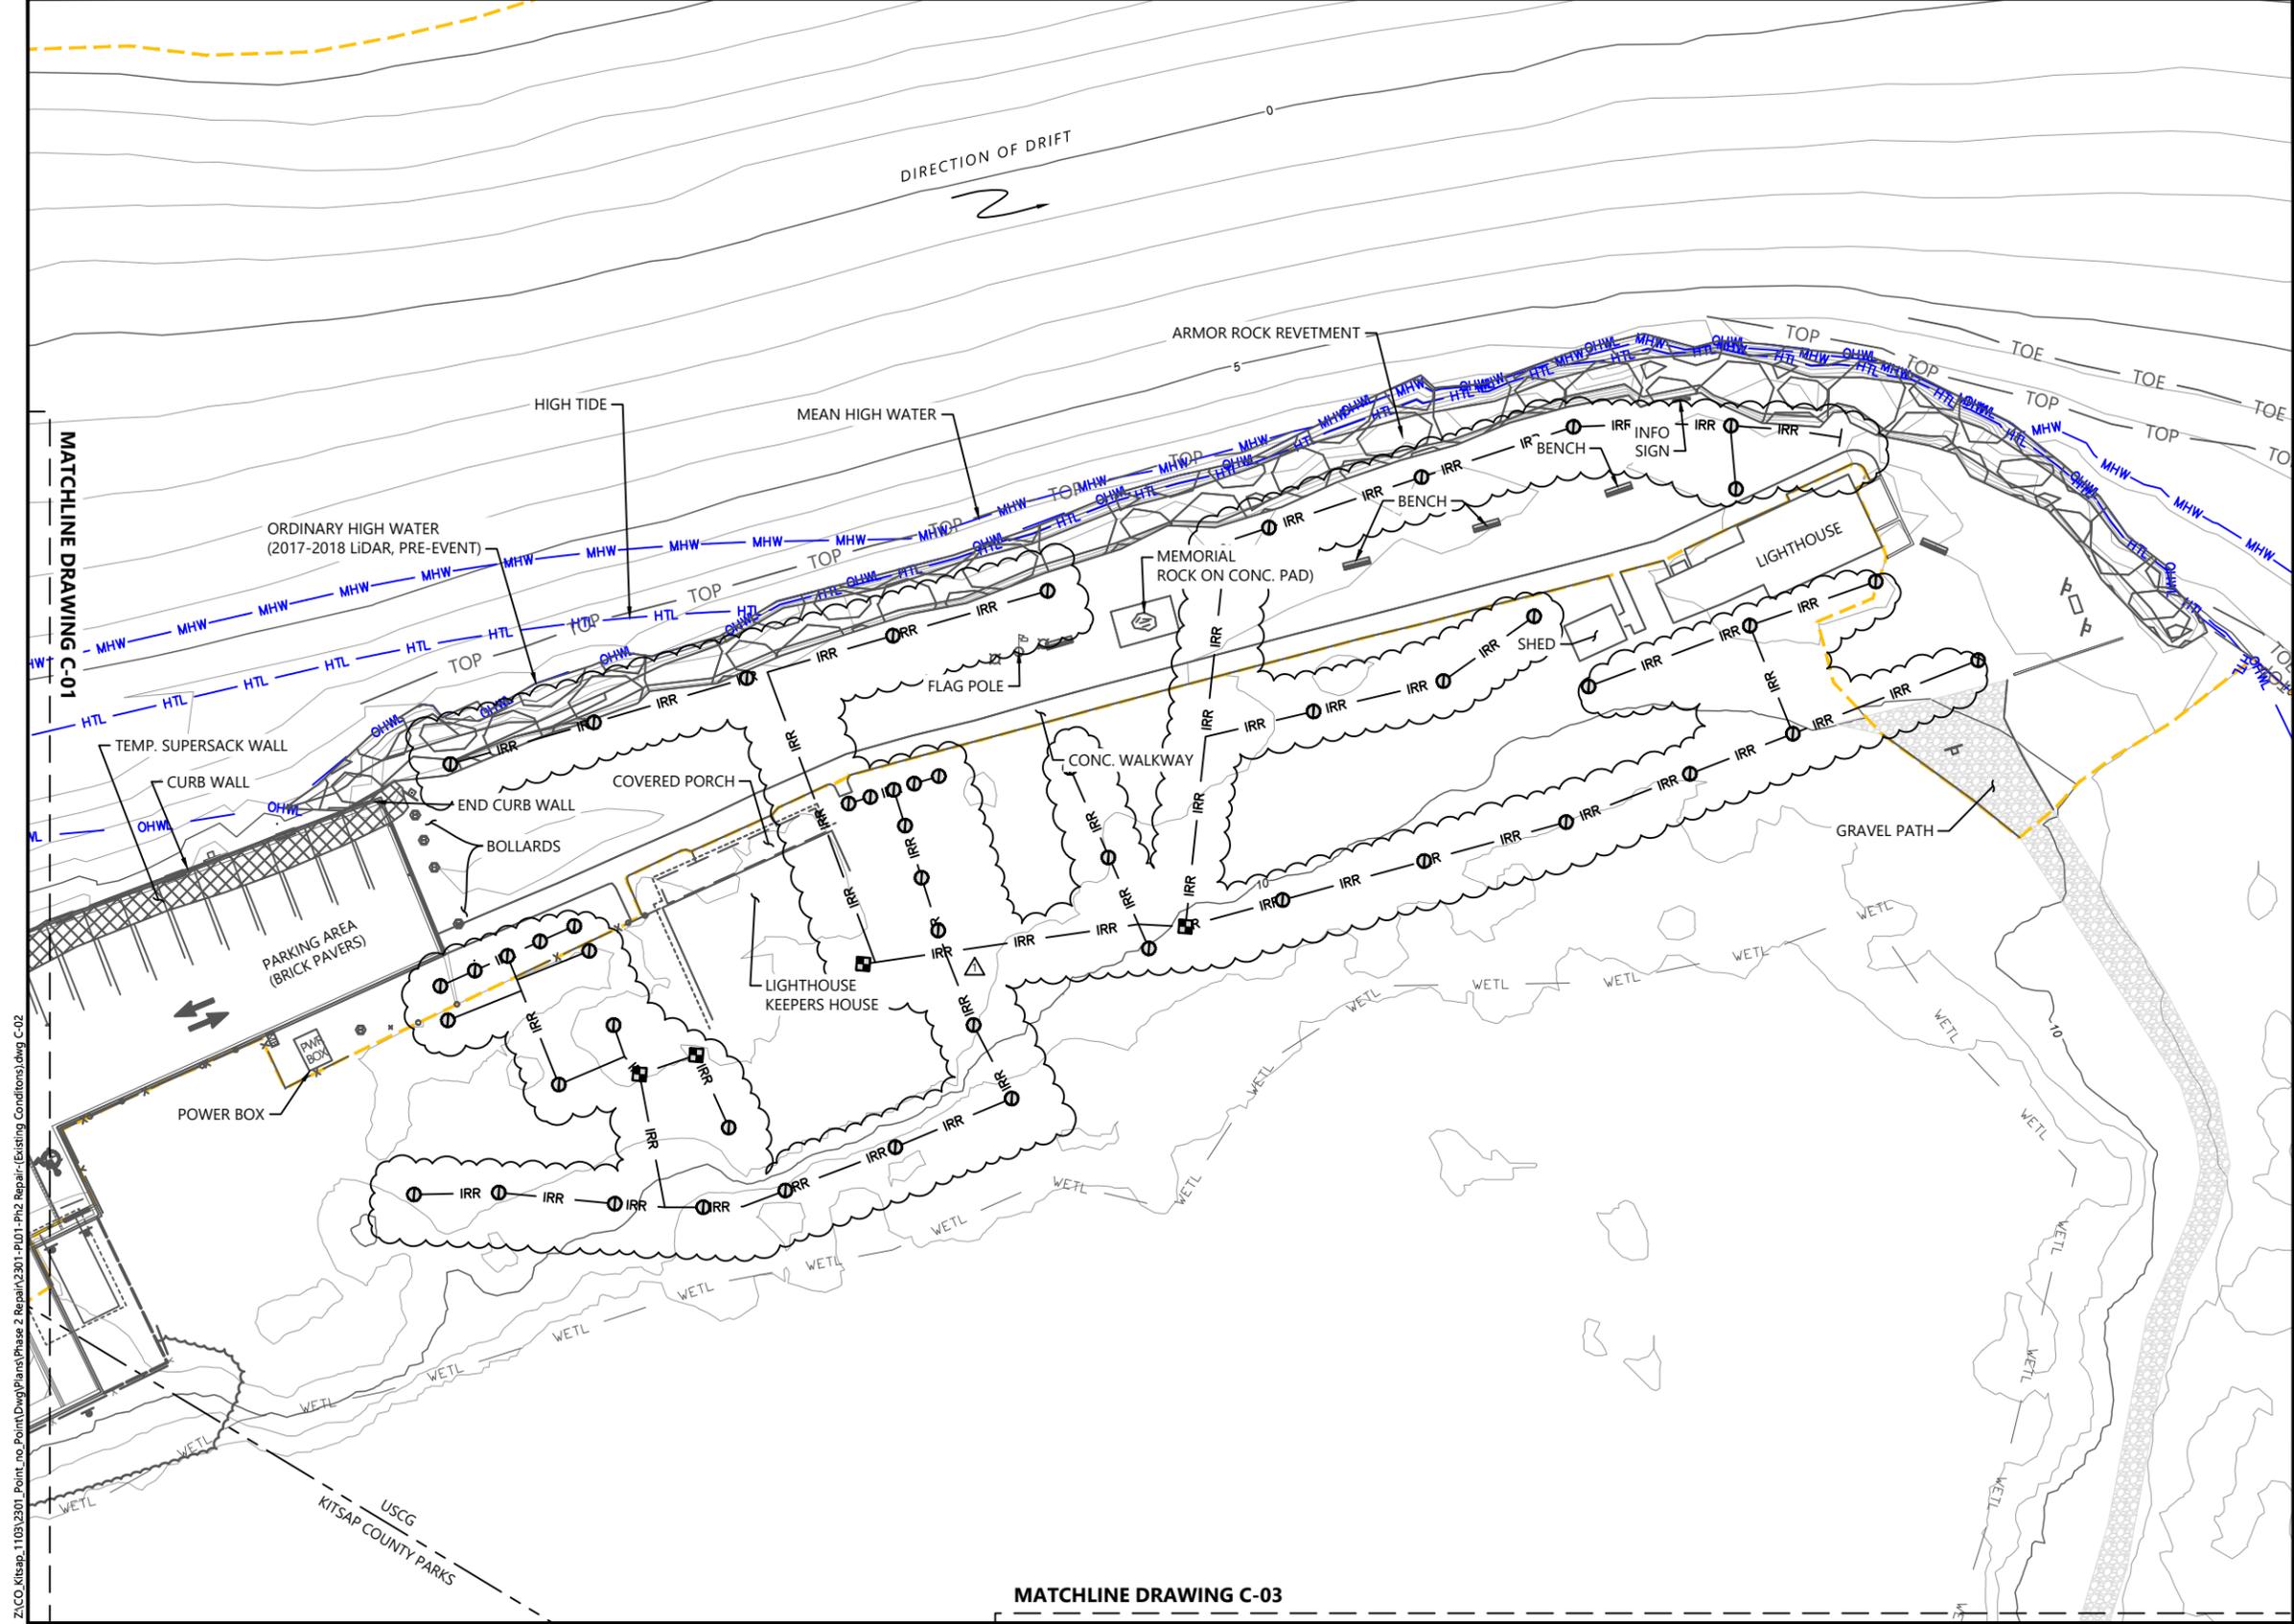
C-02

EXISTING CONDITIONS PLAN (2 OF 3)
