Figure 1
Sediment Source Mapping Results
Kitsap County Regional Shoreline Restoration
Feasibility and Prioritization Study

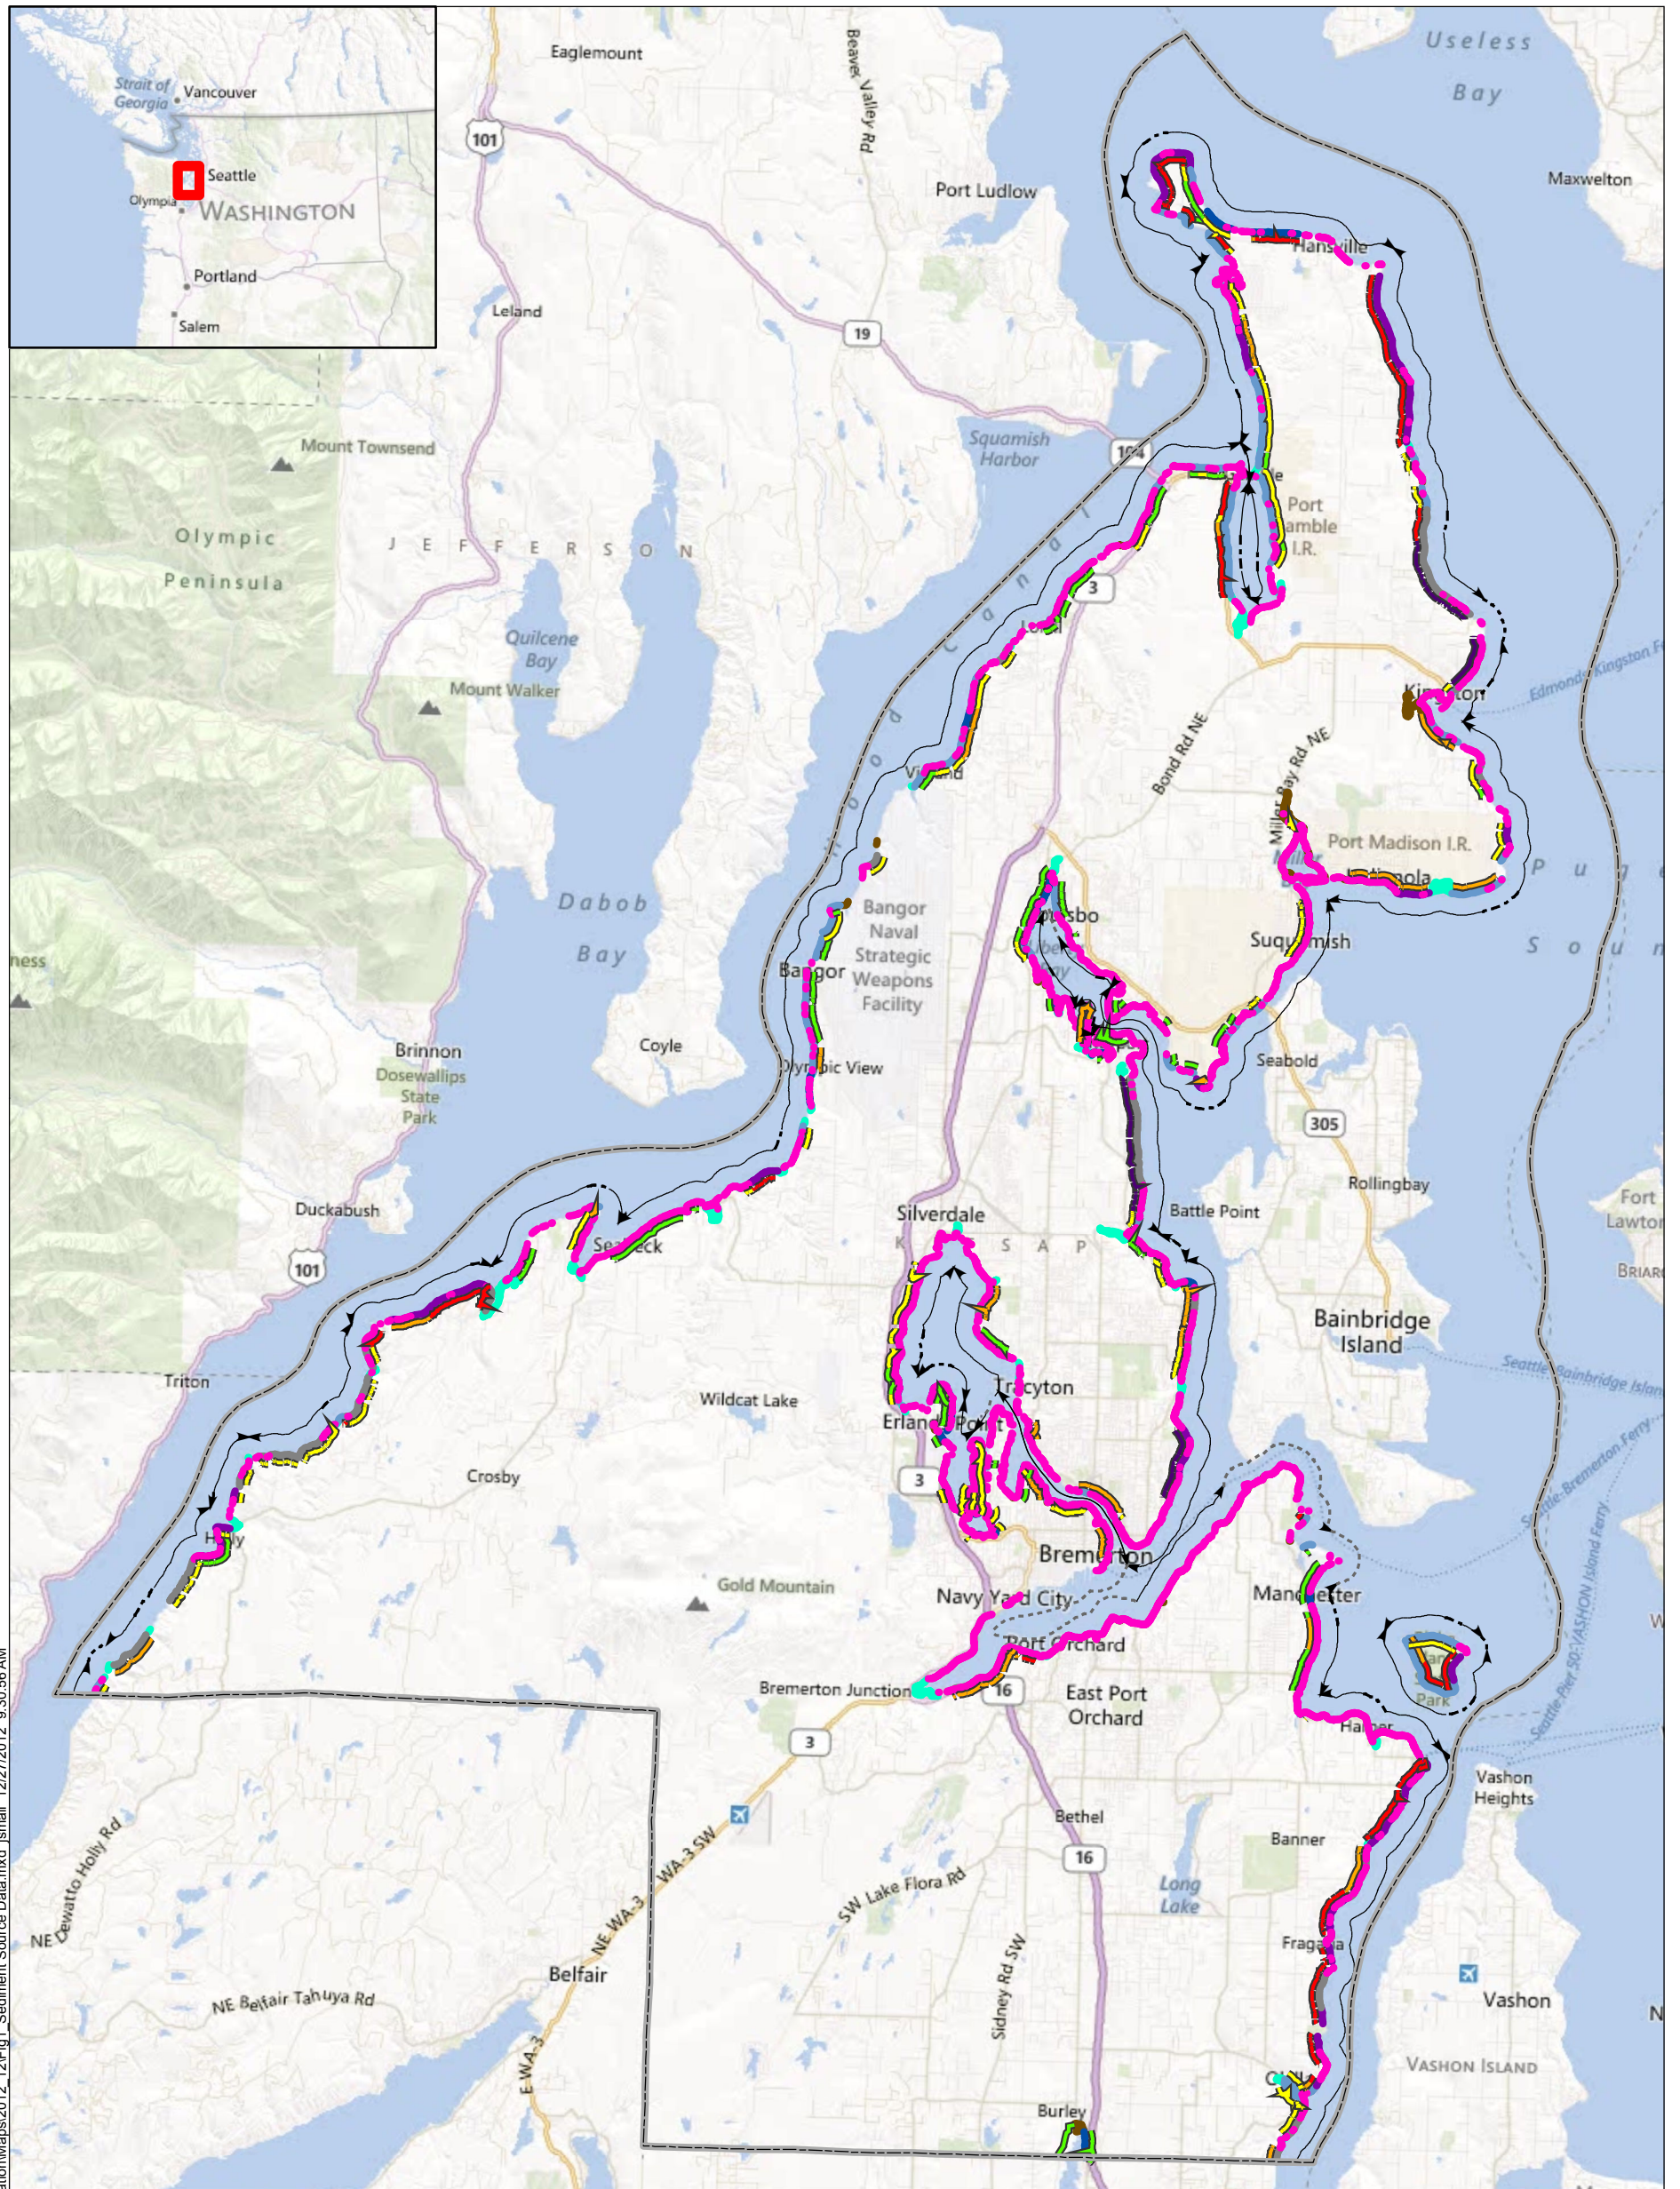
<p>Bank Height</p> <ul style="list-style-type: none"> No to Low Medium Medium to High High Highly Variable 	<p>Tributary</p> <ul style="list-style-type: none"> Not Identified As A Tributary Sediment Source Possible Tributary Sediment Source <p>Landslide Class</p> <ul style="list-style-type: none"> Predominantly Deep-Seated Mix of Both Shallow and Deep-Seated Predominantly Shallow Landslide/Debris Fall Bluffs 	<p>Net Shore Drift</p> <ul style="list-style-type: none"> Convergence Zone Divergence Zone Transport Zone No Appreciable Drift 	<ul style="list-style-type: none"> Shoreline Armoring (Batelle Nearshore Habitat Assessments, 2009/2010) Kitsap County Boundary
---	---	--	--
