REMEDIAL INVESTIGATION REPORT
FORMER POPE & TALBOT INC. SAWMILL SITE,
PORT GAMBLE, WASHINGTON

Anchor QEA, LLC
Seattle, Washington 98101

Environmental Partners, Inc.
Issaquah, Washington 98027

February 2011

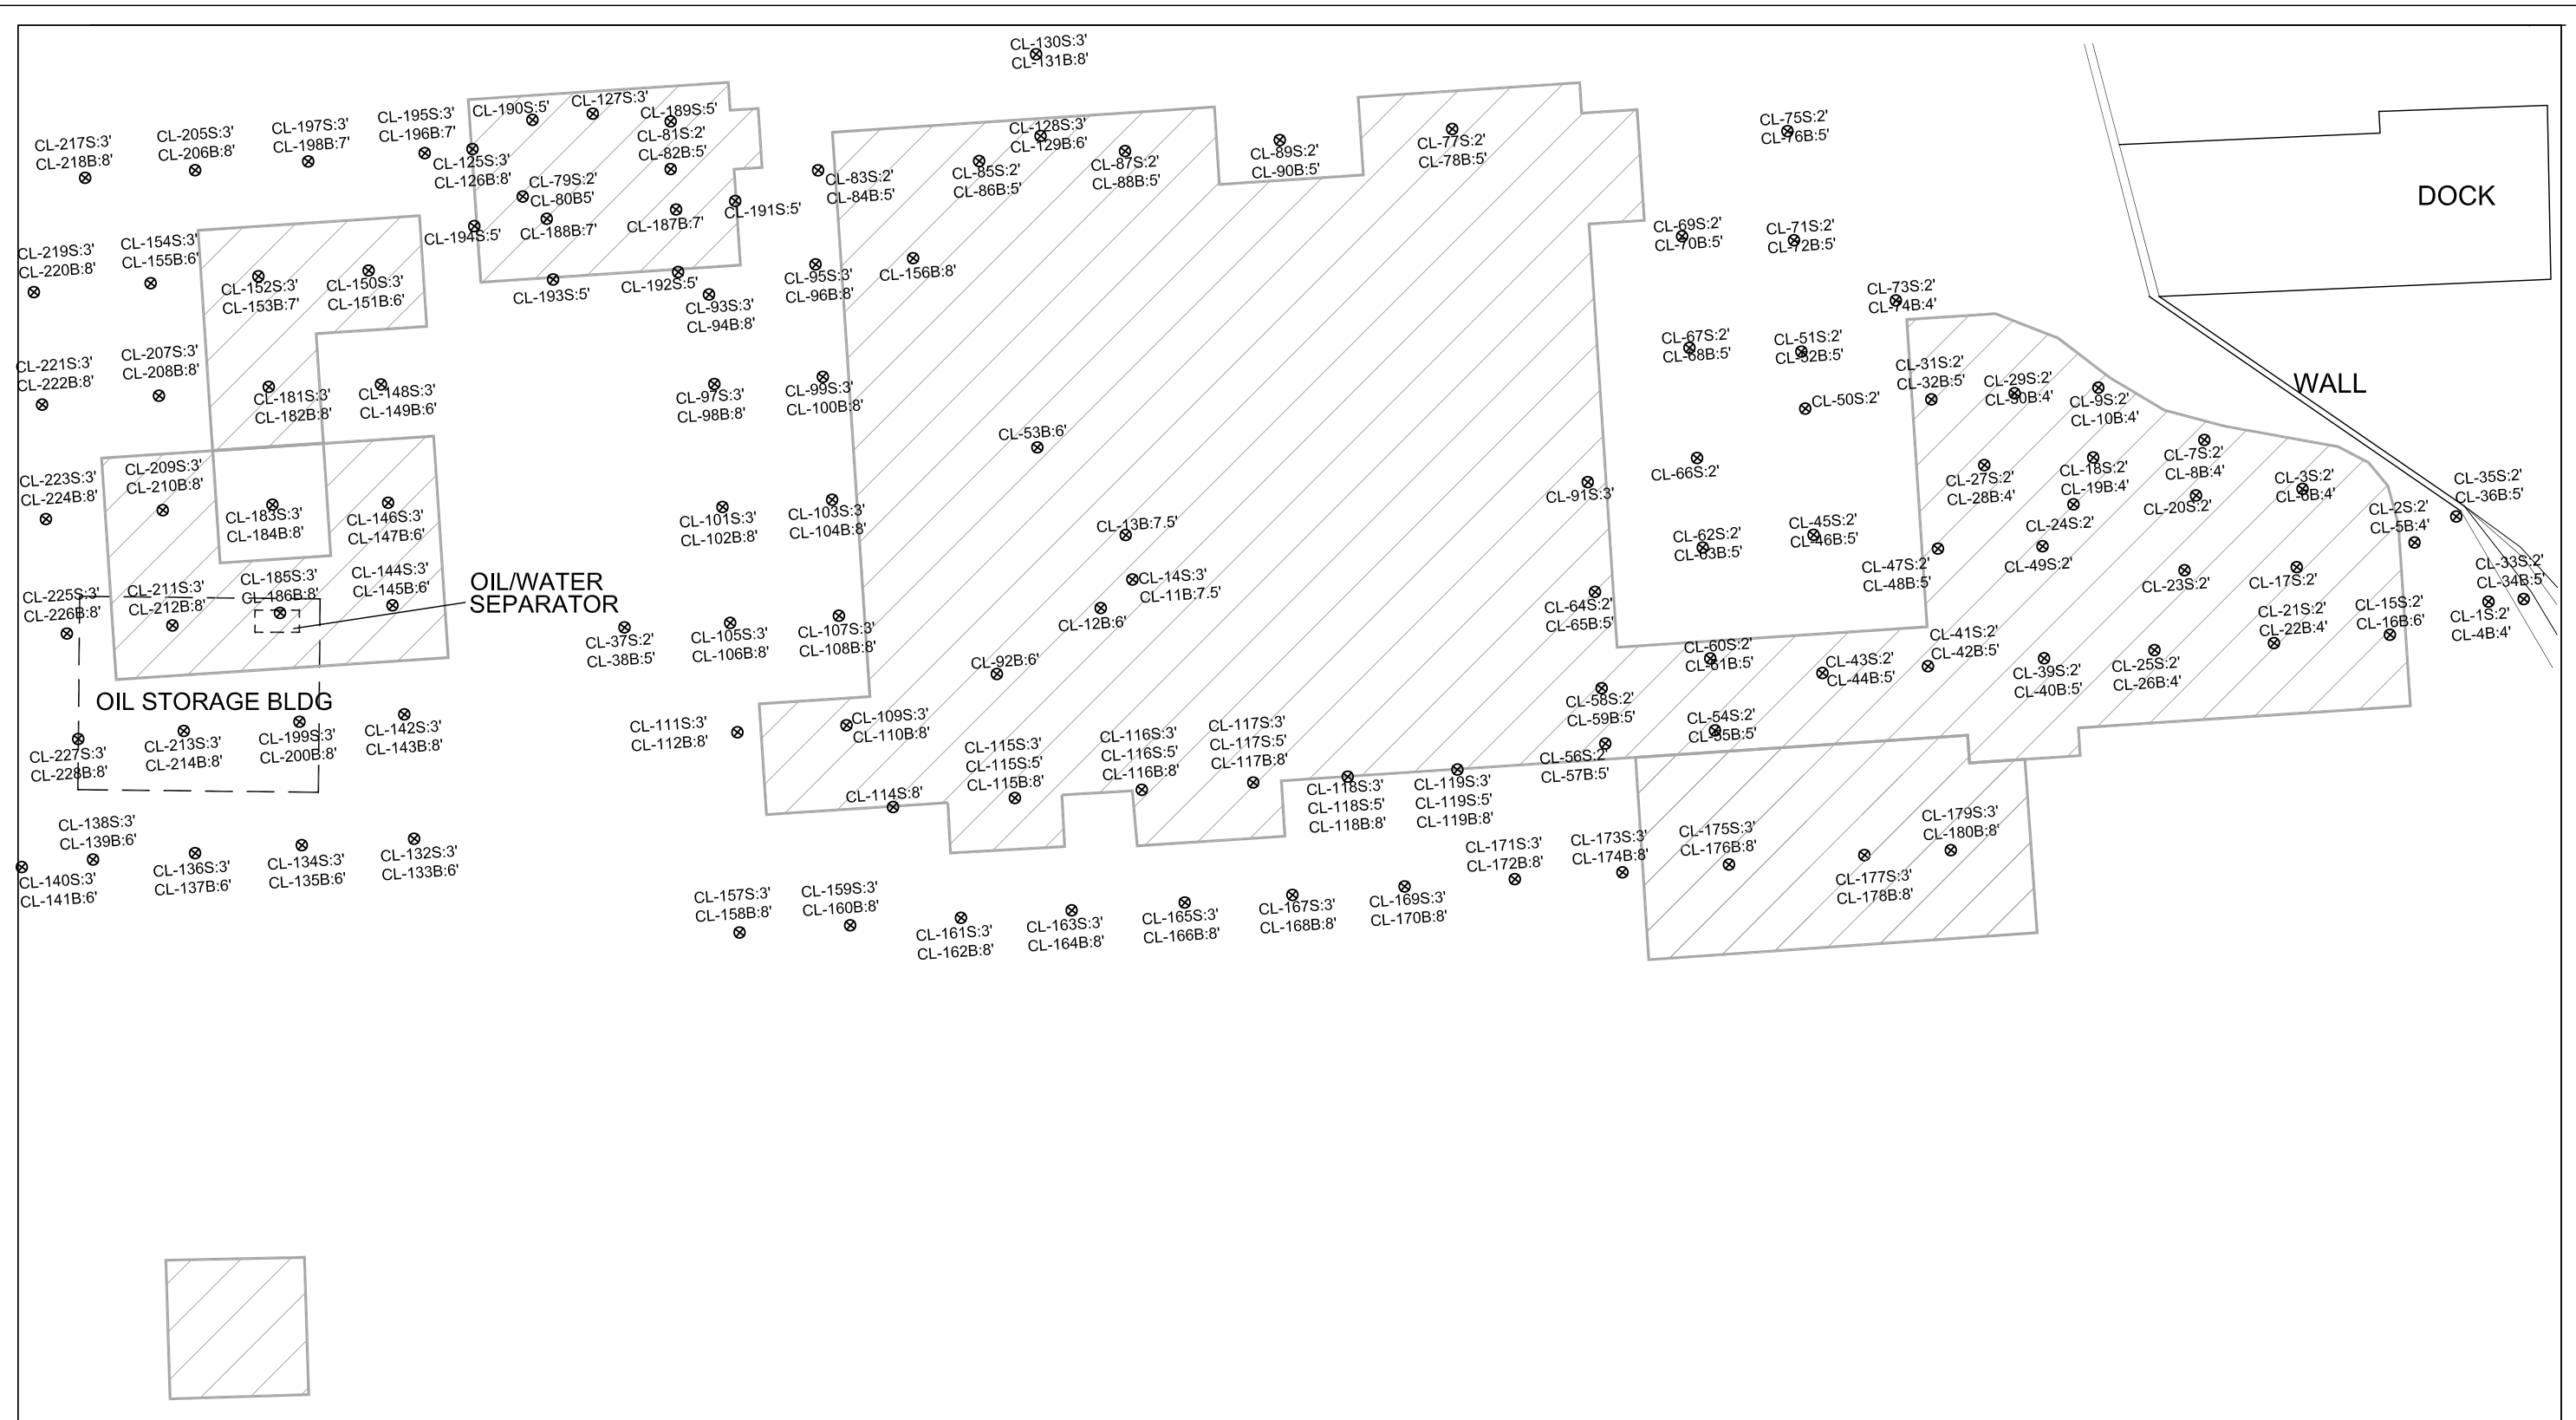
295 NE Gilman Boulevard, Suite 201 Issaquah, Washington 98027 FIGURE 4-1 CHARACTERIZATION SOIL SAMPLING LOCATIONS AREA 1 AND FORMER OIL STORAGE BUILDING 2002 IRM	PROJECT		17008.2	
	PREPARED FOR		POPE RESOURCES	
LOCATION		PORT GAMBLE MILL SITE PORT GAMBLE, WASHINGTON		
SHEET	DRAWN BY	REVIEWED BY	DATE	
1 of 1	MMH	SLG	04/26/07

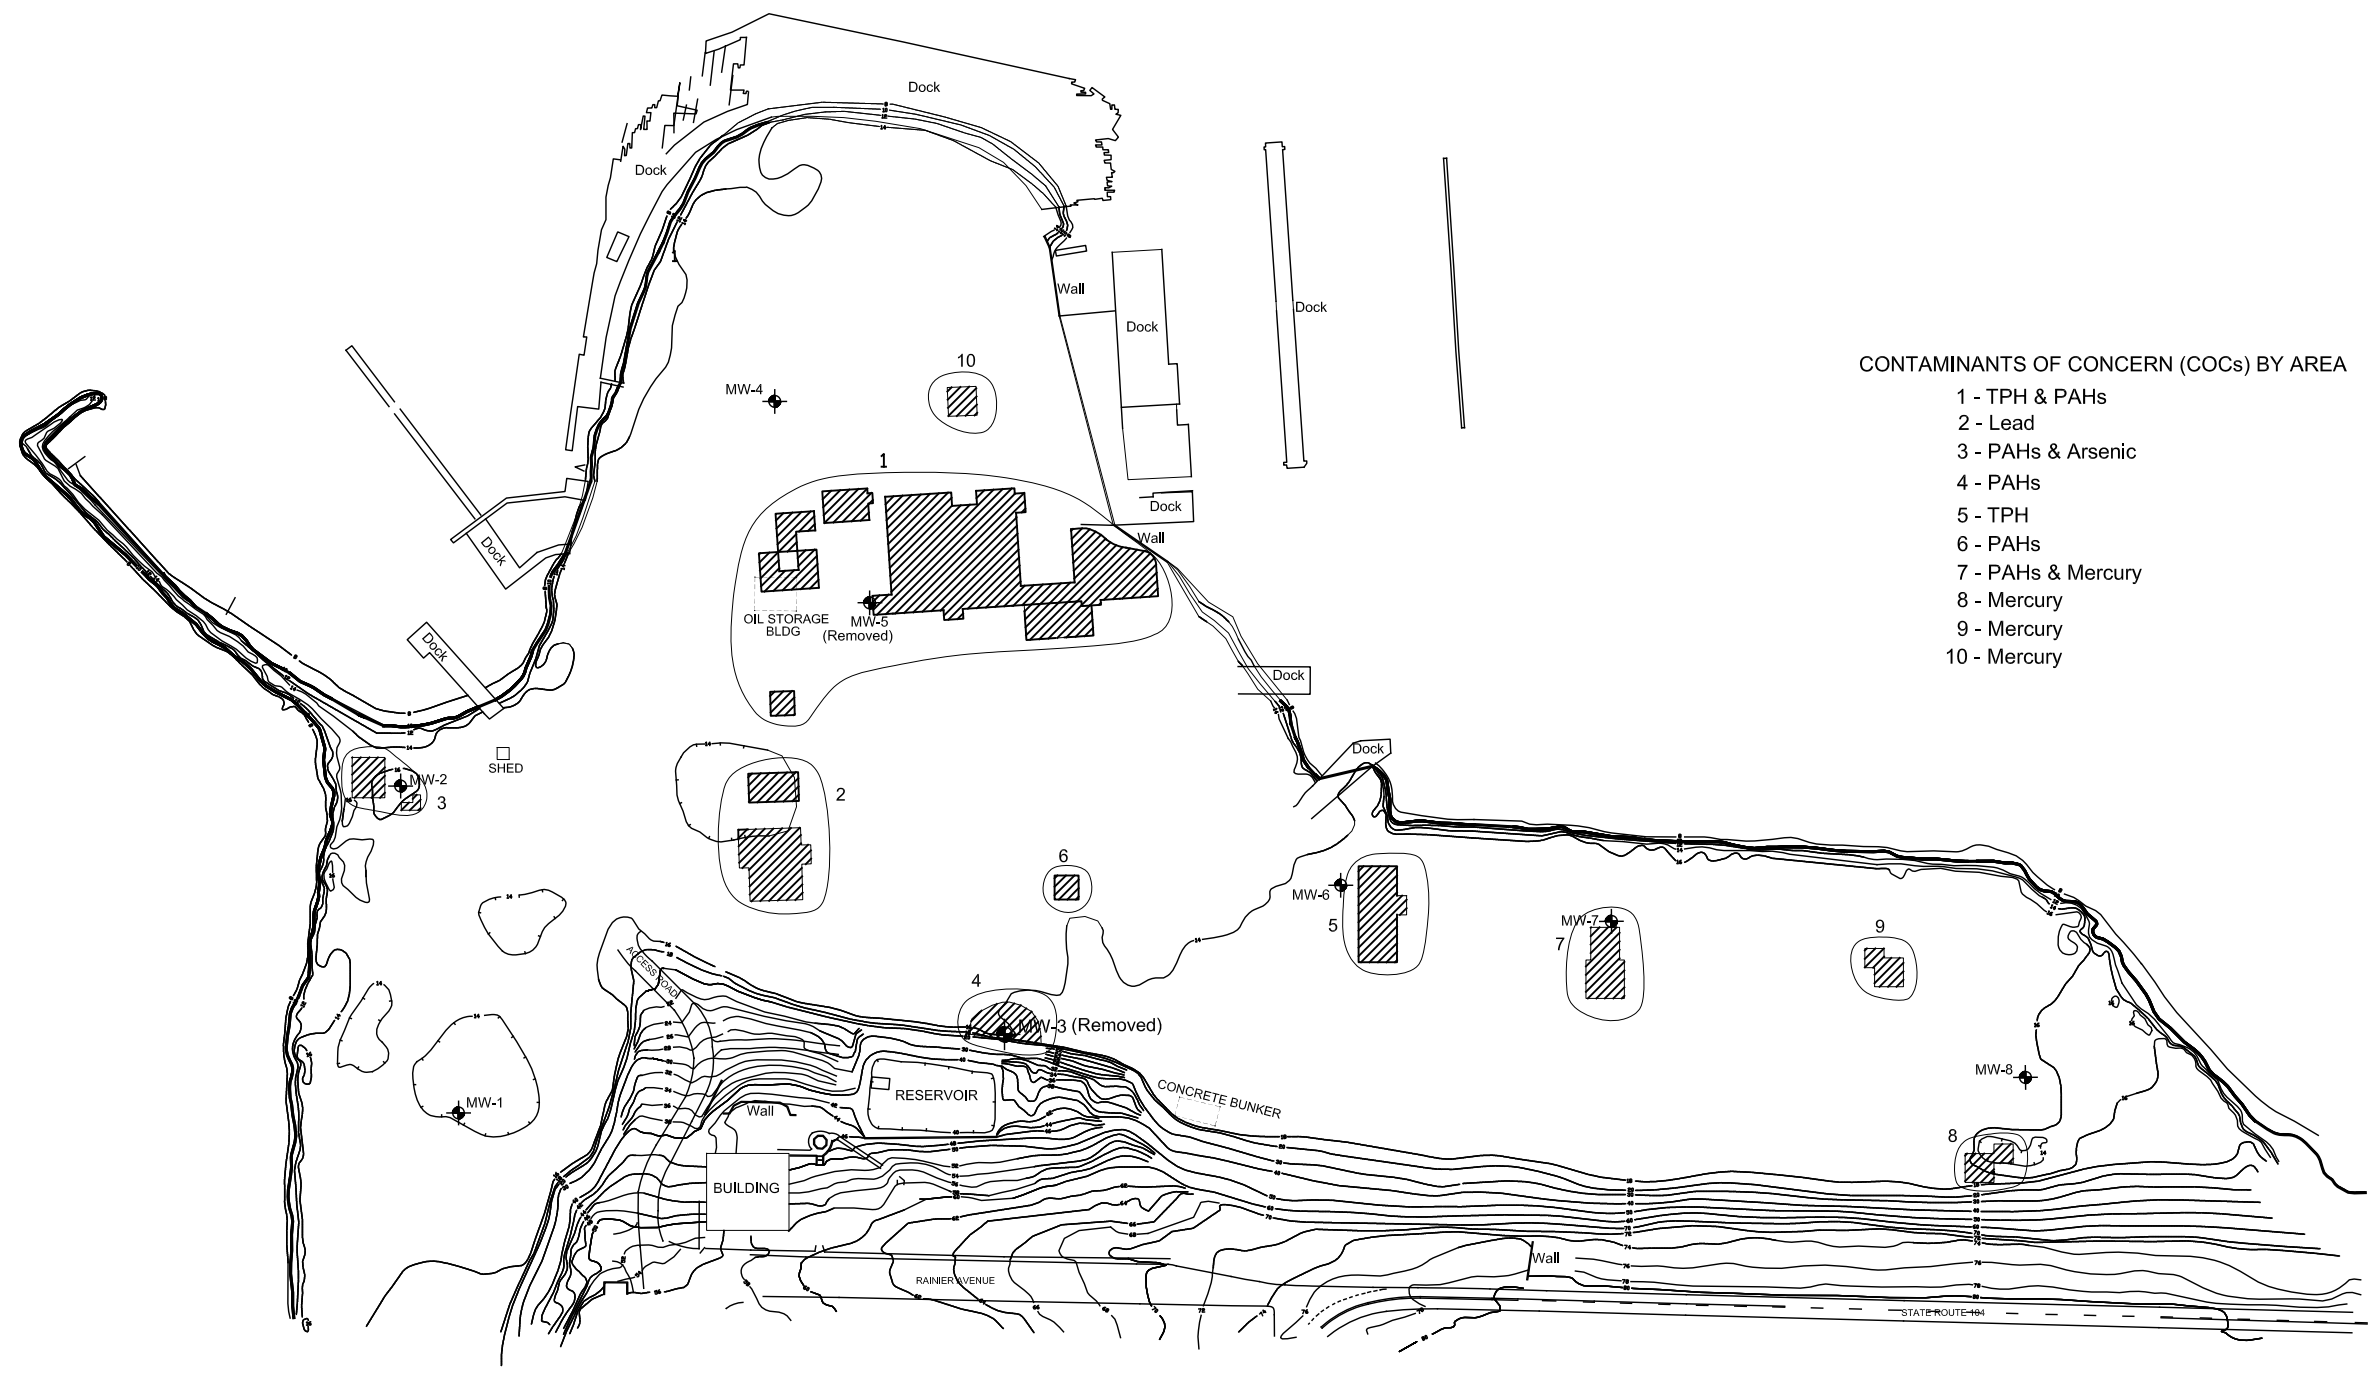
- MW-1 EXISTING MONITORING WELL LOCATION
- 72 ELEVATION CONTOUR (FEET ABOVE MEAN SEA LEVEL)
- 7 AREA DESIGNATIONS WITH APPROXIMATE FINAL EXCAVATION LIMITS

295 NE Gilman Boulevard, Suite 201 Issaquah, Washington 98027 FIGURE 4-3 SITE REPRESENTATION AND REMEDIAL EXCAVATION AREAS 2002 IRM	PROJECT	17008.2		
	PREPARED FOR	POPE RESOURCES		
	LOCATION	PORT GAMBLE MILL SITE PORT GAMBLE, WASHINGTON		
	SHEET	DRAWN BY	REVIEWED BY	DATE
	1 of 1	MMH	SLG	04/26/07

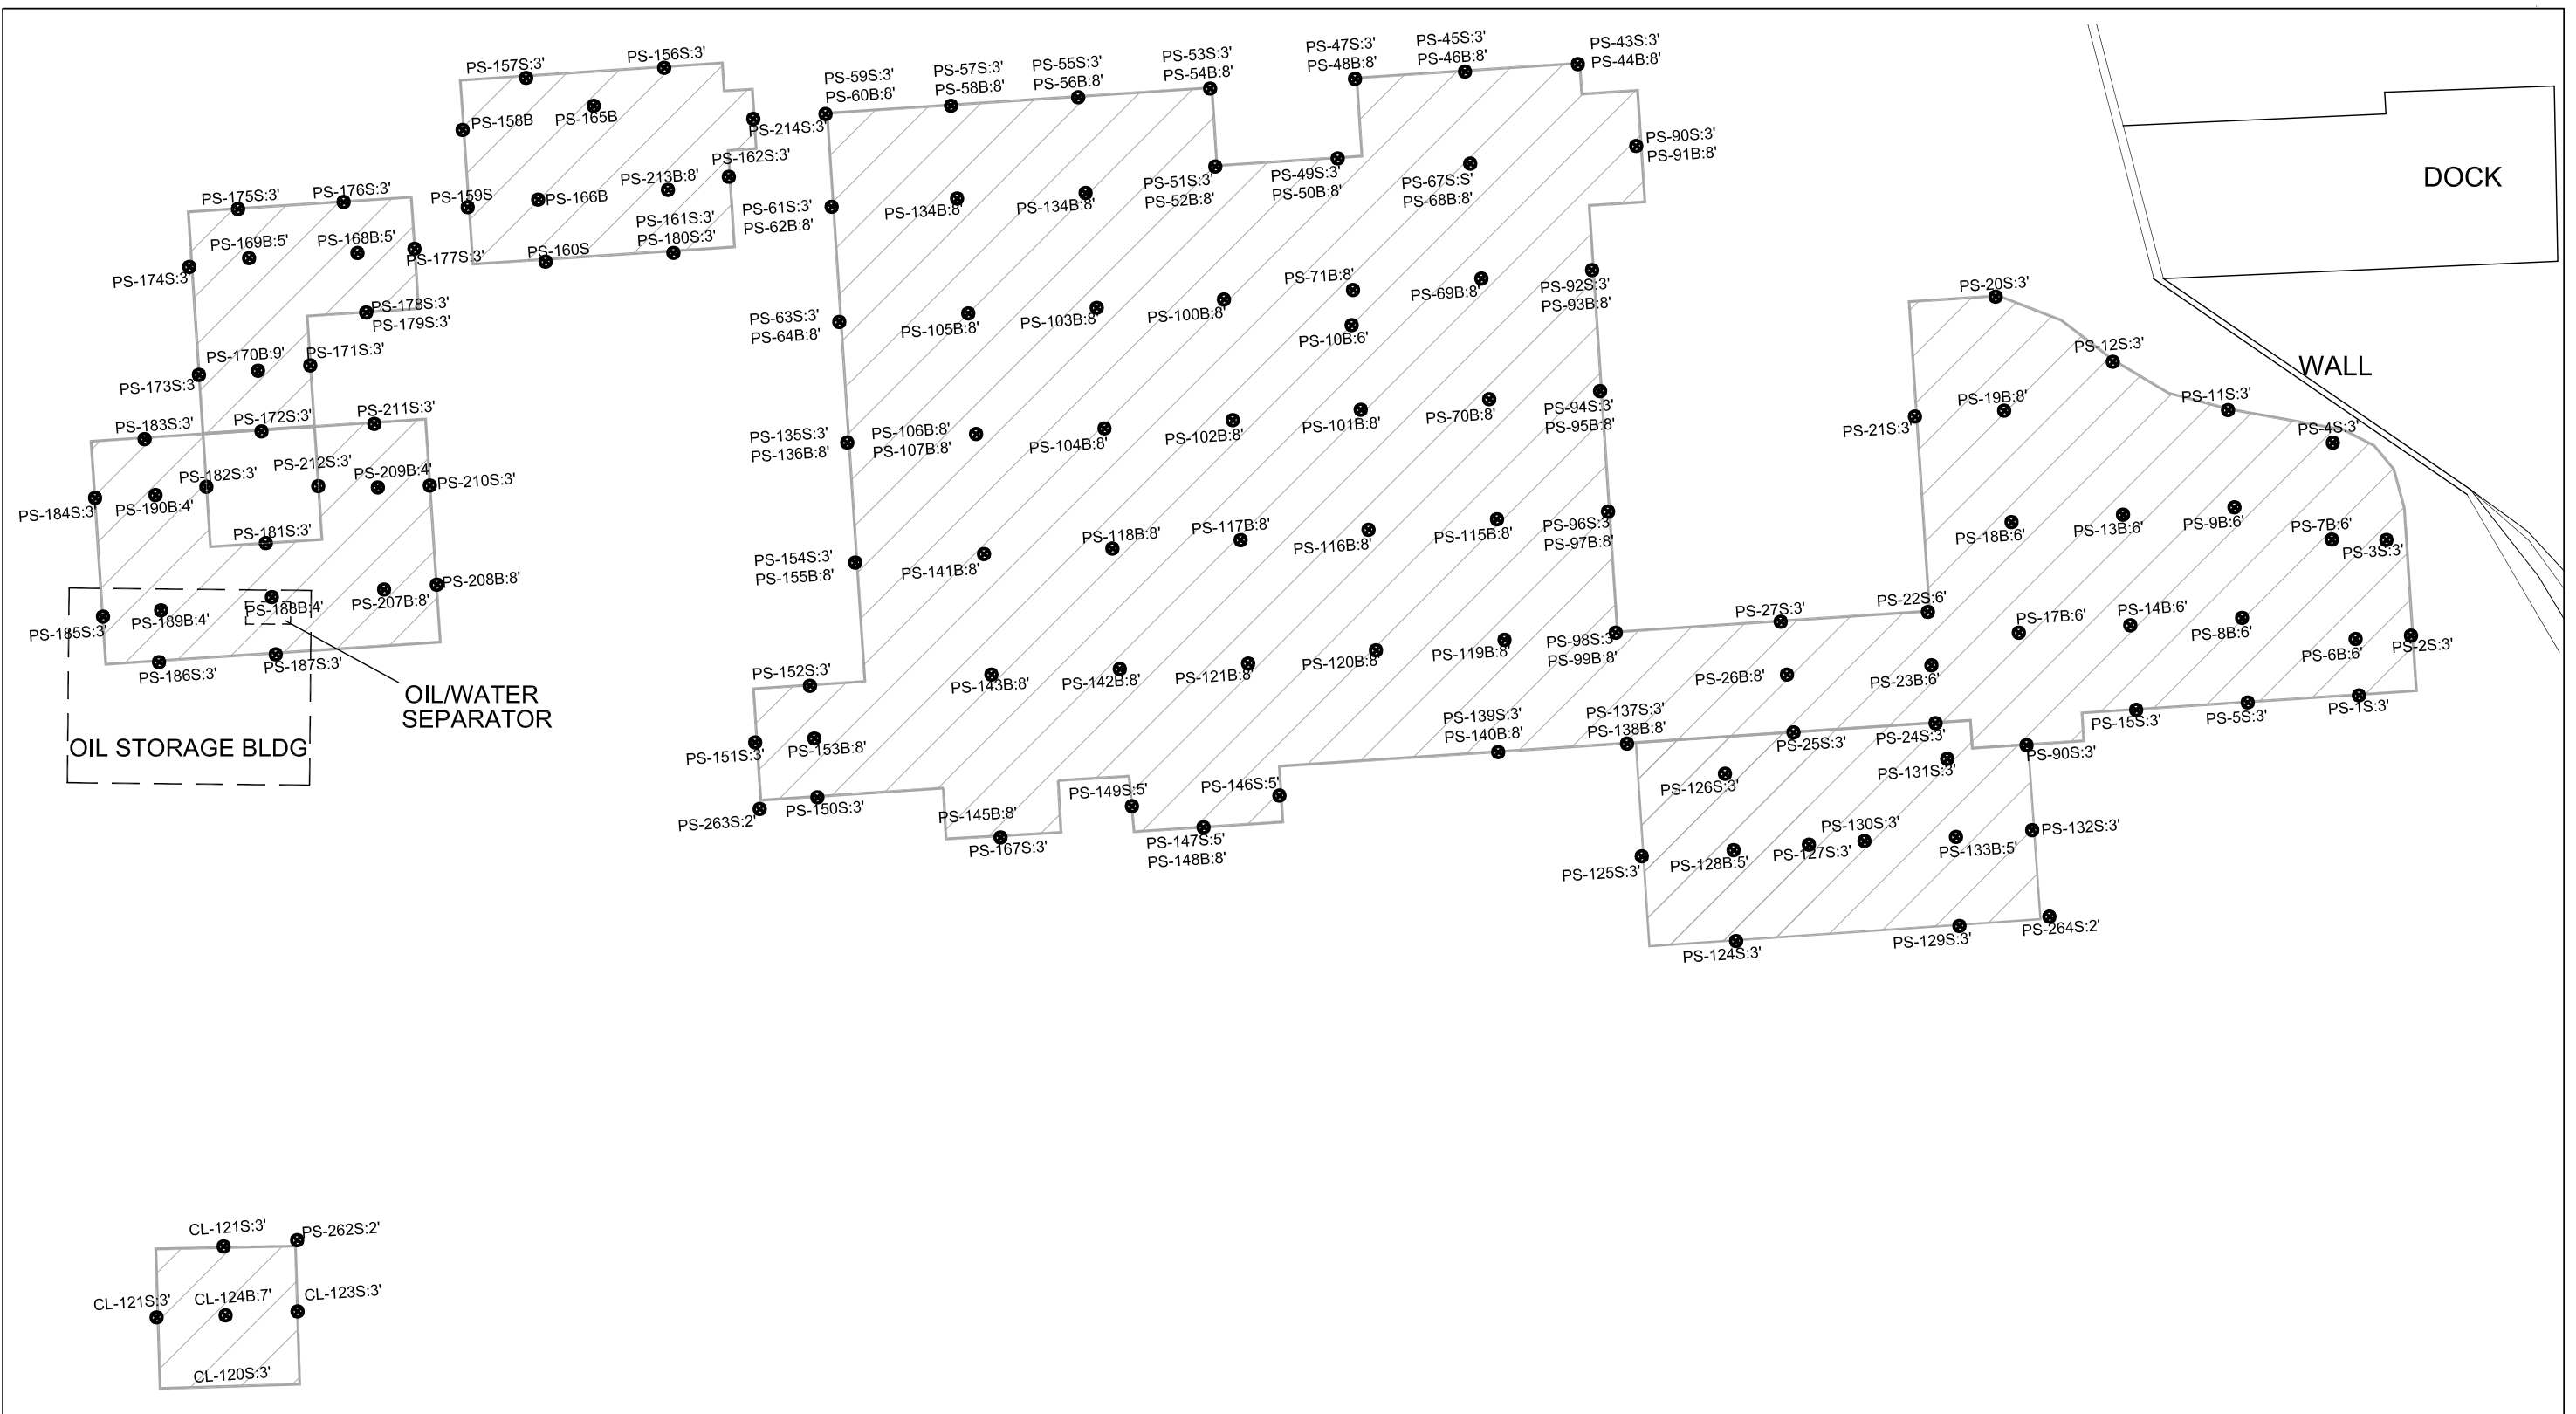
295 NE Gilman Boulevard, Suite 201 Issaquah, Washington 98027 FIGURE 4-4 EXTENT OF EXCAVATION AND FINAL PERFORMANCE SOIL SAMPLING LOCATIONS - AREA 1 2002 IRM	PROJECT 17008.2
	PREPARED FOR POPE RESOURCES
LOCATION PORT GAMBLE MILL SITE PORT GAMBLE, WASHINGTON	SHEET 1 of 1
DRAWN BY MMH	REVIEWED BY SLG
DATE 04/26/07
