### **INSPECTION REPORT**

This is a report from an inspection performed July 15, 2024, at the request of **Kitsap County Parks Department** of multiple buildings at 2485 McWilliams Road, Bremerton, WA. Known as Rolling Hills Golf Course.

The main structure, Restaurant and Pro Shop is a wood framed building built in the 1960's with a separate golf cart storage and 3 separate maintenance buildings.

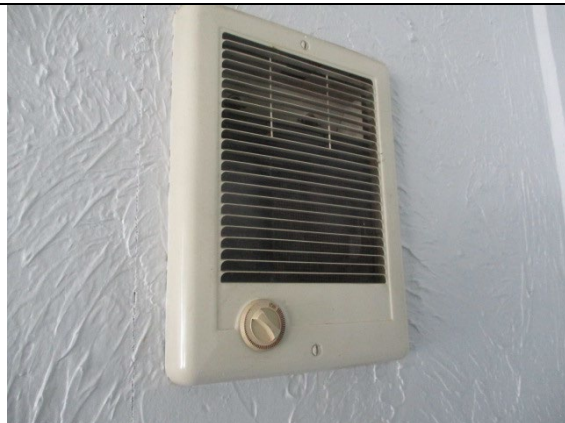
Recalled cadet heater
